ENGINEERING GEOLOGY PROBLEMS
AT AMBUCLAO DAM SITE
BOKOD, BENGUET, PHILIPPINES

SUBMITTED IN PARTIAL FULFILLMENT OF THE
REQUIREMENTS FOR THE DEGREE OF
MASTER OF SCIENCE
AT THE
MASSACHUSETTS INSTITUTE OF TECHNOLOGY
(1953)

ENGINEERING GEOLOGY PROBLEMS AT AMBUCLAO DAM SITE

BOKOD, BENGUET, PHILIPPINES

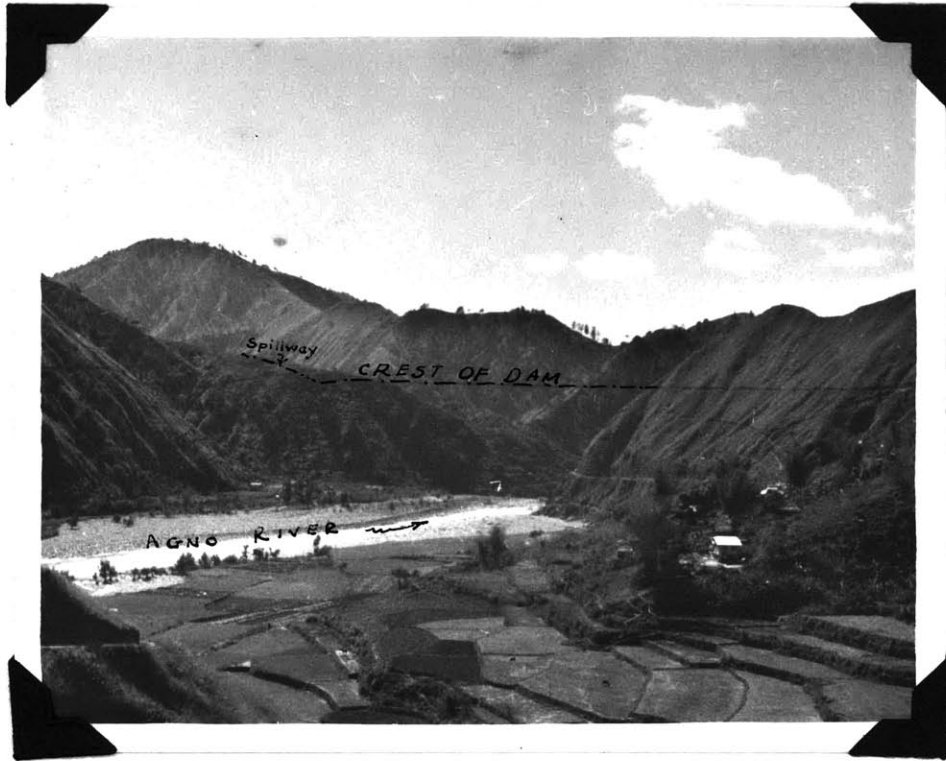
PLATE I-A

A. View of Ambuclao Dam Site.
(Upstream Side)

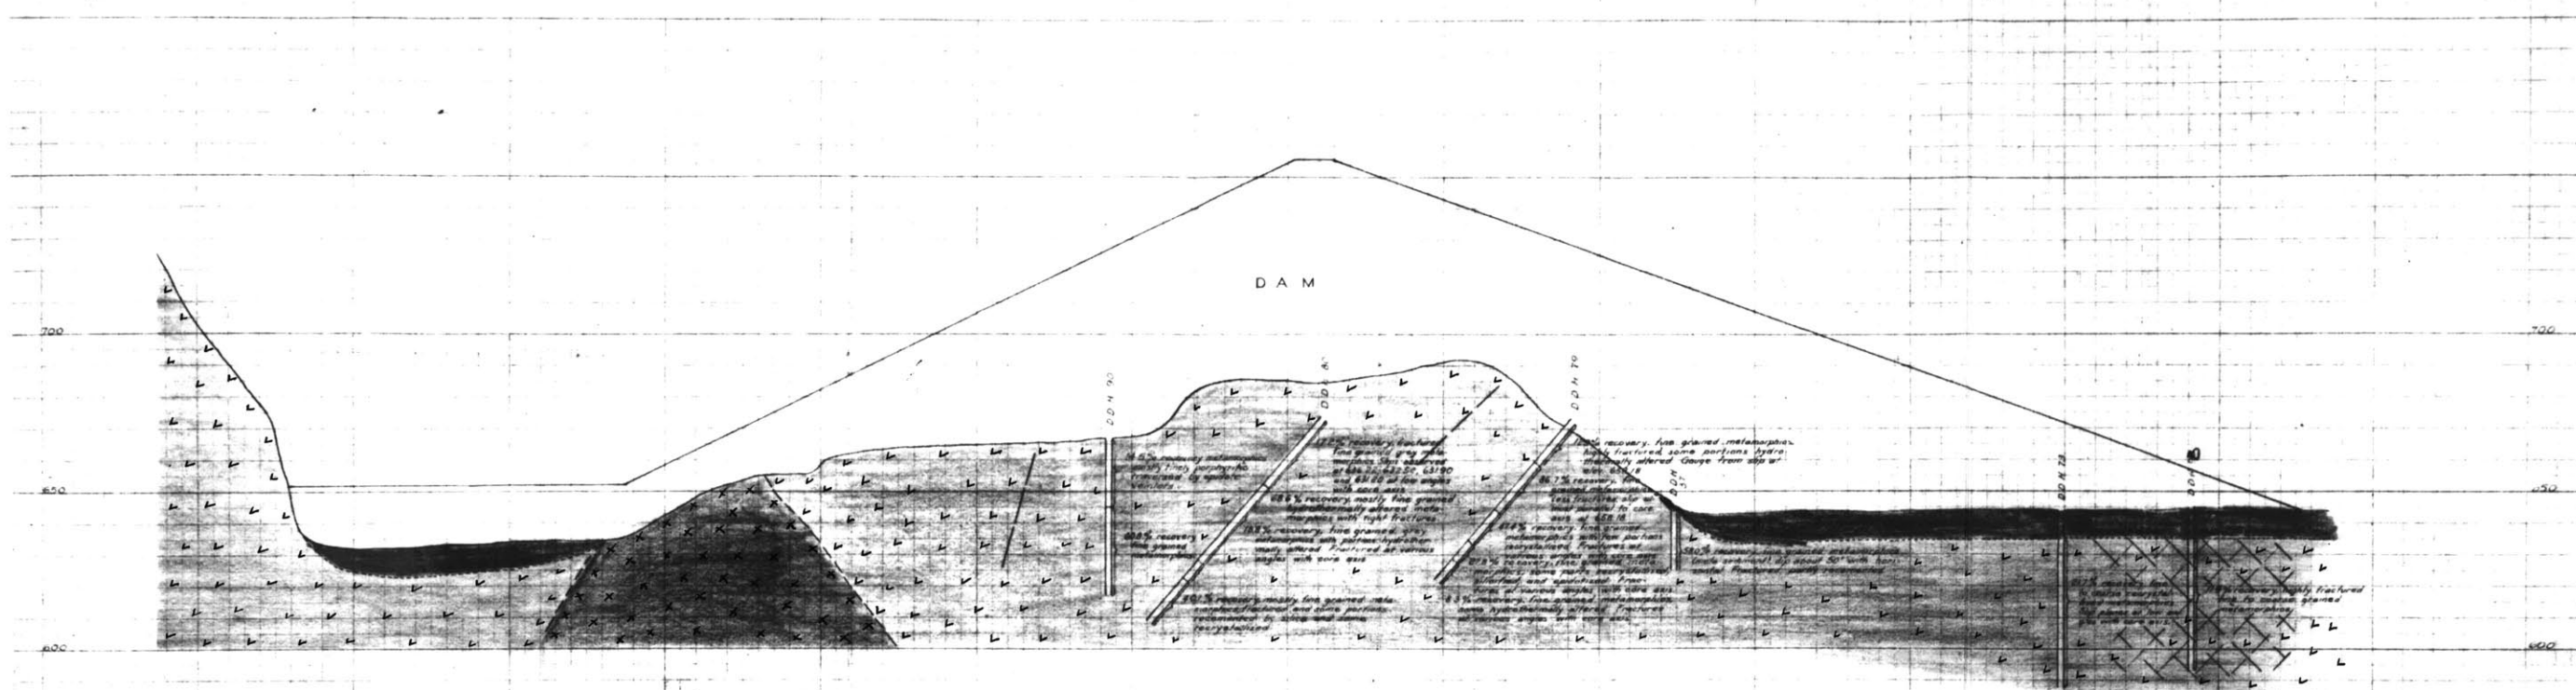
PLATE IX-B

The spillway structure is located on fractured and partly disintegrated metamorphics (Plate IX-B). A

GEOLOGIC SECTION AT WEST ABUTMENT
 (THRU DDH-73 AND 90)
 AGNO PROJECT No. 1, AMBUCLAO
 HOR. = VERT. SCALE 1:1000
