# A System Theoretic Safety Analysis of U.S. Coast Guard Aviation Mishap involving CG-6505

Jon Hickey

Master of Science in Engineering and Management  
at the  
Massachusetts Institute of Technology

May 2012

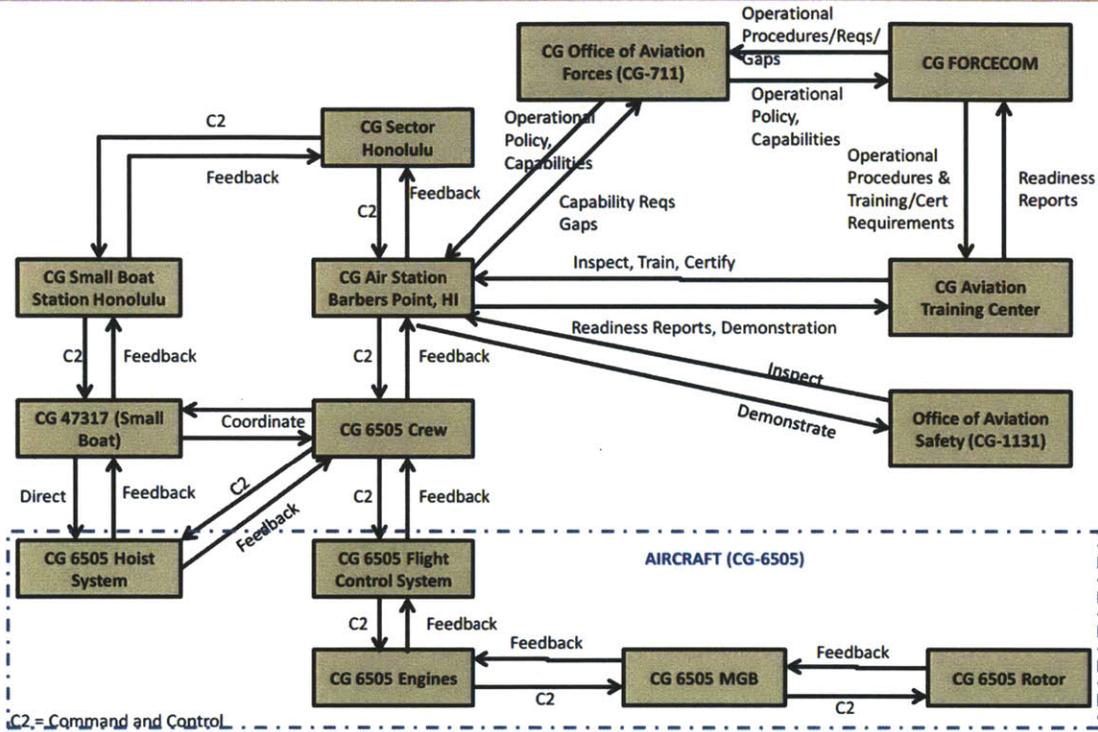
Figure 5.3 – CG-6505 Hierarchical Control Structure (System Operations Detailed View)

In this part of CAST, the physical system (e.g., CG-6505 (helicopter – dashed blue box in Figure 5.3) and CG-47317 (small boat)) is analyzed with the purpose of identifying the physical and operational controls and any potential physical failures, dysfunctional interactions and communication, or unhandled external disturbances that contributed to the events. The goal is to determine why the physical controls in place during the time of the accident were ineffective in preventing the hazard [18].

Per the Safety Control Structure (Figure 5.3), the CG-6505 Crew controlled the aircraft primarily by commanding and controlling the flight control system and the hoist system. The CG-6505 Crew received feedback from both the flight control system and hoist system via various sensors/gauges and visual/auditory observation. Additionally, the CG-6505 Crew coordinated operations with CG-47317 (small boat) via communication.

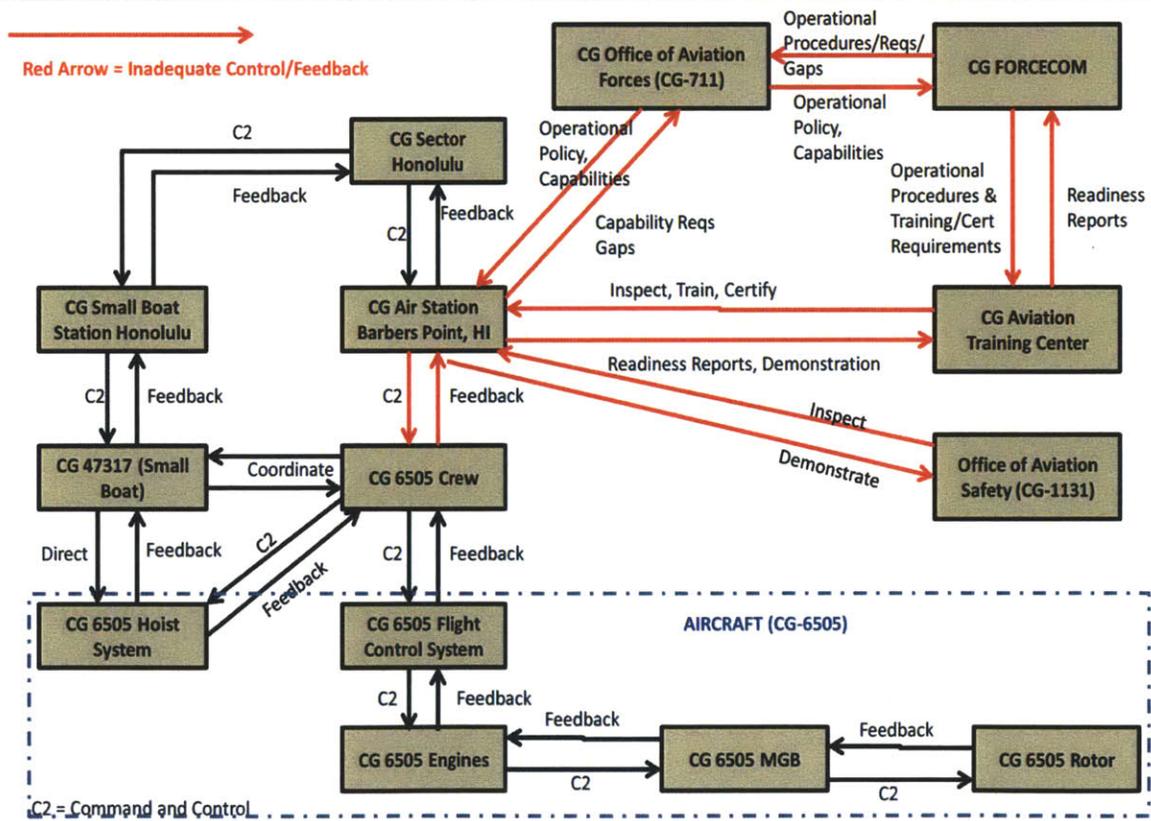
### Ditching Procedures & Life Safety Emphasis – Control/Feedback Inadequacies

Inadequate Control/Feedback – Capabilities Management System: General lack of control and feedback in the management of existing capabilities (e.g., HH-65):

- Inadequate Control/Feedback – Lack of Periodic Capabilities Review/Communication – Lack of formal periodic capability gap assessment (e.g., Operational Analysis) required/performed.
- Inadequate Control/Feedback – Lack of Integrated Capability Management – Lack of formal integration/standardization of helicopter operational capabilities across platforms.
- Inadequate Control/Feedback – Sponsor capability and requirements cataloguing: Lack of systematic process for documenting existing system and sub-system capabilities and operational capability gaps.
- Inadequate Control/Feedback – Lack of Safety Advocacy to Address Known Risks: Rather than advocating correction/mitigation, the Aviation Safety Division generally accepted known aviation operational risks (e.g., nighttime hoisting operations).

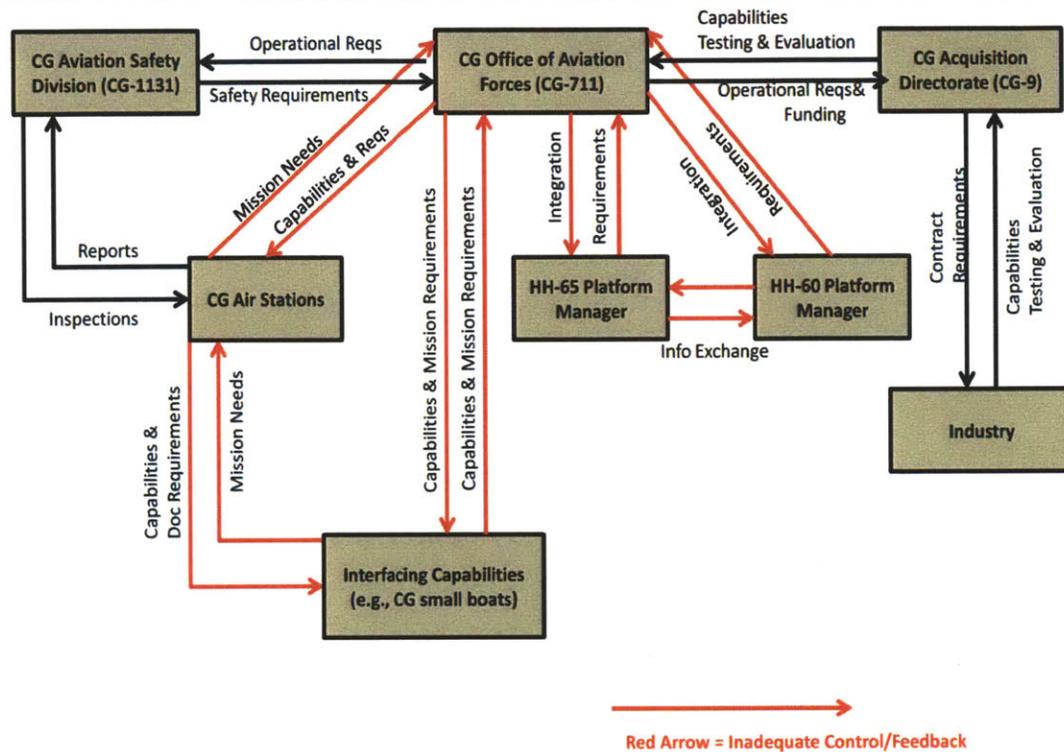
Sponsor/User Involvement in Design & Development – Control/Feedback Inadequacies

Inadequate Control/Feedback – Sponsor/User involvement in design/development: Lack of sponsor and user involvement, including like platforms and interfacing capabilities during acquisition and modernization efforts.

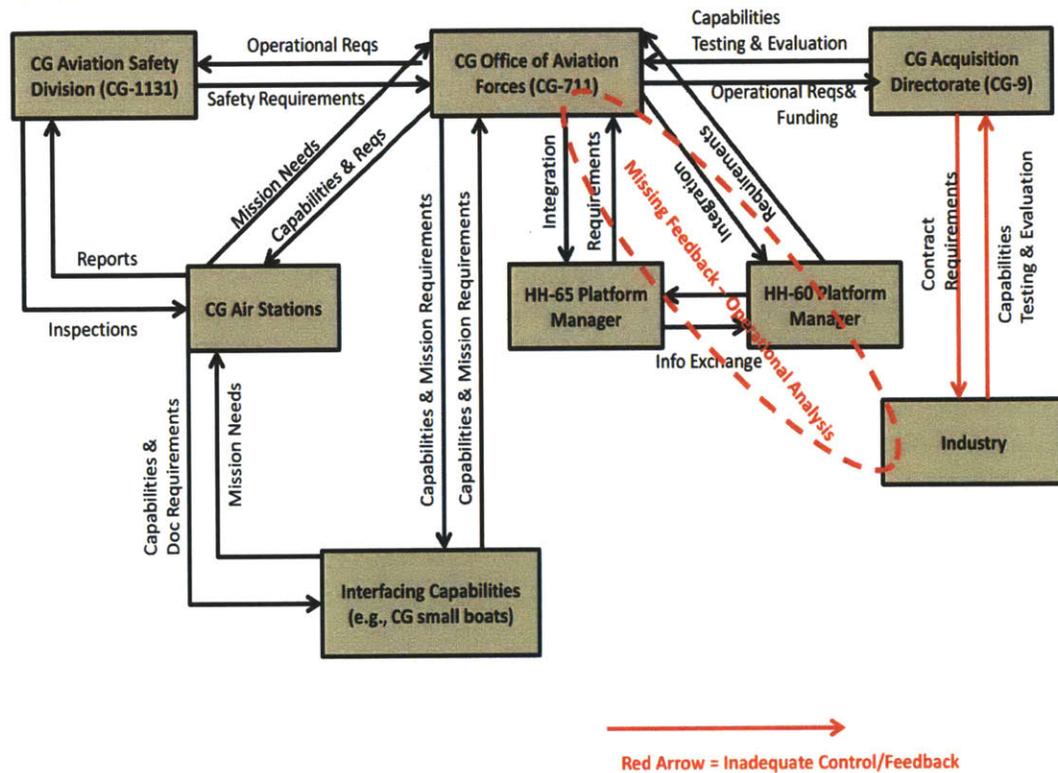
### Industry Involvement – Control/Feedback Inadequacies

Inadequate Control/Feedback – Coast Guard Acquisition Directorate and Industry: Lack of involvement with industry regarding state of the market capabilities and procedures.

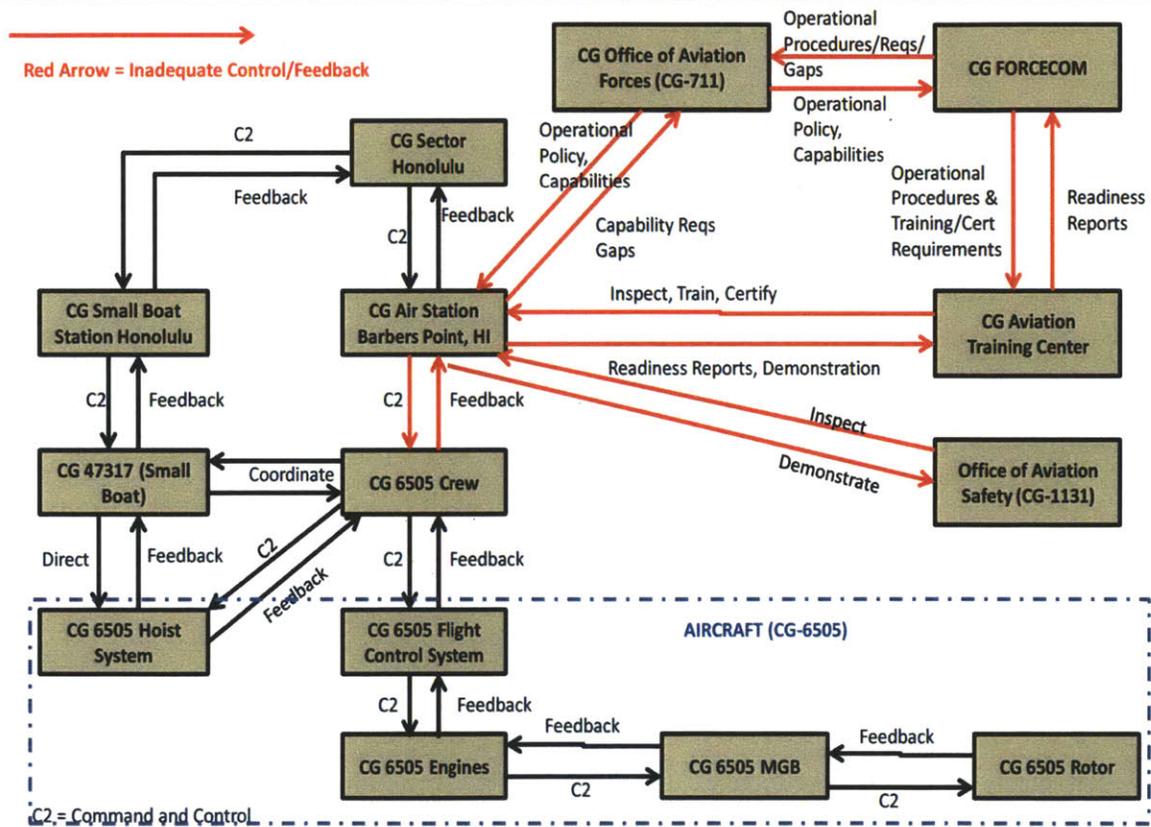
### CRM / ORM Training – Control/Feedback Inadequacies

Inadequate Control/Feedback – Lack of Standardized CRM/ORM Training: Lack of standardized training (observation and reporting) of Crew Resource Management and Operational Risk Management programs through use of multiple training delivery sources, collateral duty program, and limited programmatic guidance. Lack of identifying/cataloguing operational risks and mitigating actions specific to operational procedures/conditions.
