*Lessons from accidents during tunnel construction*

**Citation:** Sousa, Rita L and Einstein, Herbert H. 2021. "Lessons from accidents during tunnel construction." *Tunnelling and Underground Space Technology*, 113.

# Lessons from Accidents during Tunnel Construction

Rita L. Sousa\*<sup>1</sup>, Herbert H. Einstein<sup>2</sup>

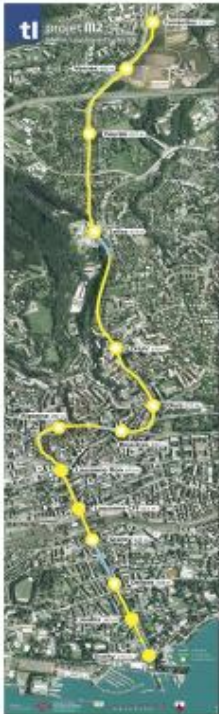
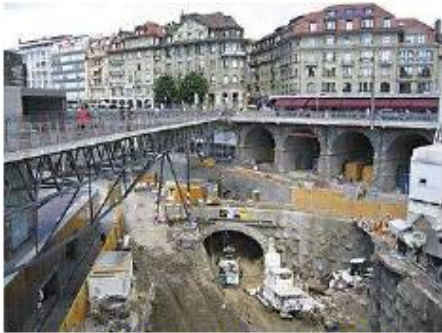
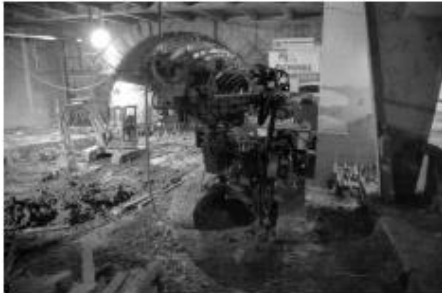
**Figure 2 Extract of the questionnaire – General Information section (Lausanne M2 metro line) (Sousa, 2010)**

| <p>Layout of the Lausanne M2 Metro Line</p> | <p>Saint-Laurent tunnel's passage under the 19th Century masonry bridge</p> |
| | <p>Line M2 in construction on the stretch of the former Metro-Ouchy</p> |

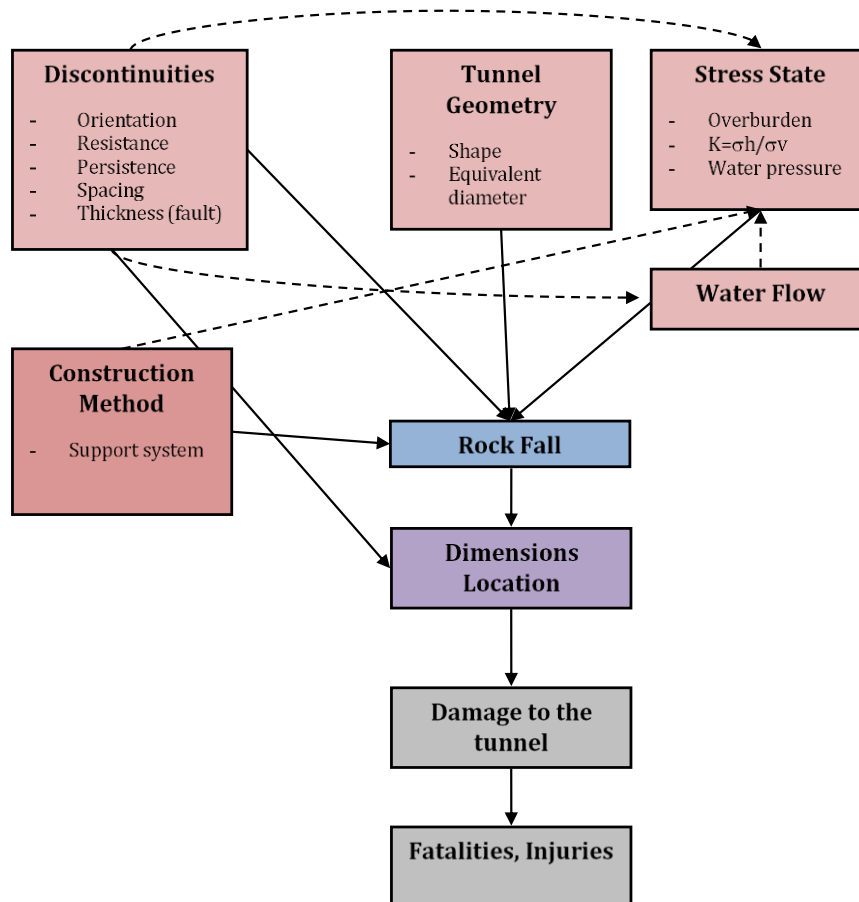
Figure 9 Rock Fall influence diagram

Figure 9 shows the influence diagram containing the factors that affect the likelihood of a rockfall as well as its consequences. The influence diagram is a summary of the most important factors that appear to be common to most of the cases of rockfall in the database. The dashed arrows in Figure 9 show how the factors related to the rock structure (discontinuities), stress state, water flow and construction method relate to each other. The presence of the discontinuities influences the local stress field around the tunnel. The discontinuities affect the water flow, since they will dictate the permeability during construction. Also, the presence of water / water flow will affect the effective stress state. Finally, the support system used is extremely important. The existence of an adequate support system will prevent an unstable wedge to slide and cause damage to the tunnel and machinery, as well as injuries to the workers. If the construction method is drill and blasting, it will affect the stress and fracturing around the excavation.

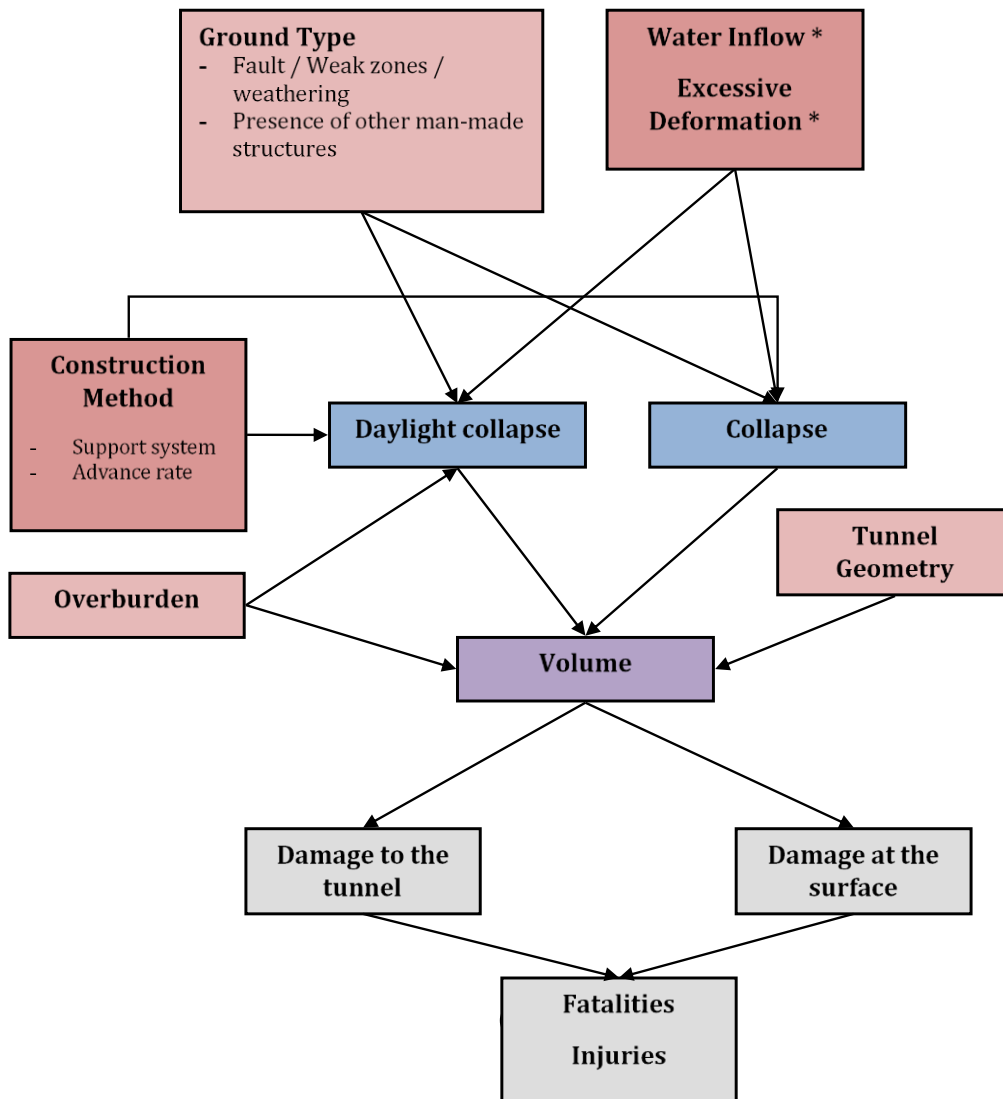
**Figure 11 Influence Diagram for Collapse and Daylight collapse**

The main “reported” cause of collapses and daylight collapses is unpredicted geology, i.e. *geology* that has not been predicted during the design phase. In most of the cases this corresponded to weak zones and fault zones, or karstic features. Examples are the collapses that occurred in Kurtkullagi irrigation tunnel in Turkey (project ID 12), where four collapses (two of them reaching the surface) occurred when the tunnel crossed an oversaturated clayey fault zone. Other examples are the Pinglin tunnels (project ID 30), the Evino-Morno tunnel in Greece (project ID 49) where a collapse occurred when the TBM ran into a very disturbed Flysch zone or the Shisanling pumped storage power station in China (project ID 54) where three large scale collapses occurred when the penstock tunnel was crossing a fault zones. Collapses can also be a consequence of *excessive deformation* and *excessive water inflow* (project ID 7) where excessive deformation among other causes led to a total or partial collapse of the tunnel lining. Excessive deformation of the lining can reach certain values that will result in the failure of the lining and eventually led to a partial or total collapse.

The presence of other man-made structures is another important factor. It is crucial to have them charted as best as possible, to avoid running into them and possible destabilizing the excavation, causing a collapse. This is what happened in the first collapse that occurred in the Porto metro (project ID 9) construction when the TBM hit an old well causing a collapse. Another collapse caused by man-made structures is the Istanbul metro (project ID 14), which involved an uncharted well. (1.5m diameter to about 12 m deep), located almost exactly above the place where the liquefied mud had flowed into the tunnel. It can be assumed that there was only about 1.5-2.0m between the well bottom and the tunnel crown and that the saturated clay and well water flowed into the tunnel, causing the well walls and surrounding clay to collapse. This allowed a fine-grained sand layer to drain into the resulting cavity. For other structures already built in the ground, it is necessary to consider their effect on the excavation of the new structure and vice versa. In the case of the Olivais station of the Lisbon metro (project ID 10), Portugal, a daylight collapse occurred in December 1996; one of the errors during construction that ultimately contributed to the daylight collapse was that a preexisting large utility tunnel located near the metro tunnel was not considered.

\* These events are shown here as possible causes for Collapse/ Daylight collapse. For more details see their own influence diagrams, which are not shown in this figure for reasons of space.

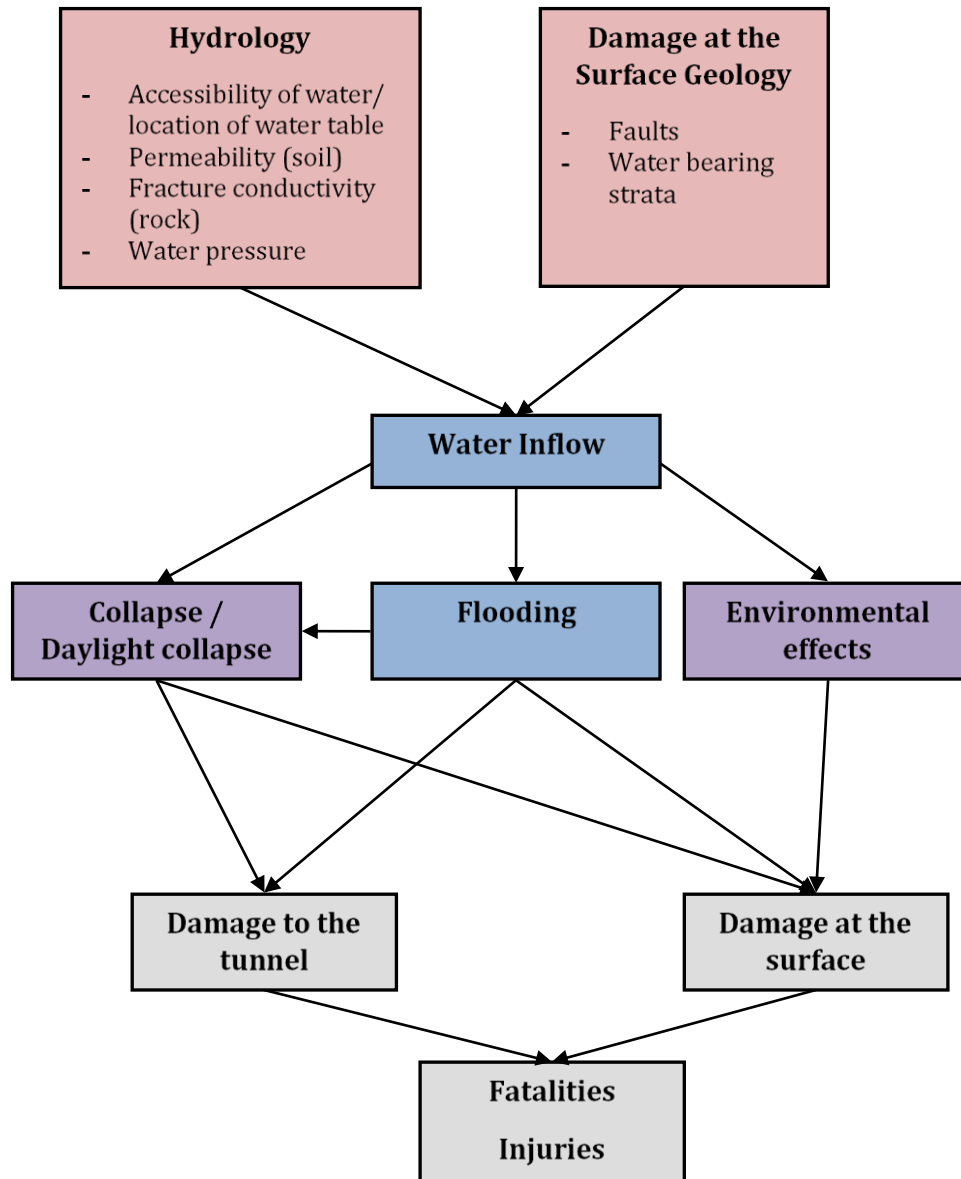
**Figure 13 Influence Diagram for Excessive water inflow / Flooding**

The impact of ground water on tunnel construction can be considerable. Gradual inflow of water is detrimental to the construction process, while the sudden inrush of water is a source of great danger, and many accidents have been caused by it. The sources of a sudden water inflow into the tunnels are faults, water bearing strata, caverns in karst formations. Therefore, the *hydrology* and *geology* along the tunnel alignment, such as the presence of faults or water bearing strata, as well as the knowledge of the permeability (soil) and fracture conductivity (rock) are extremely important when studying the problem of water inflow, in order to design and choose construction and mitigation measures that are adequate for the encountered conditions.

Water inflow and presence of water during construction can lead to *flooding* of the tunnel, can cause instability and eventually *collapse or daylight collapse* of the tunnel and / or have adverse effects on the *environment*, due to lowering of the water table. An example where collapses occurred with flooding of the tunnel is the case of the Pinglin tunnels, in Taiwan (project ID 30). Several incidents occurred due to a combination of fractured shear zones and highly pressurized water inflow. The collapses were large because the water washed the fine-grained material into the excavation, burying the TBM. The 10th stoppage was the worst incident of the pilot tunnel and caused the TBM to be totally buried requiring the construction of a bypass tunnel.

Water inflow is difficult to predict based on monitoring instrumentation results. However, exploration ahead of the face can be of great use in the identification of faults and water bearing strata. The most common mitigation measure for the problem of water inflow is to pre-treat the ground with grouting or/ and drainage. There were some cases where ground freezing was also used.

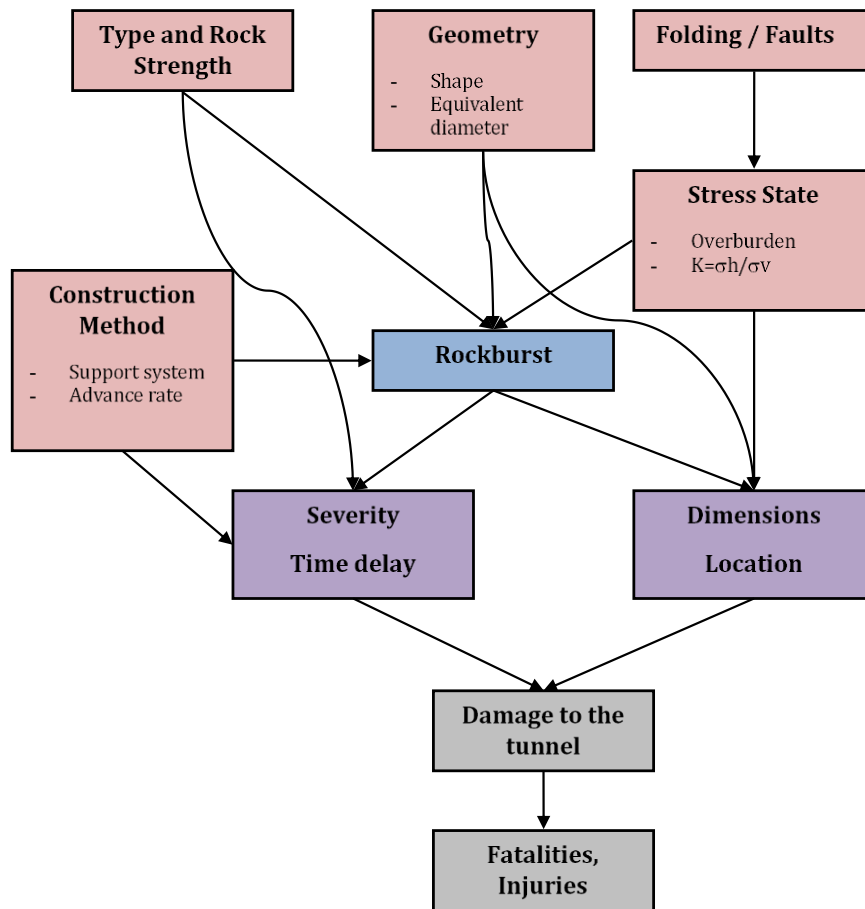
**Figure 15 Influence diagram for Rockburst**

This type of event is caused by the overstressing of massive or intact brittle rock, i.e. the stresses developed in the ground exceed the local strength of the material. It can cause spalling or in the worst case sudden and violent failure of the rock mass. There are several types of rockburst and different rockburst damage mechanisms. In this work, we narrowly define rockbursts as violent and sudden ruptures of rock that can cause serious, and often fatal, injuries. They are mainly dependent on the stress exerted on the rock, which increases with depth.

The location where the rockburst occurs usually depends on the *in-situ stress* and the *geometry* of the tunnel. An example is the Laerdal tunnel in Norway (Project ID 61), where the vertical stress was high due to an overburden reaching a maximum of 1450 m, but where the horizontal stress was also high, caused by the tectonics of the area. The rockburst can occur at the face of the tunnel or behind the face (i.e., once the face has passed) on the side walls and roof. A case of rockbursts occurring at the roof of the tunnel was a water tunnel in Korea, project ID 123 (Figure 14). Another parameter that seems to influence the time delay of the occurrence is the *advance rate* of the construction.

The *construction method* seems to also have an influence on the susceptibility of an excavation to rockburst. Not only the existence of a support system that stops the violent ejection of fragments of rock is essential to guarantee the safety, but also the type of construction process seems to influence the severity of the rockburst. According to experience, for the same type of conditions, for the same rock, strain bursting is more likely to occur in a machine-excavated tunnel than in a drill-and-blast tunnel (Stacey and Thompson 1991), because in the latter situation, the induced fracturing in the rock around the tunnel caused by blasting, destresses the rock mass and creates conditions that are less prone to rockburst by strain bursting.

Rockbursts are not easy to predict. Investigations using acoustic emission monitoring are sometimes recommended. Acoustic emissions allow one to monitor the accumulation of cracking and evaluate the tendency for the rock to suffer rockburst.

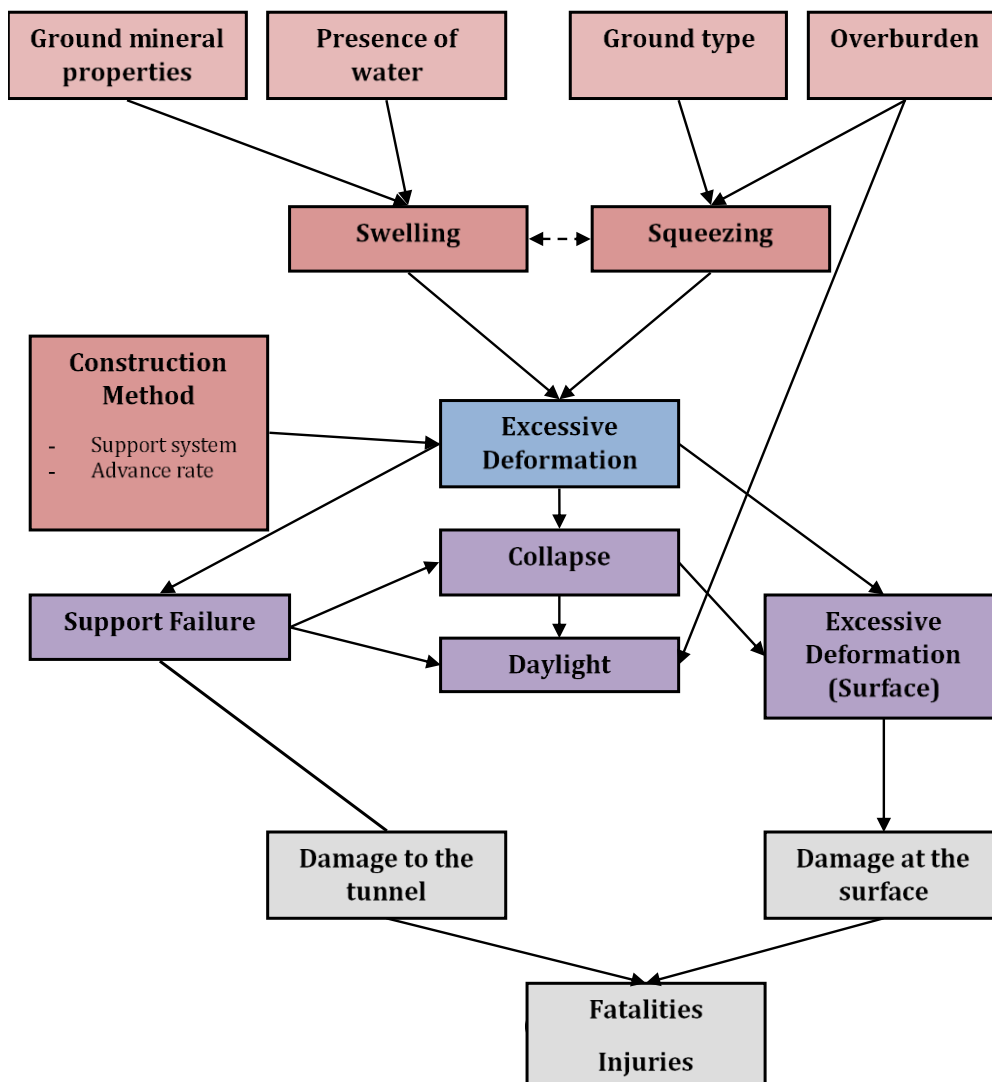
Figure 16 Influence Diagram for Excessive Deformation (inside tunnel)

These are cases where excessive deformations occur inside the tunnel or at the surface, but an actual total collapse does not happen. This can occur for example due to deficient design, construction defects and/or in a particular type of terrain, such as swelling and squeezing ground:-

Swelling is described as a time dependent volume increase of the ground, leading to inward movement of the tunnel perimeter. Three types of mechanisms have been identified: ‘mechanic’, ‘osmotic’ and ‘intra crystalline’ (for more details see Einstein, 1996). Common to all three mechanisms is the important role of *pore pressure* in the phenomenon of swelling. To predict the behavior of a tunnel in swelling or squeezing ground, it is necessary to know the natural stress state, stress changes, *ground water conditions* and *material properties*. In order to be able to make adequate predictions regarding this type of behavior, the engineer should perform several tests that will allow him/her to identify and quantify the swelling properties of the ground (see Einstein, 1996; Barla, 2008). However, due to the interaction of different mechanisms, it is not always very easy to predict the amount of swelling that may occur. Swelling occurs mostly in the tunnel invert and can develop rapidly depending on the access of water to the excavation. A case of swelling that occurred during tunnel construction is the one of the Chienberg tunnel in Switzerland (project ID 71), where during the time that the tunnel construction was stopped due to a previous collapse, the invert was left open. After 4 weeks a heave of 1.5m was observed in the invert near (behind) the zone of the collapse. Another example of excessive deformation due to swelling is what occurred in a tunnel from Rotarelle to San Vittore, part of the Naples Aqueduct, in Italy (Project ID 22). After 650m of excavation, enormous ground pressures caused cracking of the shotcrete, buckling of the steel arches after a few hours, and deformations of 200 mm in 24h and 400 mm after 12 days. The deformations were caused by swelling clay filling of the rock. Einstein (2000) presents several case studies of tunnels excavated through Opalinus Clayshale and gypsum (Keuper) in the Swiss Jura Mountains, which show how problematic swelling can be during construction and also during operation, if the invert is not strong enough and if water flows into the rock.

Squeezing is characterized by large time-dependent convergence during and after tunnel excavation. Many authors refer to squeezing ground behavior whenever large convergence occurs, whether it happens during construction or with a time delay. This occurrence of large pressure may lead to failure of the lining and / or result in great difficulties for completing underground works, with major delays in construction schedules and cost overruns (Barla and Pelizza, 2000; Kovari, K. and Staus, J. 1996). An extreme consequence of excessive deformation in tunnels is the partial or total collapse of a tunnel, which was the case in the Gotthard base tunnel (Project ID 97) in Switzerland, where a partial collapse occurred due to squeezing.
