Witness to the Light  
The Evolution of Church Sanctuary Design &  
Standards of Comfort in the Last Century in Harrison County, Iowa

Submitted to the Department of Architecture in Partial  
Fulfillment of the Requirements for the Degree of

Bachelor of Science in  
Art and Design

Massachusetts Institute of Technology

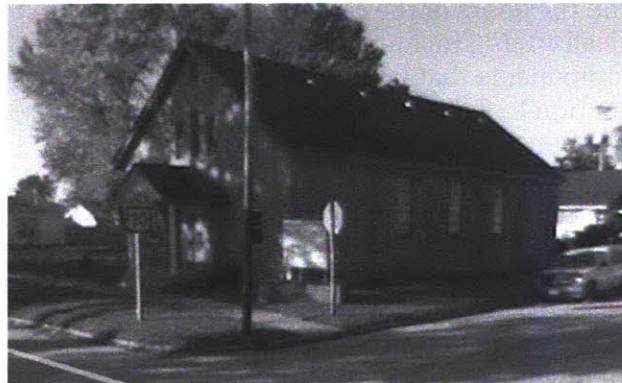
Figure 4. Grace Community Fellowship Church, built in 1954 (Google Maps).

In figure 4 above, a more typically modern approaches to sanctuary construction can be seen. The windows are made of uncolored glass and take up a relatively small percentage of the overall wall space. There is no steeple; the most noticeable signs that this is a religious, semi-public building are the double doors and the single, undifferentiated volume of the building.

windows, repainting dark interior finishes white, and so on. However, in churches of newer construction (as shown in figure 4), which can have lower ceilings and smaller windows in the sanctuary, it seems likely that the overall quantity of light throughout the year has decreased.

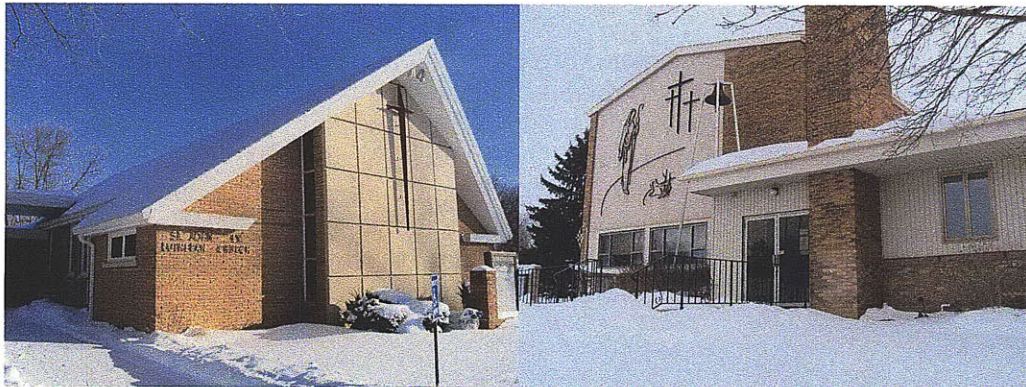
Figure 12. Churches of the 1950s in Harrison County; at left, St. John Evangelical Lutheran Church, built 1958; at right, Missouri Valley First Lutheran, built 1959 (Darling 2009).

Churches built in the 1950s through the 1970s, such as those in figures 12 and 13, in Harrison County typically used more angular shapes in their windows, smaller areas of glazing, and larger individual panes of glass. Often the sanctuaries lowered their ceilings from previous heights. Of course there are exceptions to these general trends; the First Lutheran church sanctuary shown in figure 12 has a twenty foot ceiling and ceiling-to-floor windows spanning fifteen feet of its north wall. However, the desire for a more “modern,” angular shape is still clear from its form.

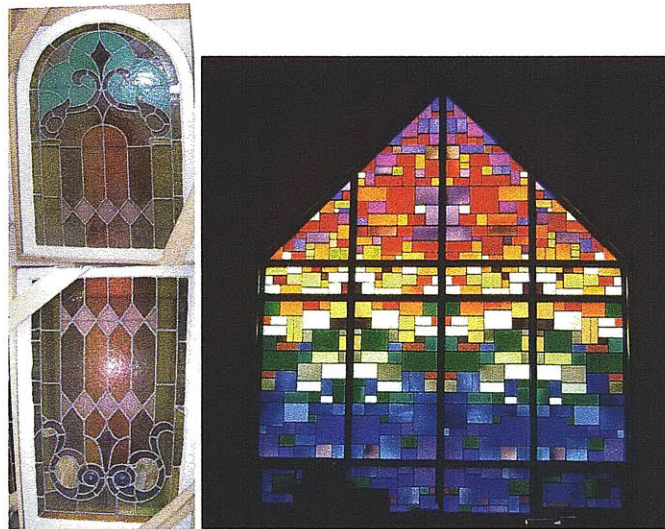
Figure 26. Windows from Logan Christian Church before and after renovation.

Perhaps the most interesting transition made in the Logan Christian Church is from their original stained windows to the large, puzzle-like “art glass” windows added in the 1970s, shown below in figure 26. The original windows used organic shapes and Romanesque Revival forms, whereas the new windows are simpler and more angular. From visual inspection of the exterior of the church it is apparent that these new windows are double-paned or have a protective hard plastic sheet covering them.

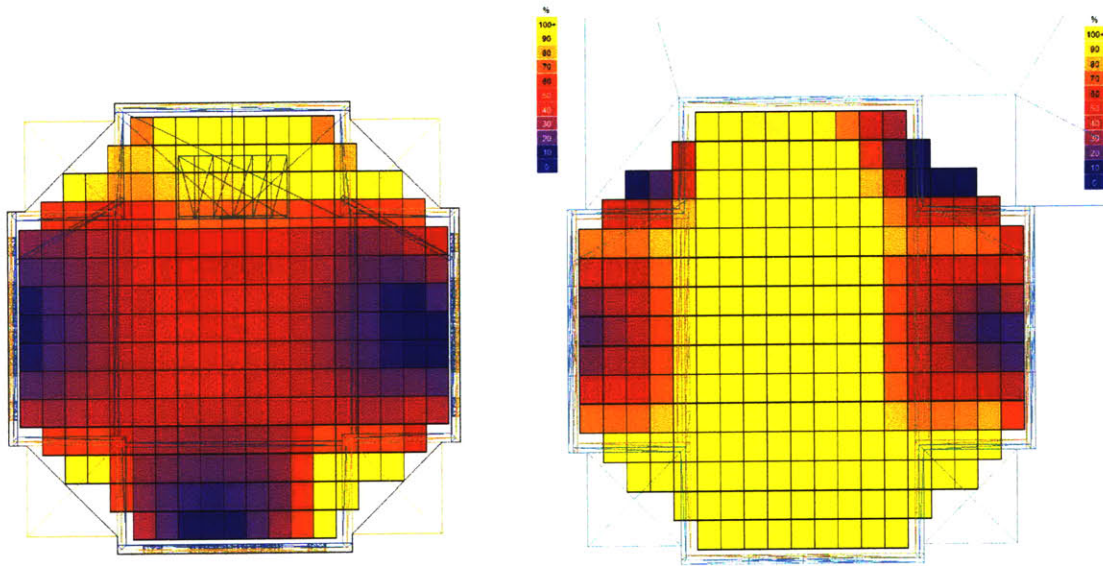
Figure 44. Log UDI < 100 before and after changes, balcony

In both conditions, the occupied portions of the balcony level are above 100 lux for most of the year (figure 44).

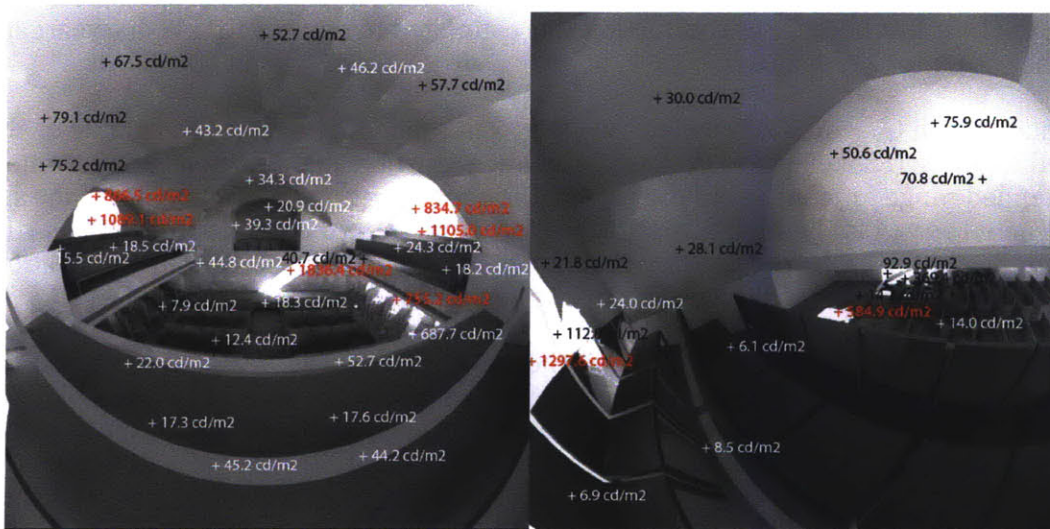
Figure 48. Radiance simulation image with measurements of luminance for a seat in the south balcony (pre-renovation) and the west balcony (post renovation) on September 21 at 9 AM.

Like the Missouri Valley Church of Christ, one way the Logan Christian Church mitigated glare problems was by removing sanctuary seating for which glare was an issue. The south balcony, because it commanded such a complete view of the church, had glare issues all year long (figure 48). This balcony was removed, and the somewhat limited visibility of the remaining east and west balconies effectively reduces glare.

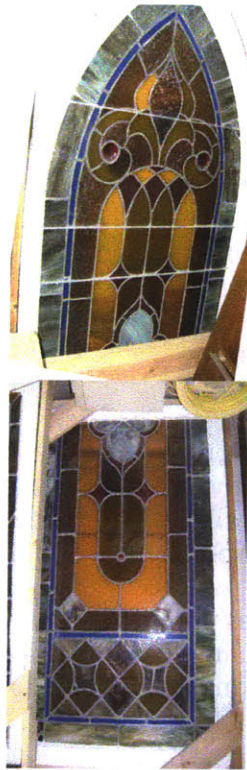
Figure 53. One of the original windows from the 1904 Logan Christian Church, removed in 1970.

The deciding factor in the renovation might not have been the cost of energy lost through the windows but the cost of repairs. The old windows, one of which is shown in figure 53 and discussed in the the introduction, were quite intricate, with almost no two pieces of glass the same size or shape. These windows had apparently suffered some damage during their six decades of use, because during the 1970s renovations they were deemed too expensive to repair and instead entirely replaced with “art glass” (Logan Centennial 1987). The new windows were composed of rectangular pieces of glass, which are presumably easier to replace if necessary.

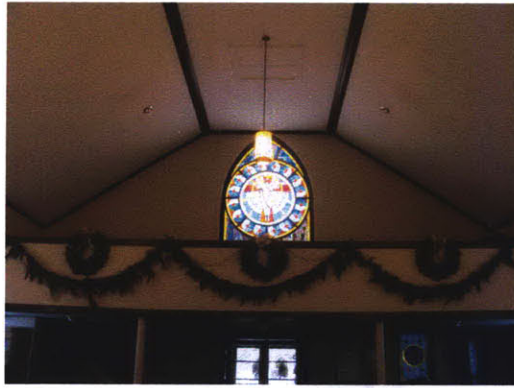
Figure 53. Dropped ceiling in St. Anne's Catholic Church in Logan, Iowa.

Certain changes seen in the two case studies seem fairly typical for churches in this county. For instance, both of these churches dropped their ceilings about mid-century, a decision shortly preceding the introduction of air conditioning and the accompanying air ducts. Dropping the ceiling also provides a place to add in more insulation. As shown in figure 53, this type of ceiling is invariably made planar and angular, or simply flat, when dropped, although the original ceilings were frequently vaulted in a smooth curve. Neither of these types of renovations reflects light in the same way a barrel vault.

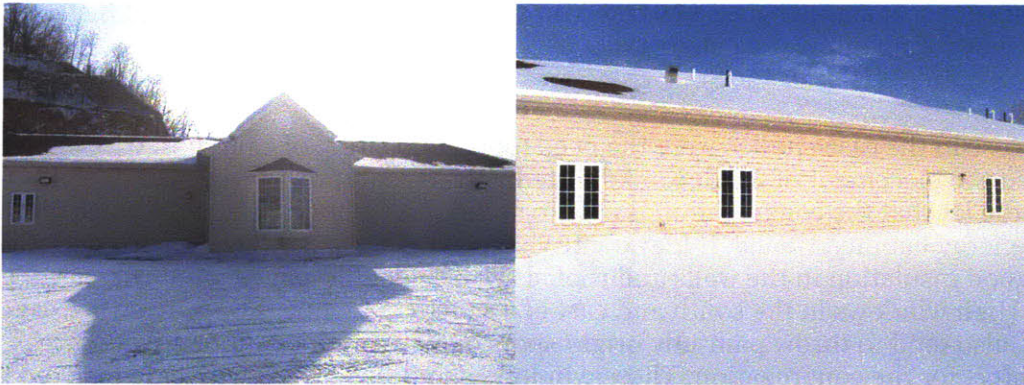
Figure 54. Recently build Missouri Valley Community of Christ Church (formerly R.L.D.S.); a minimum of glazing.

There is an obvious trend toward using less glazing in newer churches and building with lower ceilings. In some ways, this could be considered a return to the earliest sanctuary forms that appeared in Harrison County, the simple Prairie Gothic boxes with small pointed windows. However, at that point in time the cost of glass rather than the cost of energy was the limiting factor (*Glass History 2010*.) The far extreme of this approach is perhaps displayed in figure 54 below, which show the relatively new Community of Christ (formerly R.L.D.S.) church in Missouri Valley. This building has virtually no glazing at all, a ceiling no higher than a single-story house, and at first, second, and even third glance is indistinguishable from a private home.
