IMPACT DAMAGE MECHANISMS IN SEVERAL LAMINATED MATERIAL SYSTEMS

Submitted to the Department of Aeronautics and Astronautics in Partial
Fulfillment of the Requirements for the Degree of

MASTER OF SCIENCE

MASSACHUSETTS INSTITUTE OF TECHNOLOGY

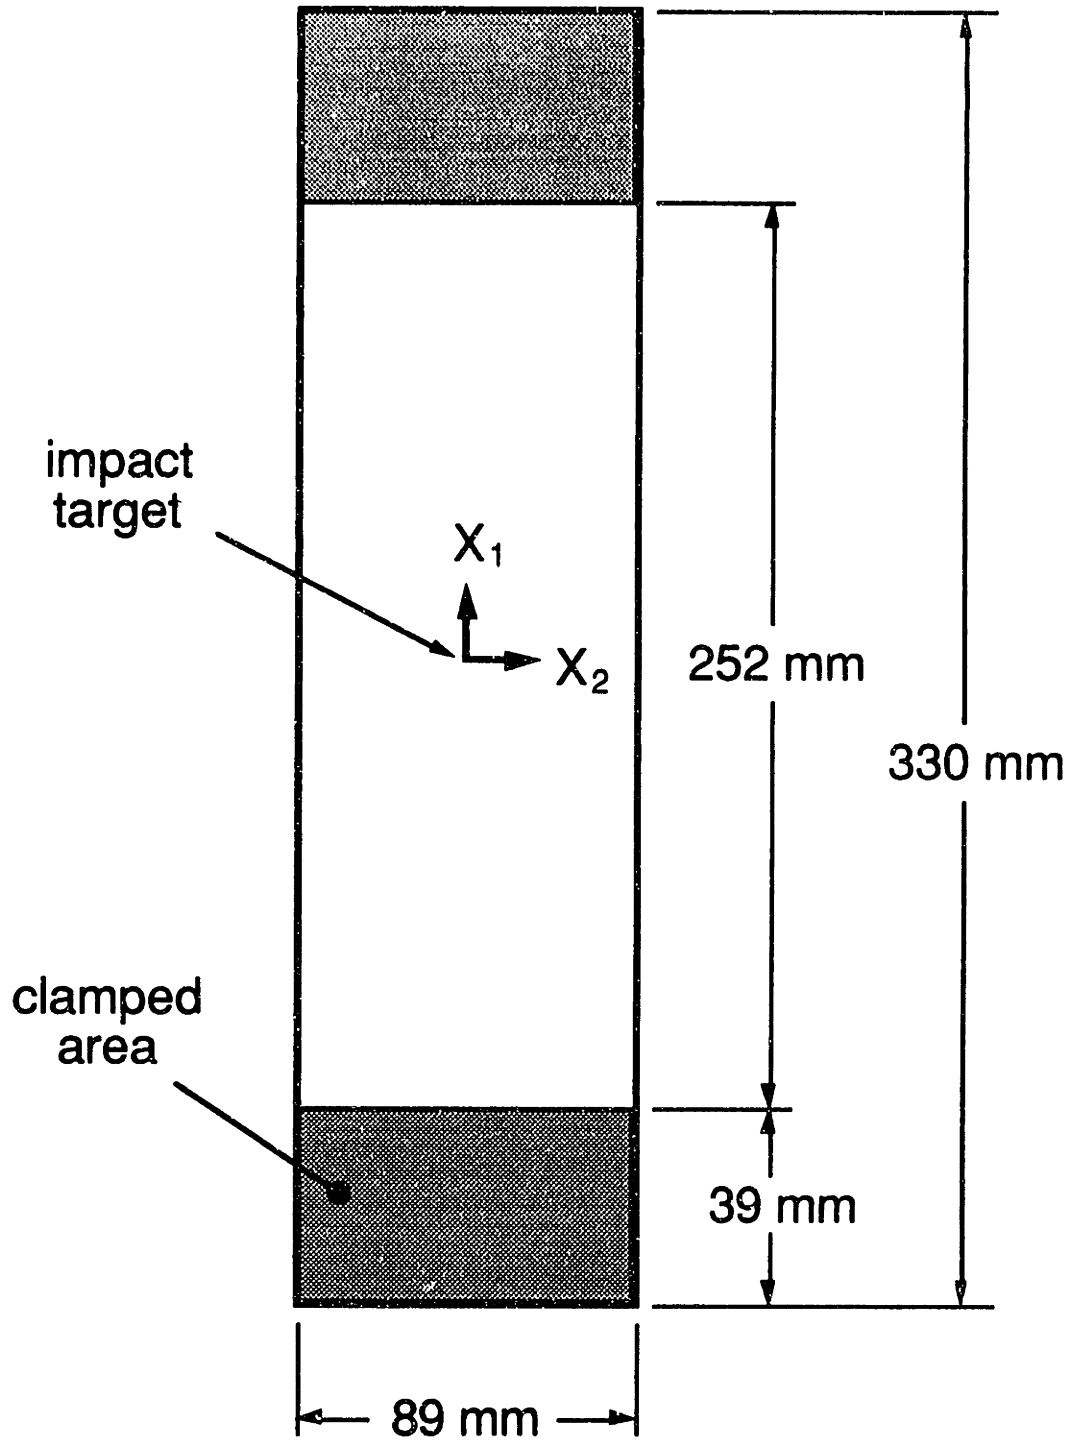
Figure 3.1 Impact specimen geometry.

The geometry of the impact specimens used is the same as that used by Ryan [30]. The specimens are 89 mm wide and 330 mm in length, as can be seen in Figure 3.1. Specimens of this width were used so that damage from impact could progress without the interference of edge effects of the coupon. Three specimens were obtained from each standard TELAC laminate of dimensions 304 mm by 356 mm. When clamped in the impact holding jig, the span of the specimen is 252 mm. All impacts were targeted at the center of the specimen.

specimen (see Figure 3.1) is aligned with the vertical axis of the page. Positive ply angles are measured counter-clockwise from vertical.

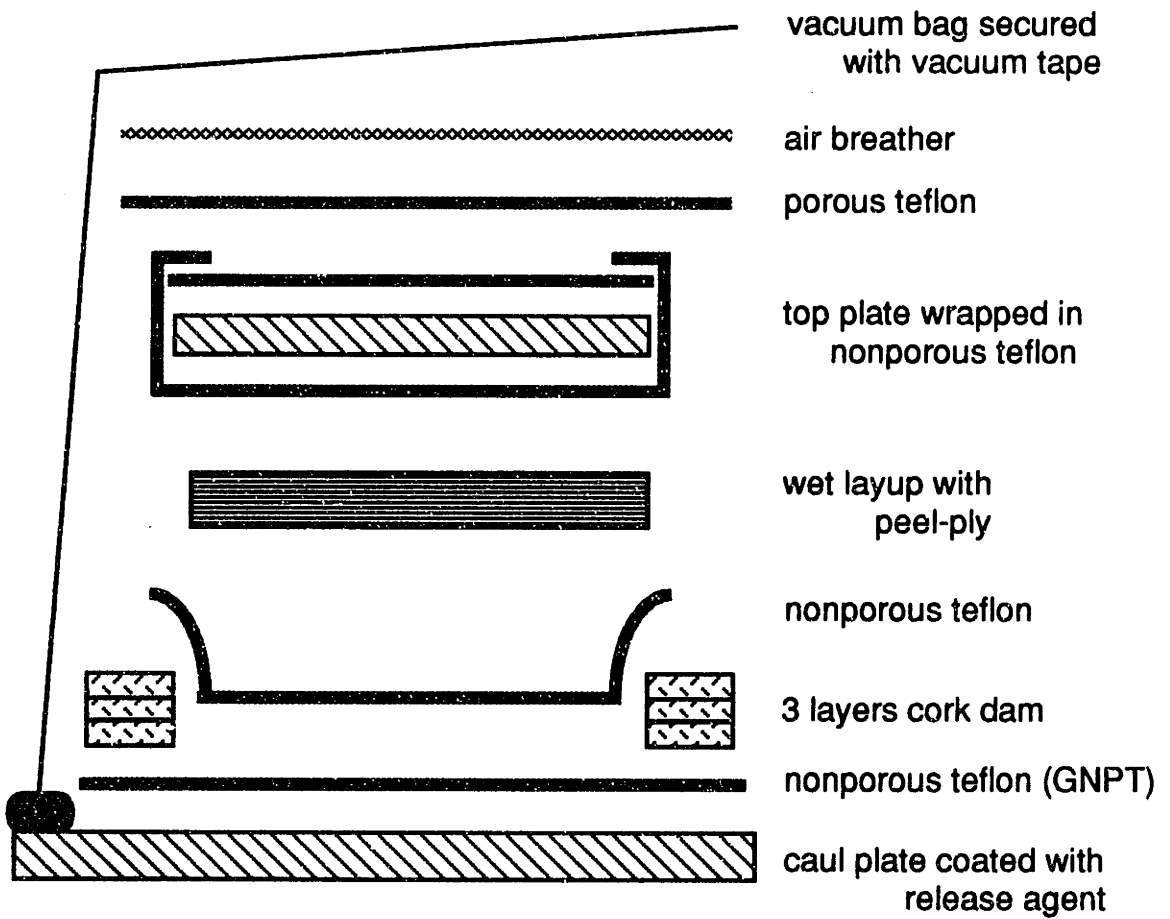
Figure 3.2 Schematic of glass/epoxy cure layup.

In preparation for the wet layup and cure, the cure plate is sprayed with Mold Wiz® release agent and covered with a sheet of nonporous teflon. On top of this, three layers of cork dam are used to make a 304 by 356 mm rectangular vessel for the laminate. A sheet of nonporous teflon is placed in the bottom of the vessel, followed by a sheet of peel-ply and then the layers of dry fabric. After the last ply of fabric is placed in the vessel, the matrix is introduced on top and allowed to soak into the plies. The matrix is applied with a one-half inch acid brush starting at the center of the laminate and working outward radially toward the edges. By working from the center outward, the amount of trapped air in the laminate is minimized. Care is taken not to disturb the alignment of the fibers while adding the matrix with the brush. When wetted, the layup changes appearance from white in color to transparent. When no areas of white are visible, any remaining matrix is spread evenly over the laminate and a sheet of peel-ply is smoothed on top. The aluminum top plate, wrapped in nonporous teflon, comes next. Sheets of bleeder paper are rolled into dams and added between the cork vessel and the vacuum ports to prevent liquid matrix from flowing into the vacuum system. The assembly is then covered with a single sheet of porous teflon, a layer of glass breather, and finally, the vacuum bag. The cure plate is then ready for the autoclave. Figure 3.2 is a schematic of the cure layup.

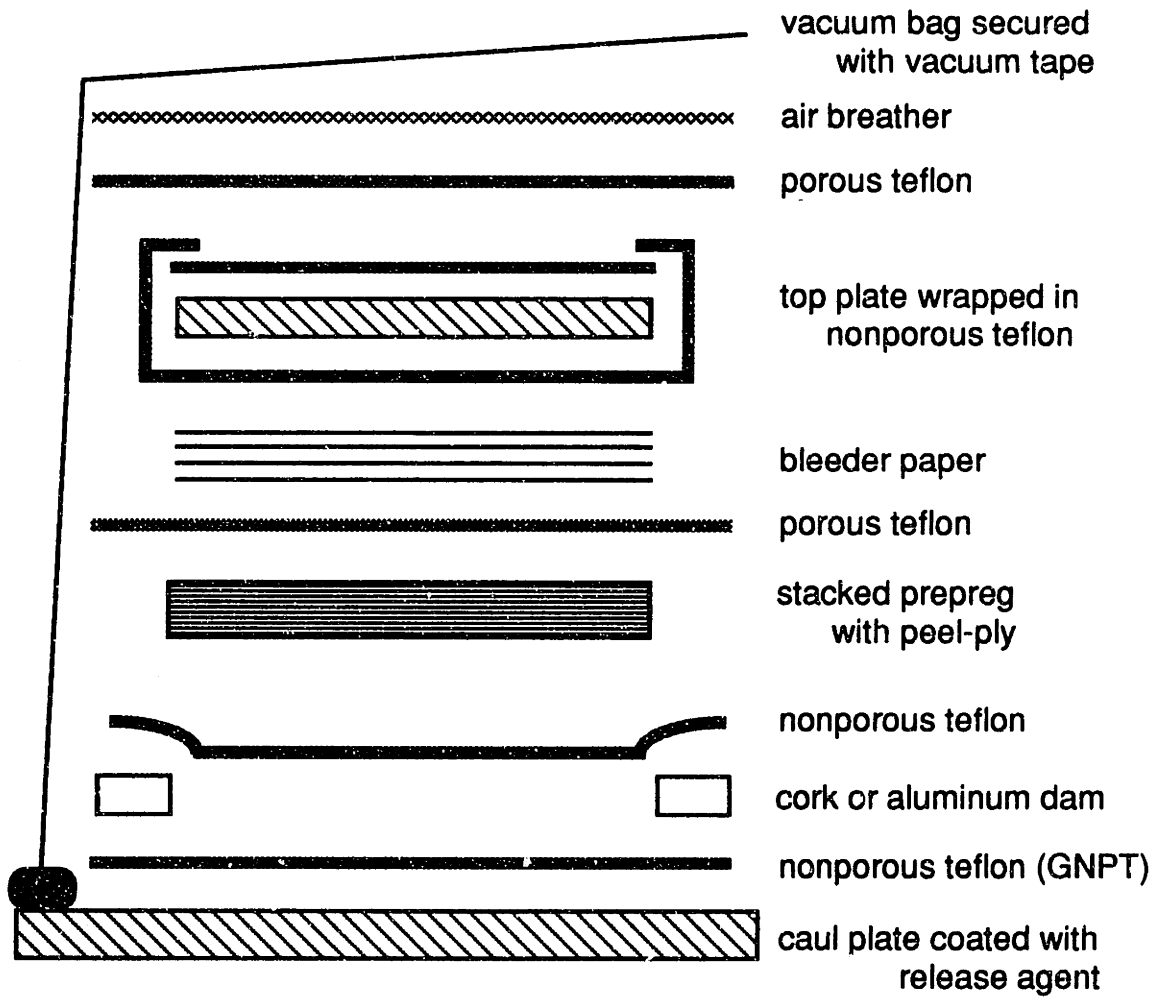
Figure 3.3 Schematic of AS4/3501-6 and A370-5H/3501-6S cure layup.

The AS4/3501-6 and A370-5H/3501-6S materials were cured according to the standard TELAC procedure. The packaging arrangement for the cure is shown in Figure 3.3. The laminate is placed on top of the sheets of nonporous

teflon and confined by the dam material. One sheet of porous teflon is placed on top of the laminate, followed by sheets of bleeder paper, the aluminum top plate, a sheet of porous teflon and a layer of fiberglass air breather. A vacuum bag is placed over this assembly and vacuum tape is used to create a seal between the bag and the aluminum caul plate.

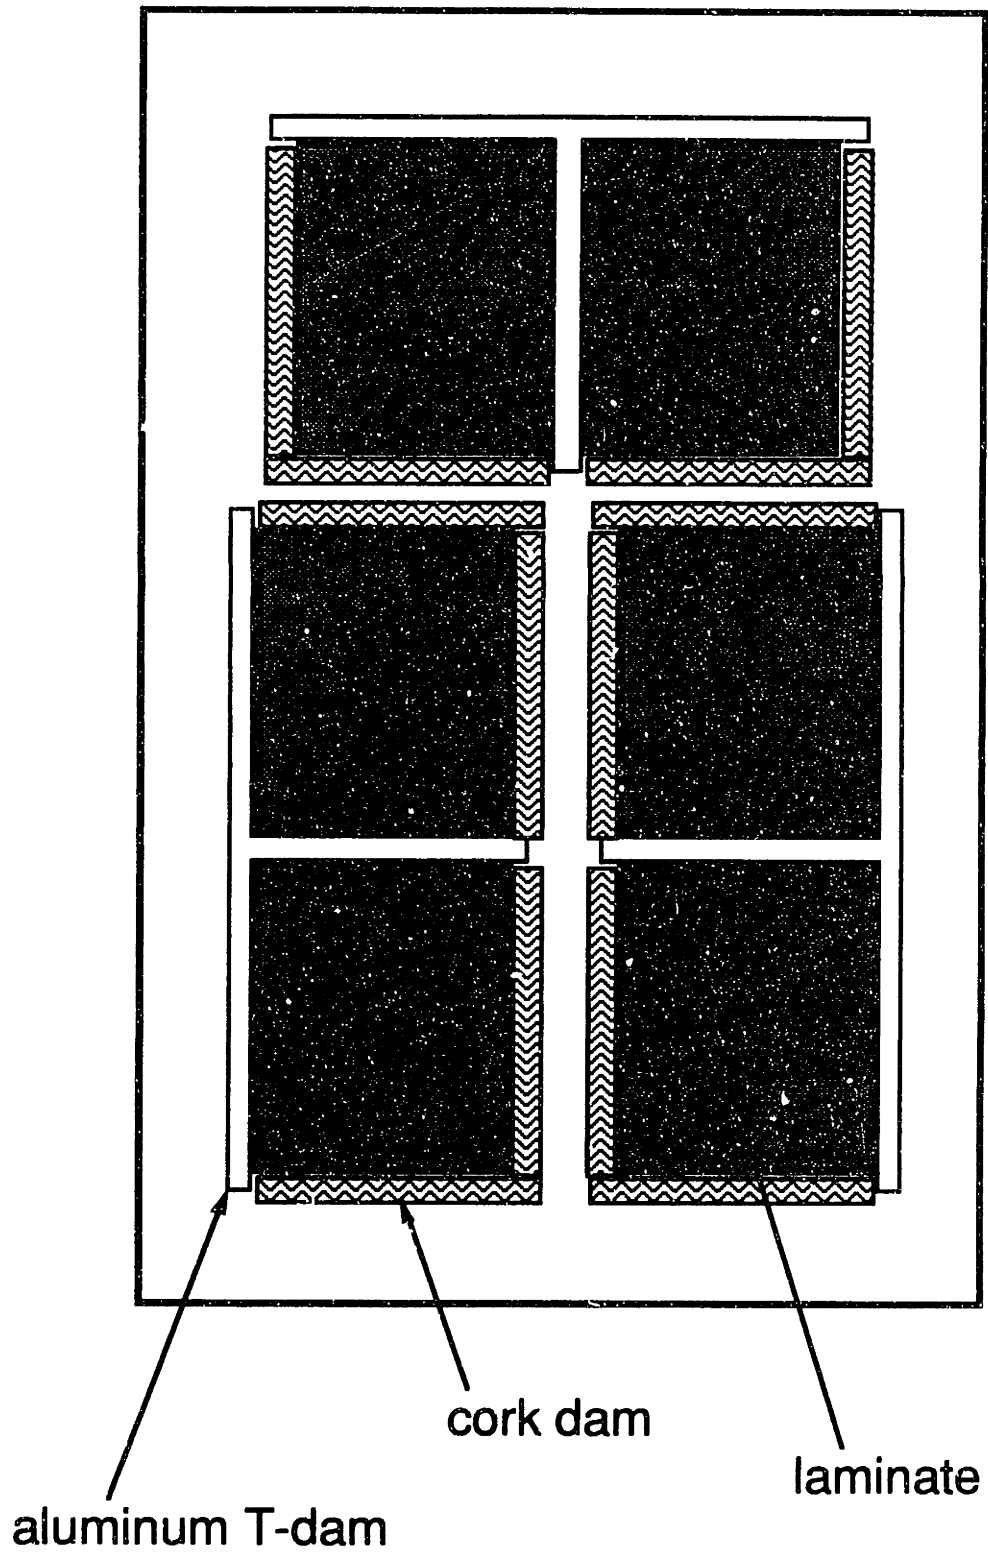
Figure 3.4 Illustration of cure plate (top view).

Six laminates are cured at one time in the autoclave. The position of the laminates on the cure plate is illustrated in Figure 3.4. T-shaped aluminum dams, as well as cork dams, are used to hold the laminates in place during the cure. The reference corner of each laminate, which was marked previously during layup, is always placed into the corner of an aluminum T-dam on the cure plate. Thus, each laminate had two sides bordered by aluminum dams and two sides bordered by cork dams.

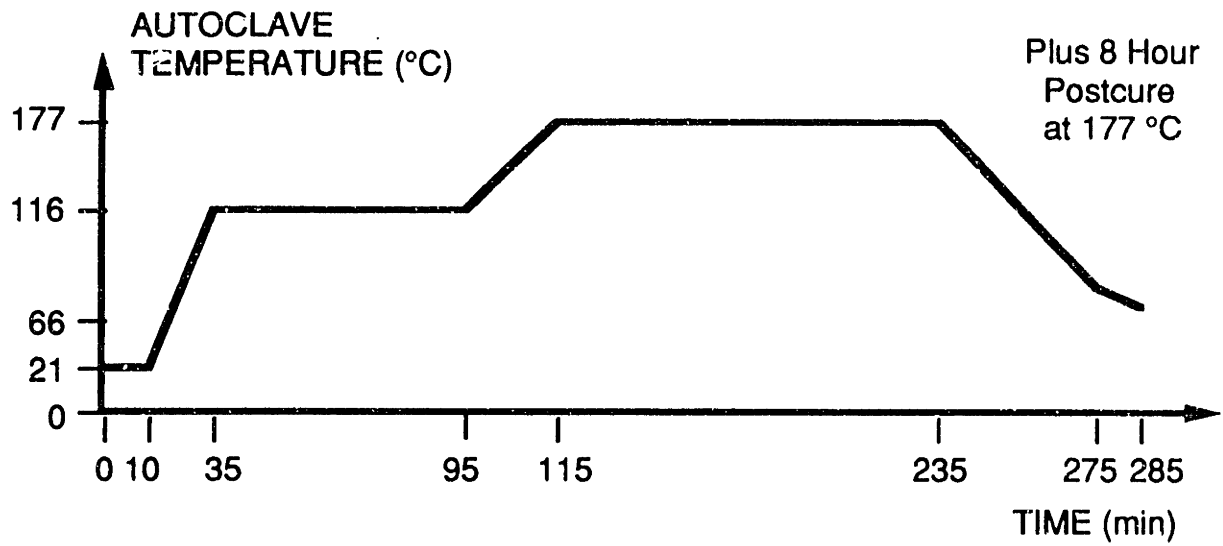
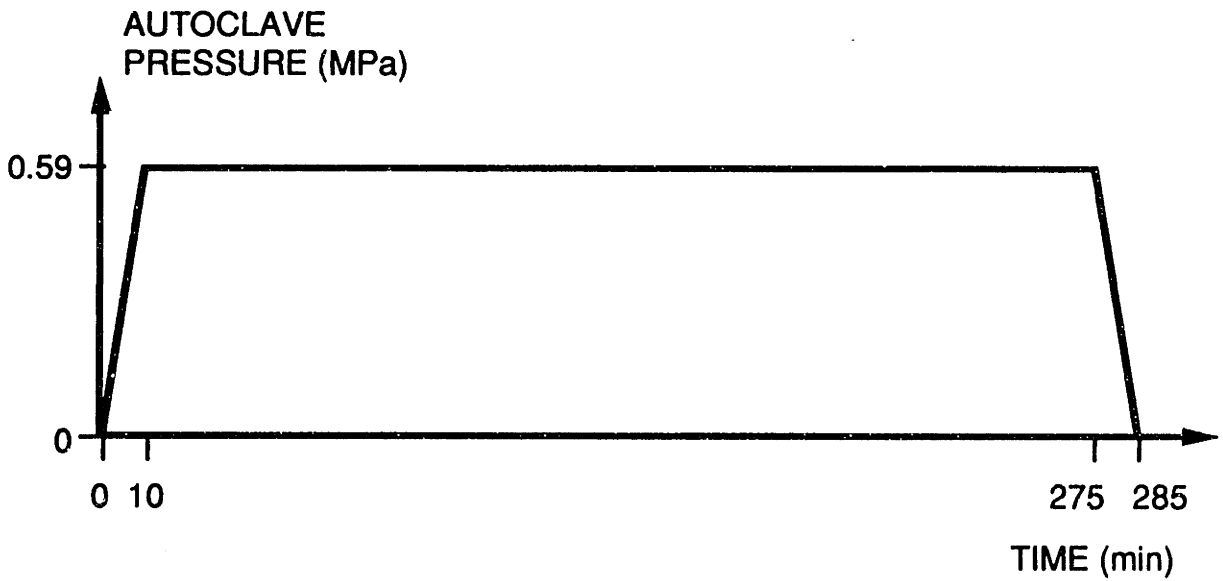
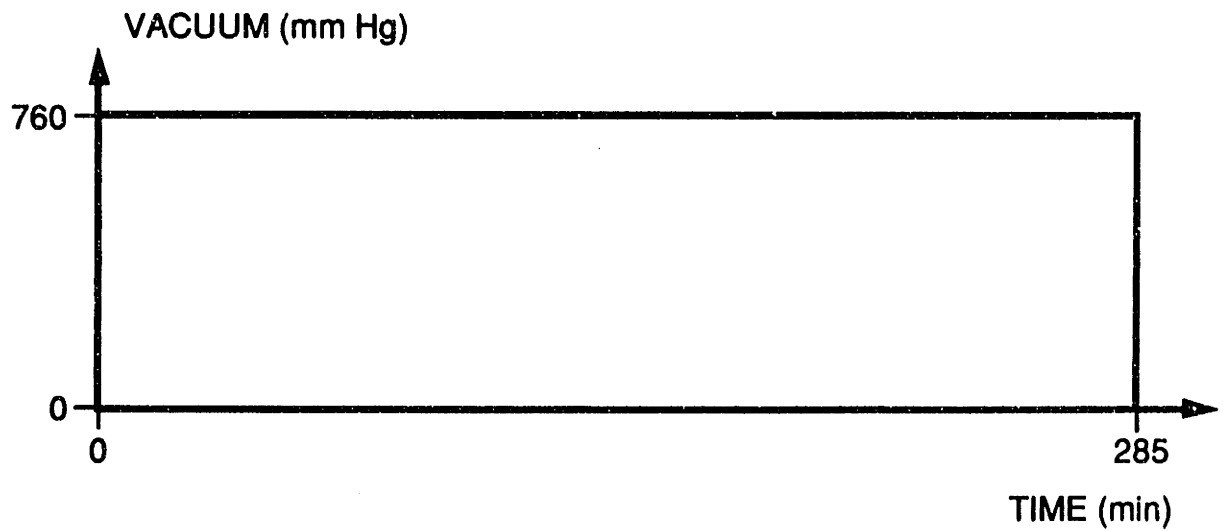
Figure 3.5 AS4/3501-6 and A370-5H/3501-6S cure cycle.

In the autoclave, a vacuum of 760 mm Hg is applied to the cure plate. The autoclave pressure is raised to a gage pressure of 0.59 MPa and held. Once this pressure is achieved, the autoclave temperature is raised at a rate of 1-3°C per minute until 116°C is reached. After one full hour at 116°C, the temperature is again raised at the same rate to 177°C and held for two hours. Finally the temperature is decreased at 3-5°C per minute to 80°C and the pressure released. The temperature, pressure and vacuum cycles are shown in Figure 3.5. The laminates were postcured in an oven at 177°C for 8 hours with no applied pressure or vacuum.

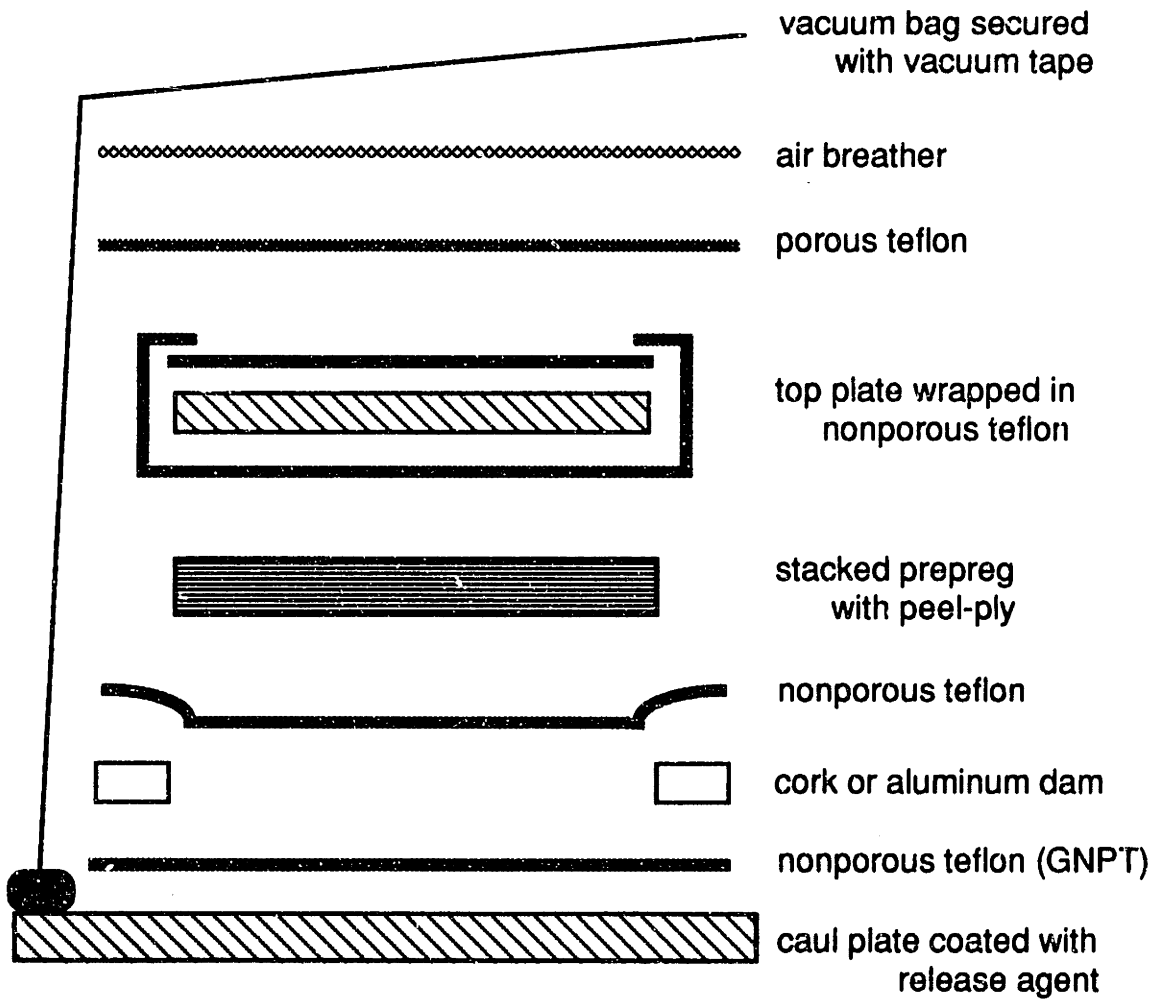
Figure 3.6 Schematic of IM7G/X8553-50 cure layup.

A similar cure was performed for the IM7G/X8553-50 material system. The cure packaging used for these laminates can be seen in Figure 3.6. As this was a net resin cure, no bleeder paper was used. Otherwise, the cure packaging is very similar to that used for the AS4/3501-6 material. Again, six laminates are cured at one time in the autoclave and the cure plate is arranged in the same way as previously shown.

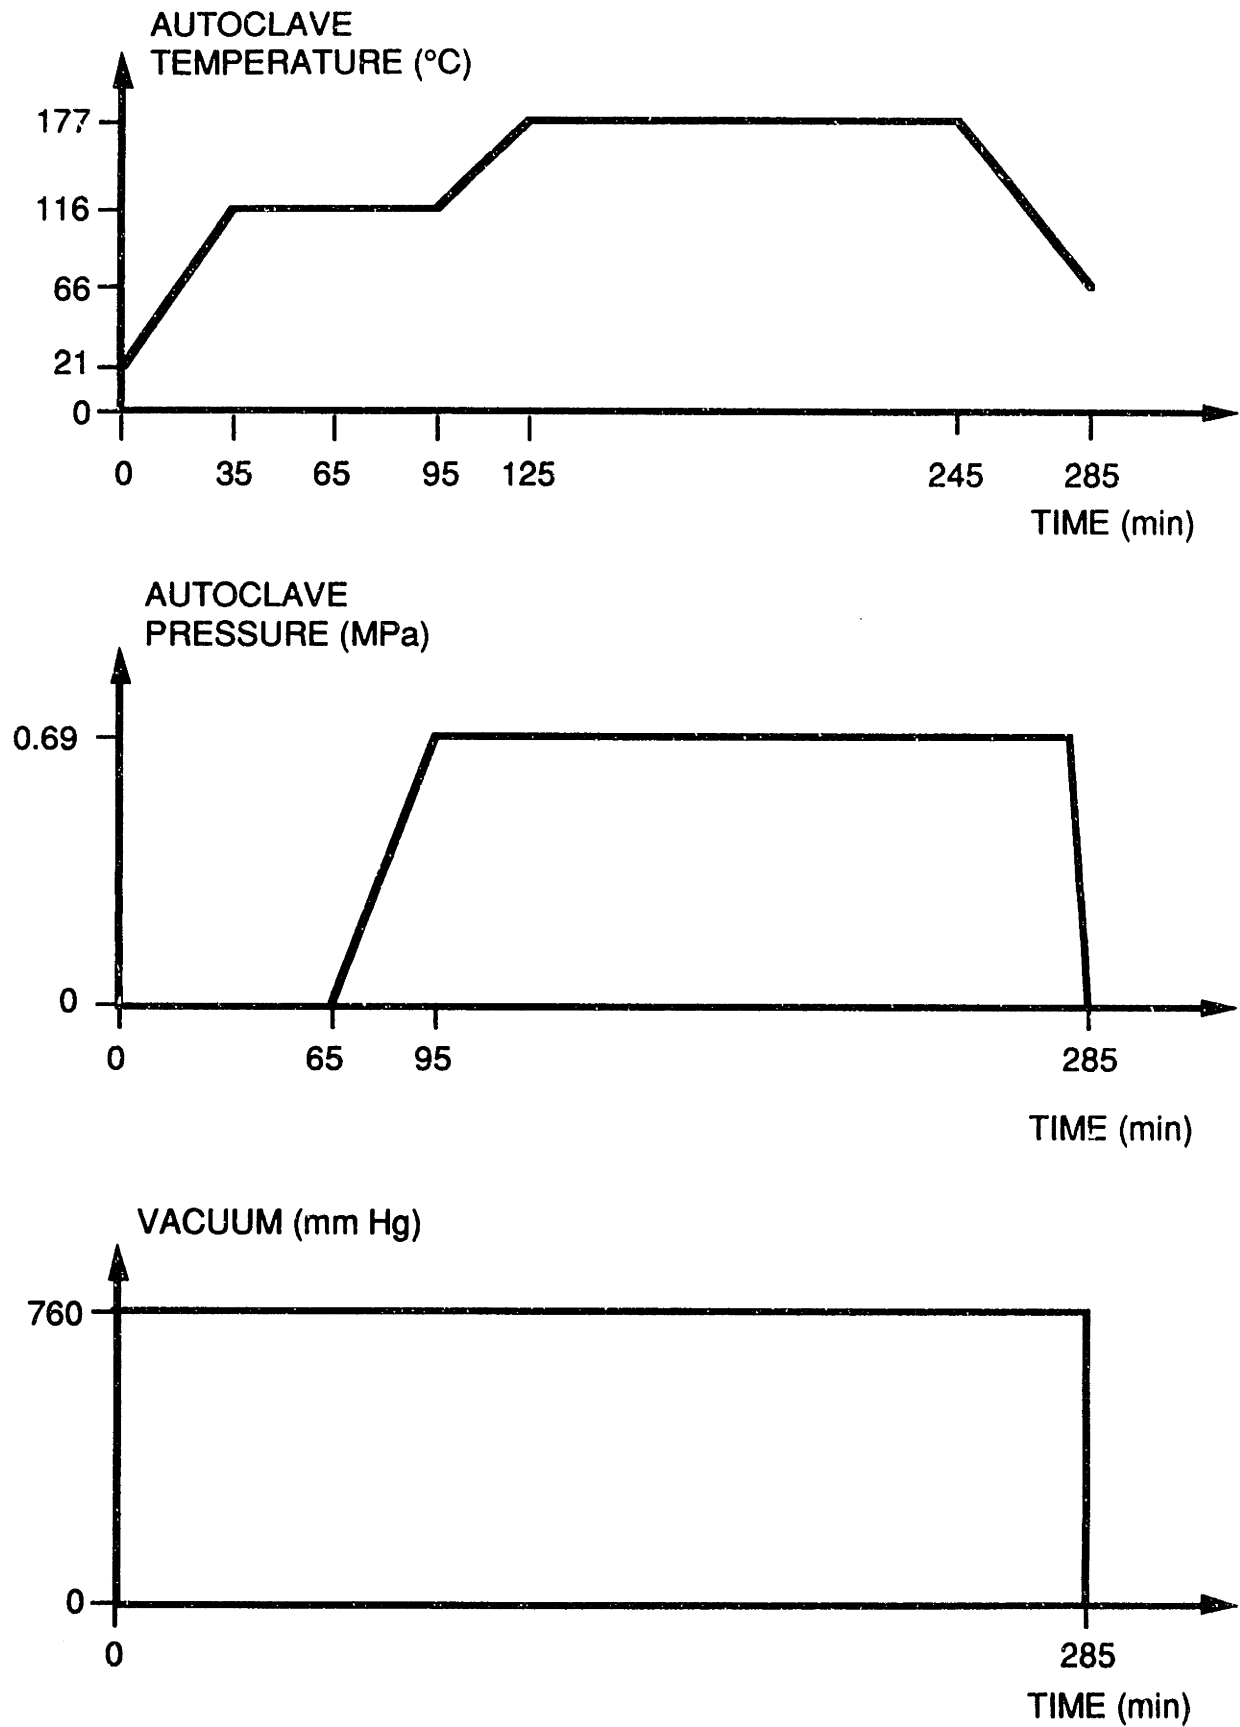
Figure 3.7 IM7G/X8553-50 cure cycle.

The temperature, pressure and vacuum cycles can be seen in Figure 3.7. After successful vacuum checks, a vacuum of 760 mm Hg is applied to the cure plate and the temperature ramped up to 116°C at a rate of 3-5°C per minute. After 30 minutes at 116°C, the autoclave pressurization begins. A pressure of 0.69 MPa is reached after approximately 30 minutes, and held for the duration of the cure. At this point, the temperature has been at 116°C for one full hour. The temperature is then ramped up to 177°C at 3-5°C per minute. This temperature is held for two hours, after which time

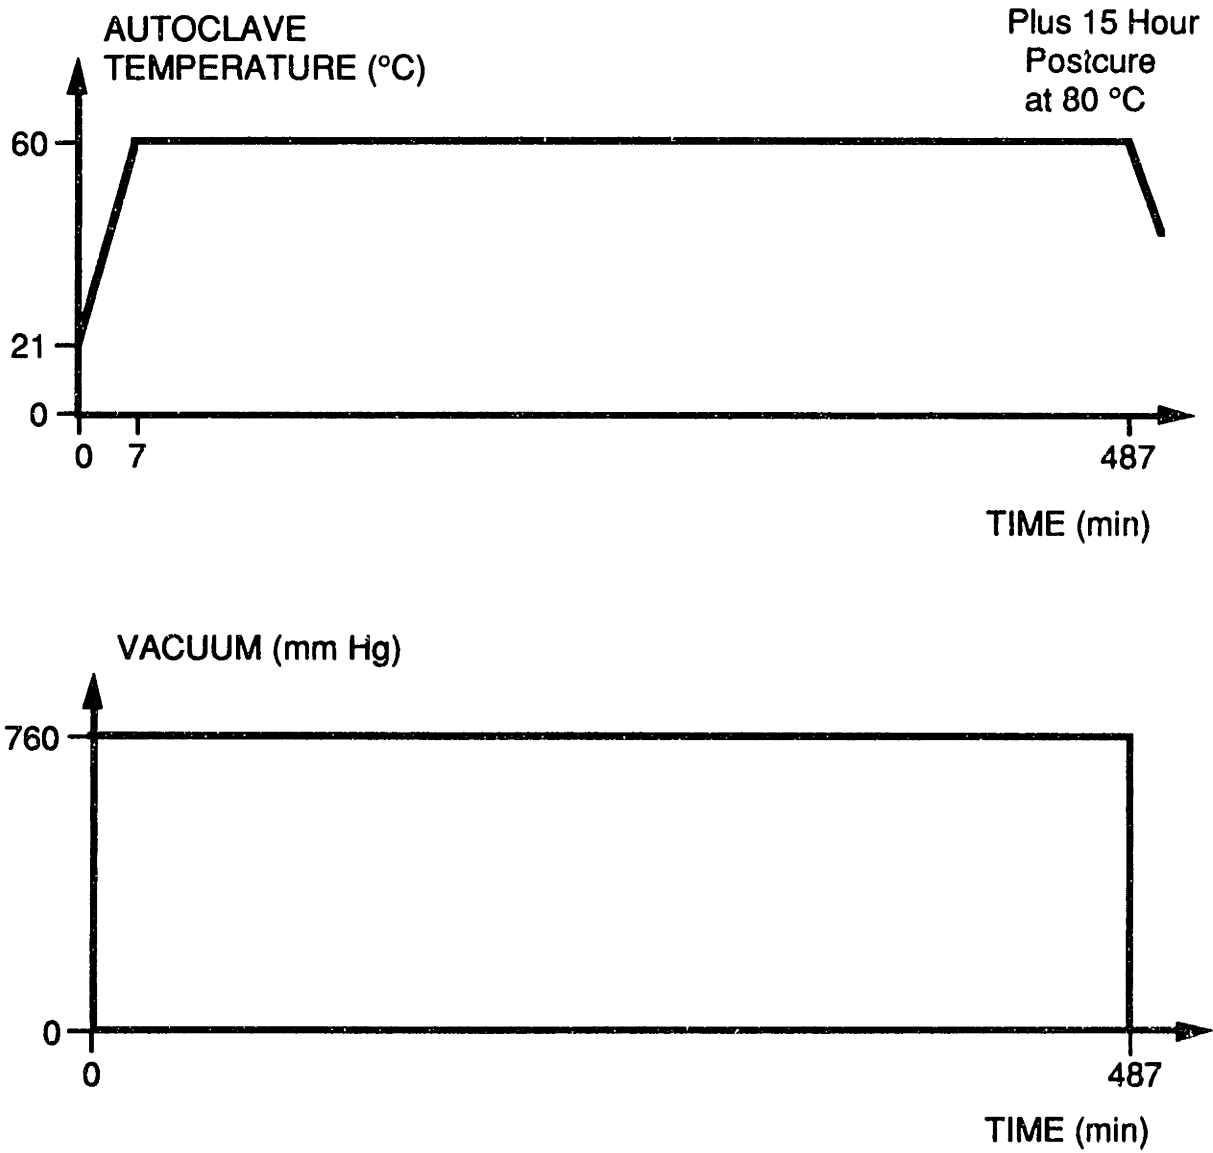
Figure 3.8 Glass/epoxy cure cycle.

The glass/epoxy required an 8-hour cure cycle with vacuum applied, but no pressure, as shown in Figure 3.8. Only two glass/epoxy laminates were cured in the autoclave at one time. After a successful vacuum check, a vacuum of 760 mm Hg is applied to the cure plate in the autoclave and the temperature raised to 60°C at a rate of 5-6°C per minute. This temperature is held for 8 hours, after which time the vacuum is released and the laminates removed from the autoclave. The laminates were then postcured in an oven for 15 hours at 80°C with no applied vacuum or pressure.

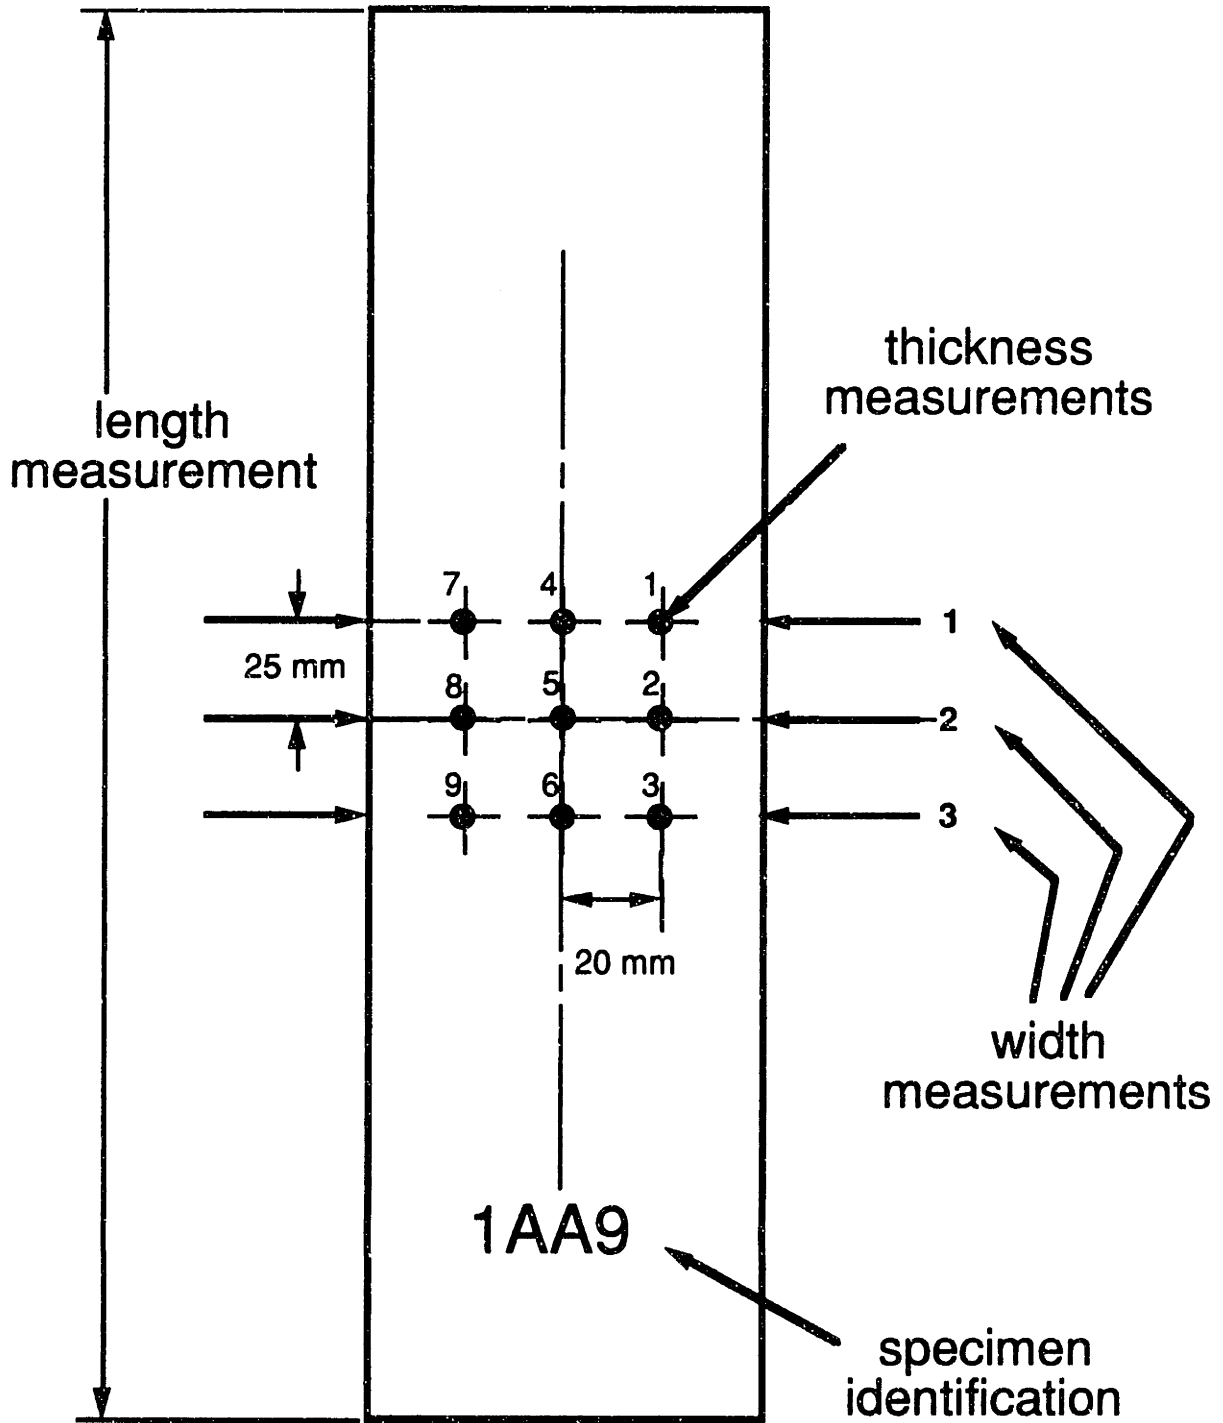
Figure 3.9 Coupon measurement locations.

The manufacturing consistency of each coupon was then checked. Nine thicknesses, three widths, and the length of each coupon were measured at the locations shown in Figure 3.9. A comparison of the nominal and average measured ply thicknesses for all four material systems can be seen in Table 3.3.

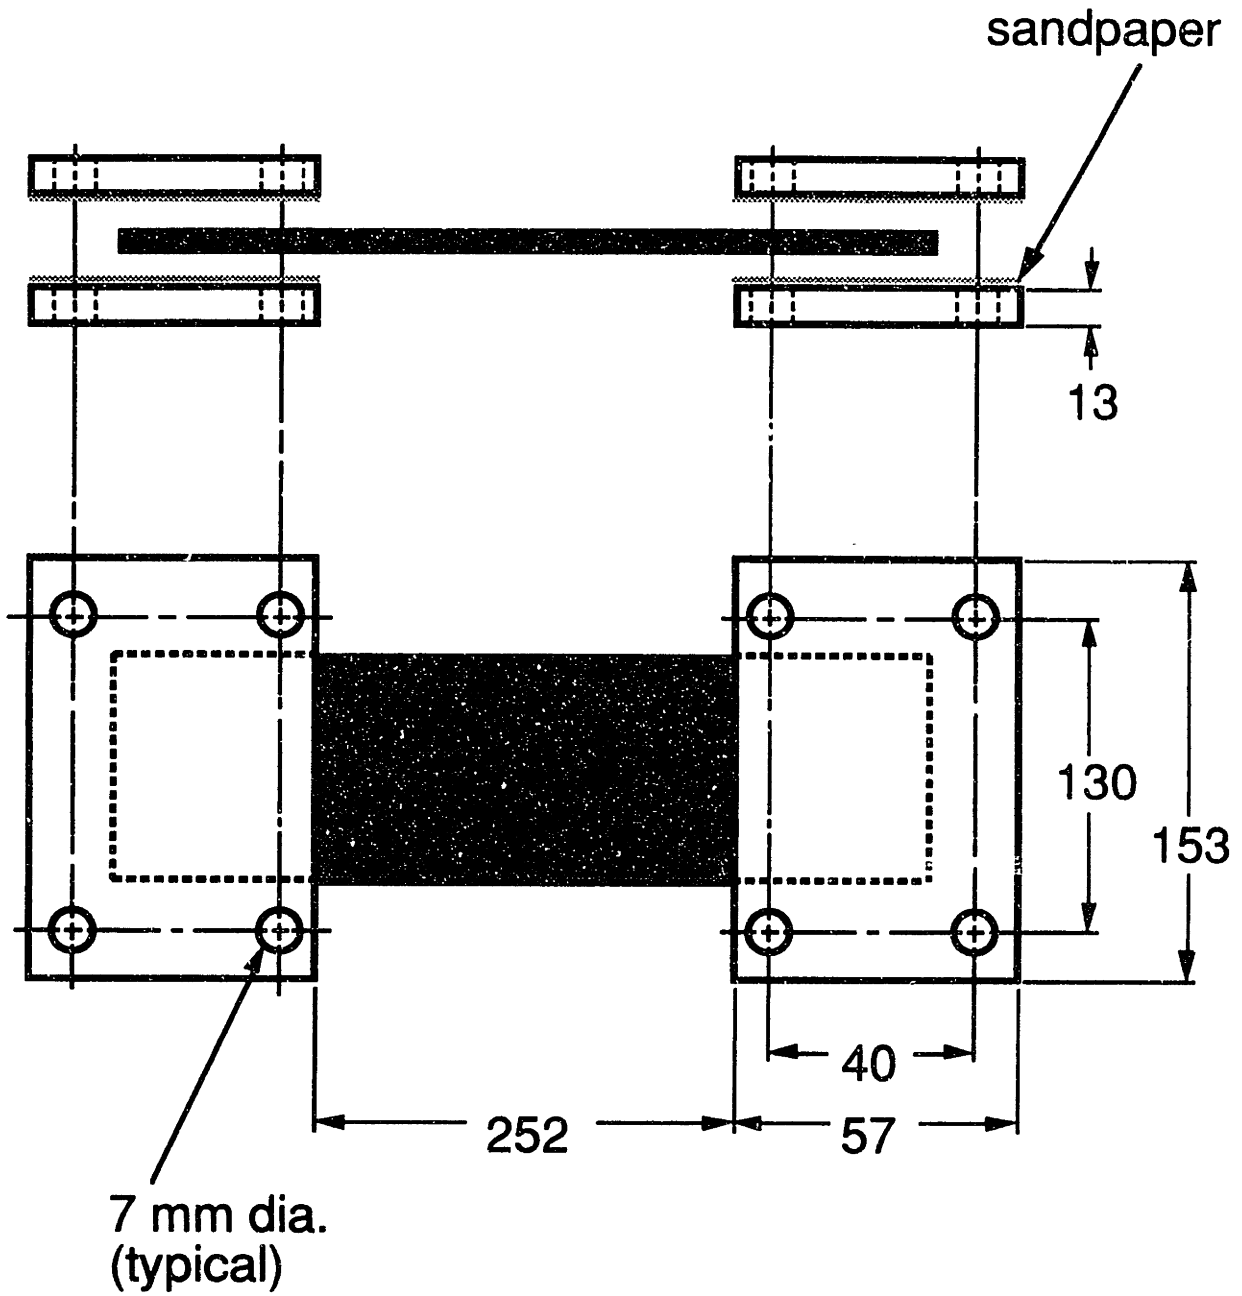
NOTE: 1. all dimensions in mm.
2. drawing not to scale.

Figure 3.10 Specimen holding jig measurements.

The specimen holding jig shown in Figure 3.10 provides clamped boundary conditions on two sides of the specimen. The specimen is held firmly between the aluminum blocks by 8 bolts, each lubricated with SAE 20 weight oil and torqued to 10 Newton-meters. Sandpaper of 80 grit roughness is glued to the blocks to help prevent slippage of the laminate during impact. All impacts were targeted at the center of the specimen. The specimen holding jig is supported by a drill press stand adopted for this function. This assembly is illustrated in Figure 3.11.

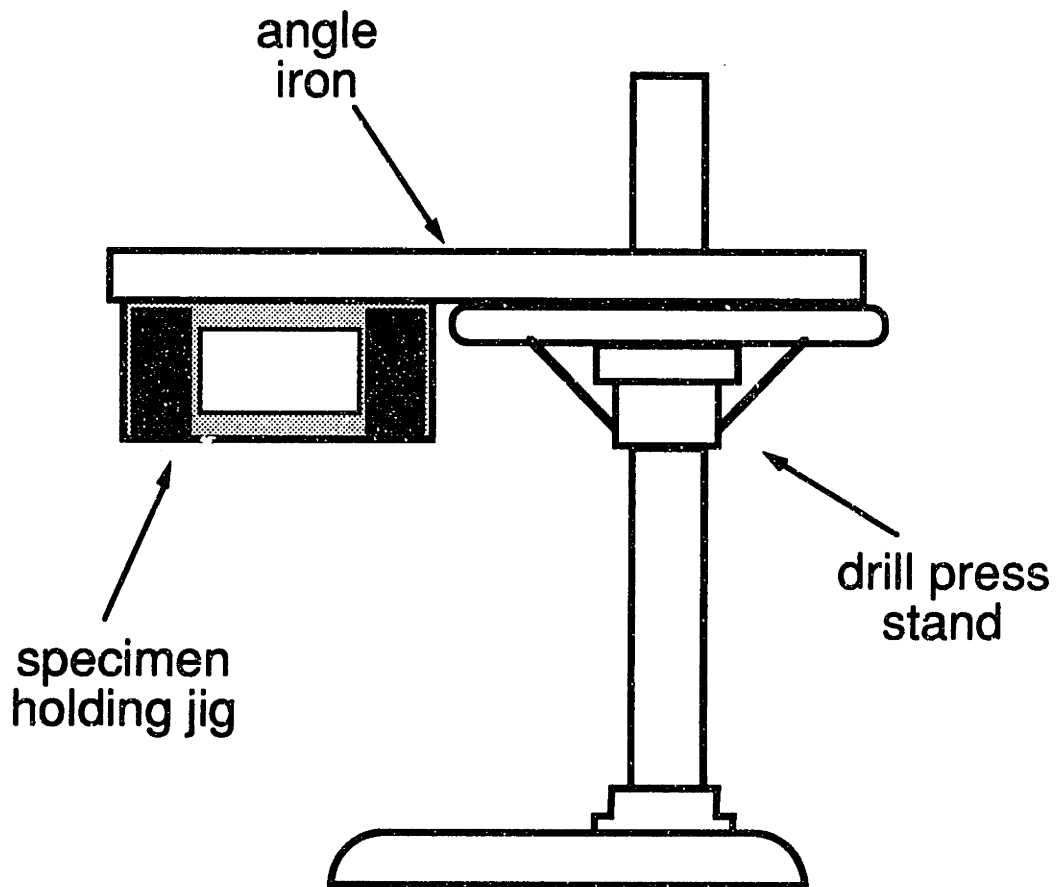
Figure 3.11 Illustration of jig support stand for impact testing.

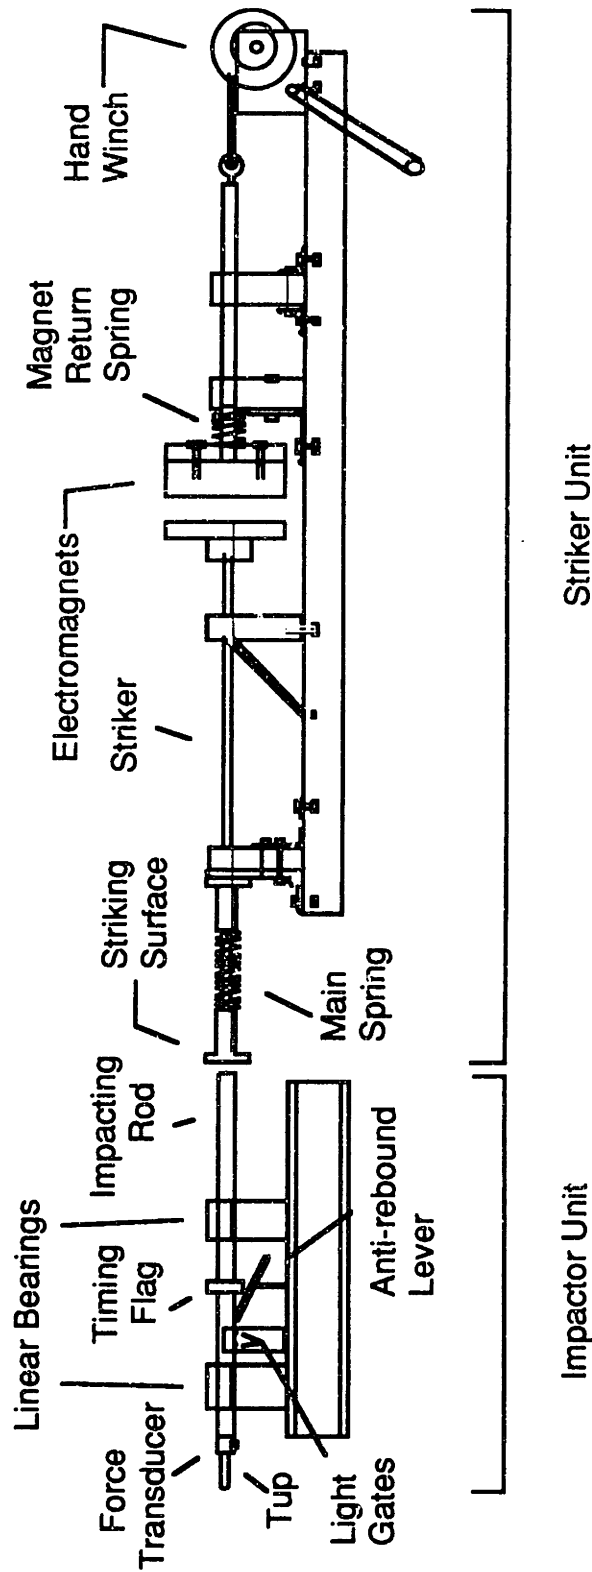
Figure 3.12 Illustration of Free Rolling Energy Device (FRED) for impact.

The striker and impactor units of the Free Rolling Energy Device (FRED) are shown in Figure 3.12. The striker unit consists primarily of an electromagnet, a winch and a large spring. The magnet is energized and the winch is used to draw back the striker rod, compressing the spring. Upon release of the magnet, the rod is free from the winch and is propelled toward the impactor unit by the spring. The impactor unit holds the impactor rod via two sets of linear motion bearings, and also houses the light gates and the anti-rebound lever. The anti-rebound lever prevents multiple impacts by restraining the impactor rod after impact. During the initial forward motion of the impactor rod, the plastic doughnut flips the anti-rebound lever into a position to catch the rod after impact. This forward motion triggers the computer to begin taking data.

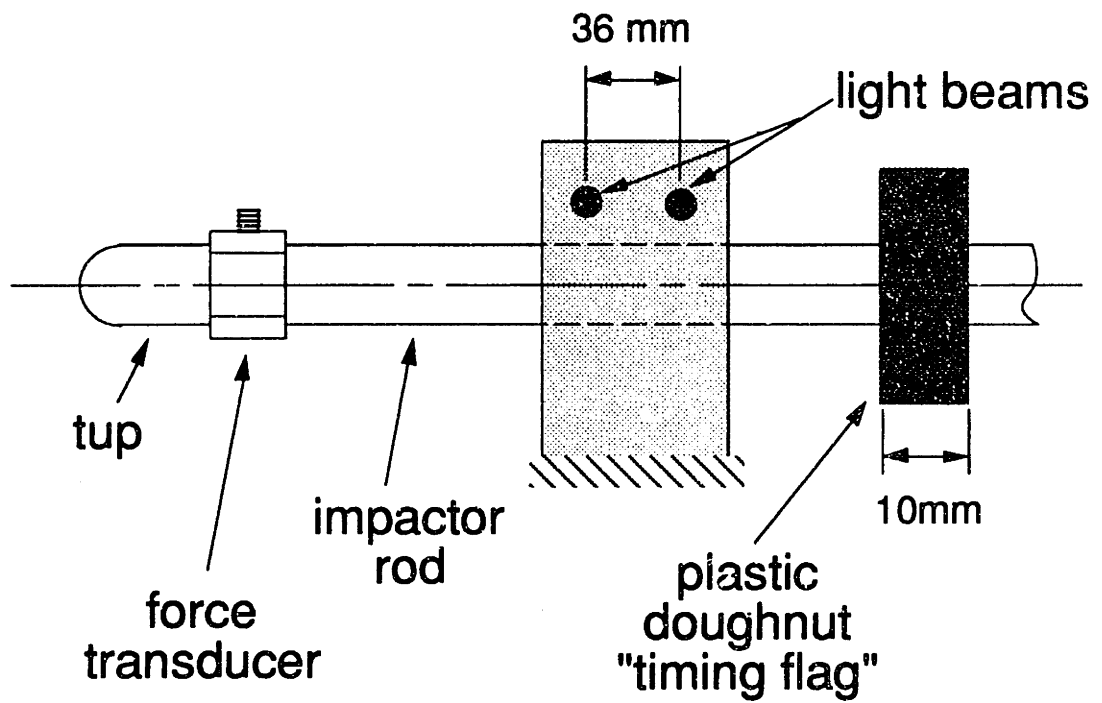
(total impacting mass = 1.53 kg)

Figure 3.13 Illustration of impactor rod and light gates.

The light gates are used for impact velocity determination. As the impactor rod approaches the specimen, but before actual contact is made, a plastic "doughnut" on the impactor rod passes through two light beams in sequence. This is shown in Figure 3.13. An electronic timer, in this case a Fluke 1953 A Counter Timer, records the difference in time between the interruption of the first and second beam. The distance between the two beams being known, the impactor rod velocity can be determined.

This conversion is required because the force transducer is not at the point of contact between the specimen and the tup, but is sandwiched between two masses as can be seen in Figure 3.13. The force at the point of contact between

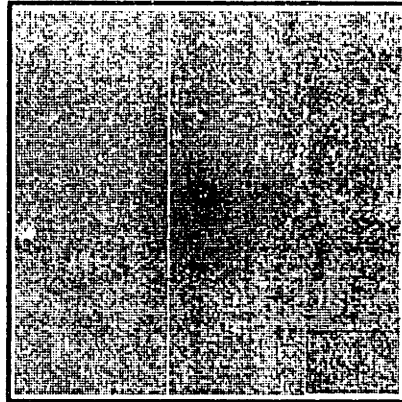
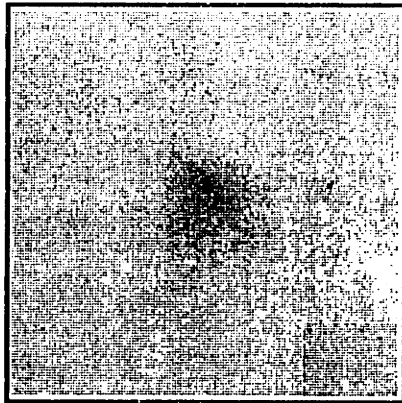
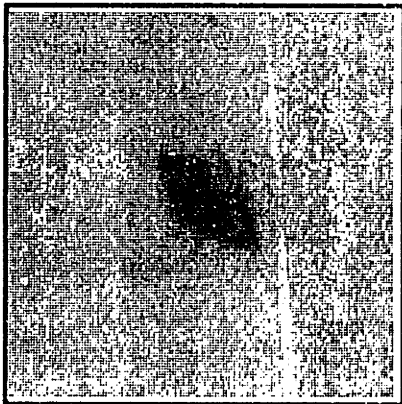
velocity = 2.5 m/s

velocity = 4.0 m/s

velocity = 5.0 m/s

Figure 3.14 Example of typical X-ray photographs.

An example of a typical X-ray photograph can be seen in Figure 3.14. The orientation of the specimen in the X-ray is such that the x_1 direction of the

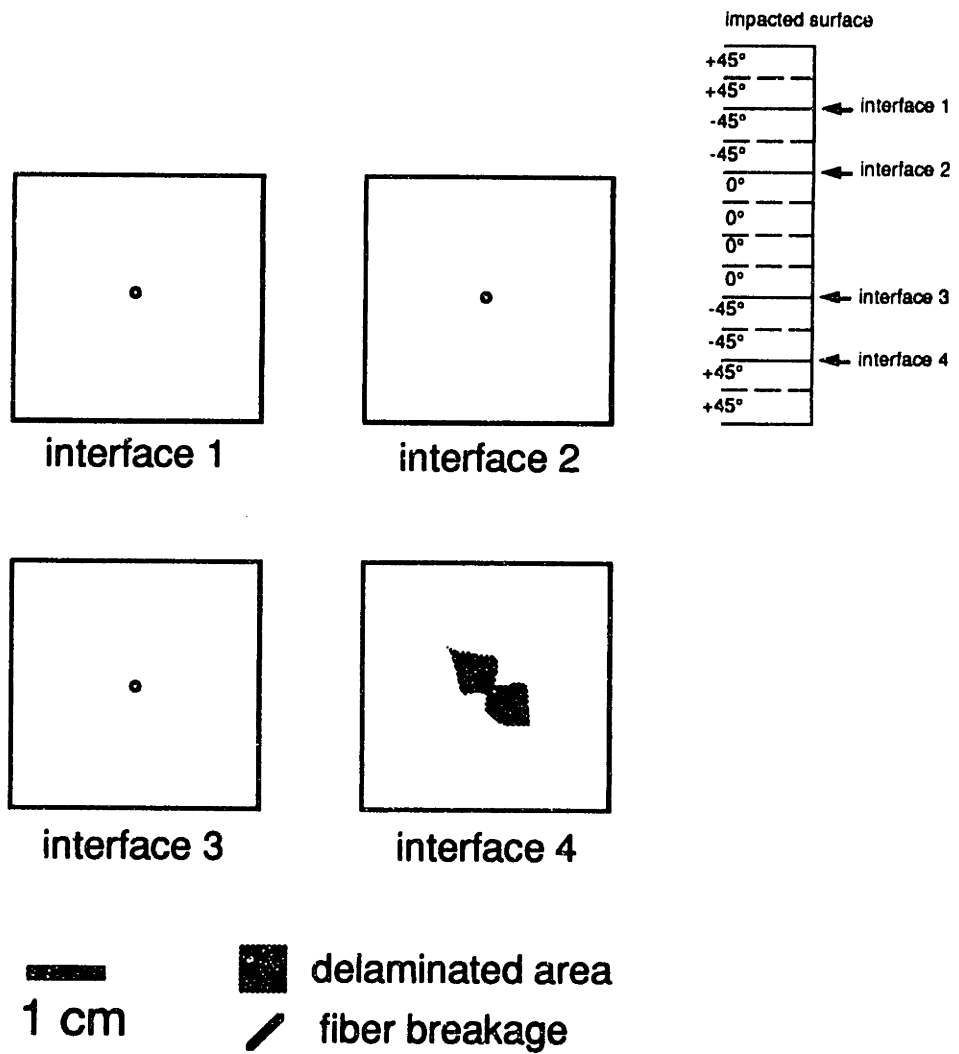
Figure 3.16 Example of typical delamination of impacted graphite/epoxy specimen.

A typical deply transcription is shown in Figure 3.16. The interfaces for each laminate are defined by the layup diagram. Only interfaces where the ply angle changes are numbered, and interface 1 is closest to the impact surface. The small circle seen at the center of each interface represents the hole drilled through the laminate at the center of the impact site, as previously mentioned. The deply technique provided information on delamination and fiber breakage. Delaminations are depicted as shaded areas, and regions of fiber fracture are shown as heavy lines. The regions of fiber fracture generally ran transversely to the fiber direction of the ply. All interfaces are shown as viewed from the impacted side of the laminate, with the x_1 direction of the specimen aligned with the vertical axis of the page. Positive ply angles are measured counter-clockwise from vertical. In several cases, fiber damage in the top ply became visible once the top ply was separated from the rest of the laminate. For such cases, an illustration of the top ply is included in the transcription.
