IMPACT DAMAGE MECHANISMS IN SEVERAL LAMINATED MATERIAL SYSTEMS

Submitted to the Department of Aeronautics and Astronautics in Partial
Fulfillment of the Requirements for the Degree of

MASTER OF SCIENCE

MASSACHUSETTS INSTITUTE OF TECHNOLOGY

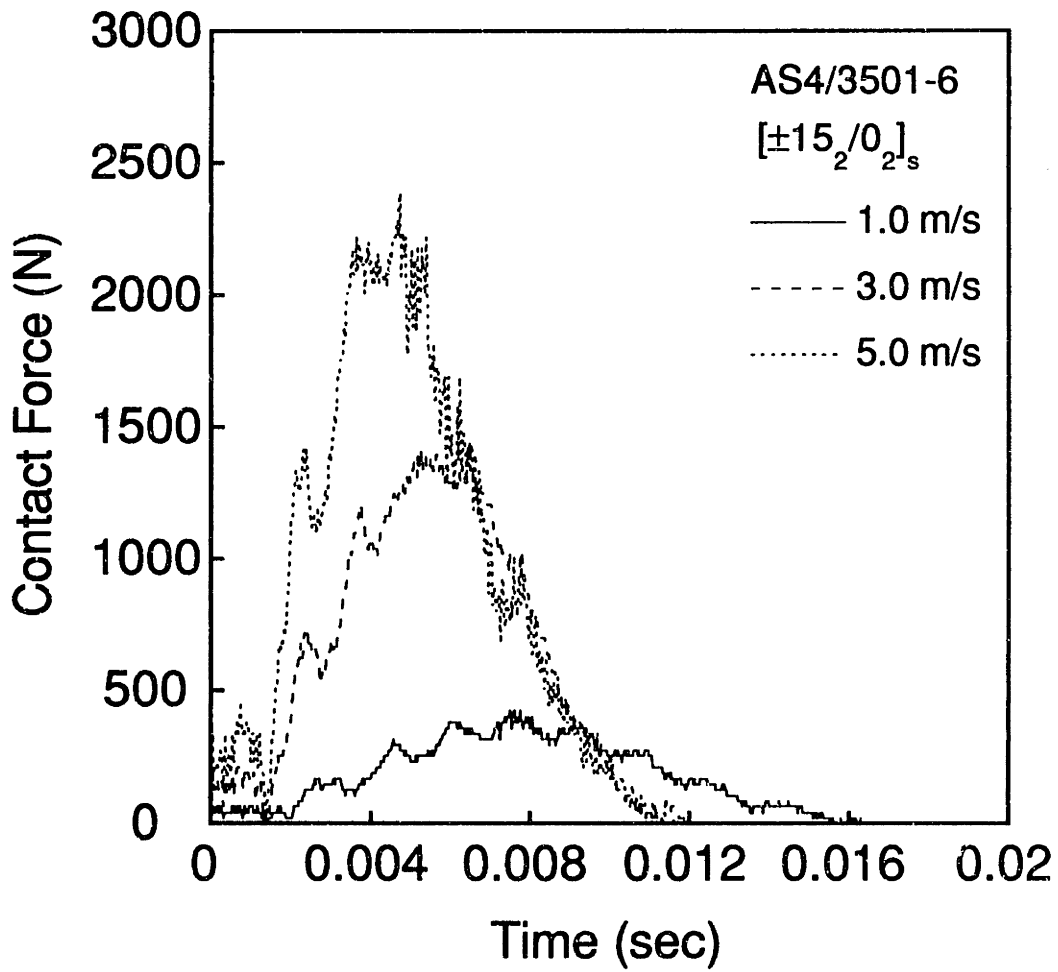
Figure 4.1 Force-time signatures of AS4/3501-6 $[\pm 15_2/0_2]_s$ laminate impacted at 1.0 m/s (undamaged) , 3.0 m/s, and 5.0 m/s (penetrated).

Signatures for the 12-ply layups of the AS4/3501-6 material system can be seen in Figures 4.1 through 4.4. All of these 12-ply specimens were penetrated by 5.0 m/s impacts. Other than these penetrated specimens, no specimens exhibited visible damage from any of the impacts. The force histories (or signatures) for the $[\pm 15_2/0_2]_s$ of AS4/3501-6 layup are presented in Figure 4.1. The 1.0 m/s impact did not damage the specimen, the 3.0 m/s impact caused matrix cracking and delamination, and the 5.0 m/s impact penetrated the specimen. The overall shape of each force history is approximately half of a sine wave, with oscillations of higher frequency superimposed upon it. For the 1.0 m/s impact, the primary wave reaches a peak (approximately 400 N) at about 8 ms, and the peaks of the secondary oscillations occur approximately 1.5 ms apart. The secondary peaks are again 1.5 ms apart in the 3.0 m/s impact, but the primary wave reaches its peak (of approximately 1400 N) sooner at 5.5 ms. In the 5.0 m/s impact, the peaks of the secondary oscillations again occur every 1.5 ms, but the time-to-peak of the primary wave is obscured by the introduction of further higher frequency oscillations approximately 4 ms into the impact. This higher frequency oscillation is visible in the signature as the force reaches a peak of approximately 2400 N and then drops significantly at about 5.5 ms, presumably as the impactor rod penetrates the specimen.

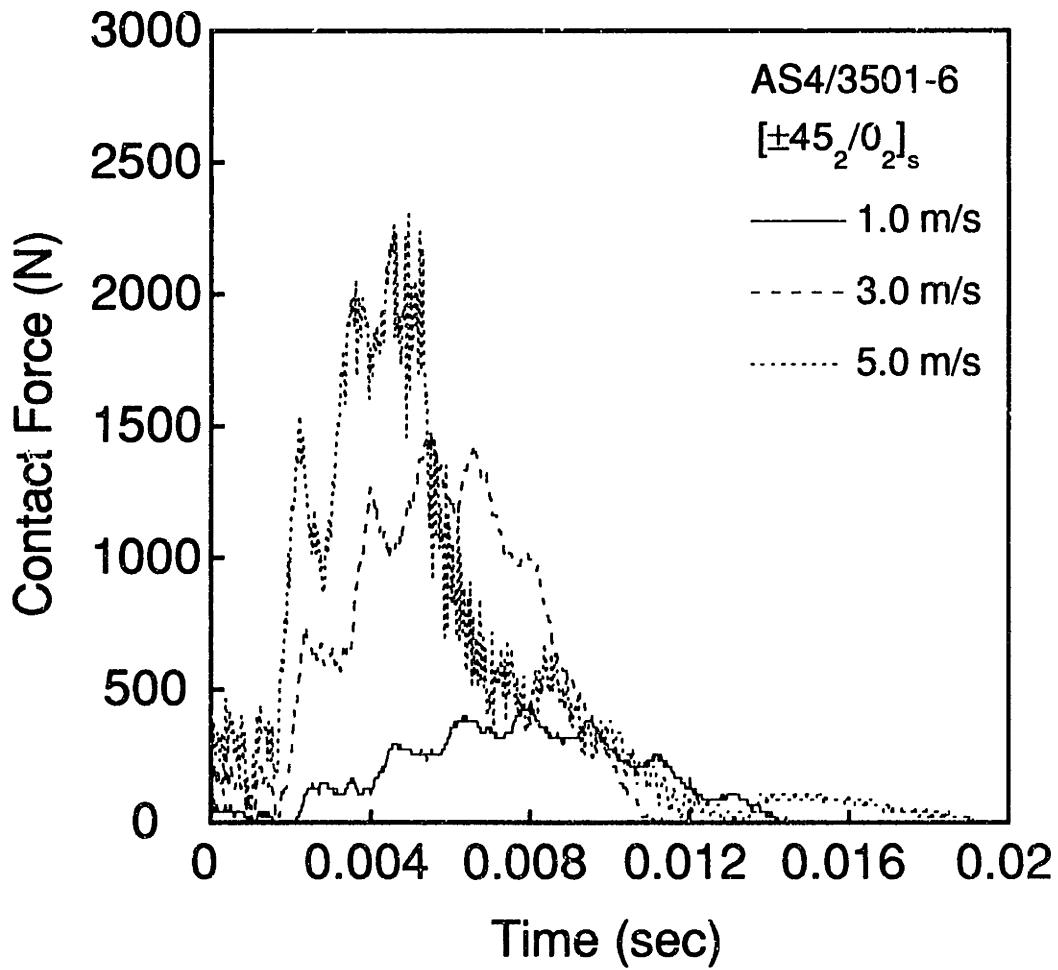
Figure 4.2 Force-time signatures of AS4/3501-6 [$\pm 45_2/0_2$]_s laminate impacted at 1.0 m/s (undamaged), 3.0 m/s, and 5.0 m/s (penetrated).

Signatures for the $[\pm 45_2/0_2]_s$ layup of AS4/3501-6 are presented in Figure 4.2. The 1.0 m/s impact did not damage the specimen, the 3.0 m/s impact caused matrix cracking and delamination, and the 5.0 m/s impact penetrated the specimen. The point of penetration is clearly indicated in the 5.0 m/s impact as a large drop in the contact force after 5.5 ms. Higher frequency

oscillations can be seen in the vicinity of penetration, and the specimen sustained a peak force of approximately 2300 N before the impactor penetrated it. The primary wave in the 1.0 m/s impact reaches a peak of approximately 400 N at about 8 ms, as with the previous layup. Although the 3.0 m/s impact caused damage to the specimen, there is no distinguishable drop in the contact force which can be attributed to the damage. The signature of the 3.0 m/s impact reaches a peak of approximately 1500 N at about 5.5 ms. The peaks of the secondary oscillation occur approximately 1.5 ms apart, as was also observed with the $[\pm 15_2/0_2]_s$ layup.

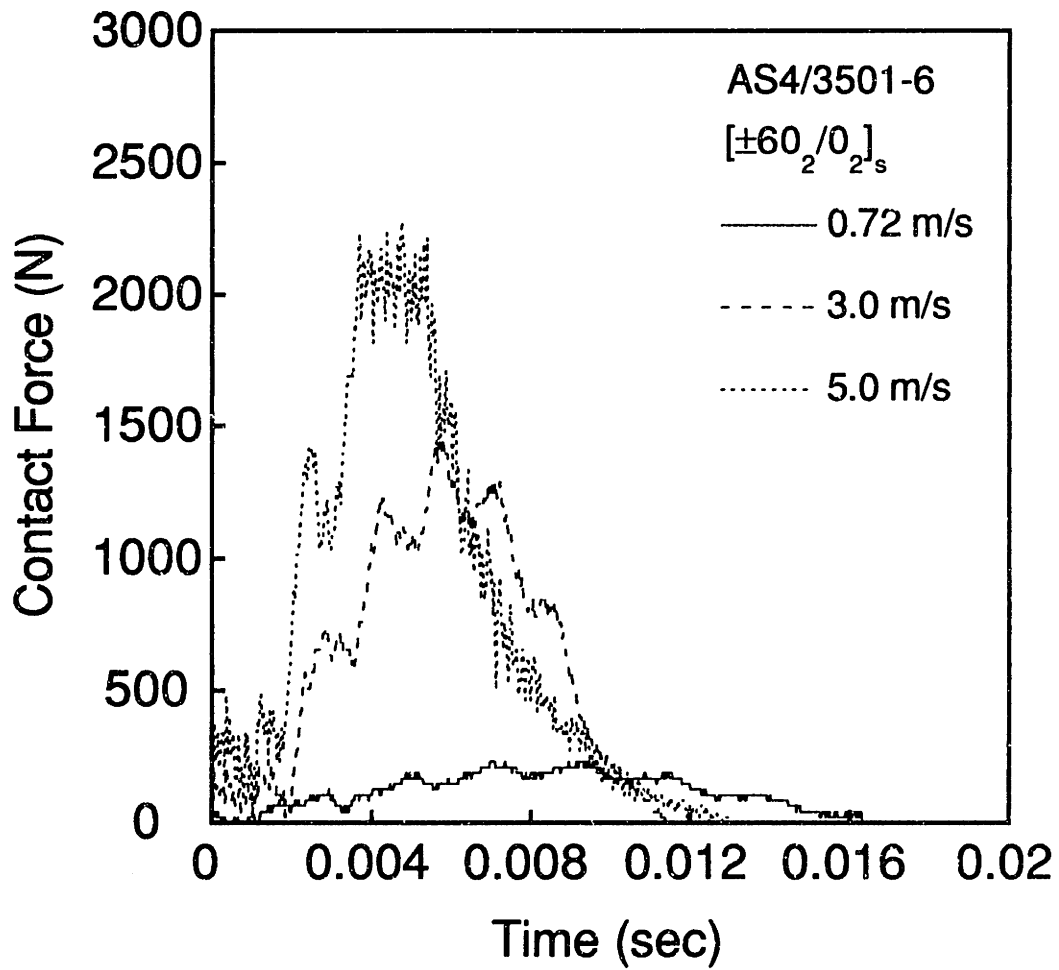
Figure 4.3 Force-time signatures of AS4/3501-6 $[\pm 60_2/0_2]_s$ laminate impacted at 0.72 m/s (undamaged), 3.0 m/s, and 5.0 m/s (penetrated).

Signatures for the $[\pm 60_2/0_2]_s$ layup of AS4/3501-6 are presented in Figure 4.3. The 0.72 m/s impact did not damage the specimen, the 3.0 m/s impact caused matrix cracking and delamination, and the 5.0 m/s impact penetrated the specimen. It can be seen that penetration in the 5.0 m/s impact was accompanied by a high frequency oscillation and large drop in the contact force after 5.5 ms. The specimen sustained a peak force of approximately 2250 N before the impactor penetrated it. The peak force of the 3.0 m/s impact is approximately 1400 N and the duration is about 11 ms. The secondary peaks occur approximately 1.5 ms apart, as was observed for the previous two layups. The peak and duration of the primary wave is nearly the same as that of the previous layup.

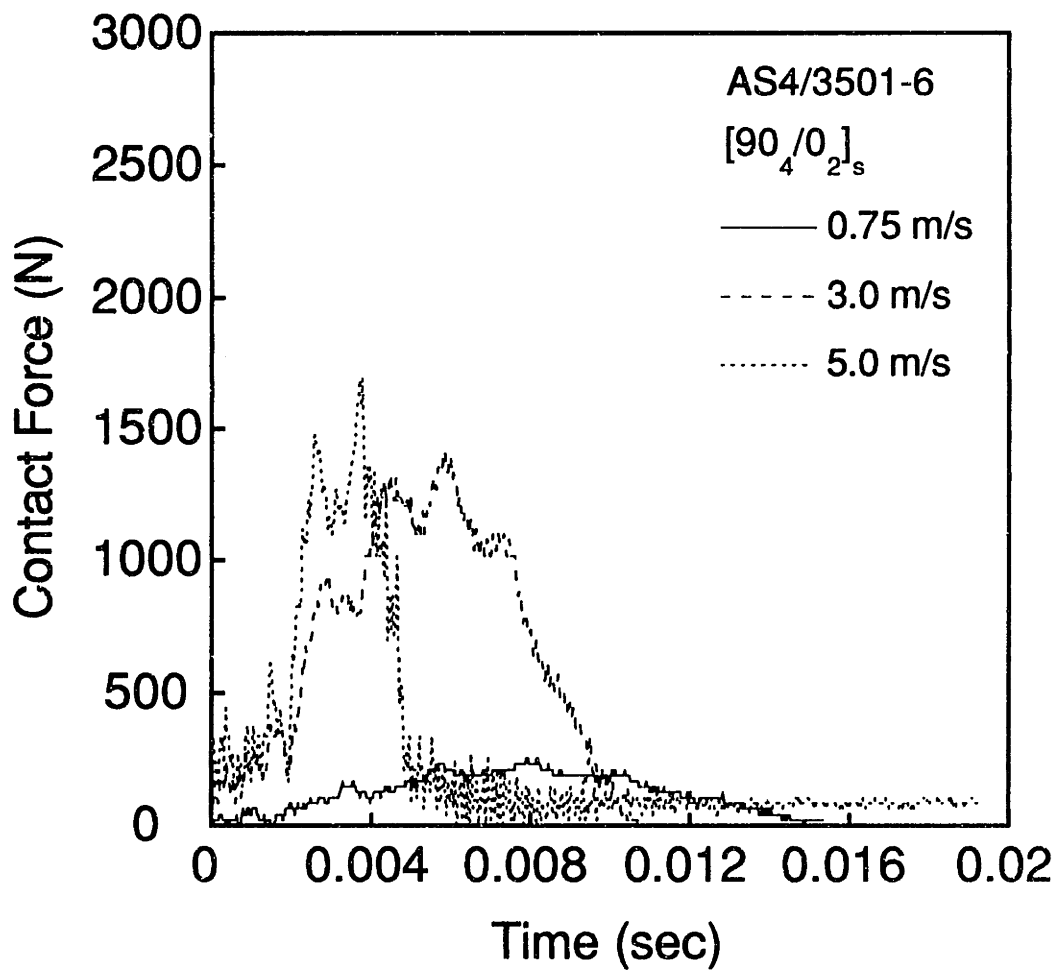
Figure 4.4 Force-time signatures of AS4/3501-6 $[90_4/0_2]_s$ laminate impacted at 0.75 m/s (undamaged), 3.0 m/s, and 5.0 m/s (penetrated).

Signatures for the $[90_4/0_2]_s$ layup of AS4/3501-6 are presented in Figure 4.4. The 0.75 m/s impact did not cause damage to the specimen, the 3.0 m/s impact caused matrix cracking and delamination, and the 5.0 m/s impact penetrated the specimen. In terms of peak force before penetration, this layup was the most easily penetrated of the 12-ply layups of this material system. It can be seen that after reaching a peak force (at about 4 ms) of approximately 1700 N, the contact force falls dramatically and a higher frequency oscillation

occurs in the signature. The primary wave in the 3.0 m/s impact has nearly the same peak (1500 N) and duration (11 ms) as the previous layup. However, slight differences in the secondary oscillations can be observed.

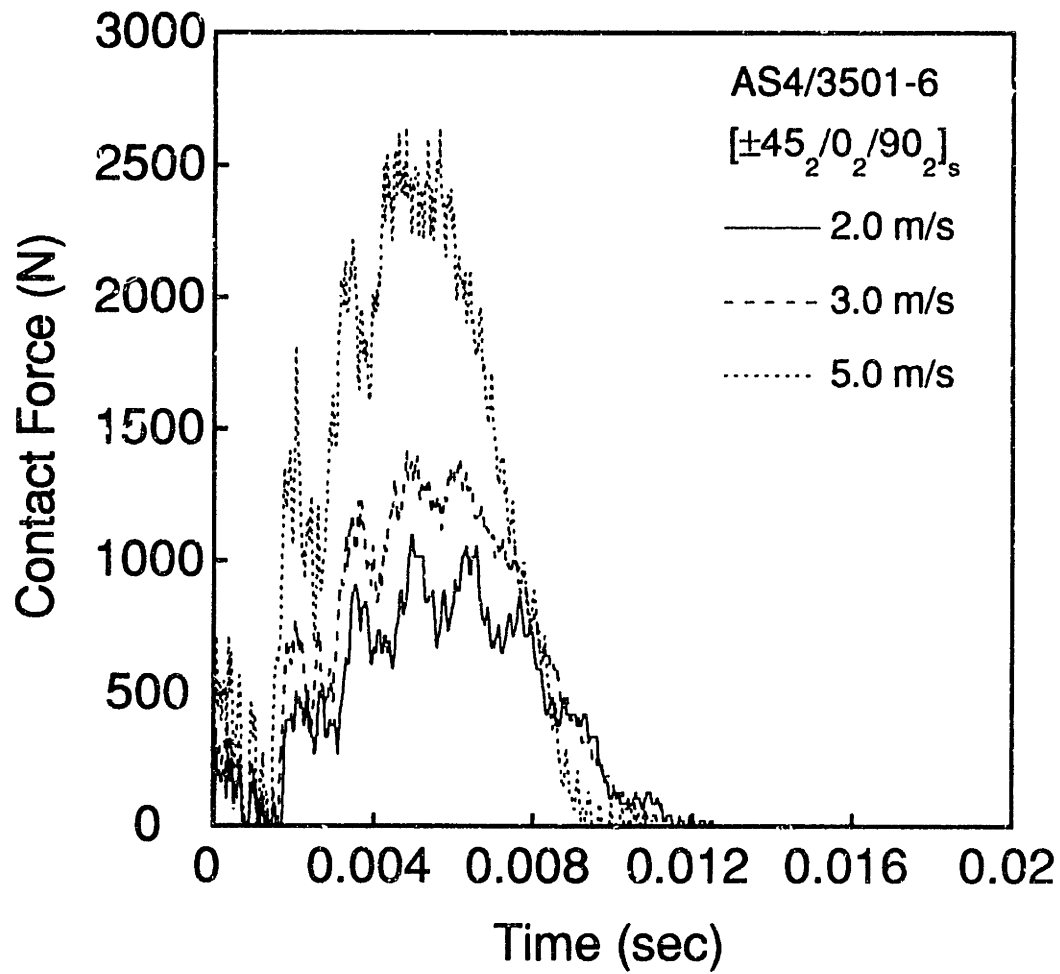
Figure 4.5 Force-time signatures of AS4/3501-6 $[\pm 45_2/0_2/90_2]_s$ laminate impacted at 2.0 m/s (undamaged), 3.0 m/s, and 5.0 m/s.

Signatures of the two 16-ply quasi-isotropic layups of AS4/3501-6 are presented in Figures 4.5 and 4.6. Signatures can be seen for impact velocities of 2.0, 3.0 and 5.0 m/s for the $[\pm 45_2/0_2/90_2]_s$ layup in Figure 4.5. No damage resulted from the 2.0 m/s impact, while the 3.0 and 5.0 m/s impacts both created internal damage to the specimens. In the 5.0 m/s impact, this laminate was able to sustain a contact force of approximately 2600 N without any visible surface damage. Secondary oscillations are visible in the 5.0 m/s signature before the peak force is reached (at approximately 5 ms). After the peak force, higher frequency oscillations are observed, and the amplitudes of the secondary oscillations are smaller. Like the signatures of the 12-ply laminates, the shape of the signatures of the 16-ply laminates is a half sine wave with oscillations of higher frequency superimposed on it. From the 3.0 m/s impact, it can be seen that the peak force and duration are not significantly different from those of the 12-ply laminates.

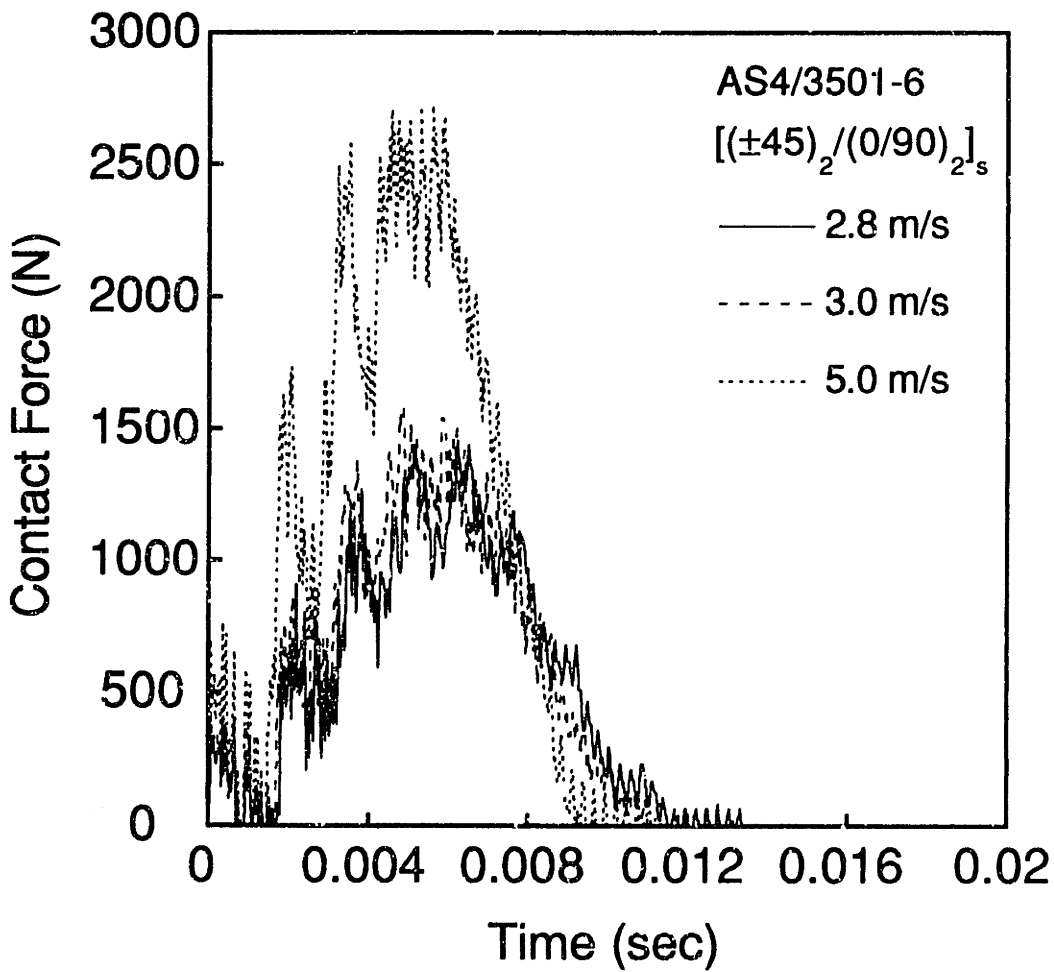
Figure 4.6 Force-time signatures of AS4/3501-6 $[(\pm 45)_2 / (0/90)_2]_s$ laminate impacted at 2.8 m/s (undamaged), 3.0 m/s, 5.0 m/s.

Signatures for impact velocities of 2.8, 3.0 and 5.0 m/s impacts for the $[(\pm 45)_2/(0/90)_2]_s$ layup of AS4/3501-6 are presented in Figure 4.6. These signatures have more high frequency oscillations than was observed with the $[\pm 45_2/0_2/90_2]_s$ layup. No damage resulted from the 2.8 m/s impact, while the 3.0 and 5.0 m/s impacts created internal damage to the specimens. In the 5.0 m/s impact, this layup withstood a force of approximately 2700 N without visible surface damage. After the peak force (at approximately 5 ms), the secondary oscillation can no longer be seen, as was the case with the previous layup. The amplitudes of the secondary oscillations were greater with this

layup than with the $[\pm 45_2/0_2/90_2]_s$ layup, as can be seen clearly from the 3.0 m/s signatures.

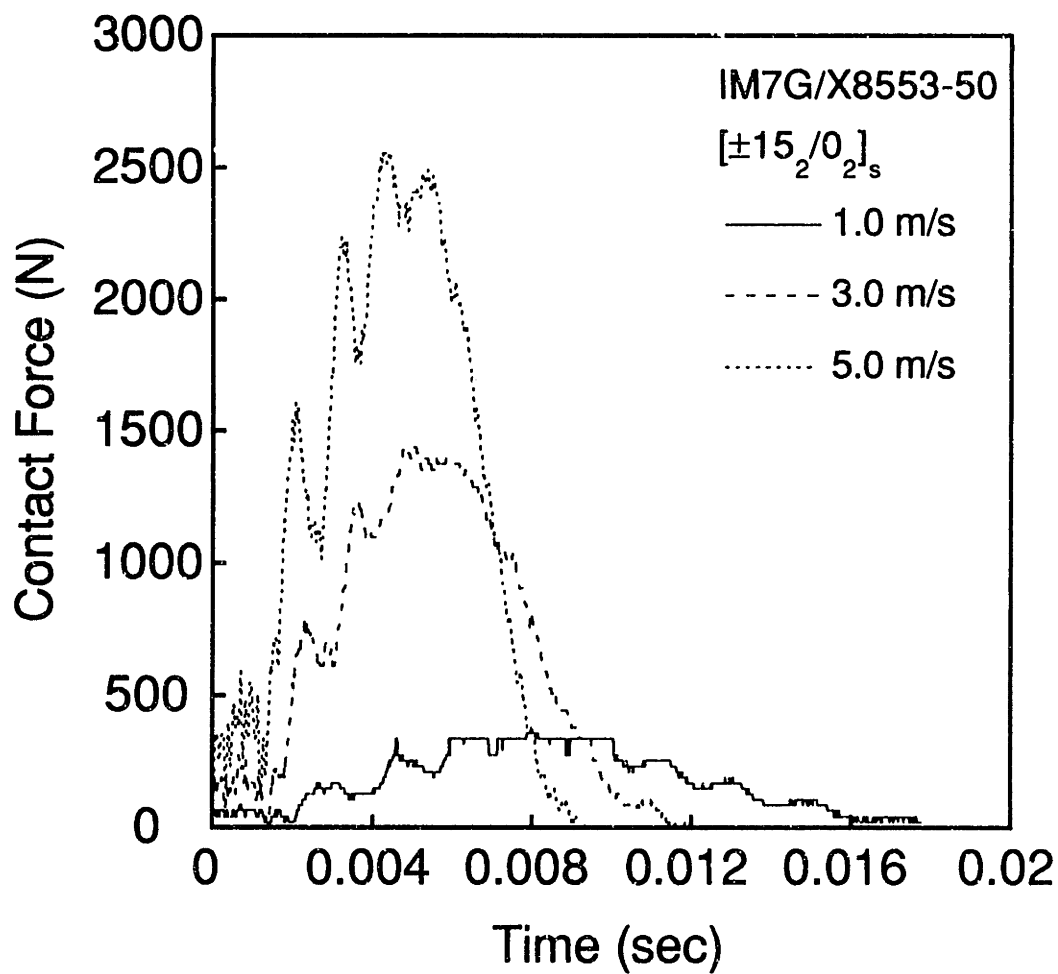
Figure 4.7 Force-time signatures of IM7G/X8553-50 $[\pm 15_2/0_2]_s$ laminate impacted at 1.0 m/s (undamaged), 3.0 m/s, and 5.0 m/s.

Signatures for impact velocities of 1.0, 3.0, and 5.0 m/s for the $[\pm 15_2/0_2]_s$ layup of IM7G/X8553-50 are presented in Figure 4.7. The 1.0 m/s impact did not cause damage to the specimen, while the 3.0 and 5.0 m/s impacts caused internal damage. As was the case with the AS4/3501-6 laminates, the shape of these signatures is half of a sine wave with oscillations of higher frequency superimposed on it. As was the case with the AS4/3501-6 laminates, it is observed here that a higher impact velocity causes an impact of shorter duration. The duration of the 1.0 m/s impact is greater than 16 ms, while the duration of the 3.0 m/s impact is about 12 ms and that of the 5.0 m/s impact is less than 10 ms. The peak force of the 5.0 m/s impact is approximately 2550 N, as compared to 2400 N with the same layup of AS4/3501-6, in which penetration occurred. In the 5.0 m/s signature, secondary oscillations can be seen before the peak force is reached (approximately 4.5 ms), but the force falls sharply after 6 ms and the secondary oscillations do not appear on this "downward" side of the signature. This specimen was not penetrated in this impact. A similar behavior can be seen in the 3.0 m/s signature. The secondary peaks are more pronounced on the "upward" side of the signature than on the "downward" side. The signature of the 3.0 m/s impact of this laminate is nearly identical to that of the same layup of AS4/3501-6.

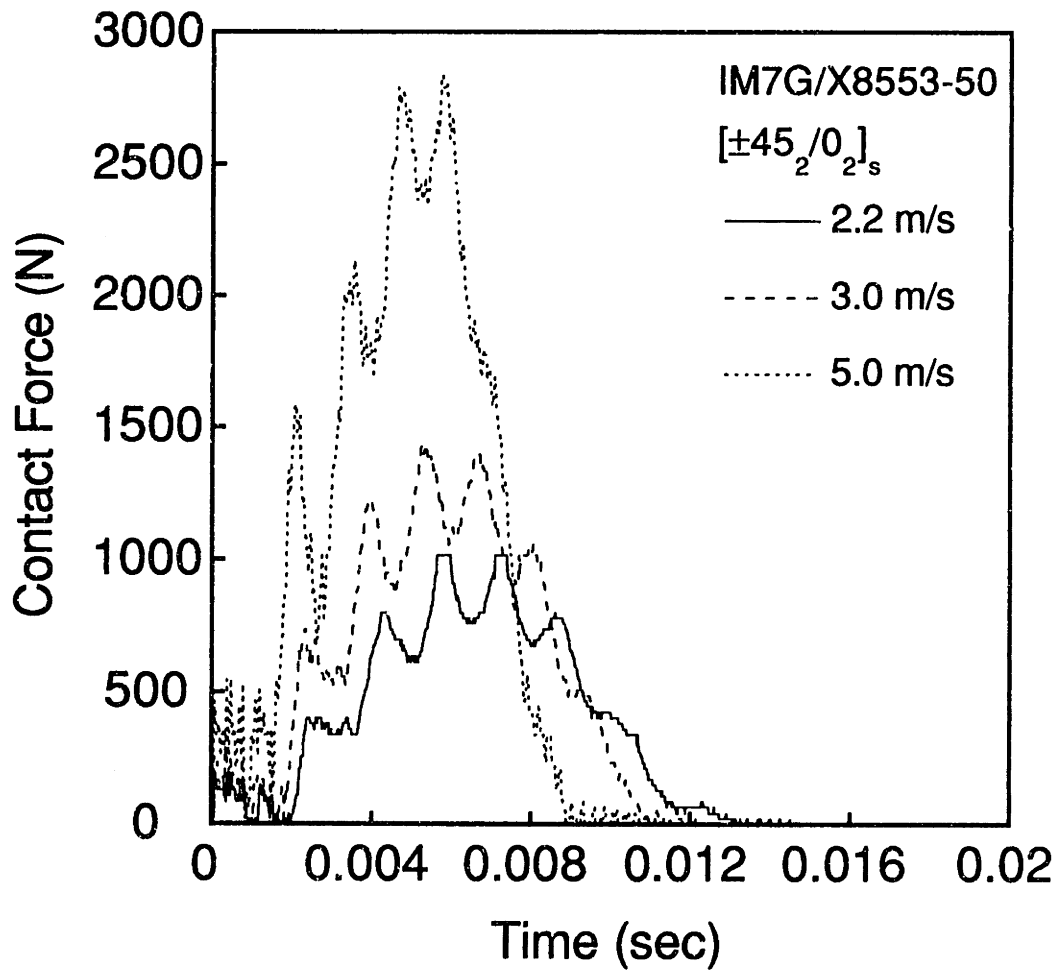
Figure 4.8 Force-time signatures of IM7G/X8553-50 $[\pm 45_2/0_2]_s$ laminate impacted at 2.2 m/s (undamaged), 3.0 m/s, and 5.0 m/s.

Signatures for the $[\pm 45_2/0_2]_s$ layup impacted at 2.2, 3.0 and 5.0 m/s are presented in Figure 4.8. The 2.2 m/s impact caused no damage to the specimen, while the 3.0 and 5.0 m/s impacts caused internal damage. As with the previous layups, a shorter impact duration is observed here for a higher impact velocity. The peak force of the 5.0 m/s impact is approximately 2800 N and occurs after 6 ms. The 5.0 m/s impact on the same layup of AS4/3501-6 attained a peak force of only 2250 N, which caused penetration of the specimen. As noted in the 5.0 m/s signature of the $[\pm 15_2/0_2]_s$ layup of IM7G/X8553-50, the force falls sharply on the "downward" side of the signature with little evidence of a secondary oscillation, and this is not due to penetration. The 3.0 m/s signature of this laminate is nearly identical to that of the same layup of AS4/3501-6.

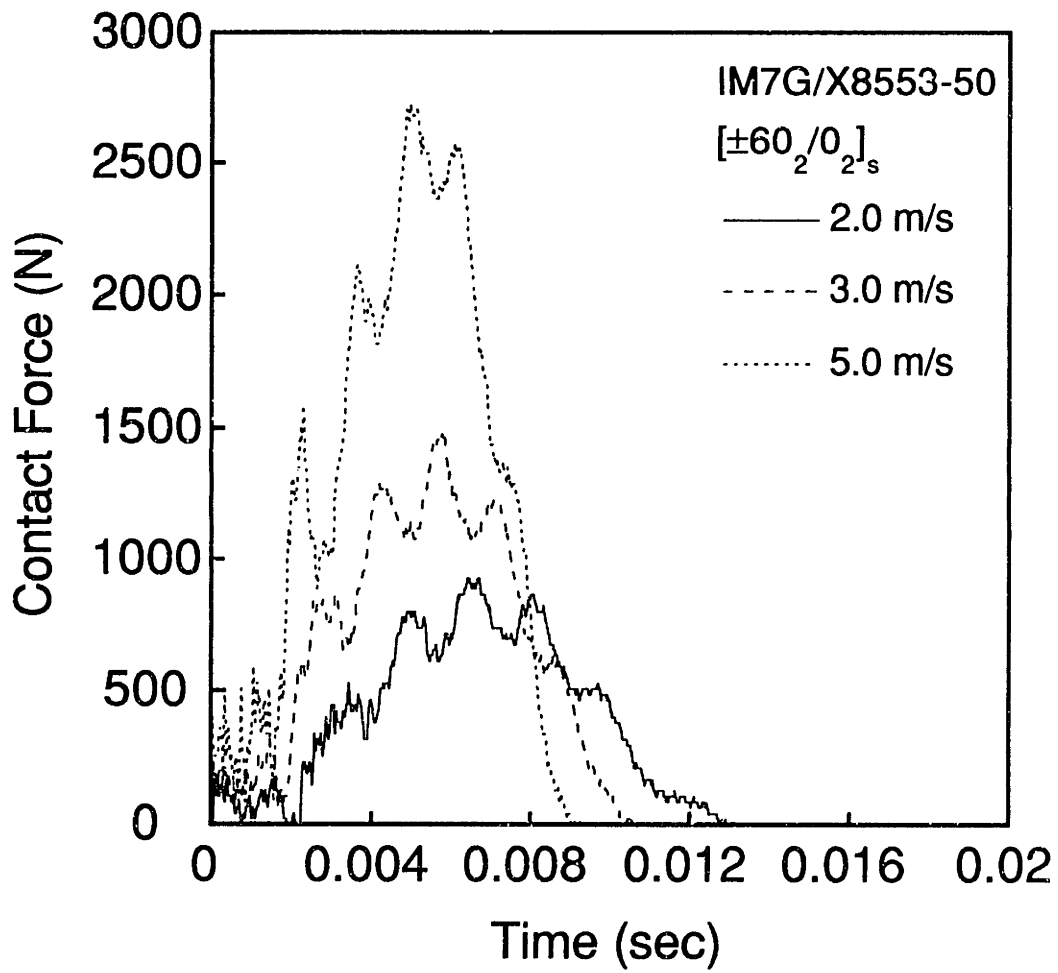
Figure 4.9 Force-time signatures of IM7G/X8553-50 $[\pm 60_2/0_2]_s$ laminate impacted at 2.0 m/s (undamaged), 3.0 m/s, and 5.0 m/s.

Signatures for the $[\pm 60_2/0_2]_s$ layup of IM7G/X8553-50 impacted at 2.0, 3.0, and 5.0 m/s are presented in Figure 4.9. The 2.0 m/s impact caused no damage, while the 3.0 and 5.0 m/s impacts caused internal damage only. As before, the secondary oscillations are more pronounced on the "upward" side of the 5.0 m/s signature than on the "downward" side. The peak force in this impact is approximately 2700 N, as compared to 2250 N at which the same layup of AS4/3501-6 was penetrated. In the 3.0 m/s signature, the peak force and the spacing of the secondary peaks are virtually identical to those of the same layup of AS4/3501-6. However, there are differences between these two signatures. There is a difference in the height of the last secondary peak on the "downward" side of the signature. This small peak on the signature of the AS4/3501-6 laminate is 200 N higher than its counterpart in the IM7G/X8553-50 signature, and the duration of the impact is about 1 ms longer for the AS4/3501-6 laminate (11.5 ms) than it is for the IM7G/X8553-50 laminate (10.5 ms).

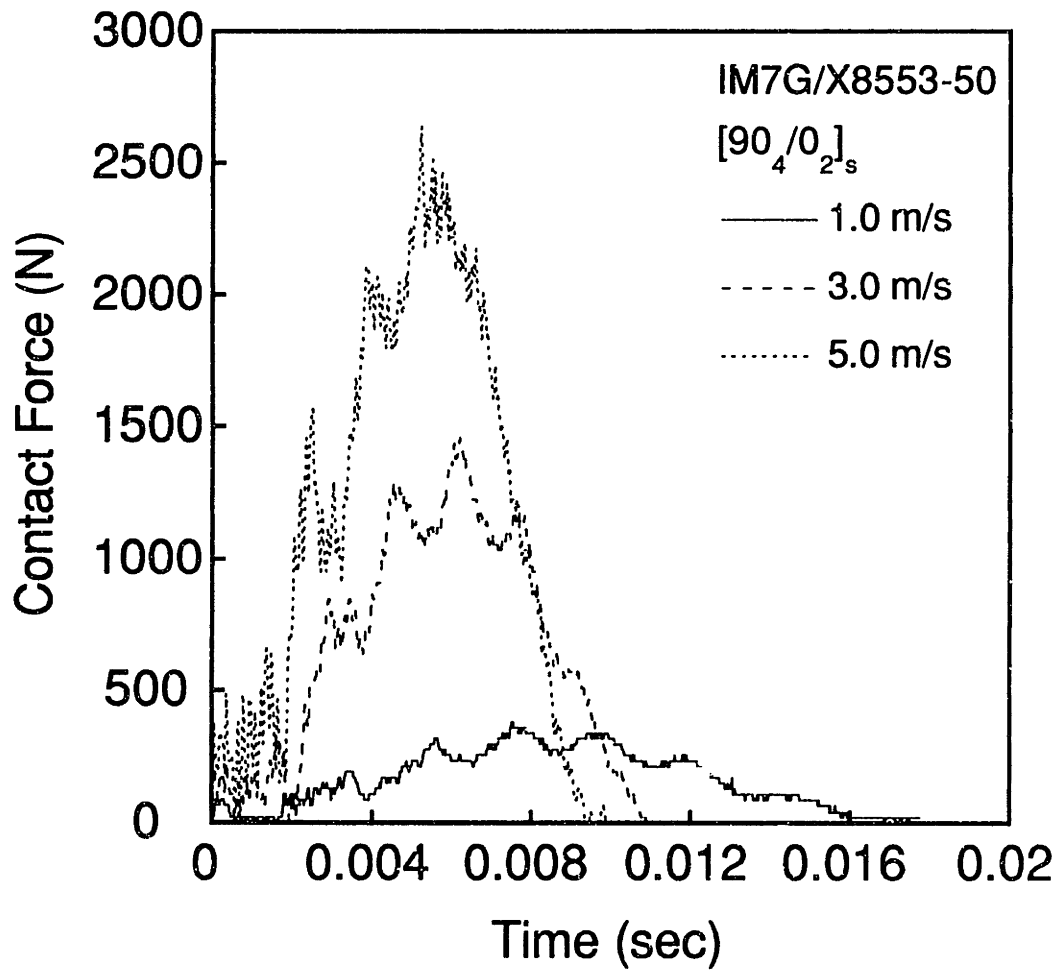
Figure 4.10 Force-time signatures of IM7G/X8553-50 $[90_4/0_2]_s$ laminate impacted at 1.0 m/s (undamaged), 3.0 m/s, and 5.0 m/s.

Signatures for the $[90_4/C_2]_s$ layup of IM7G/X8553-50 impacted at 1.0, 3.0 and 5.0 m/s are presented in Figure 4.10. The 1.0 m/s impact did not cause damage to the specimen, while the 3.0 and 5.0 m/s impacts caused internal damage. Secondary oscillations are again more apparent on the "upward" side of the 5.0 m/s signature than on the "downward" side. A peak force of 2600 N is reached after approximately 5.0 ms, as compared to 1700 N at which the same layup of AS4/3501-6 was penetrated. The 3.0 m/s signature has nearly the same peak force and duration as the 3.0 m/s signature of the AS4/3501-6 $[90_4/0_2]_s$ laminate.

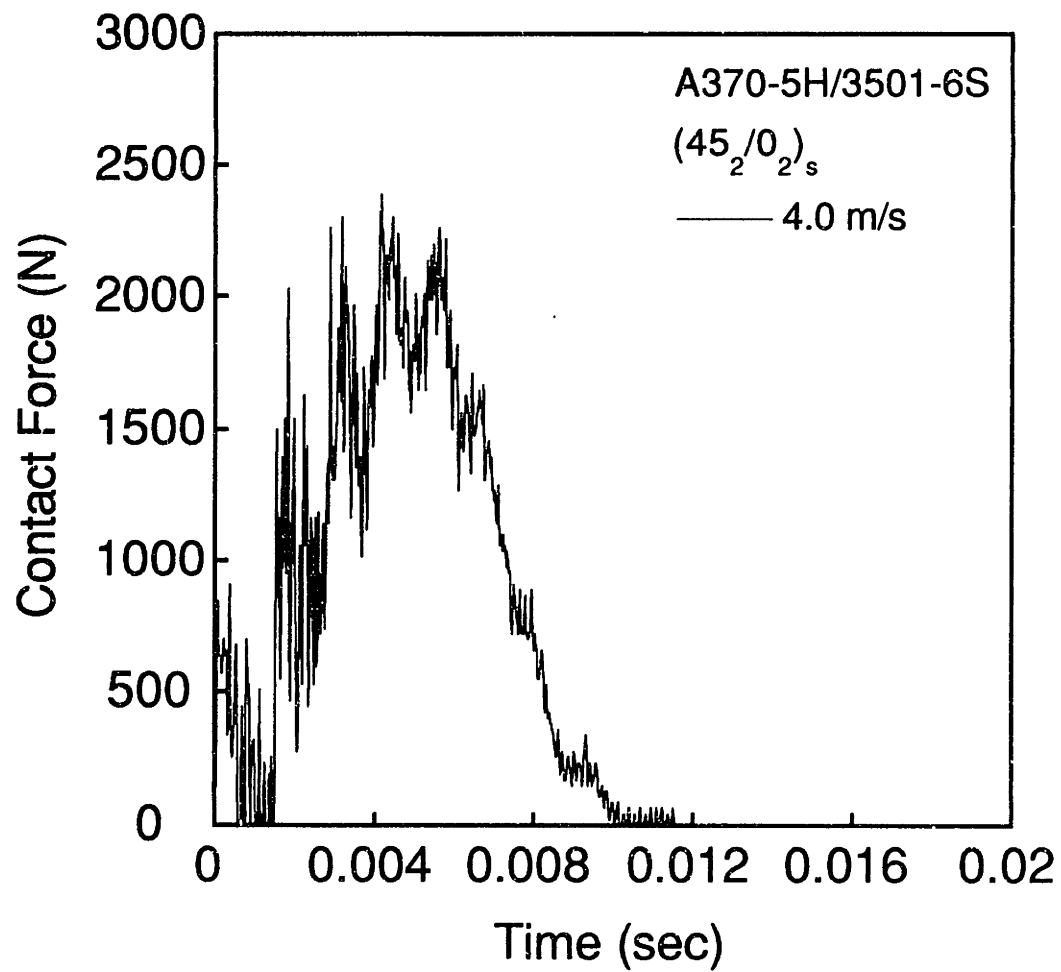
Figure 4.11 Force-time signature of A370-5H/3501-6S $(45_2/0_2)_s$ laminate impacted at 4.0 m/s (undamaged).

Signatures of the fabric graphite/epoxy system impacted at 4.0 and 5.0 m/s are presented in Figures 4.11 and 4.12, respectively. The 4.0 m/s impact did not cause damage to the specimen, while the 5.0 m/s impact caused internal damage. The presence of high frequency oscillations is obvious in these signatures. Also, it can be seen that the amplitudes of the superimposed waves are higher on the "upward" side of the signatures than on the "downward" side. In the 5.0 m/s signature, the location of the secondary peaks is nearly the same as with the 16-ply tape laminates. The duration of the impact is the same (9 ms) but the peak force is higher with the fabric laminate (approximately 3000 N) than with the tape simulations (approximately 2700 N). It is clear that the secondary oscillations are much more pronounced on the "upward" side than on the "downward" side of the signatures for these laminates, but oscillations of higher frequency can be seen on the "downward" side. On the "upward" side, the amplitudes of the secondary oscillations are greater for the fabric laminate.

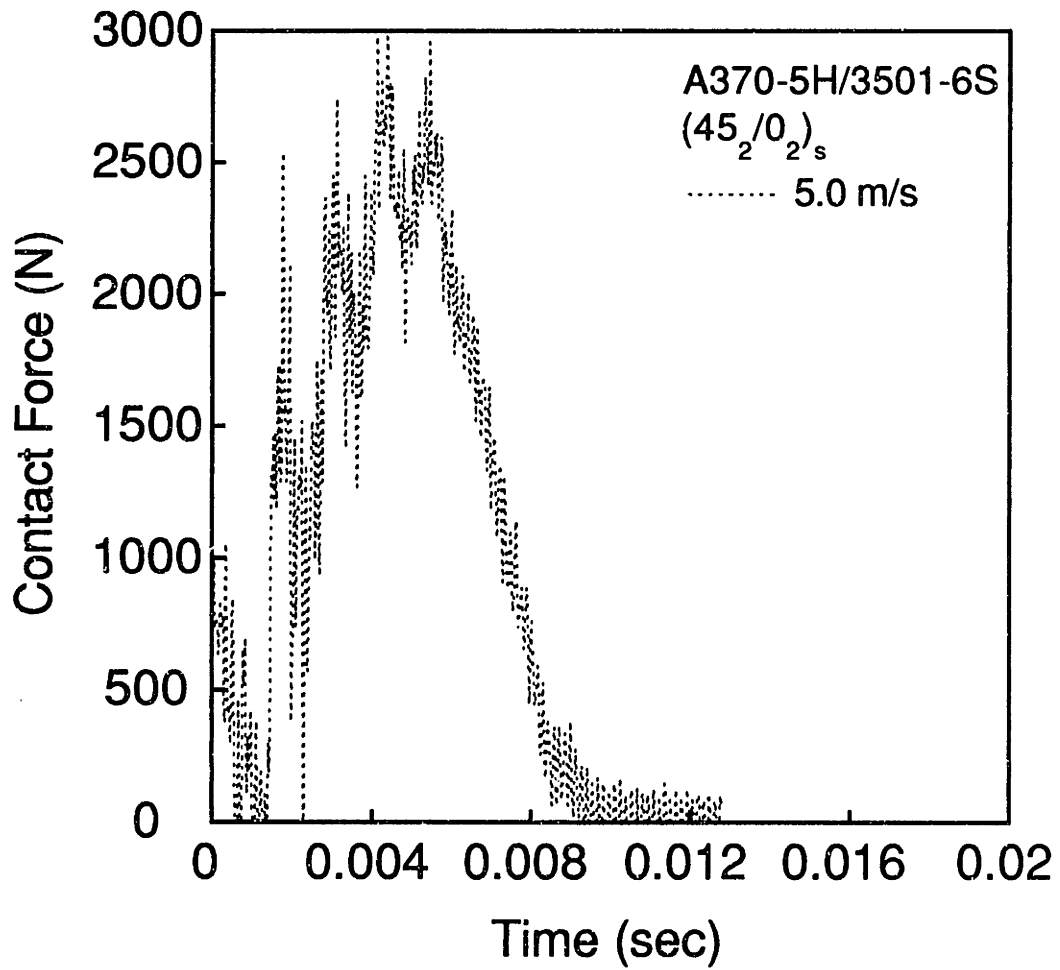
Figure 4.12 Force-time signature of A370-5H/3501-6S (45₂/0₂)_s laminate impacted at 5.0 m/s.

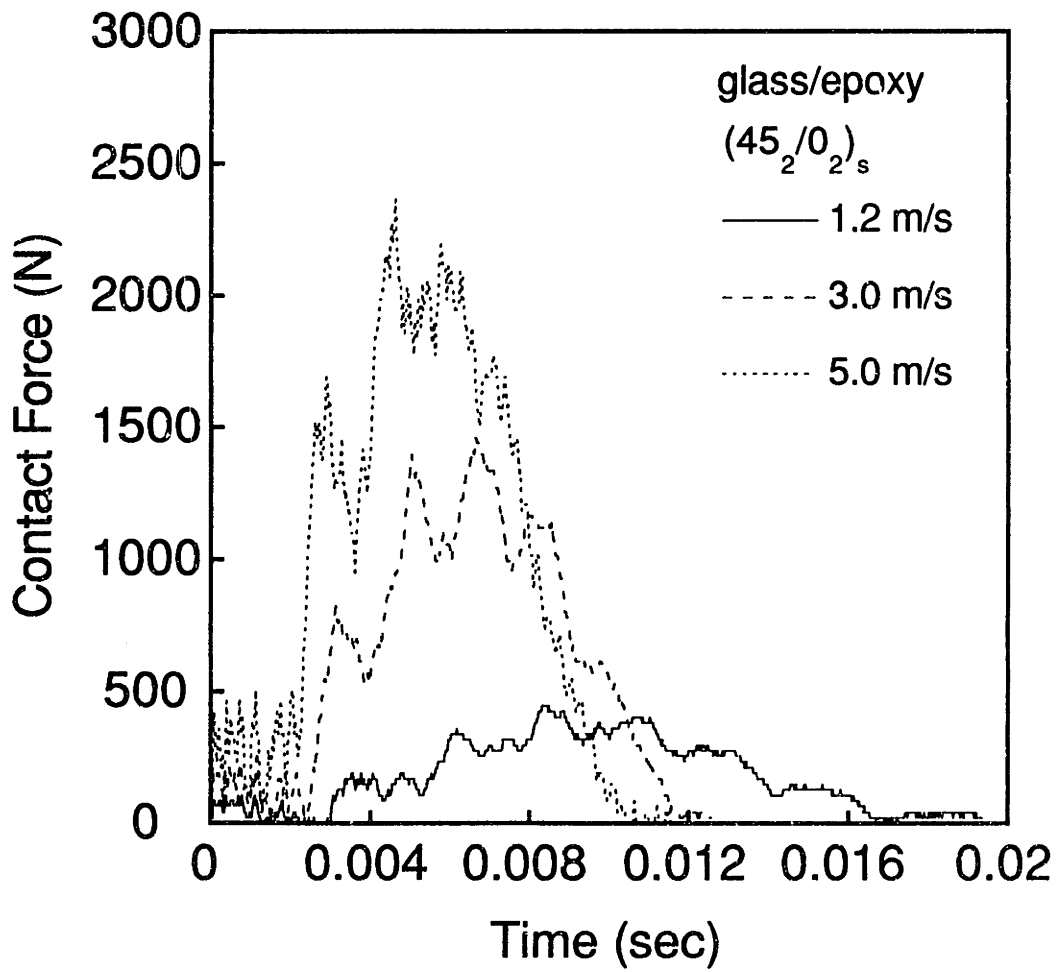
Figure 4.13 Force-time signatures of glass/epoxy $(45_2/0_2)_s$ laminate impacted at 1.2 m/s (undamaged), 3.0 m/s, and 5.0 m/s.

The signatures for the various layups of glass/epoxy are presented in Figures 4.13 through 4.17. Signatures for the $(45_2/0_2)_s$ layup impacted at 1.2, 3.0, and 5.0 m/s are presented in Figure 4.13. No damage occurred from the 1.2 m/s impact, while visible damage was caused by the 3.0 and 5.0 m/s impacts, but penetration did not occur. The shape of the signatures is a half sine wave with oscillations of higher frequency superimposed on it, as was the case with the signatures of the graphite/epoxy laminates. The peak force of the 3.0 m/s signature is nearly identical to those of the graphite/epoxy specimens (1500 N). Although the locations of the peaks of the secondary oscillations differ somewhat, the peak force of the impact is virtually identical. The duration of the 3.0 m/s impact of the glass/epoxy laminate is approximately 12 ms, which is only 1 ms longer than the typical duration of the same impact on the 12-ply graphite/epoxy laminates. The peak force from the 5.0 m/s impact is approximately 2350 N, which is significantly lower than the peak force of 3000 N experienced by the graphite/epoxy $(45_2/0_2)_s$ laminate. The duration of the glass/epoxy impact (10 ms) is approximately 1 ms longer than that of the impact on the graphite/epoxy, and the peak forces of both impacts occur at nearly the same time (5 ms). The amplitude of the secondary oscillations of the graphite/epoxy laminate are several times larger than those of the glass/epoxy laminate. It can be seen, however, that the secondary oscillations are more apparent on the "upward" side of both signatures than on the "downward" side.

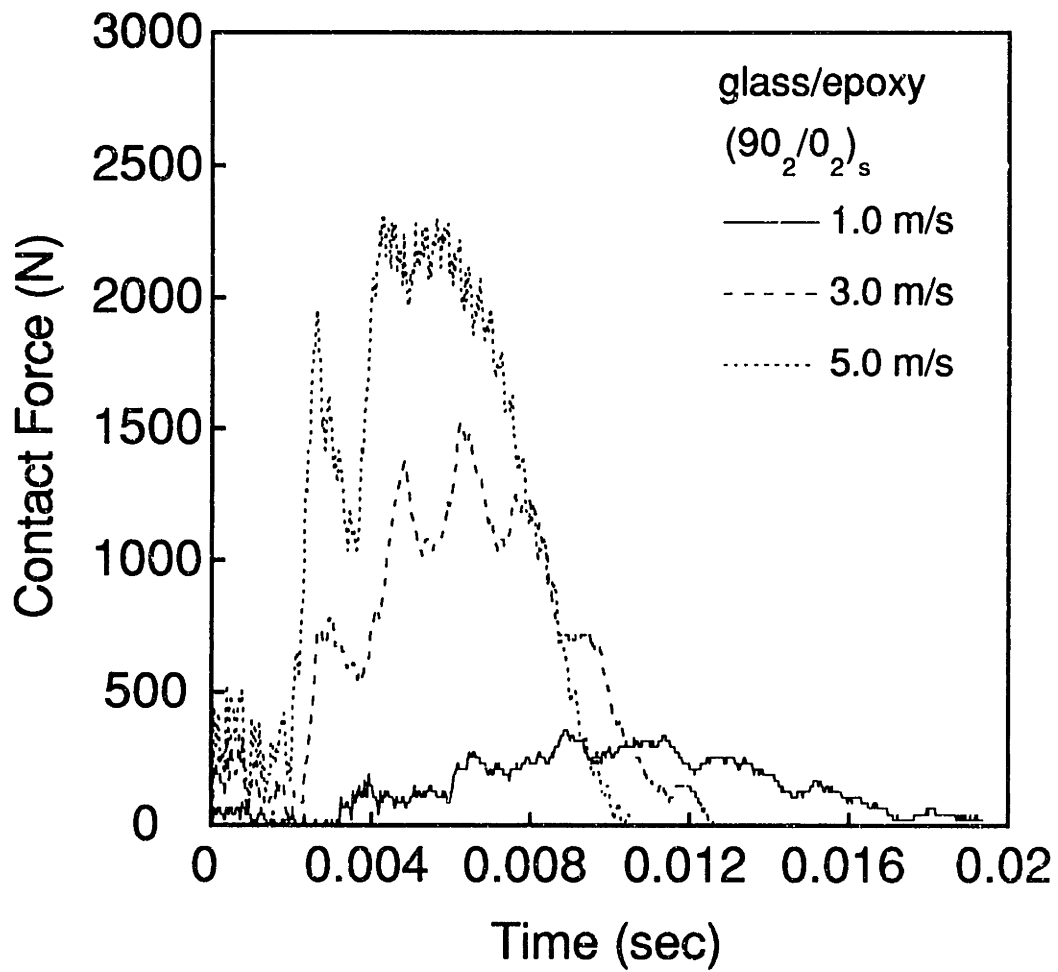
Figure 4.14 Force-time signatures of glass/epoxy (90₂/0₂)_s laminate impacted at 1.0 m/s (undamaged), 3.0 m/s, and 5.0 m/s.

Signatures for the $(90_2/0_2)_s$ layup impacted at 1.0, 3.0, and 5.0 m/s are presented in Figure 4.14. No damage occurred from the 1.0 m/s impact, while visible damage was caused by the 3.0 and 5.0 m/s impacts, again, without penetration.

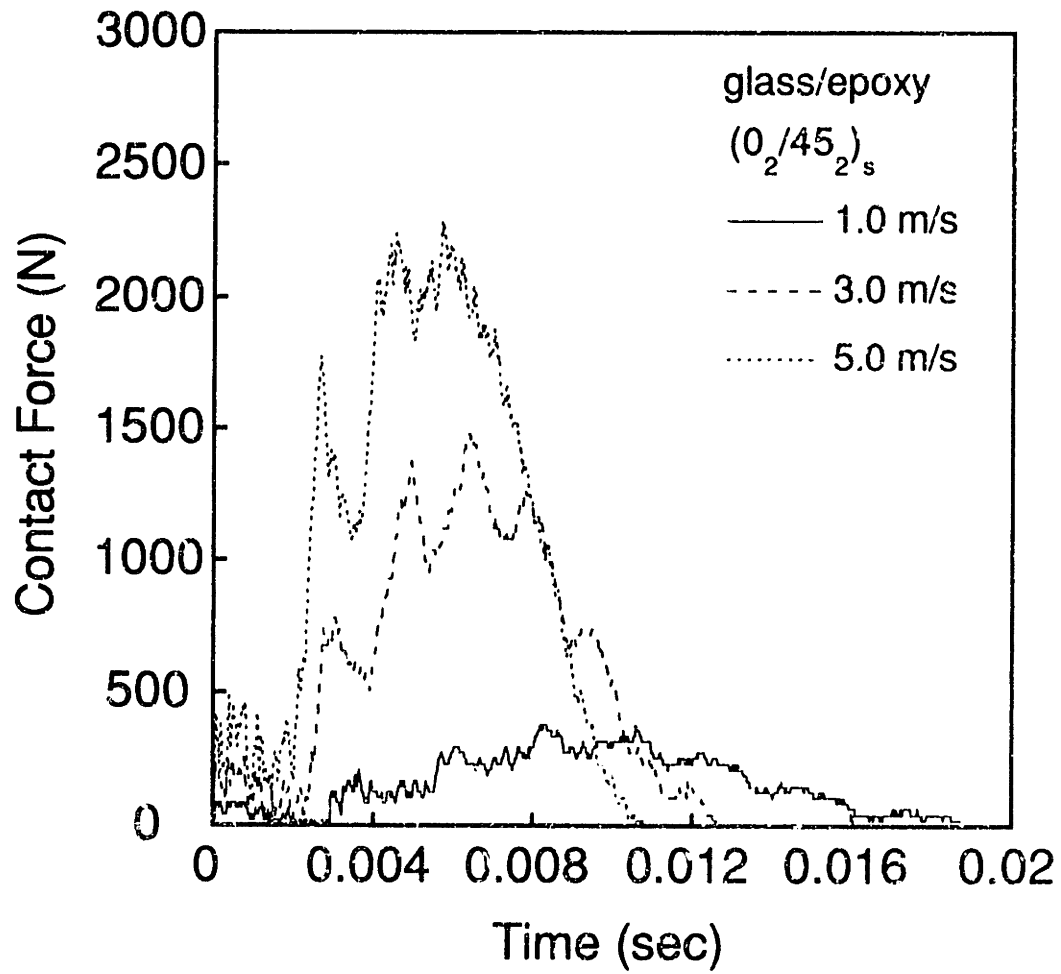
Figure 4.15 Force-time signatures of glass/epoxy (0₂/45₂)_s laminate impacted at 1.0 m/s (undamaged), 3.0 m/s, and 5.0 m/s.

Signatures for the $(0_2/45_2)_s$ layup impacted at 1.0, 3.0 and 5.0 m/s are presented in Figure 4.15. No damage occurred from the 1.0 m/s impact, while visible damage was caused by the 3.0 and 5.0 m/s impacts, again, without penetration.

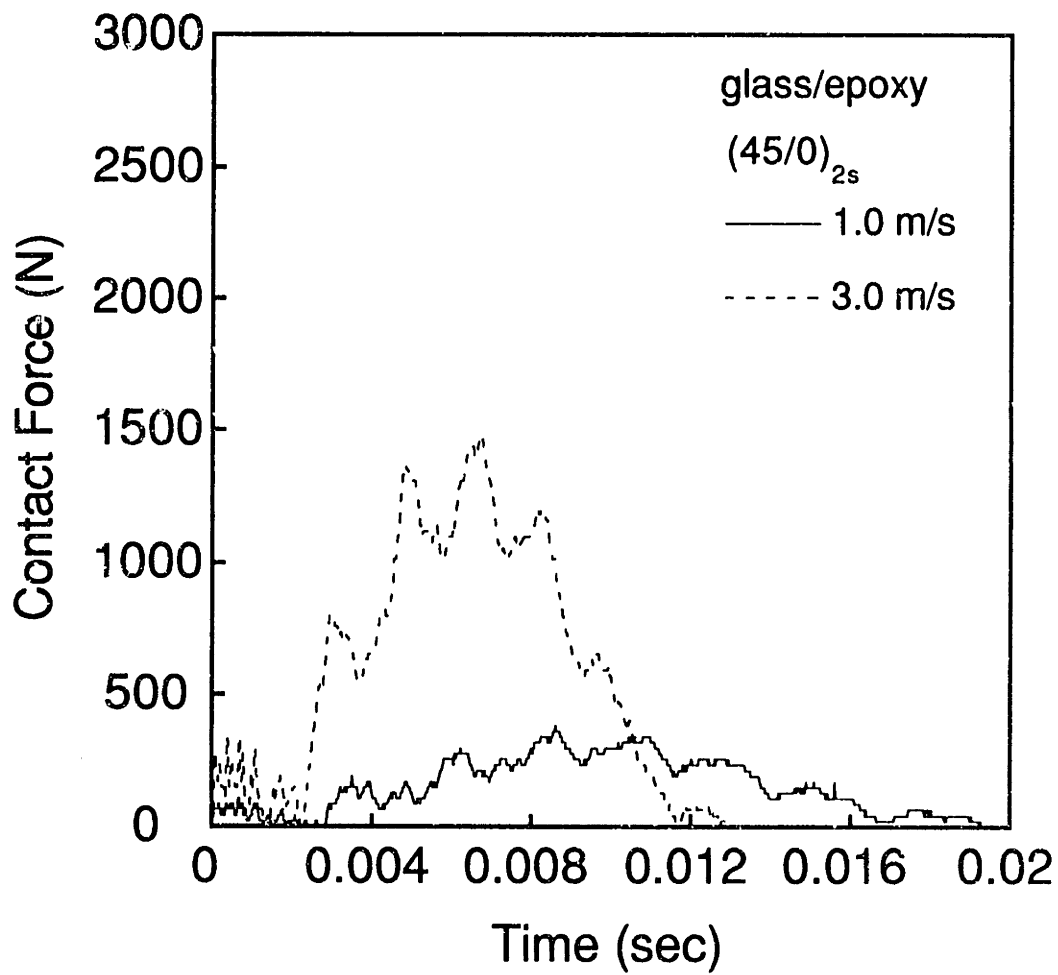
Figure 4.16 Force-time signature of glass/epoxy (45/0)_{2s} laminate impacted at 1.0 m/s (undamaged), and 3.0 m/s.

Signatures for the $(45/0)_{2s}$ layup impacted at 1.0 and 3.0 m/s are presented in Figure 4.16. A specimen of this layup was not impacted at 5.0 m/s. The specimen was undamaged from the 1.0 m/s impact, but visible damage occurred from the 3.0 m/s impact.

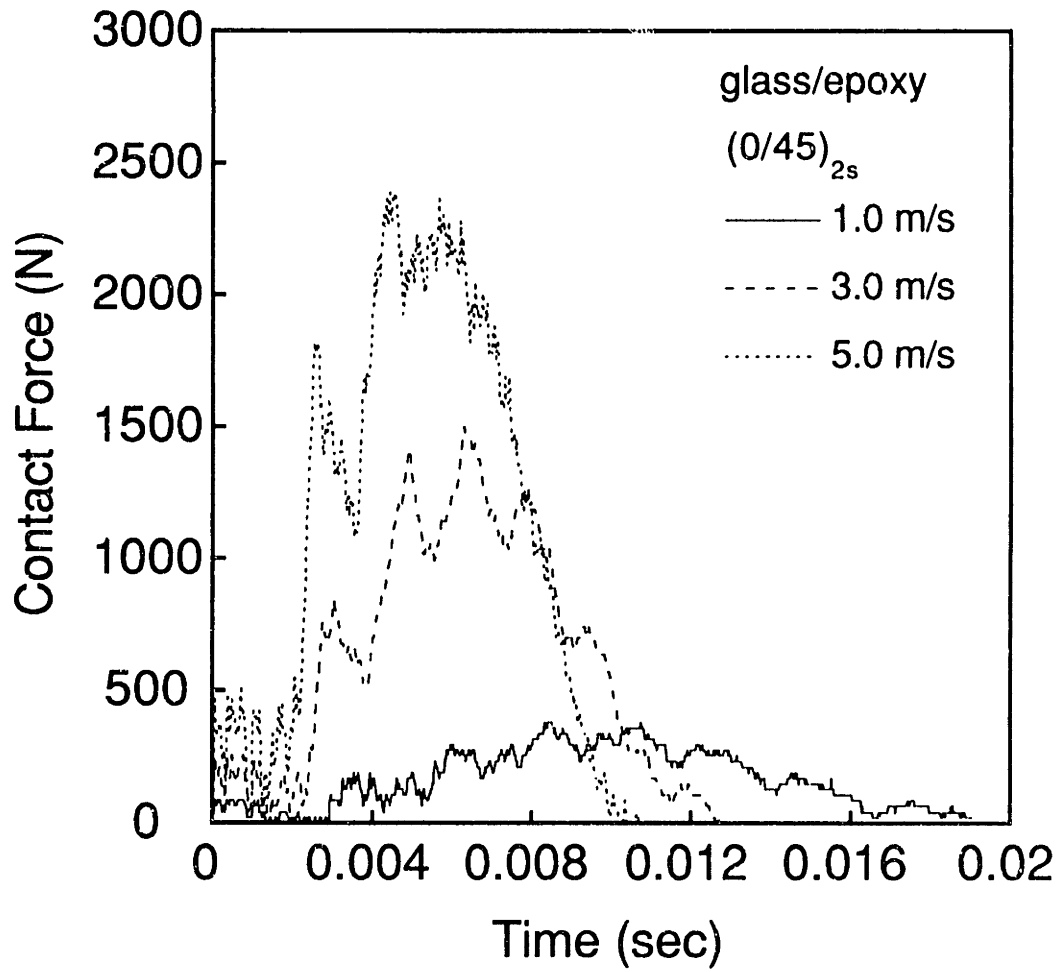
Figure 4.17 Force-time signatures of glass/epoxy (0/45)_{2s} laminate impacted at 1.0 m/s (undamaged), 3.0 m/s, and 5.0 m/s.

Signatures for the $(0/45)_{2s}$ layup impacted at 1.0, 3.0 and 5.0 m/s are presented in Figure 4.17. No damage occurred from the 1.0 m/s impact, while visible damage was caused by the 3.0 and 5.0 m/s impacts, but penetration did not occur.

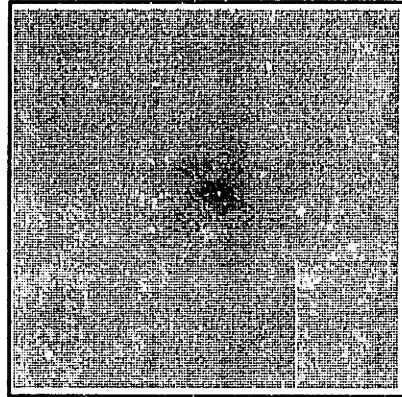
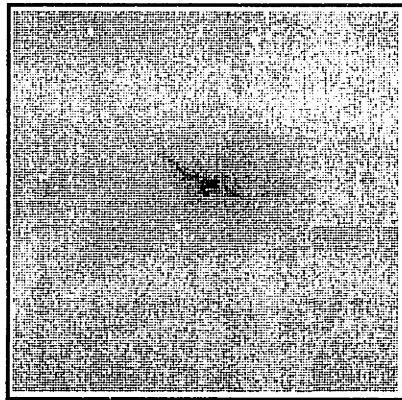
Figure 4.22 X-ray photographs of AS4/3501-6 $[\pm 60_2/0_2]_s$ specimens for impact velocities of (top) 0.9 m/s (incipient), (middle) 1.5 m/s, and (bottom) 3.0 m/s.

Matrix cracking of the $+60^\circ$ plies is the incipient damage mode for the $[\pm 60_2/0_2]_s$ layup, as shown in Figure 4.22. A crack 35 mm in total length occurred in the $+60^\circ$ direction from an impact of 0.9 m/s, and a 3.0 m/s impact caused significant delamination aligned with a $+60^\circ$ crack 35 mm in total length. In certain places, the edge of the delamination is defined by matrix
