IMPACT DAMAGE MECHANISMS IN SEVERAL LAMINATED MATERIAL SYSTEMS

Submitted to the Department of Aeronautics and Astronautics in Partial
Fulfillment of the Requirements for the Degree of

MASTER OF SCIENCE

MASSACHUSETTS INSTITUTE OF TECHNOLOGY

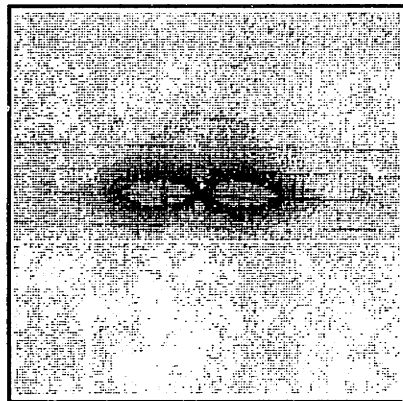
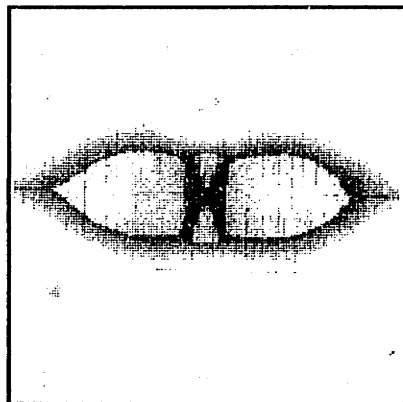
Figure 4.24 X-ray photographs of AS4/3501-6 $[90_4/0_2]_s$ specimens for impact velocities of (top) 0.9 m/s (incipient), (middle) 2.0 m/s, and (bottom) 3.0 m/s.

The damage progression of the $[90_4/0_2]_s$ layup is depicted in Figure 4.24. The incipient damage mode was a matrix crack in the 90° direction. A 90° crack across the entire width (89 mm) of the specimen occurred at an impact velocity of 0.9 m/s. Higher impact velocities caused more 90° matrix cracks and delaminations shaped like a "figure 8" with their longitudinal axes in the 90° direction. A large delamination of approximately 40 mm in overall length is visible in the X-ray image of the specimen impacted at 3.0 m/s and this delamination is bisected by a crack in the 90° direction. As visible from the deply transcription of Figure 4.25, the 3.0 m/s impact caused delaminations at both interfaces of this laminate, but the larger delamination occurred at the interface closer to the back surface of the laminate. The smaller delamination at the upper interface of the laminate is also shaped like a "figure 8" but its longitudinal axis is oriented in the 0° direction. This smaller delamination is approximately 12 mm in its longest dimension. Again, the major axes of the delaminations follow the fiber direction of the lower ply at the interface.

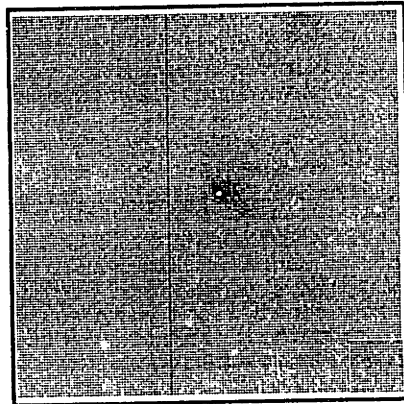
Figure 4.26 X-ray photographs of AS4/3501-6 $[\pm 45_2/0_2/90_2]_s$ specimens for impact velocities of (*top*) 2.3 m/s (incipient), (*middle*) 2.6 m/s, and (*bottom*) 5.0 m/s.

The incipient damage mode in the $[\pm 45_2/0_2/90_2]_s$ layup is matrix cracking in the $+45^\circ$ plies. A matrix crack in the $+45^\circ$ direction and approximately 20 mm in total length was caused from a 2.1 m/s impact, as shown in Figure 4.26. It can be inferred from the shapes of delaminations at higher impact velocities, that the incipient matrix cracks occur in the plies at the back surface of the laminate. Matrix cracks in the 0° and 90° directions as

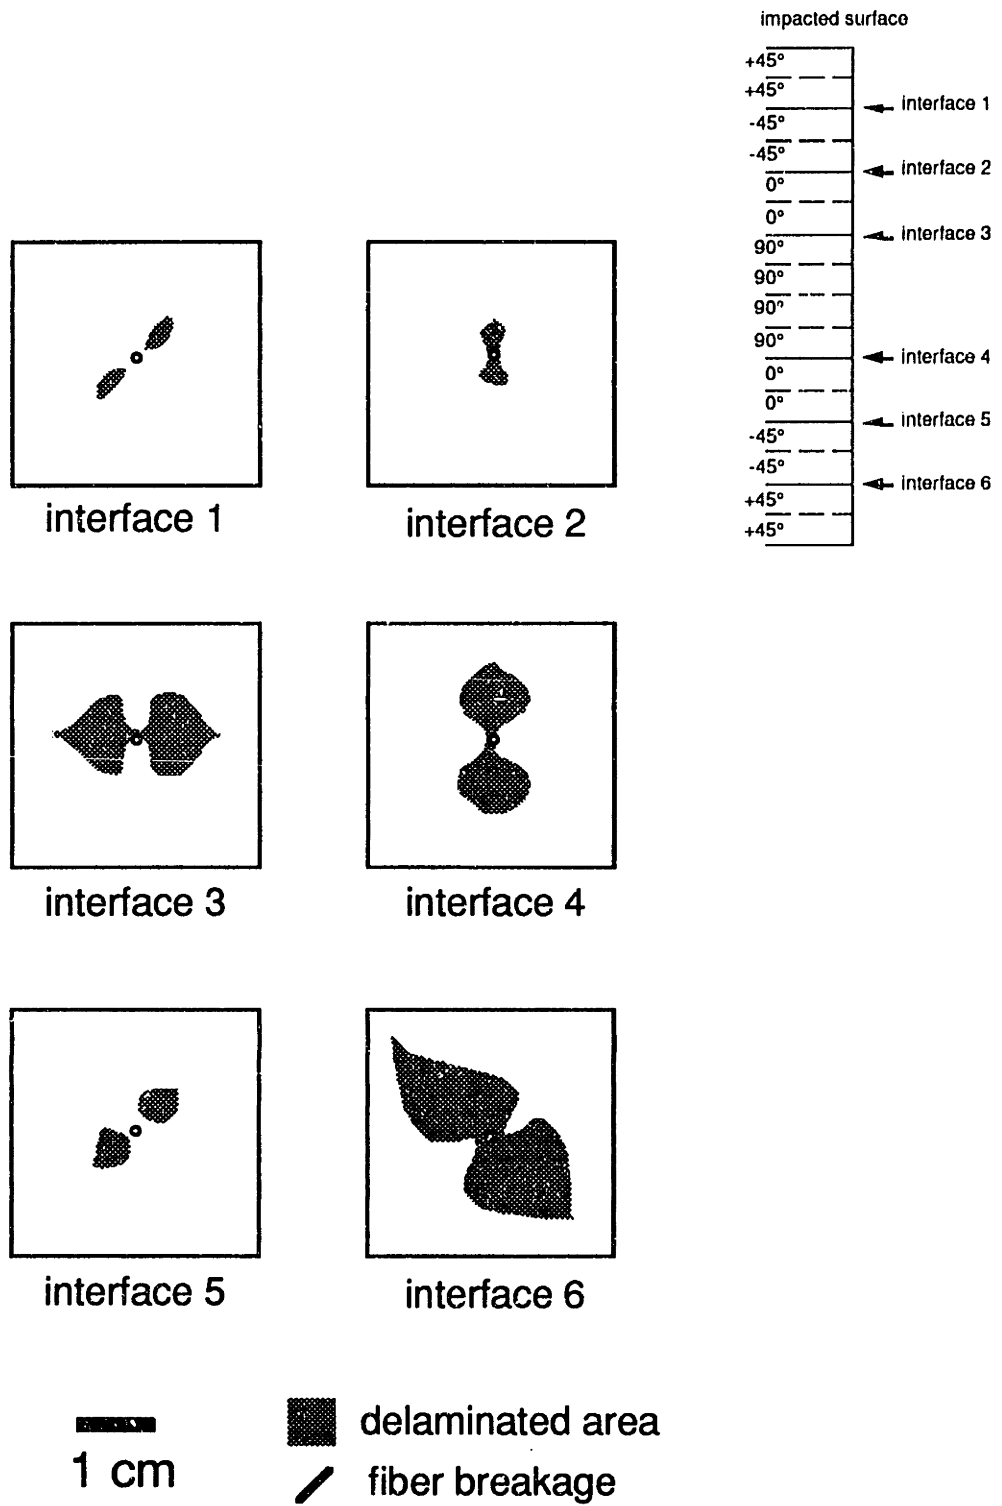
Figure 4.27 Deply transcription of AS4/3501-6 $[\pm 45_2/0_2/90_2]_s$ specimen impacted at 5.0 m/s.

well as delaminations were caused from impacts of higher velocity. The 2.6 m/s impact caused intense matrix cracking in the 0° and 90° direction in addition to several matrix cracks in the $+45^\circ$ direction, and multiple delaminations are observed. The major axis of the largest delamination is aligned with the $+45^\circ$ direction. This delamination appears to have an elliptical shape and its longest dimension is approximately 20 mm. Very extensive matrix cracking in the 0° and 90° directions are also observed from the 5.0 m/s impact. Multiple delaminations are observed, and the largest delamination is again aligned with the $+45^\circ$ direction and has an elliptical shape. The major axis of this delamination is 42 mm and it is bounded by a matrix crack at one end where the edge of the delamination is defined by a $+45^\circ$ matrix crack for approximately 5 mm. The 5.0 m/s impact caused delaminations at all interfaces of the specimen, as can be seen in Figure 4.27. All delaminations have a "figure 8" shape with the longitudinal axis of each delamination aligned with the fiber direction of the lower ply at the interface. The largest delamination occurs at the rearmost interface, and is oriented in the $+45^\circ$ direction.

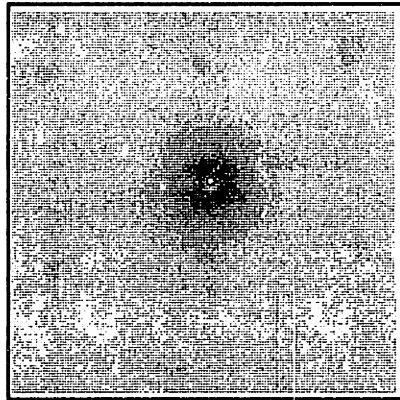
Figure 4.28 X-ray photographs of AS4/3501-6 $[(\pm 45)_2/(0/90)_2]_s$ specimens for impact velocities of (top) 3.0 m/s (incipient), (middle) 3.6 m/s, and (bottom) 5.0 m/s.

X-ray photographs of impacted specimens of the $[(\pm 45)_2/(0/90)_2]_s$ layup are shown in Figure 4.28. The incipient damage velocity was determined to be 3.0 m/s, but a single incipient damage mode is not easily described. What appears to be a combination of matrix cracking and delamination resulted from the 3.0 m/s impact. A circular area of intense matrix cracking in the 0° and 90° directions can be seen near the impact center, and this damage area has a diameter of approximately 9 mm. This area of intense matrix cracking is surrounded by a circular "halo" of delamination of diameter 12 mm. Virtually the same damage state is observed from the 3.6 m/s impact. The 5.0 m/s impact caused elliptical delaminations of approximately 20 mm in length

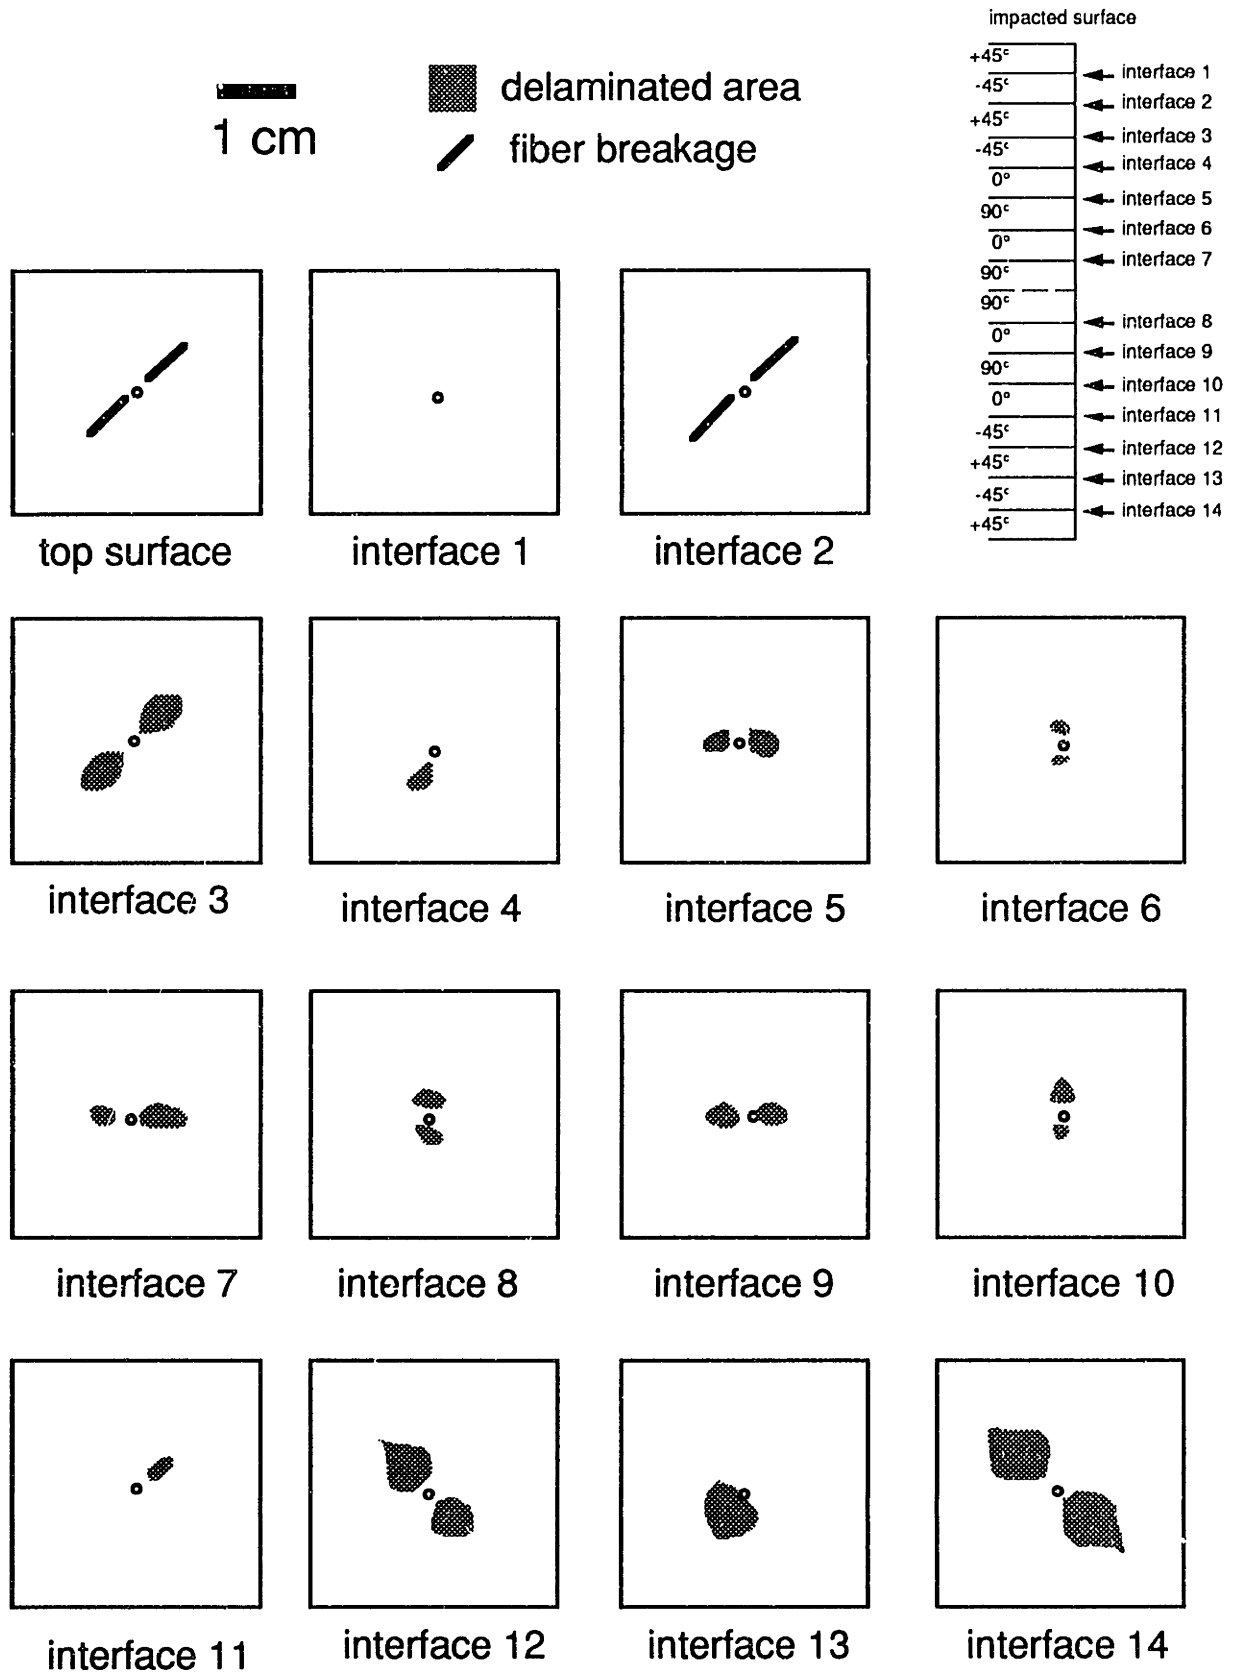
Figure 4.29 Deply transcription of AS4/3501-6 $[(\pm 45)_2 / (0/90)_2]_s$ specimen impacted at 5.0 m/s.

aligned with the +45° direction. These delaminations are noticeably smaller than those observed in the previous laminate impacted at the same velocity. A dark line in the -45° direction can be seen in the X-ray, and this corresponds to fiber breakage, as shown in Figure 4.29. Fiber breaks were observed in both +45° plies near the impacted surface. This is in stark contrast to the other 16-ply layup in which fiber damage was not observed. The fiber damage took the form of lines of fiber breakage oriented in the -45° direction and extending radially outward from the center of impact. The lines of broken fibers ran perpendicular to the fiber direction of the ply, and they did not run completely through the center of impact. The fiber breaks started approximately 2 mm away from the center and extended radially outward approximately 10 mm on either side. Some delamination occurred at almost all of the interfaces, with the largest delamination occurring at the rearmost interface and aligned with the +45° fibers below it.

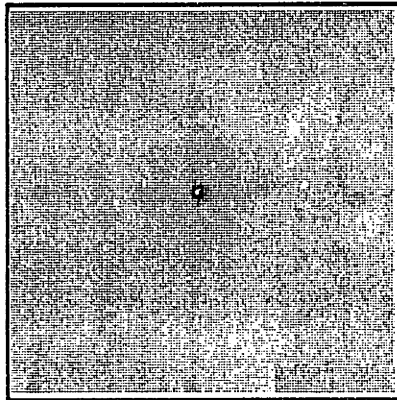
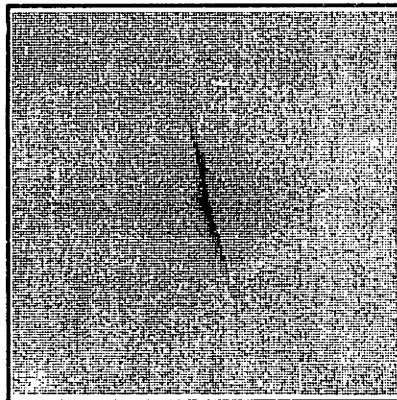
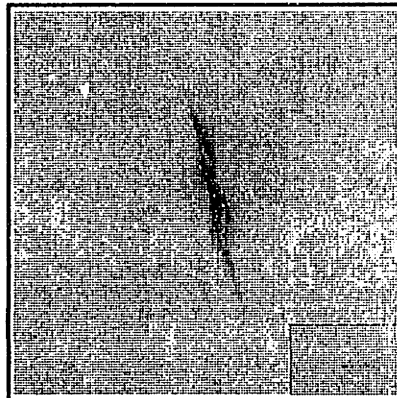
Figure 4.30 X-ray photographs of IM7G/X8553-50 $[\pm 15_2/0_2]_s$ specimens for impact velocities of (top) 1.5 m/s (incipient), (middle) 4.0 m/s, and (bottom) 5.0 m/s.

X-ray photographs of the $[\pm 15_2/0_2]_s$ layup of IM7G/X8553-50 impacted at 1.5, 4.0, and 5.0 m/s can be seen in Figure 4.30. As was the case with this same layup of AS4/3501-6, the incipient damage mode was matrix cracking in the +15° plies for this laminate. At an impact velocity of 1.5 m/s, a +15° crack 13 mm in overall length occurred. At an impact velocity of 4.0 m/s, this crack had a total length of 33 mm and at a velocity of 5.0 m/s, a delamination can be seen near the matrix crack (36 mm total length). The slender delamination is bounded by this matrix crack in places. This progression of damage is very similar to that of the $[\pm 15_2/0_2]_s$ layup of AS4/3501-6, but the impact velocities are higher in this case. Fiber damage, as well as delamination, can be seen in the deply transcription in Figure 4.31. A small line of broken fibers was found in

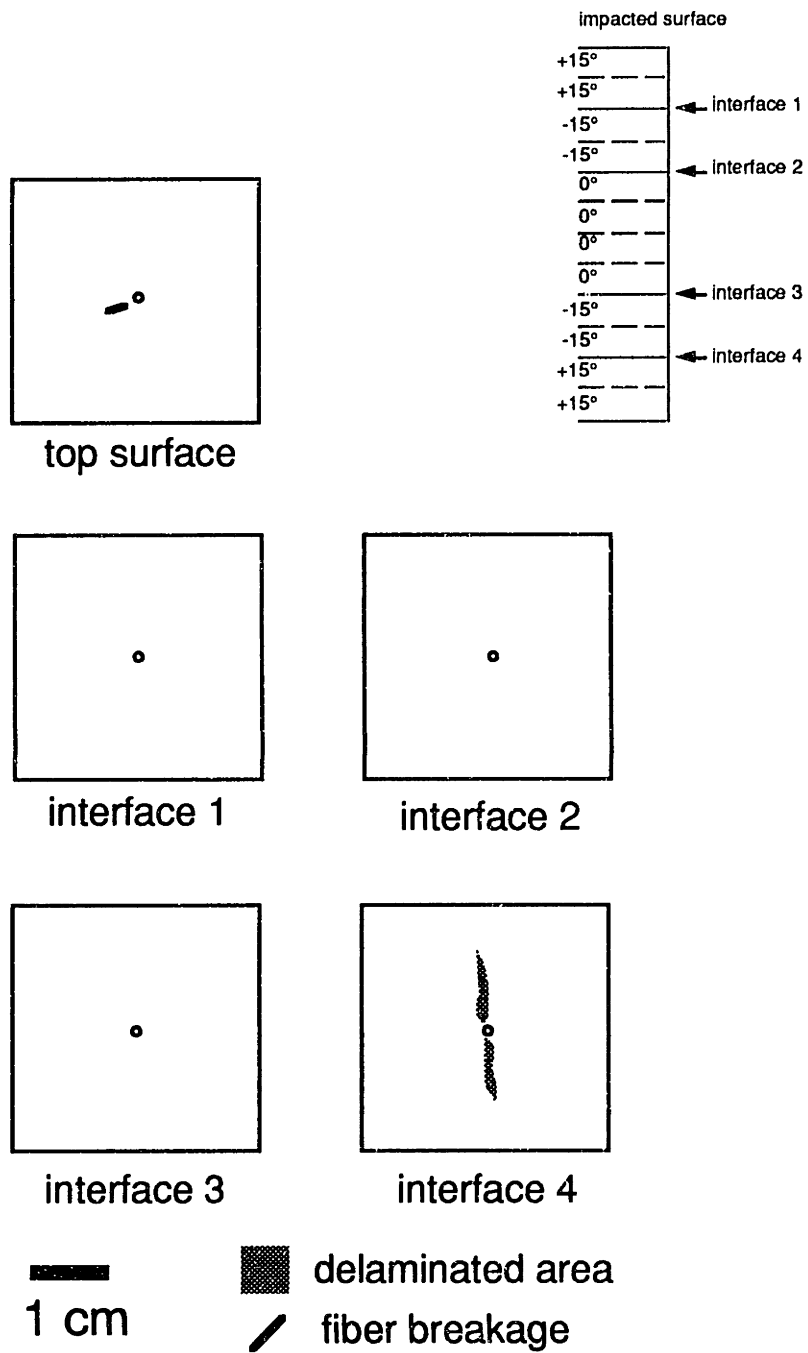
Figure 4.31 Delply transcription of IM7G/X8553-50 $[\pm 15_2/0_2]_s$ specimen impacted at 5.0 m/s.

the top ply. This line is perpendicular to the fiber direction of the ply (+15°) and its total length is approximately 3 mm. A slender delamination of approximately 18 mm in length can be seen at the rearmost interface of the laminate, where a similar delamination was observed in the same layup of AS4/3501-6.

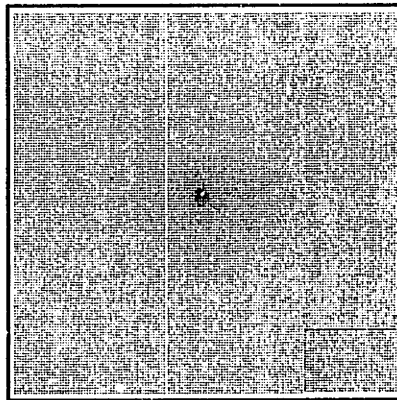
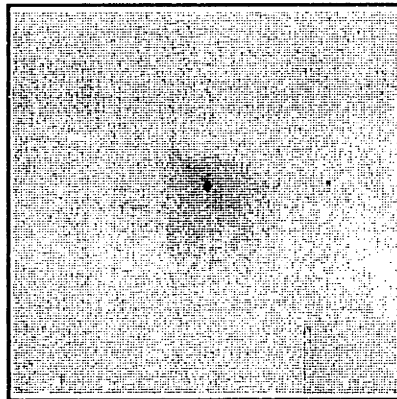
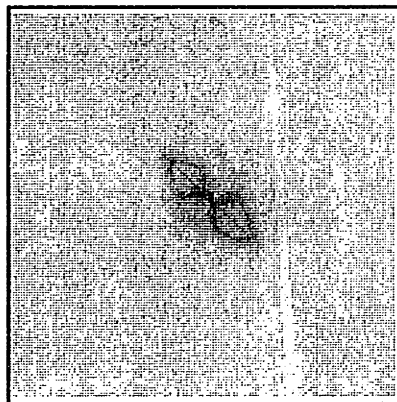
Figure 4.32 X-ray photographs of IM7G/X8553-50 $[\pm 45_2/0_2]_s$ specimens for impact velocities of (top) 2.5 m/s (incipient), (middle) 4.0 m/s, and (bottom) 5.0 m/s.

Matrix cracking of the +45° plies was the incipient damage mode for the $[\pm 45_2/0_2]_s$ layup, as shown in Figure 4.32. An impact of 2.5 m/s caused a matrix crack approximately 10 mm in length in the +45° direction. A similar crack of length 14 mm was caused by the 4.0 m/s impact and a small circular delamination (2 mm diameter) can be seen to one side of the impact center. This delamination is bisected by the +45° crack. An impact of 5.0 m/s caused a delamination which extends approximately 7 mm on either side of the impact center and is aligned with and bisected by a +45° matrix crack (23 mm total length). Small matrix cracks (less than 7 mm total length) in the -45° direction can also be observed. The delamination has the shape of a "figure 8" and is similar in appearance to that observed in the AS4/3501-6 laminate of the same layup. This delamination is located at the rearmost interface of the laminate, as shown by the deply transcription in Figure 4.33. The damage mode is very similar to that of the same layup of AS4/3501-6 material, but the impact velocities here are higher to cause the same damage state.

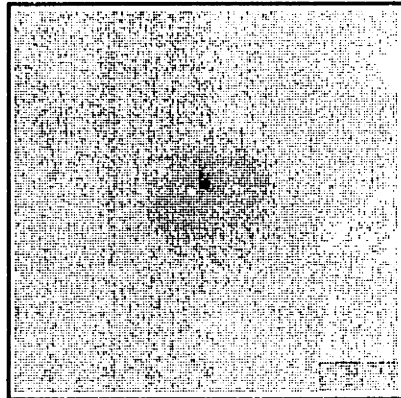
velocity = 2.2 m/s

Figure 4.34 X-ray photographs of IM7G/X8553-50 $[\pm 60_2/0_2]_s$ specimens for impact velocities of (top) 2.2 m/s (incipient), (middle) 4.0 m/s, and (bottom) 5.0 m/s.

Matrix cracking in the +60° direction is the incipient damage mode in the $[\pm 60_2/0_2]_s$ layup as well, as shown in Figure 4.34. Two matrix cracks, each approximately 12 mm in total length, resulted from the 2.2 m/s impact. Two +60° matrix cracks (each of 25 mm total length) can be observed from the 4.0 m/s impact, as well. The 4.0 m/s impact also caused matrix cracking in the -60° and 0° directions. More intense matrix cracking in the +60°, -60° and 0° directions are caused by the 5.0 m/s impact, and from the deply in Figure 3.35

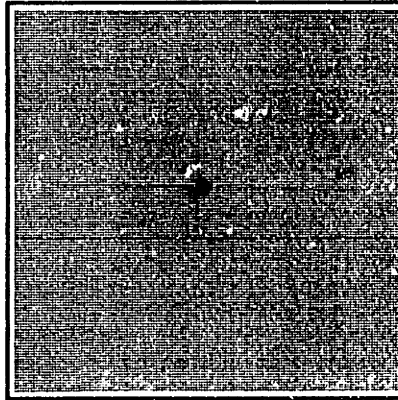
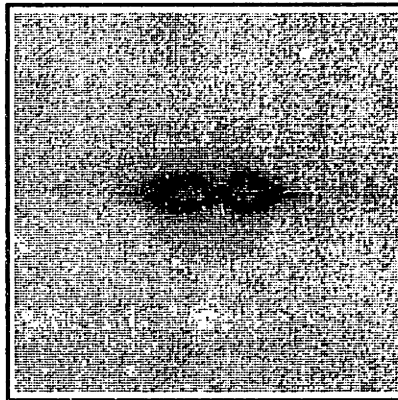
Figure 4.36 X-ray photographs of IM7G/X8553-50 $[90_4/0_2]_8$ specimens for impact velocities of (top) 1.5 m/s (incipient), (middle) 4.0 m/s, and (bottom) 5.0 m/s.

As was shown for the $[90_4/0_2]_s$ layup of AS4/3501-6, matrix cracking in the 90° direction is the incipient damage mode for the $[90_4/0_2]_s$ laminate of IM7G/X8553-50, as shown in Figure 4.36. At an impact velocity of 1.5 m/s, a matrix crack in the 90° direction can be observed extending approximately 21 mm on either side of the impact center. With the same layup of AS4/3501-6, the 90° crack extended across the entire width of the specimen, while here it did not. At 4.0 m/s, a delamination shaped like a "figure 8" and bisected by a crack (78 mm total length) in the 90° direction can be seen. This delamination is symmetric about the impact center and its overall length is approximately 16 mm. A similar delamination (32 mm overall length) is caused by the 5.0 m/s impact. In this case, the 90° matrix crack extends to the edges of the specimen, as was observed with the AS4/3501-6 $[90_4/0_2]_s$ laminates. The delamination is bounded by the 90° matrix crack near the tips of the delamination. The delamination is not quite symmetric about the 90° crack, and borders the matrix crack for approximately 2 mm at each end. This delamination is shown in Figure 4.37 to occur at the lower interface of the laminate, where a similar delamination was observed in the AS4/3501-6 specimen of this layup. The major axis of the delamination follows the fiber direction of the 90° plies below it. In contrast to the impact damage in the

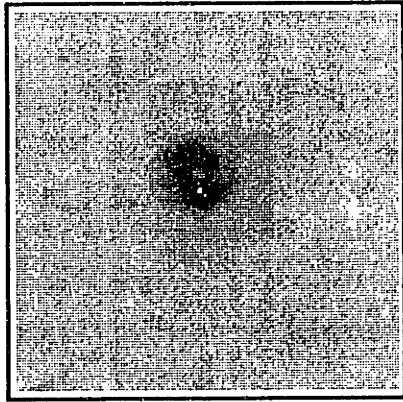
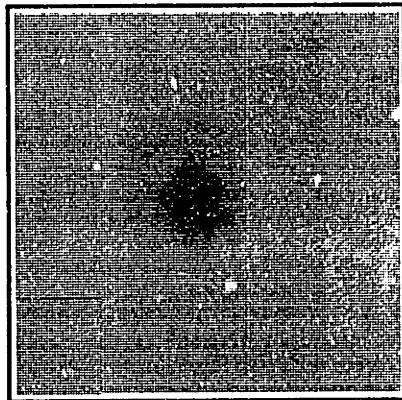
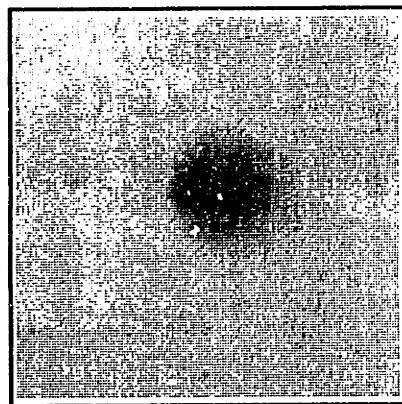
Figure 4.38 X-ray photographs of A370-5H/3501-6S $(45_2/0_2)_S$ specimens for impact velocities of (top) 4.1 m/s (incipient), (middle) 4.5 m/s, and (bottom) 5.0 m/s.

X-ray photographs of damaged $(45_2/0_2)_s$ specimens of A370-5H/3501-6S fabric are presented in Figure 4.38. The incipient damage velocity is 4.1 m/s, but the incipient damage mode is not easily identified. What appear to be many small cracks can be seen near the center of impact in the X-ray photographs. The damage from the 4.1 and 4.5 m/s impacts is confined to a circular region of approximately 10 mm diameter. No areas of delamination like those observed with the 16-ply tape laminates are readily identified. The damage from the 5.0 m/s impact is confined to a circular region of 13 mm diameter, and a dark line can be seen within this region. This line is approximately 5 mm in length and runs in the -45° direction. This is identified as fiber damage from the deply transcription in Figure 4.39. An additional broken tow, which could not be seen in the X-ray photograph, was found via deply in the upper ply of the laminate. A total of three broken tows of fibers were found in the upper two plies of the specimen. The broken tows ran in the $+45^\circ$ direction in these plies. This fiber damage pattern is very similar to that observed in the $[(\pm 45)_2/(0/90)_2]_s$ layup of AS4/3501-6 impacted at 5.0 m/s, but no delamination was observed here. In both cases, broken $+45^\circ$ fibers were noted near, but not directly under, the center of the impact. No other damage was observed from the deply of the fabric specimen. Because of the woven nature of the fabric plies, the surfaces of the plies were not as smooth as the tape plies when separated during deply. With the deply technique, the traces of gold chloride often could only be observed by holding the ply at a certain angle to a light source and observing the reflected light. The uneven surface of the fabric

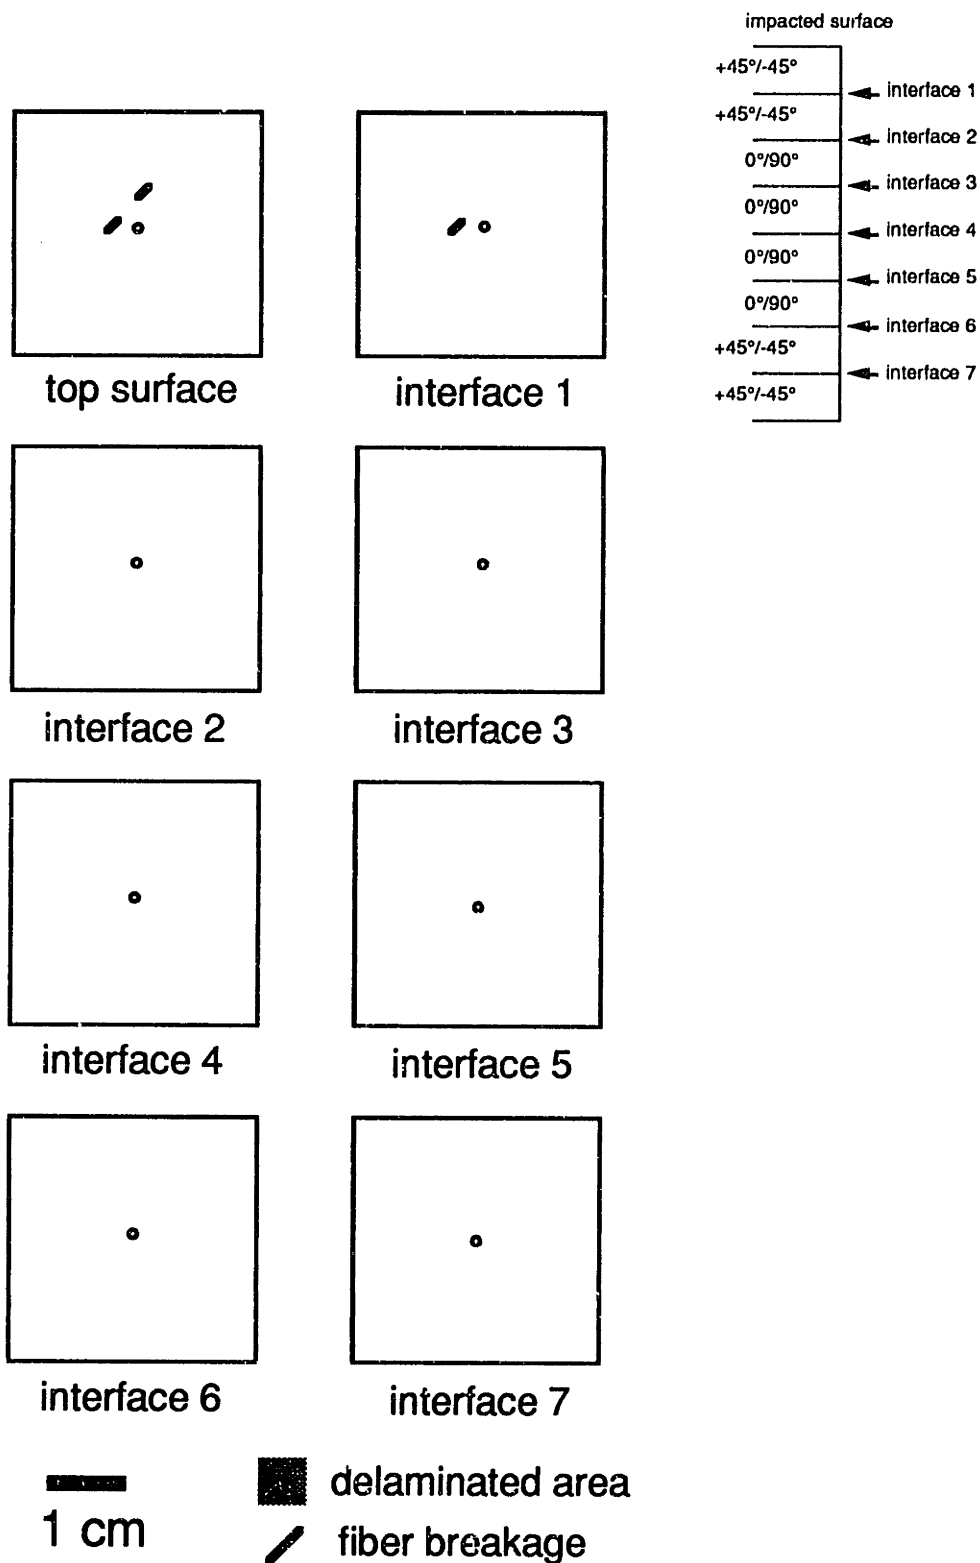
Figure 4.39 Deply transcription of A370-5H/3501-6S $(45_2/0_2)_s$ specimen impacted at 5.0 m/s.

plies scattered light in many directions, and made detecting any traces of gold chloride very difficult. Hence, the deply technique would not be recommended for identifying interlaminar-type damage with woven materials.

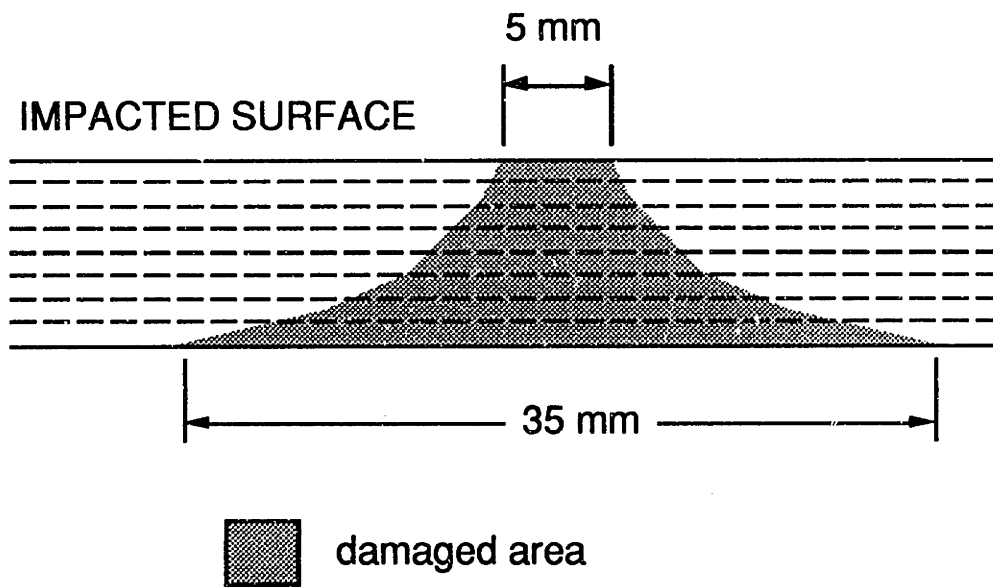
Figure 4.40 Illustration of cross-section of glass/epoxy (45/0)_{2s} specimen impacted at 5.0 m/s.

The damage states of the glass/epoxy specimens are presented in Figures 4.40 through 4.45. The specimens of this material system were transparent and the damage was such that the appearance of the damaged material became opaque. With this material system, visual inspections of the impacted specimens indicated that damage first occurred at the rear surface of the specimens. One specimen (impacted at 5.0 m/s) was cross-sectioned through the impact center, and the damage was found to expand radially as one travels through the thickness of the laminate, as shown in Figure 4.40. The diameter of the damaged area is approximately 5 mm at the impacted surface and flares out to a much larger diameter (approximately 35 mm) at the back surface.

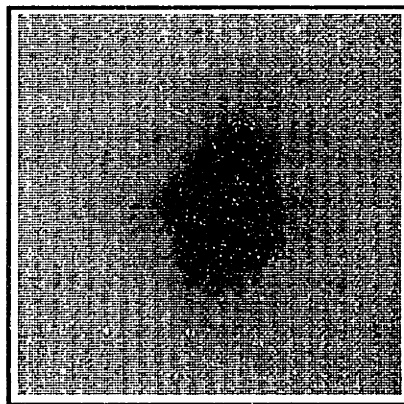
Figure 4.41 Photographs of glass/epoxy $(45_2/0_2)_s$ specimens impacted at (top) 3.0 m/s and (bottom) 5.0 m/s.

Photographs of the damage states from 3.0 and 5.0 m/s impacts are shown for the $(45_2/0_2)_s$ layup of glass/epoxy in Figure 4.41. The damage from a 3.0 m/s impact formed a ring of approximately 6 mm diameter around the center of impact. At the very center of this ring is an apparently undamaged circular region with a diameter of approximately 3 mm. The 5.0 m/s impact caused an elliptical region of damage which is longer in the 0° direction than in the 90° direction. The major and minor axes of the damaged area are approximately 10 and 7.5 mm, respectively. This damage appears consistent near the point of contact, such that no undamaged inner circle can be detected.

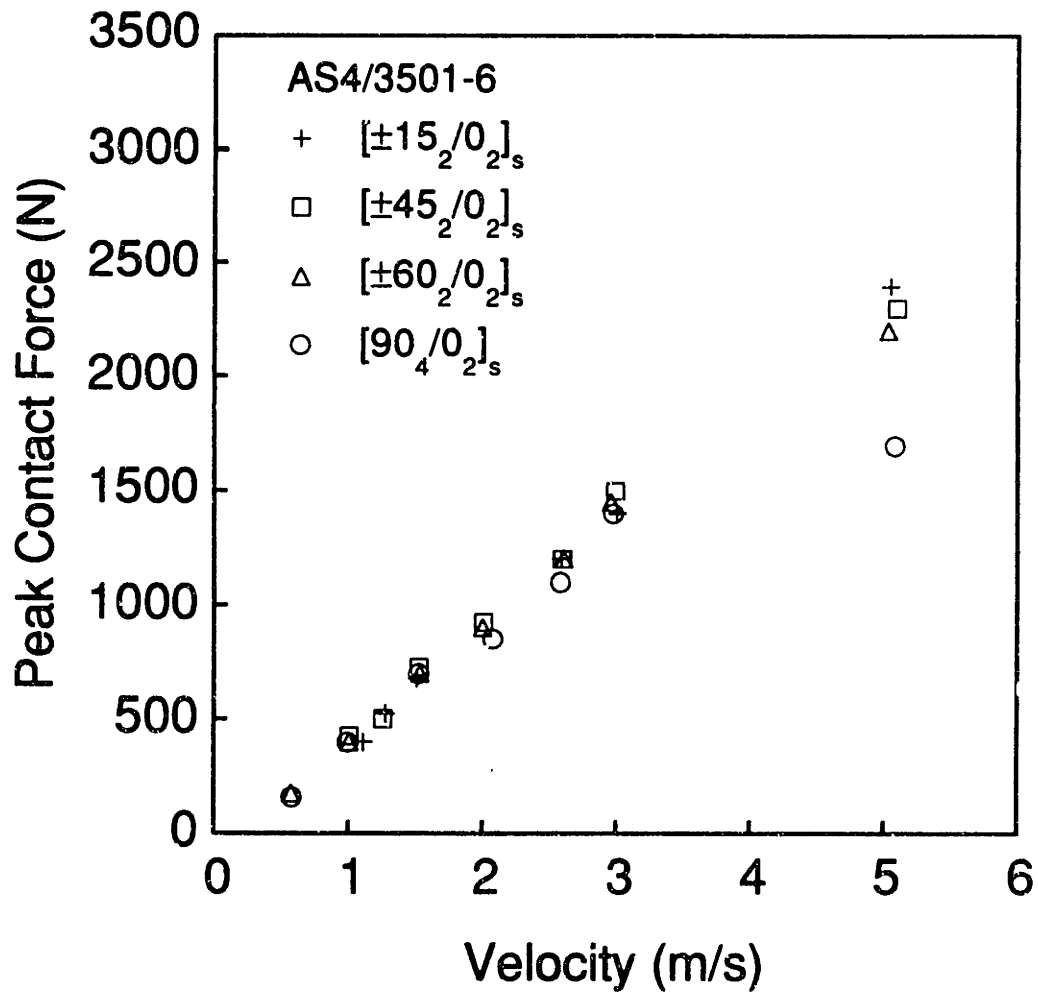
Figure 5.1 Peak force versus impact velocity for the 12-ply AS4/3501-6 layups.

The 12-ply laminates of AS4/3501-6 and IM7G/X8553-50 were constructed in a $[\pm\theta_2/0_2]_s$ layup format with θ taking on the values 15° , 45° , 60° and 90° . Hence, the effect of the angle θ can be observed on the impact signatures in these laminates. It was found that this angle had very little effect on the impact signatures when penetration did not occur. Although the laminate bending stiffnesses were affected dramatically by this angle (see Table 5.1), the peak force and duration of impact were virtually unaffected by the layup angle. The peak impact force is plotted versus impact velocity for the AS4/3501-6 and IM7G/X8553-50 laminates in Figures 5.1 and 5.2. It can be seen from these figures that the peak force was not influenced by layup angle. For the 12-ply layups of AS4/3501-6, the peak contact force for a given impact velocity is independent of layup for impact velocities below 3.0 m/s. Laminates of all four layups were penetrated by the 5.0 m/s impact, and some deviation of the peak force can be seen. Most notably, the peak force before penetration of the

Several observations can be made regarding the effect of impact velocity on the force-time signatures of the laminates. First, it can be seen (see Figures 5.1 and 5.2) that the peak force scales approximately linearly with impact velocity for the 12-ply graphite/epoxy laminates (excluding those impacts which caused penetration). Second, it can be observed (see Figures 5.3 and 5.4) that impact duration decreases with increasing impact velocity in a nonlinear way. Finally, it can be seen that as the impact velocity increases, the secondary oscillations become less pronounced in the signature after the peak force. This can be seen in Figure 5.21. In the 2.0 and 3.0 m/s signatures, the secondary oscillations occur both before and after the peak force of the impact. In the 5.0 m/s signature, however, the secondary oscillations are much more

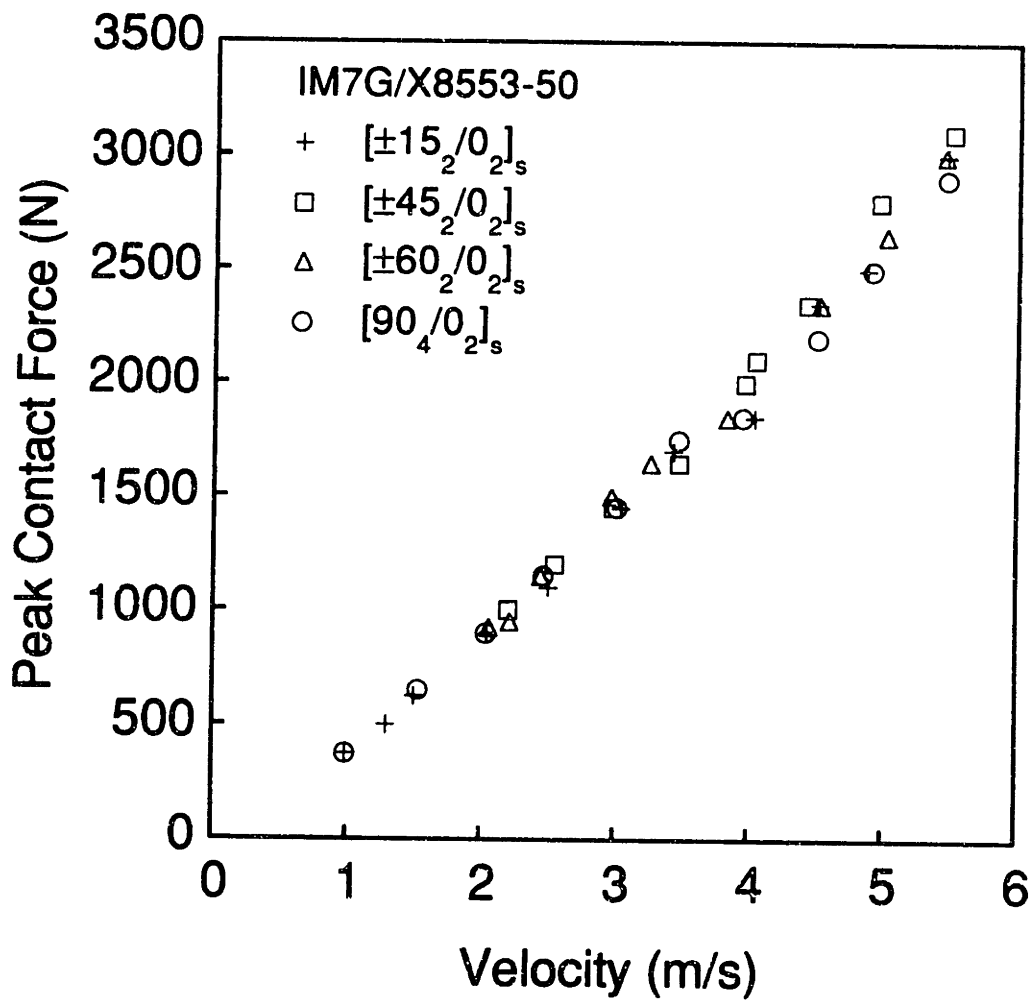
Figure 5.2 Peak force versus impact velocity for the 12-ply IM7G/X8553-50 layups.

$[90_4/0_2]_s$ layup was approximately 500 N lower than those of the other three layups. Penetration did not occur with any of the IM7G/X8553-50 layups, and peak force is shown to be virtually independent of layup for impact velocities through 5.5 m/s.

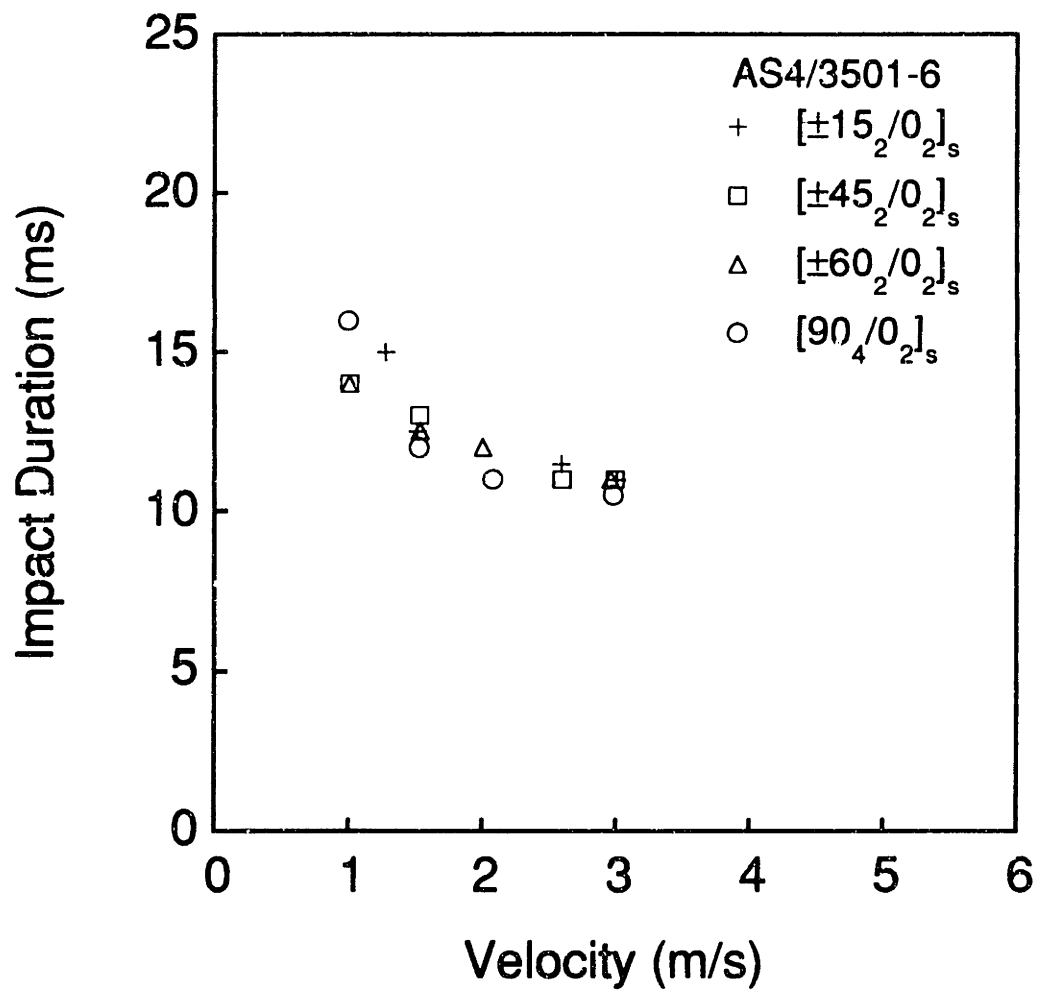
Figure 5.3 Impact duration versus impact velocity for the 12-ply AS4/3501-6 layups.

Impact duration is also not significantly affected by the layup angle θ . Impact duration is plotted versus impact velocity for the 12-ply layups of AS4/3501-6 and IM7G/X8553-50 in Figures 5.3 and 5.4. It can be seen in these graphs that the impact duration decreased with increasing impact velocity, but the impact duration does not appear to be affected by the layup.

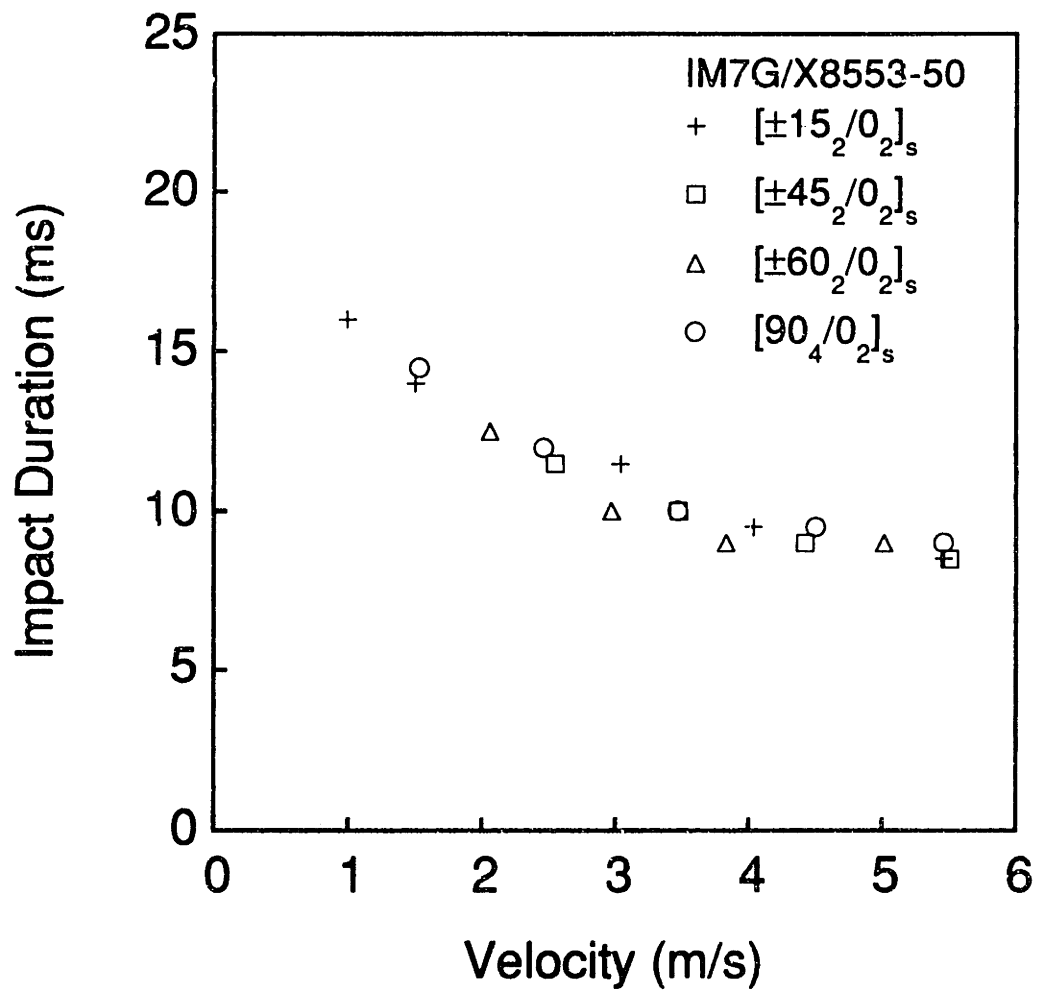
Figure 5.4 Impact duration versus impact velocity for the 12-ply IM7G/X8553-50 layups.

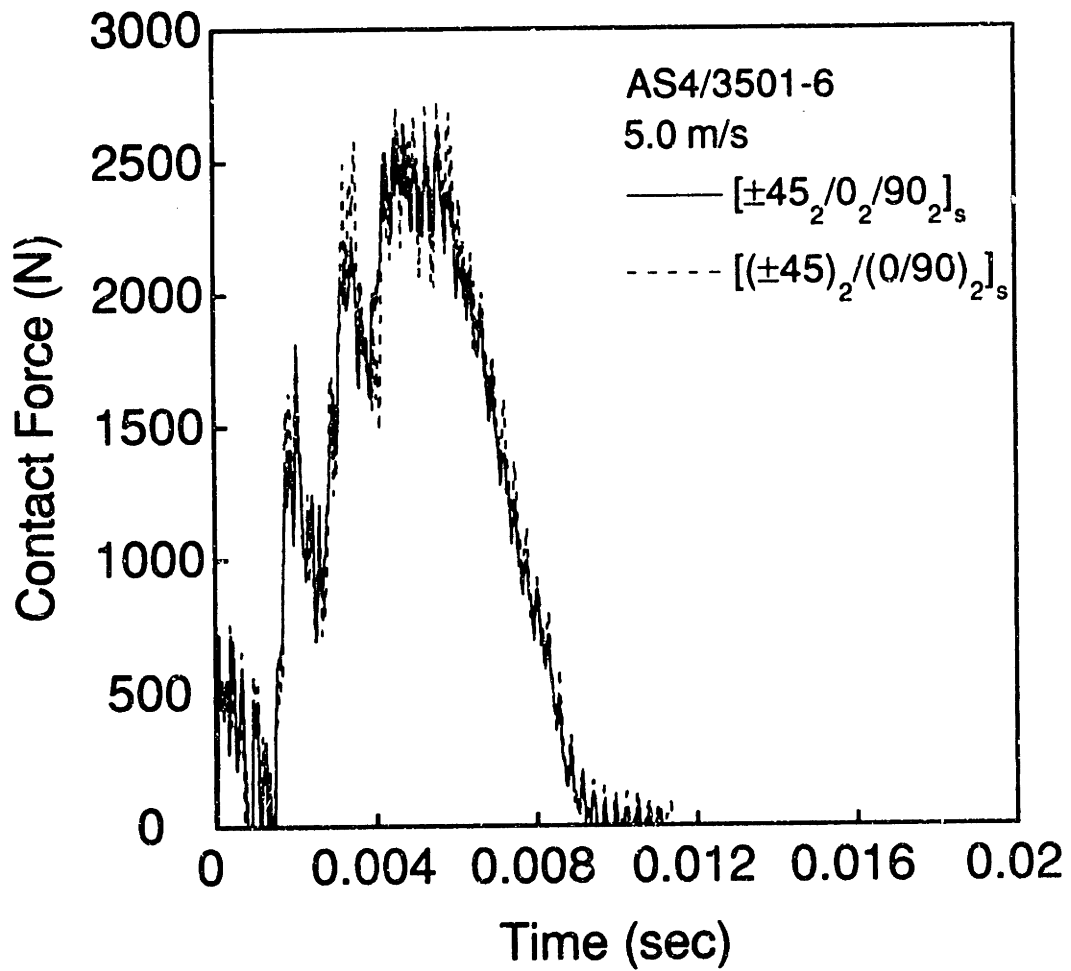
Figure 5.6 Signatures of AS4/3501-6 $[\pm 45_2/0_2/90_2]_s$ and $[(\pm 45)_2/(0/90)_2]_s$ laminates impacted at 5.0 m/s.

The differences in layup of the two 16-ply AS4/3501-6 laminates did not affect their force-time signatures, as can be seen in Figure 5.6. The signature for the 5.0 m/s impact of the laminate with ply grouping $[\pm 45_2/0_2/90_2]_s$ is virtually identical to that of the $[(\pm 45)_2/(0/90)_2]_s$ laminate. The peak forces are nearly the same (approximately 2700 N) and the secondary oscillations overlap.

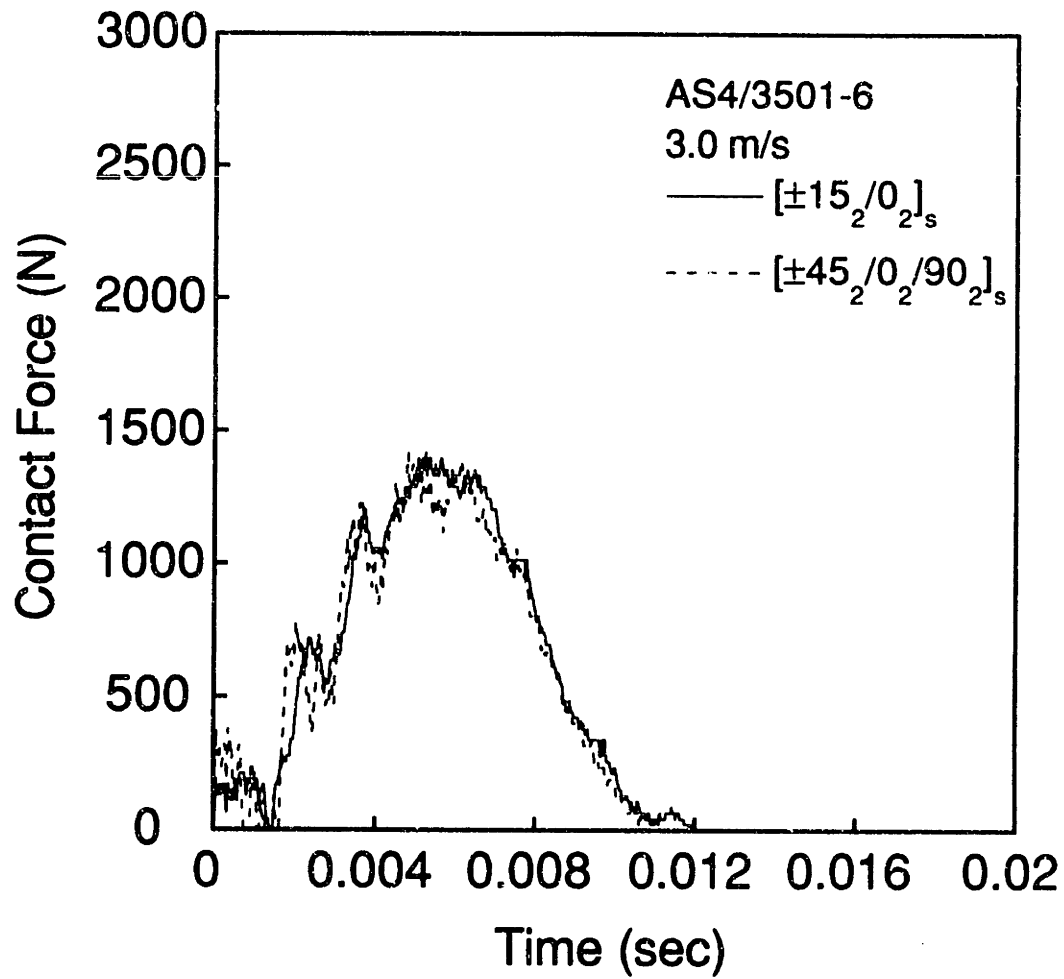
Figure 5.7 Signatures of AS4/3501-6 $[\pm 45_2/0_2/90_2]_s$ and $[\pm 15_2/0_2]_s$ laminates impacted at 3.0 m/s.

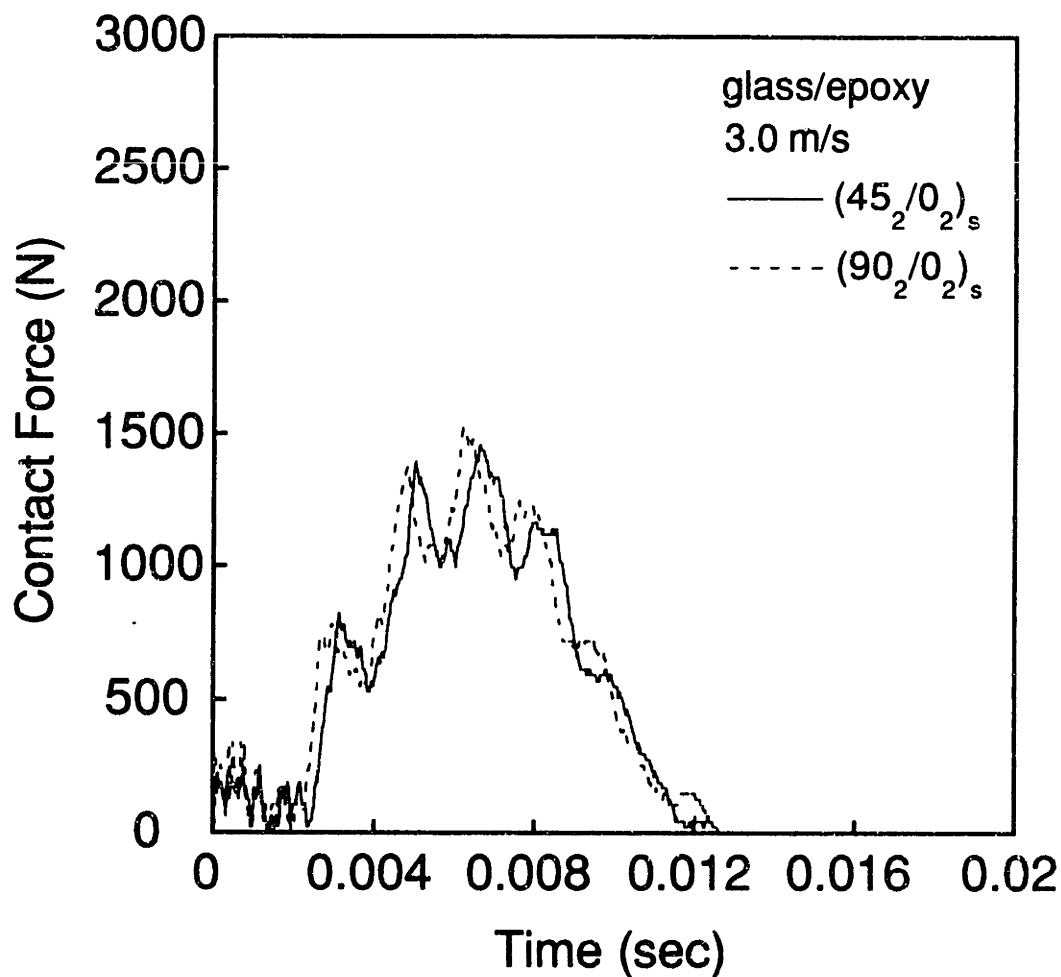
Figure 5.8 Force-time signatures of glass/epoxy $(45_2/0_2)_s$ and $(90_2/0_2)_s$ laminates impacted at 3.0 m/s.

The signatures of the glass/epoxy laminates were not affected significantly by layup. The 3.0 m/s signatures are virtually identical for all five layups used, and a typical comparison is shown in Figure 5.8.
