IMPACT DAMAGE MECHANISMS IN SEVERAL LAMINATED MATERIAL SYSTEMS

Submitted to the Department of Aeronautics and Astronautics in Partial
Fulfillment of the Requirements for the Degree of

MASTER OF SCIENCE

MASSACHUSETTS INSTITUTE OF TECHNOLOGY

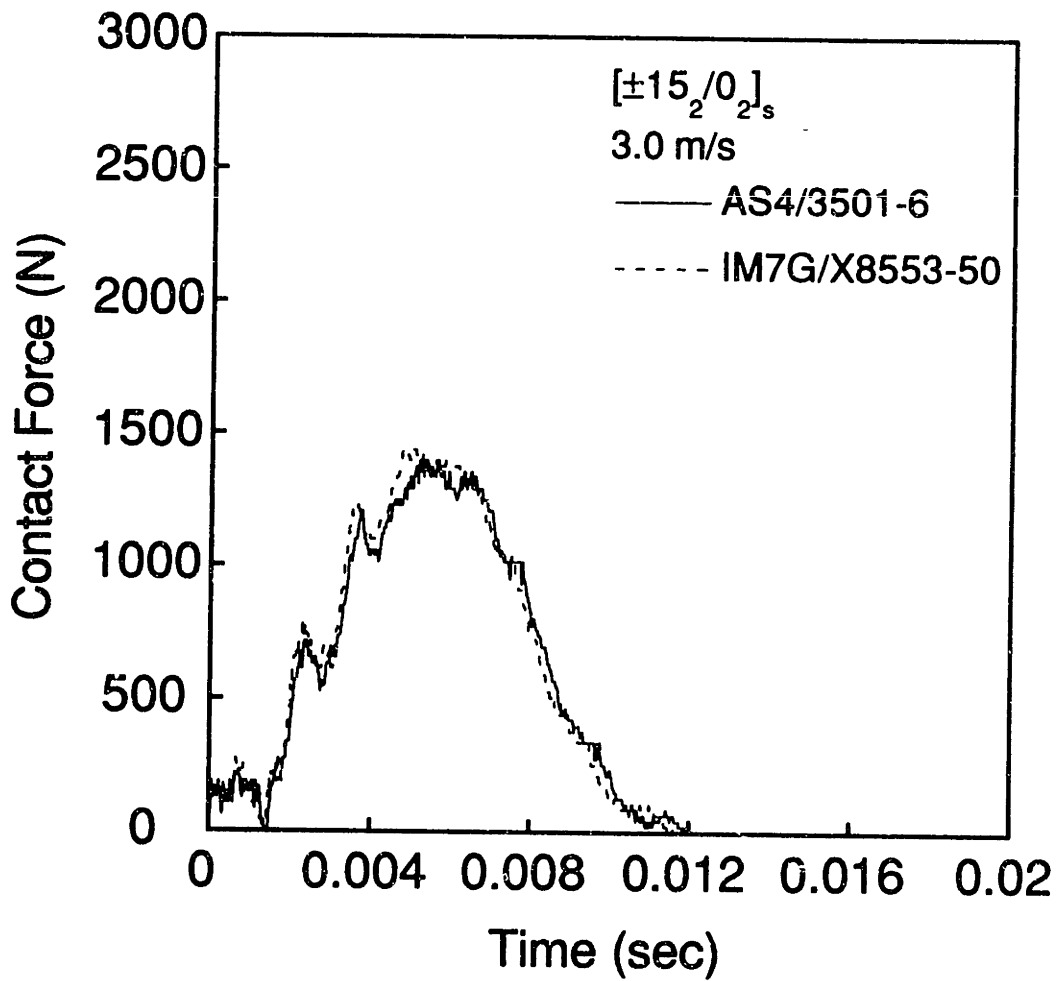
Figure 5.9 Signatures of $[\pm 15_2/0_2]_s$ laminates of AS4/3501-6 and IM7G/X8553-50 impacted at 3.0 m/s.

The material system was found to have no effect on the signatures of the 12-ply laminates of AS4/3501-6 and IM7G/X8553-50 when penetration did not occur. The 3.0 m/s impact signatures of the four 12-ply laminates of AS4/3501-6 and IM7G/X8553-50 material systems are compared in Figures 5.9 through 5.12. The signatures of the laminates of these two material systems with the same layup are nearly identical despite the fact that the ply elastic properties of these material systems are not the same, as shown in Table 5.3. The longitudinal ply modulus (E_L) of AS4/3501-6 is 142 GPa, while that of the IM7G/X8553-50 ply is 152 GPa, which is a 7% difference. The ply thicknesses of these material systems are also different. The nominal ply thickness is 0.134 mm for AS4/3501-6 compared to 0.144 mm for IM7G/X8553-50. This amounts to a significant difference in the bending stiffnesses, as shown in Table 5.1. For

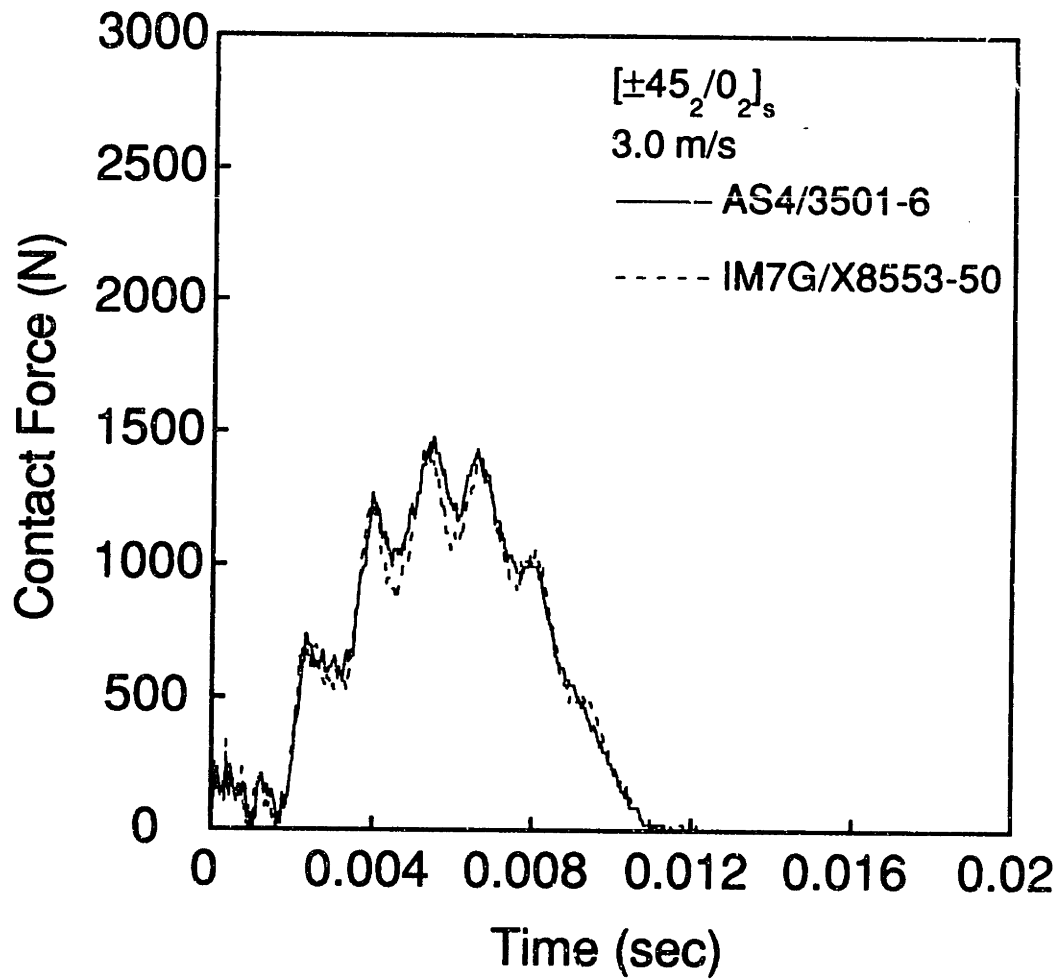
Figure 5.10 Signatures of $[\pm 45_2/0_2]_s$ laminates of AS4/3501-6 and IM7G/X8553-50 impacted at 3.0 m/s.

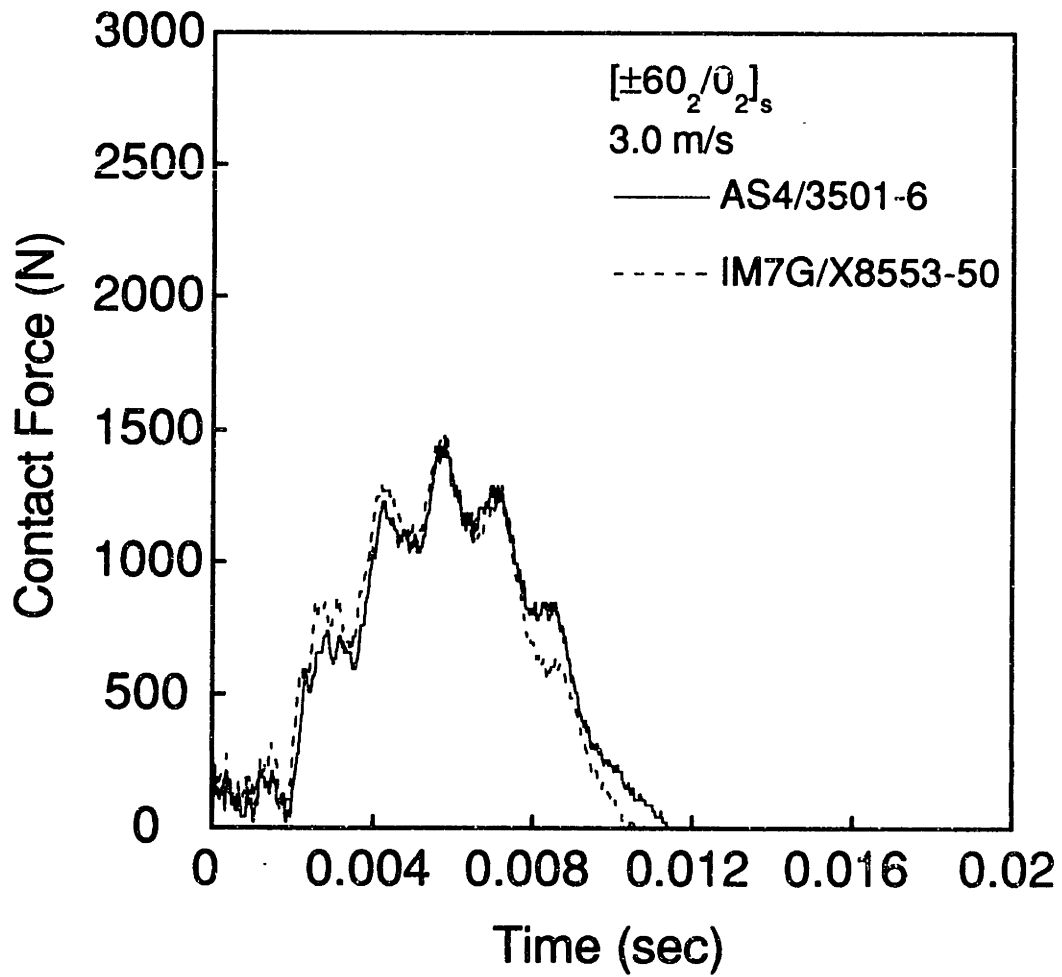
Figure 5.11 Signatures of $[\pm 60_2/0_2]_s$ laminates of AS4/3501-6 and IM7G/X8553-50 impacted at 3.0 m/s.

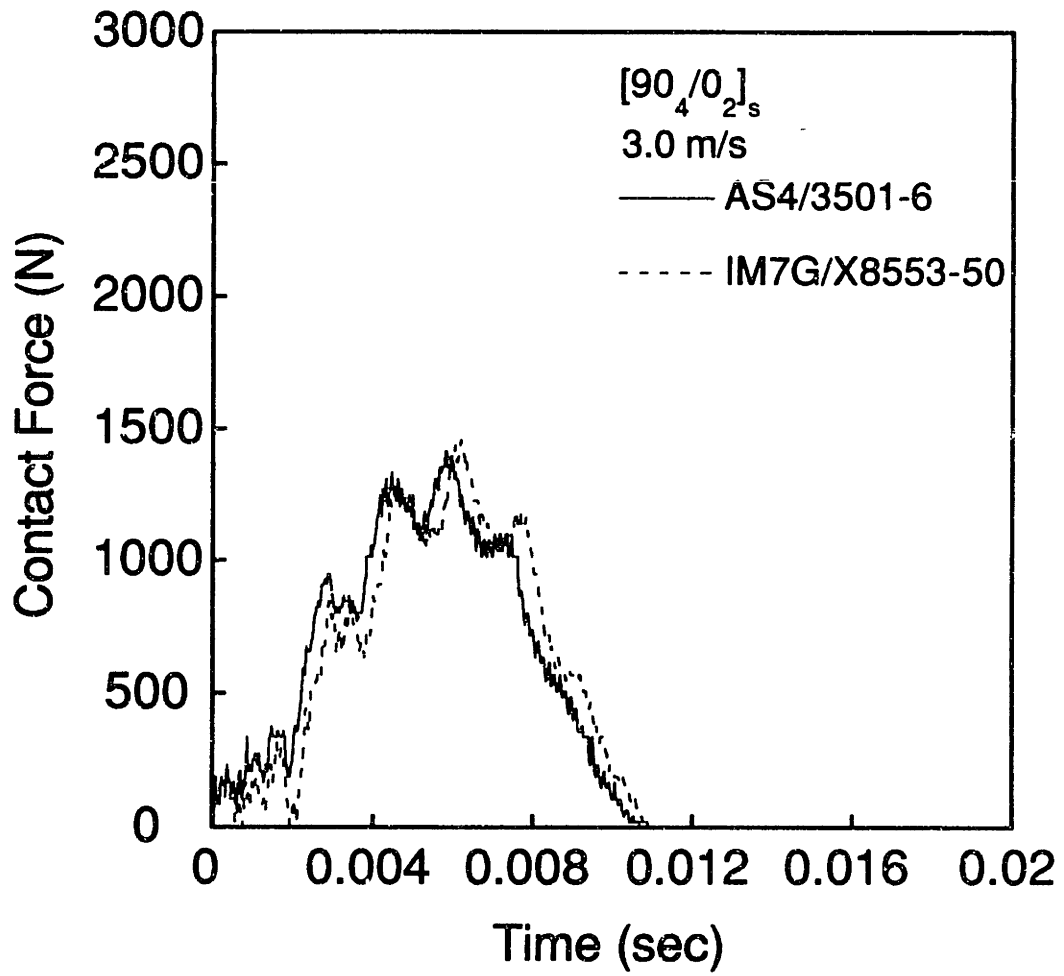
Figure 5.12 Signatures of $[90_4/0_2]_s$ laminates of AS4/3501-6 and IM7G/X8553-50 impacted at 3.0 m/s.

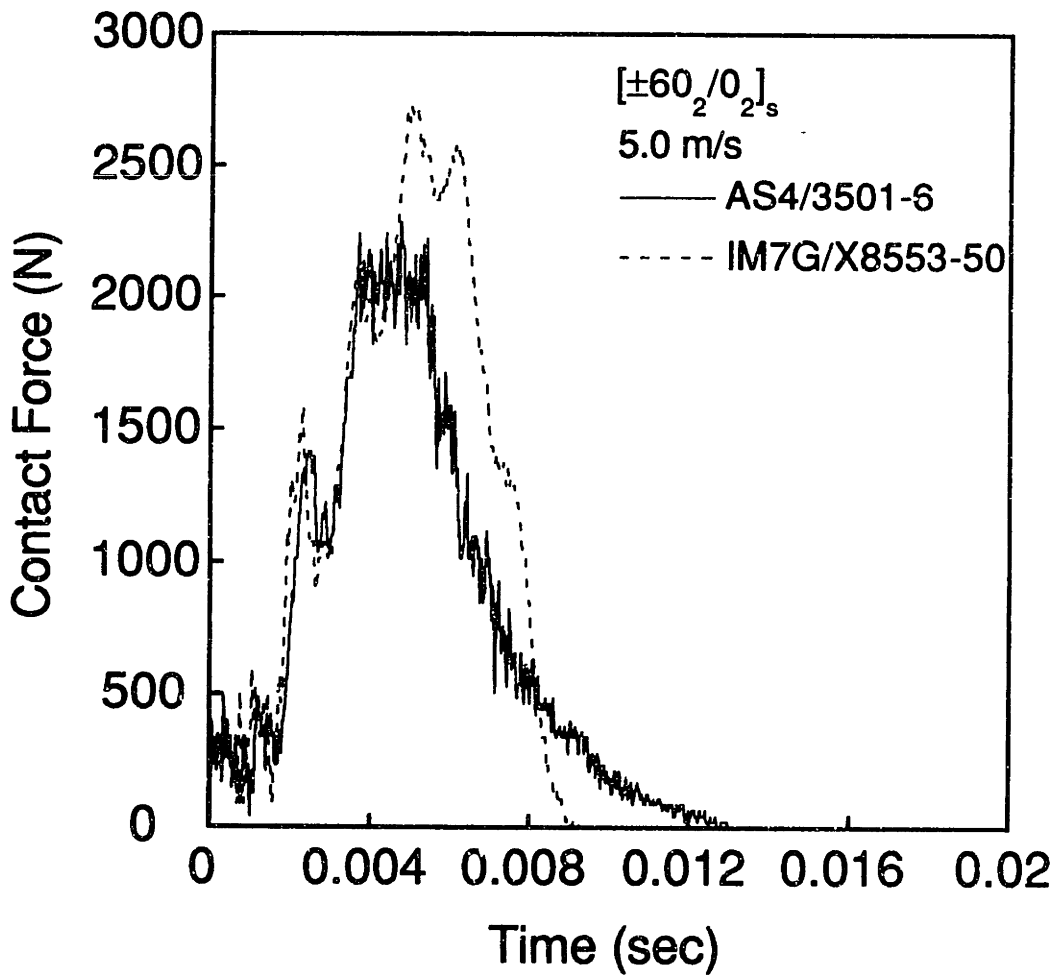
Figure 5.13 Signatures of $[\pm 60_2/0_2]_s$ laminates of AS4/3501-6 and IM7G/X8553-50 impacted at 5.0 m/s.

However, the signatures are affected greatly when penetration occurs. All of the 12-ply laminates of the AS4/3501-6 material system were penetrated from the 5.0 m/s impact, while the laminates of IM7G/X8553-50 sustained only internal damage. A typical example of the differences in the signatures is shown in Figure 5.13. Because penetration occurs, the contact forces on the AS4/3501-6 laminates do not reach the levels that they do in the IM7G/X8553-50 laminates. This behavior is further discussed in the next section.

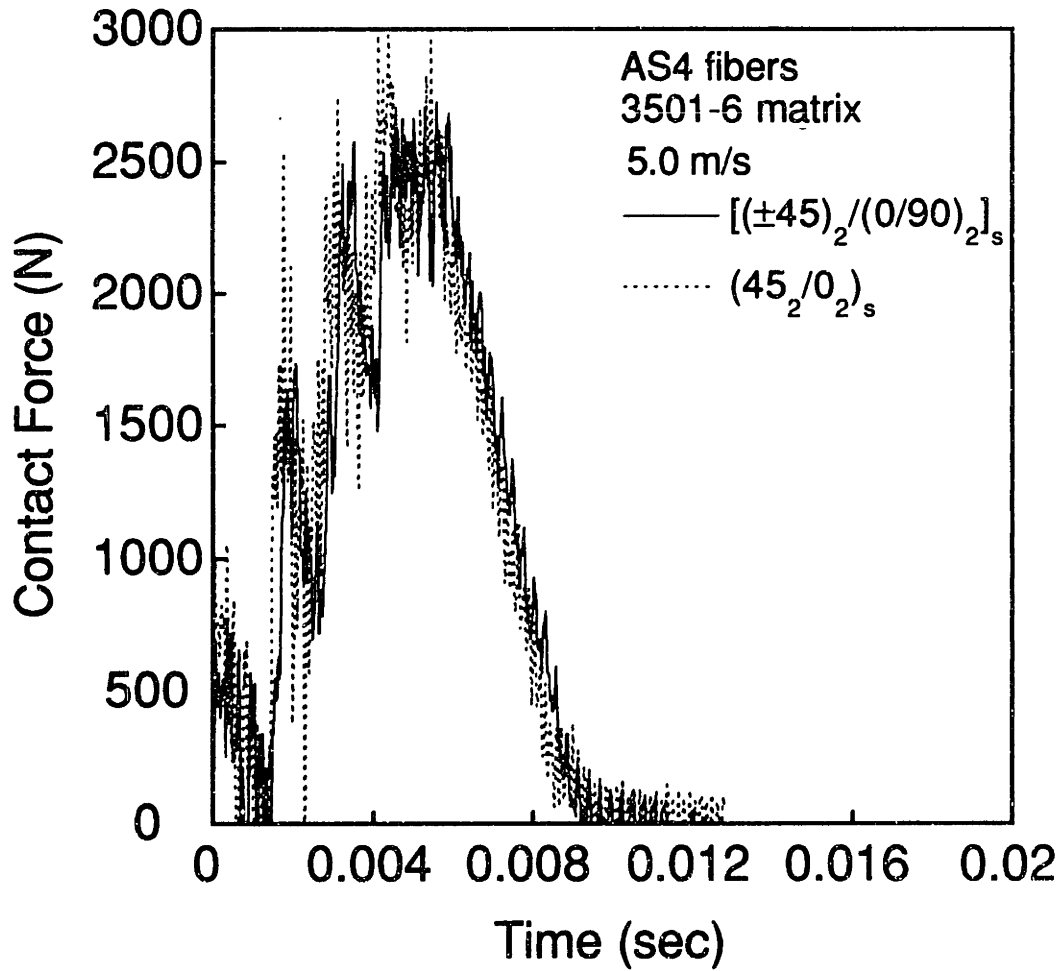
Figure 5.14 Signatures of AS4/3501-6 $[(\pm 45)_2 / (0/90)_2]_s$ and A370-5H/3501-6S $(45_2 / 0_2)_s$ laminates impacted at 5.0 m/s.

The material system has an effect on the signatures of the fabric A370-5H/3501-6S laminate as compared to the 16-ply AS4/3501-6 laminates. A comparison of the signatures of the tape and fabric laminates is shown in Figure 5.14. The basic shapes of these signatures is the same, in terms of the primary and secondary oscillation patterns, but the amplitudes of the secondary oscillations are much greater with the fabric laminate. The bending and extensional stiffnesses of the A370-5H/3501-6S $(45_2/0_2)_s$ laminate are shown in Table 5.2. The bending stiffnesses for this laminate are typically twice those for either of the 16-ply AS4/3501-6 tape laminates and the extensional stiffness of the fabric laminate is 26% higher, as well. These differences in the bending and extensional stiffnesses may account for the difference in amplitudes of the secondary oscillations, but the individual contribution of each of the laminate properties remains unclear.

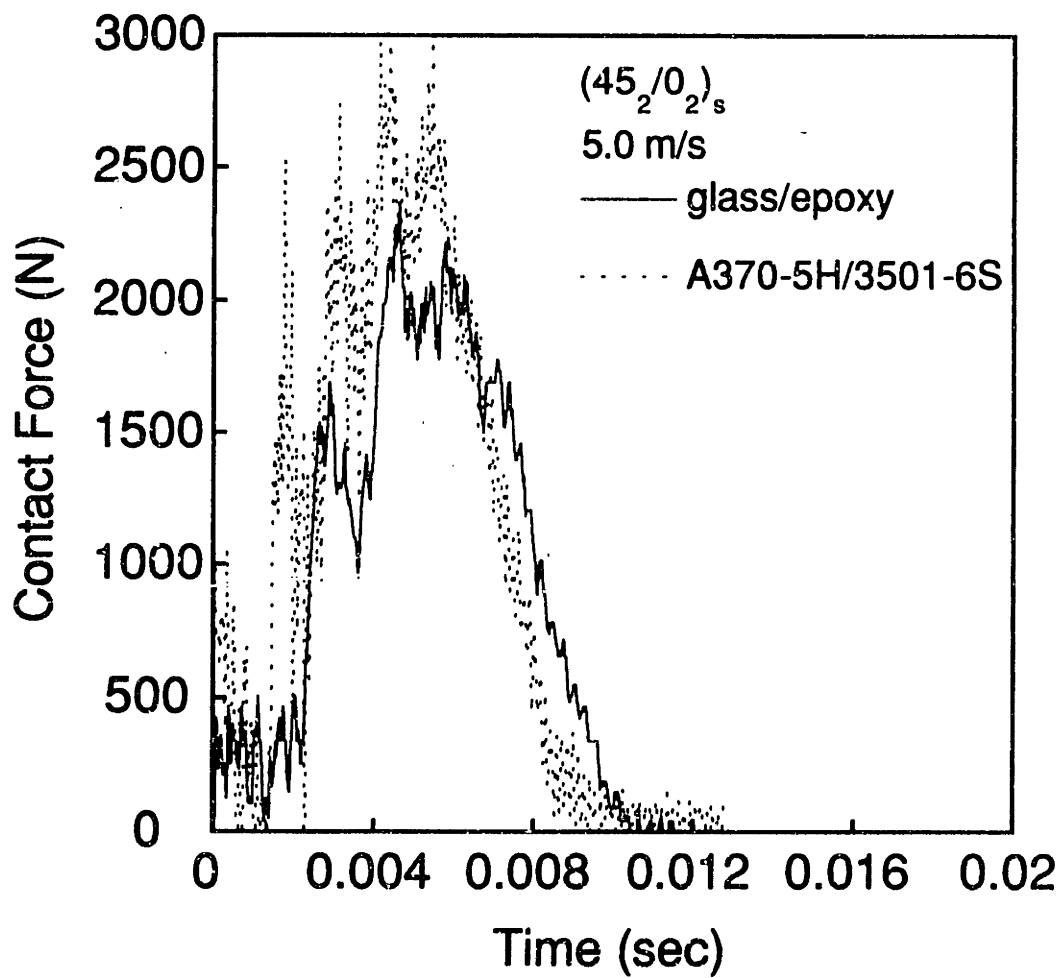
Figure 5.15 Signatures of A370-5H/3501-6S and glass/epoxy $(45_2/0_2)_s$ laminates impacted at 5.0 m/s.

Differences can be noted in the signatures of the $(45_2/0_2)_s$ layup of glass/epoxy and A370-5H/3501-6S, as shown in Figure 5.15. The primary and secondary oscillations of the 5.0 m/s signatures of these $(45_2/0_2)_s$ laminates are clearly different. The graphite/epoxy signature has a higher peak (3000 N as compared to 2350 N) and a shorter duration (9 ms as compared to 10 ms). In addition, the amplitude of the secondary oscillations in the graphite/epoxy signature is much larger than in the glass/epoxy signature, and the frequency of the secondary oscillations in the graphite/epoxy signature appears to be higher. The differences in the appearance of these signatures should not be surprising in light of the differences in the bending and extensional stiffnesses of the two laminates (see Table 5.2). The bending stiffnesses (D_{1111} and D_{2222}) of the A370-5H/3501-6S laminate are typically 9 times those of the glass/epoxy laminate. The extensional stiffness (A_{1111}) of the graphite/epoxy laminate is 5 times that of the glass/epoxy laminate.

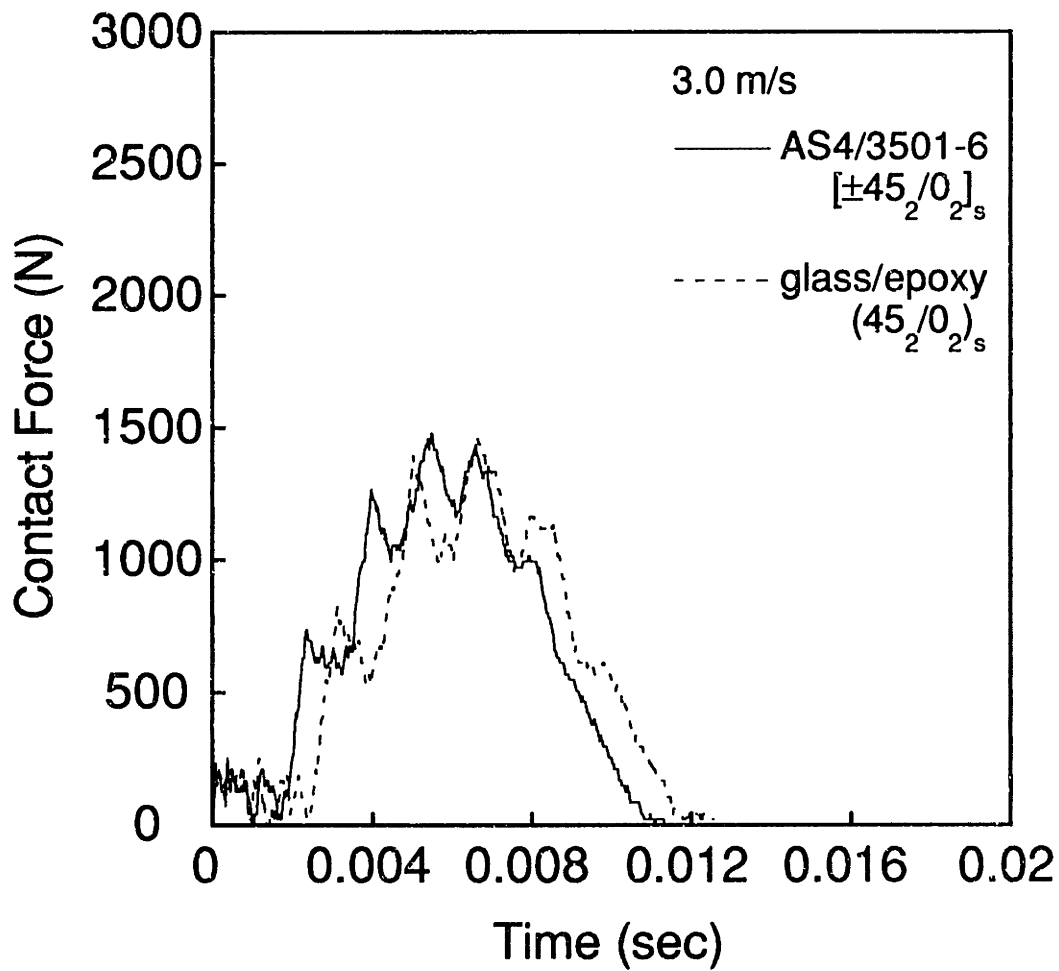
Figure 5.16 Signatures of AS4/3501-6 [±45₂/0₂]_s and glass/epoxy (45₂/0₂)_s laminates impacted at 3.0 m/s.

The peak forces in the signatures of the glass/epoxy specimens are comparable to those of the graphite/epoxy tape specimens at the same impact velocity. This can be seen for an impact velocity of 3.0 m/s in Figure 5.16. Despite the higher bending stiffnesses (D_{1111} and D_{2222}) of the graphite/epoxy laminate (see Tables 5.1 and 5.2), the peak impact force is virtually the same. The secondary oscillations differ somewhat, and the impact durations are typically slightly longer for the glass/epoxy specimens. The signatures shown here are typical for both the graphite/epoxy tape laminates and the glass/epoxy laminates.

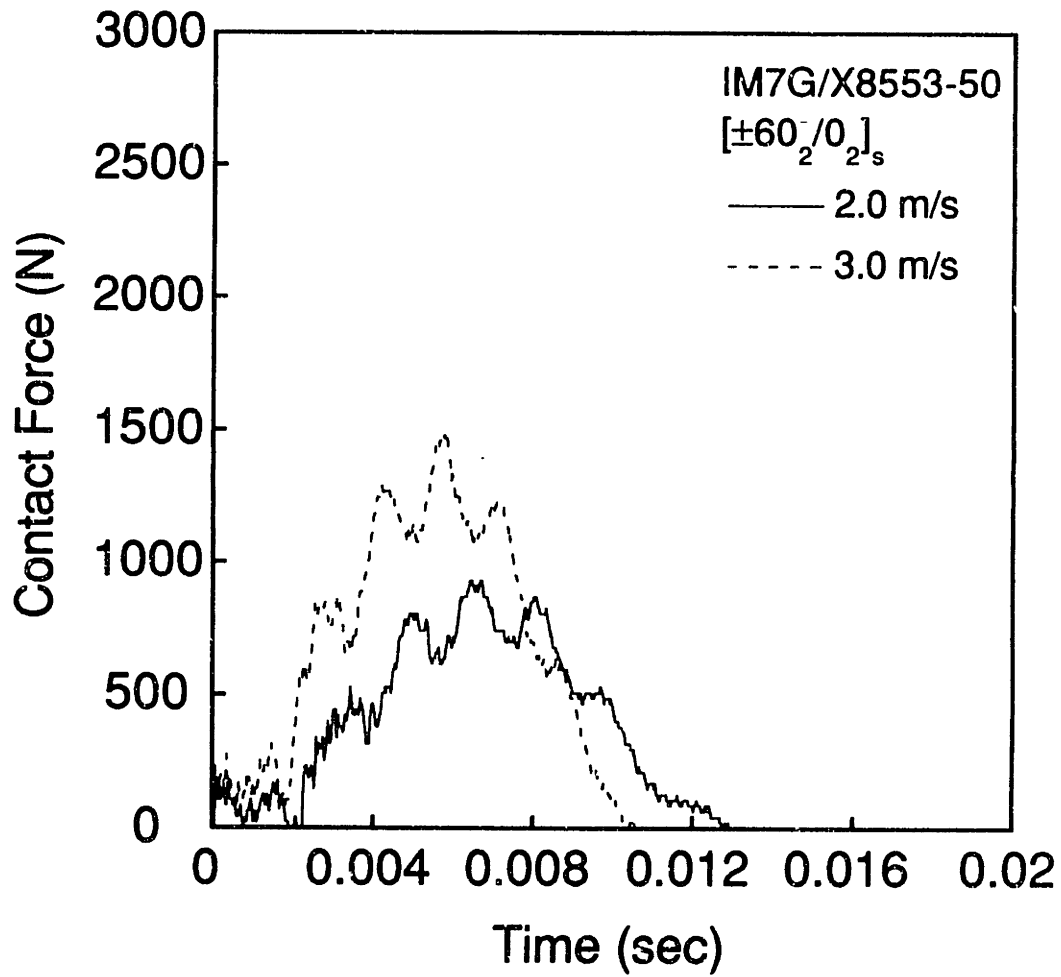
Figure 5.17 Signatures of IM7G/X8553-50 $[\pm 60_2/0_2]_s$ laminates for impact velocities of 2.0 m/s (undamaged) and 3.0 m/s (damaged).

The occurrence of incipient damage cannot be detected on the force-time histories of the impacts. A typical example of this is presented in Figure 5.17, where the signatures are shown for the IM7G/X8553-50 $[\pm 60_2/0_2]_s$ laminate impacted at 2.0 and 3.0 m/s. No damage was caused by the 2.0 m/s impact, but matrix cracking resulted from the 3.0 m/s impact. The signatures differ in duration and amplitude, but there is no characteristic difference in the shapes of the signatures which can be attributed to the formation of this incipient crack. This is a general result and applies to all of the laminates tested.

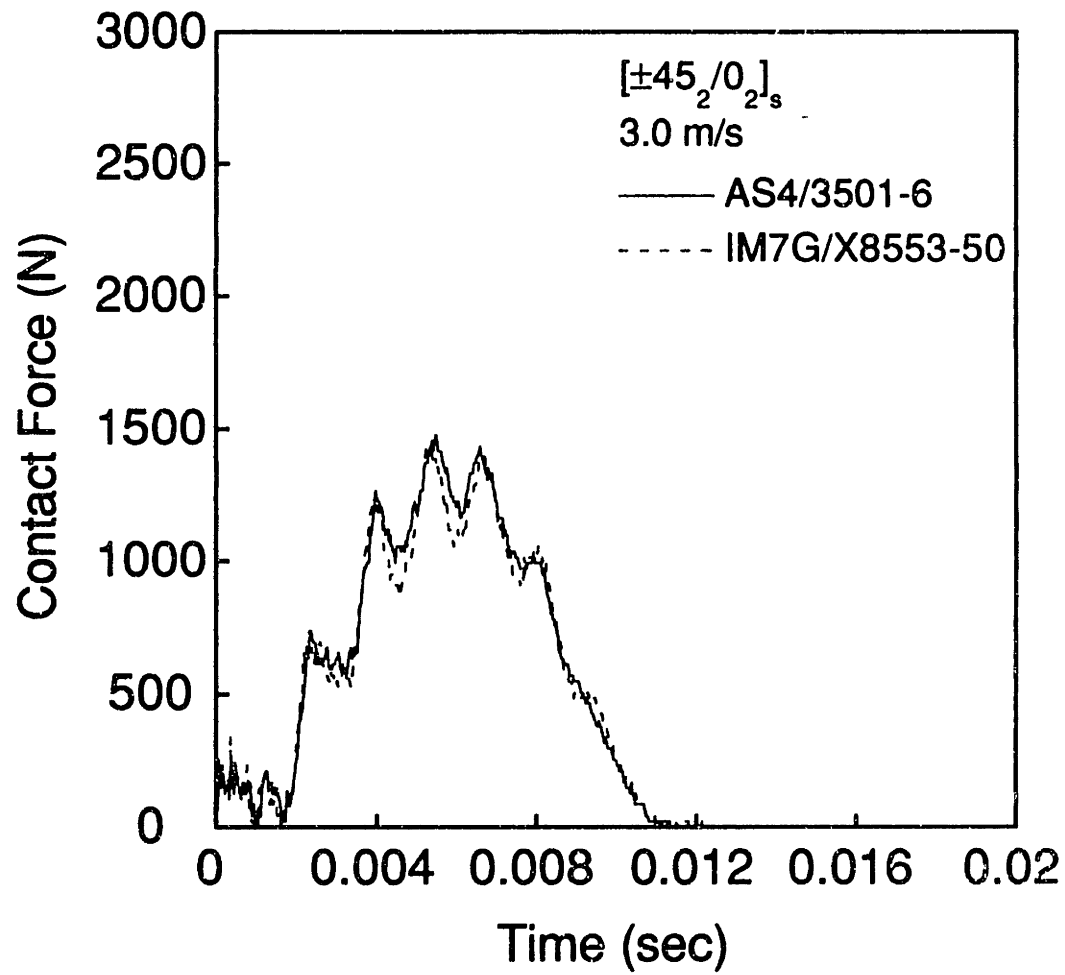
Figure 5.18 Signatures of $[\pm 45_2/0_2]_s$ laminates of AS4/3501-6 and IM7G/X8553-50 impacted at 3.0 m/s.

A change in the shape of the force-time signature cannot be observed from damage which is progressed well beyond the incipient stage, either. The force-time signature is unaffected by the presence of delaminations in addition to matrix cracks. This is a general result and is demonstrated for the $[\pm 45_2/0_2]_s$ layup in Figure 5.18. The force-time signatures of these $[\pm 45_2/0_2]_s$ laminates of AS4/3501-6 and IM7G/X8553-50 impacted at 3.0 m/s are nearly identical, yet very different damage states result in these specimens from this impact (see Figure 5.19). A single matrix crack exists in the IM7G/X8553-50 specimen, while matrix cracking and delamination are present in the AS4/3501-6 specimen. If the damage were to influence the force-time signature, differences would be expected in the signatures of these two

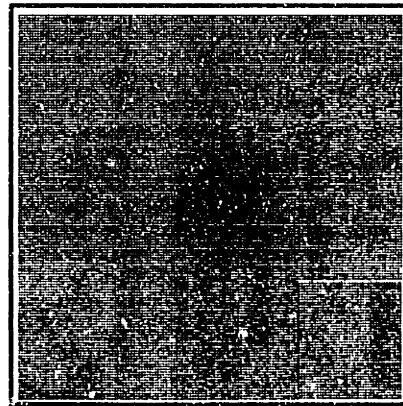
AS4/3501-6

IM7G/X8553-50

laminates with dissimilar damage states. However, this is clearly not the case here.

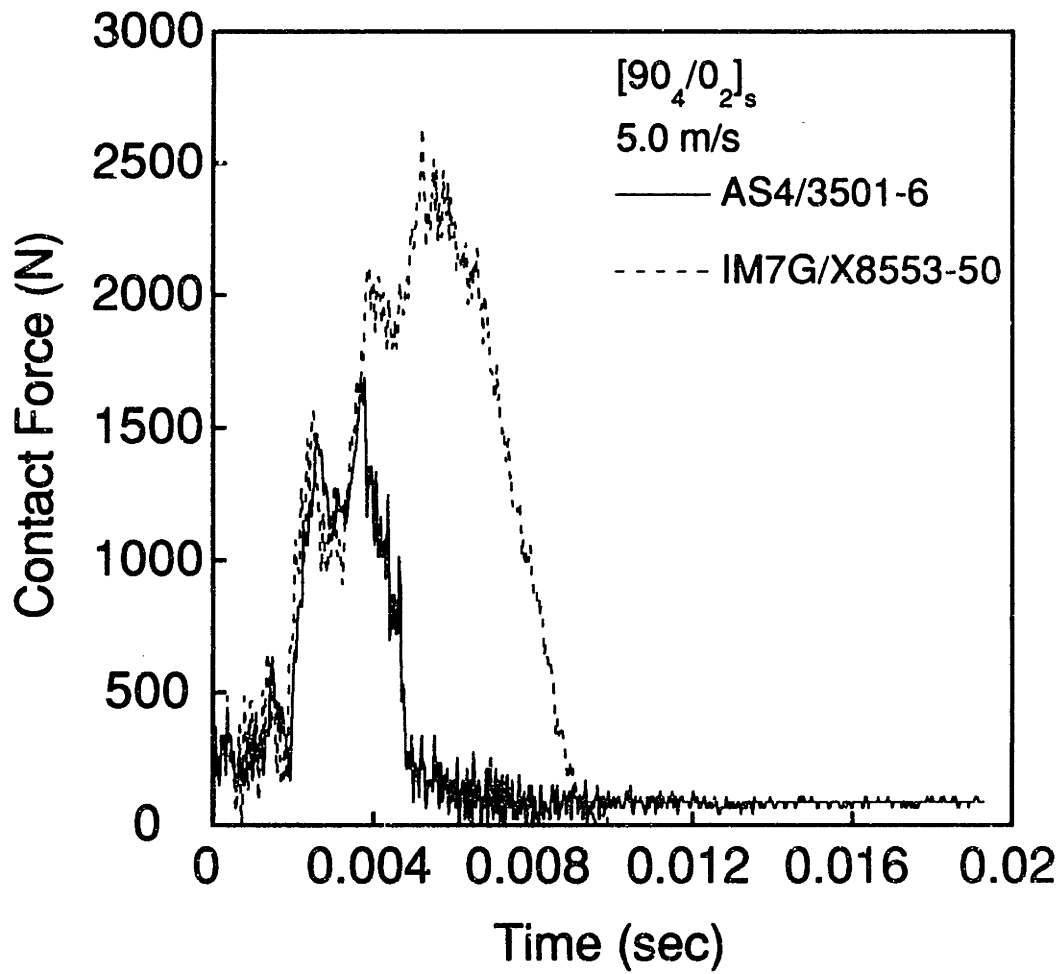
Figure 5.20 Signatures of $[90_4/0_2]_s$ laminates of AS4/3501-6 (penetrated) and IM7G/X8553-50 (no penetration) impacted at 5.0 m/s.

Penetration of the laminate by the impactor rod, however, can be seen on the force-time signature as a sharp drop in contact force. Up until the point of penetration, the signature is not visibly altered, as shown for the $[90_4/0_2]_s$ laminates of AS4/3501-6 and IM7G/X8553-50 in Figure 5.20. After approximately 4 ms, the contact force falls sharply in the signature of the AS4/3501-6 laminate as penetration occurs. Up until this point, the signatures of the IM7G/X8553-50 and AS4/3501-6 laminates nearly coincide. As the contact force of the penetrated AS4/3501-6 laminate trails off, the contact force in the unpenetrated laminate continues to rise to reach a peak (2600 N) which is much higher than the force (1700 N) which penetrated the AS4/3501-6 laminate. In this way, penetration of the impactor is observed to limit the peak force in the impacts of the 12-ply AS4/3501-6 laminates.

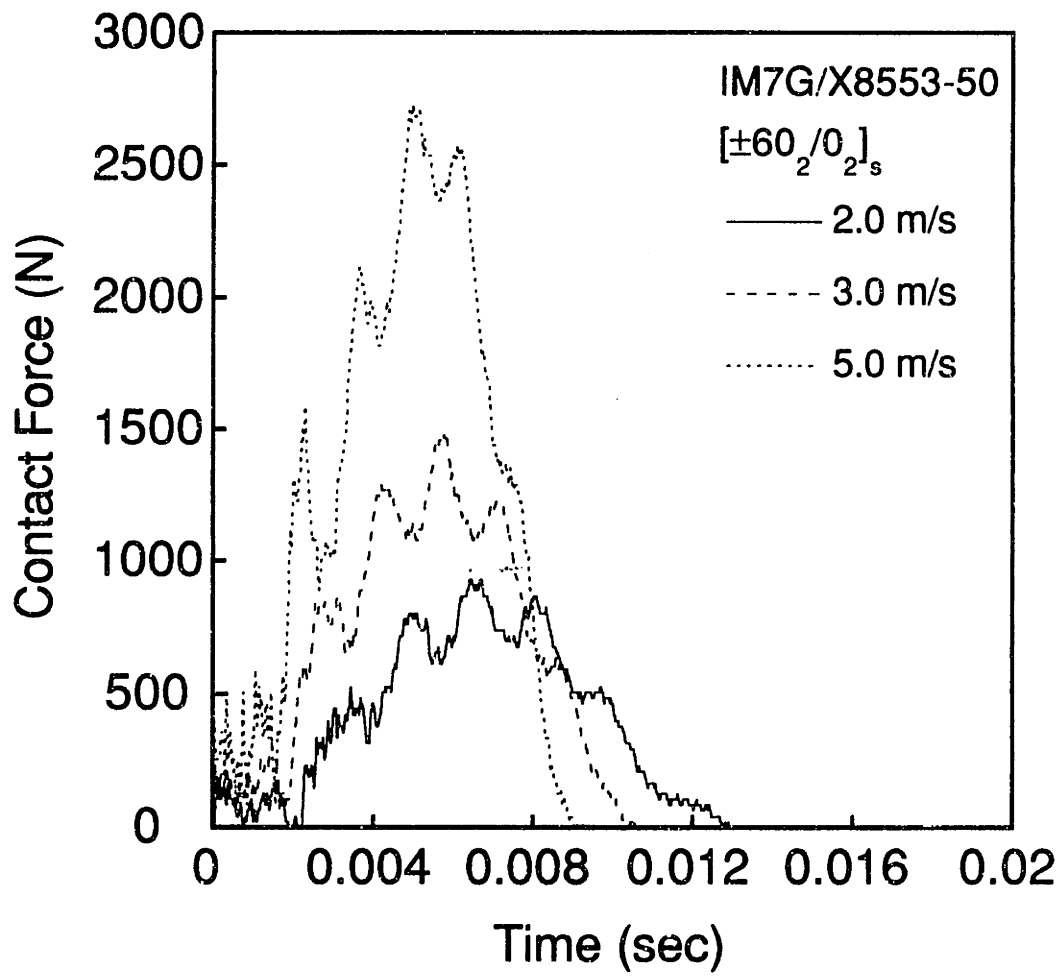
Figure 5.21 Force-time signatures of IM7G/X8553-50 $[\pm 60_2/0_2]_s$ laminate impacted at 2.0 m/s (undamaged), 3.0 m/s, and 5.0 m/s.

apparent in the signature before the peak force, than after. This behavior is common to all of the laminates tested here.

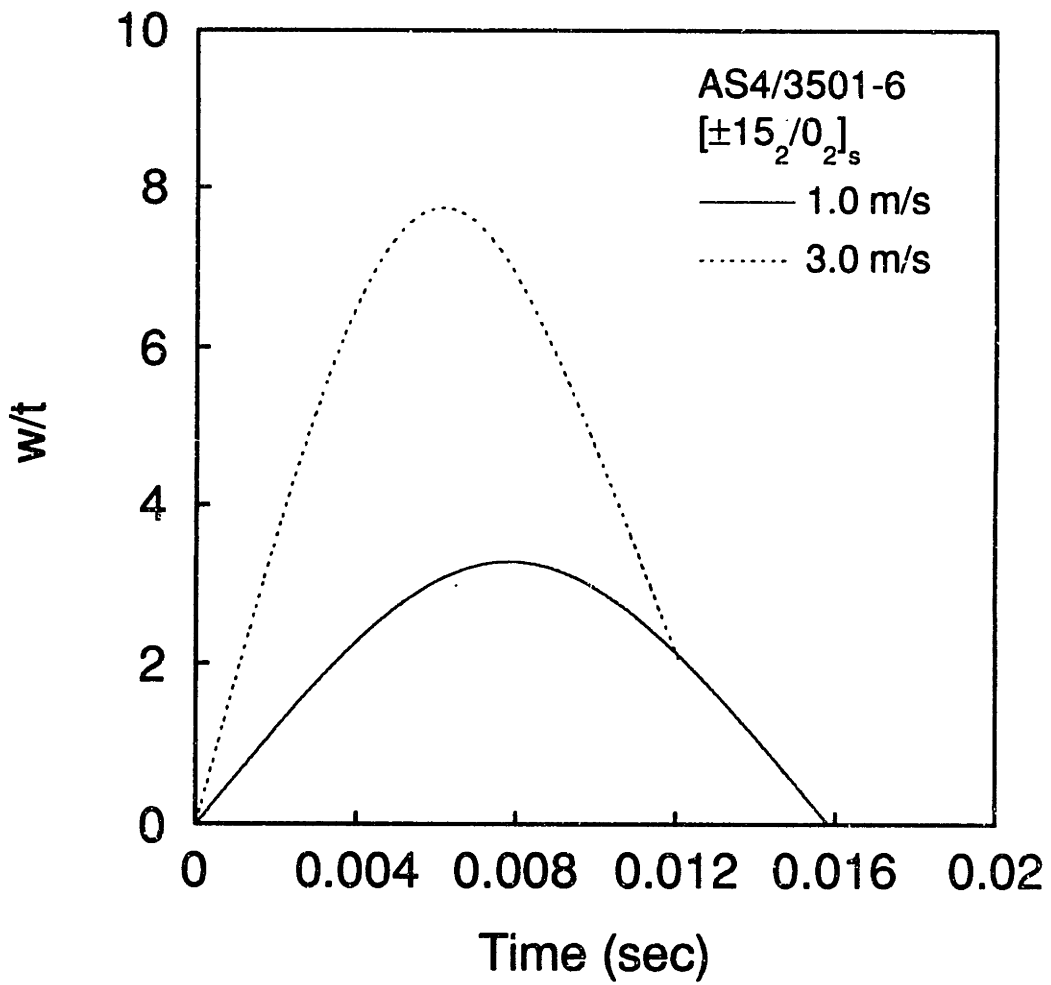
Figure 5.22 Derived center deflection curves (normalized by thickness) for AS4/3501-6 $[\pm 15_2/0_2]_s$ laminates impacted at 1.0 m/s and 3.0 m/s.

Displacement curves normalized by the plate thickness for 1.0 and 3.0 m/s impacts can be seen in Figure 5.22 for the AS4/3501-6 $[\pm 15_2/0_2]_s$ laminate. The magnitudes of the deflections shown here are typical. The center deflection caused by the 1.0 m/s impact was greater than 3 laminate thicknesses, while the deflection from the 3.0 m/s impact was nearly 8 laminate thicknesses. Deflections this large may be sufficient to cause a significant amount of membrane stretching in the laminates [4].

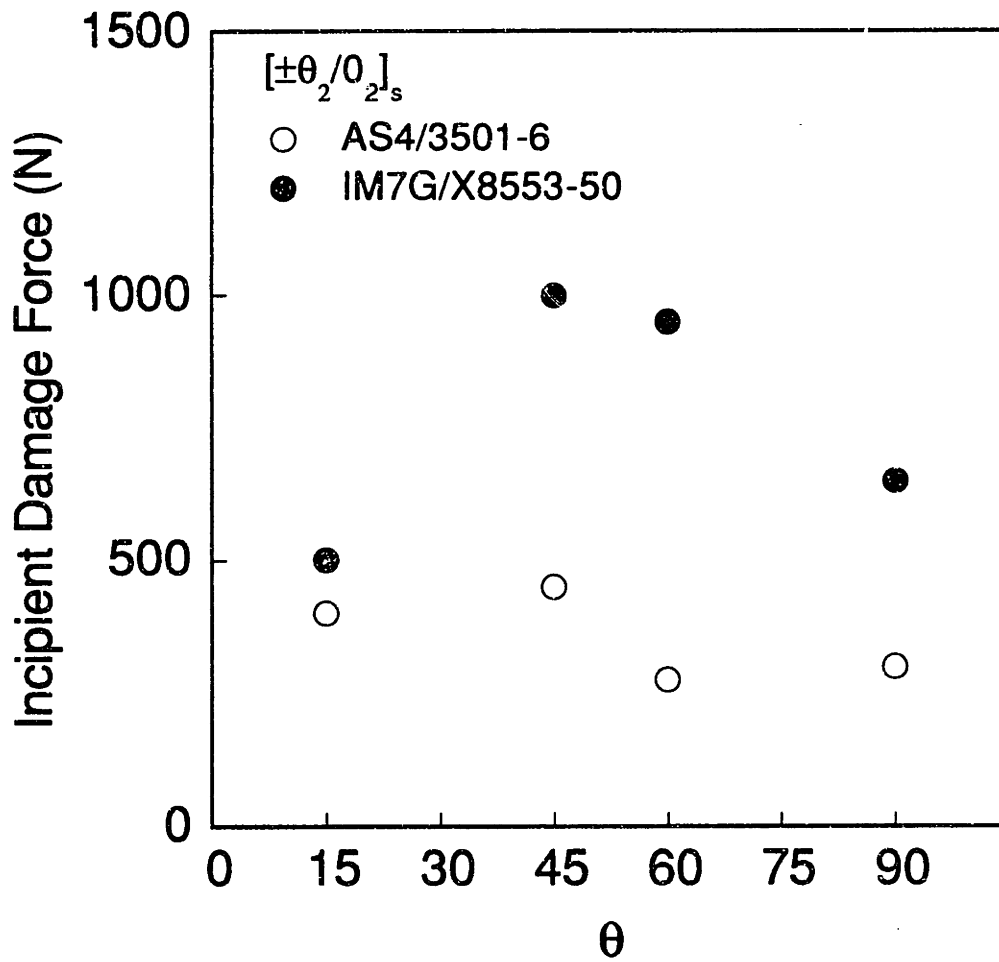
Figure 5.23 Incipient damage force versus layup angle for 12-ply laminates of AS4/3501-6 and IM7G/X8553-50.

The effect of the layup angle θ on the incipient damage force for the $[\pm\theta_2/0_2]_s$ laminates can be seen in Figure 5.23. For the AS4/3501-6 material system, the $[\pm60_2/0_2]_s$ laminate is the most easily damaged, in terms of

incipient damage force, and the $[\pm 45_2/0_2]_s$ laminate is the least easily damaged. The incipient damage force for the $[\pm 15_2/0_2]_s$ laminate is nearly as high as that for the $[\pm 45_2/0_2]_s$ laminate, and that for the $[90_2/0_2]_s$ is nearly as low as that for the $[\pm 60_2/0_2]_s$ laminate. Overall, a strong trend cannot be seen in layup angle.

For the IM7G/X8553-50 material system, the incipient damage force is greatest for the $[\pm 45_2/0_2]_s$ laminate, as was the case with the AS4/3501-6. For this material system, the incipient damage force for the $[\pm 60_2/0_2]_s$ laminate is nearly as high as that for the $[\pm 45_2/0_2]_s$ laminate. The $[\pm 15_2/0_2]_s$ and $[90_2/0_2]_s$ laminates are damaged at a much lower force.

For the $[\pm\theta_2/0_2]_s$ laminates, the effect of material system on incipient damage force is shown in Figure 5.23. It is observed that all of the AS4/3501-6 laminates are more easily damaged than any of the IM7G/X8553-50 laminates. The most easily damaged laminate of IM7G/X8553-50, the $[\pm 15_2/0_2]_s$ laminate, has a higher incipient damage force than the least easily damaged laminate of AS4/3501-6, the $[\pm 45_2/0_2]_s$ laminate. This can be explained by the higher ply transverse failure strain for the IM7G/X8553-50 material, as shown in Table 5.4. The tensile transverse failure strain of the IM7G/X8553-50 ply is twice that of the AS4/3501-6 ply. This higher strain capability allows the IM7G/X8553-50

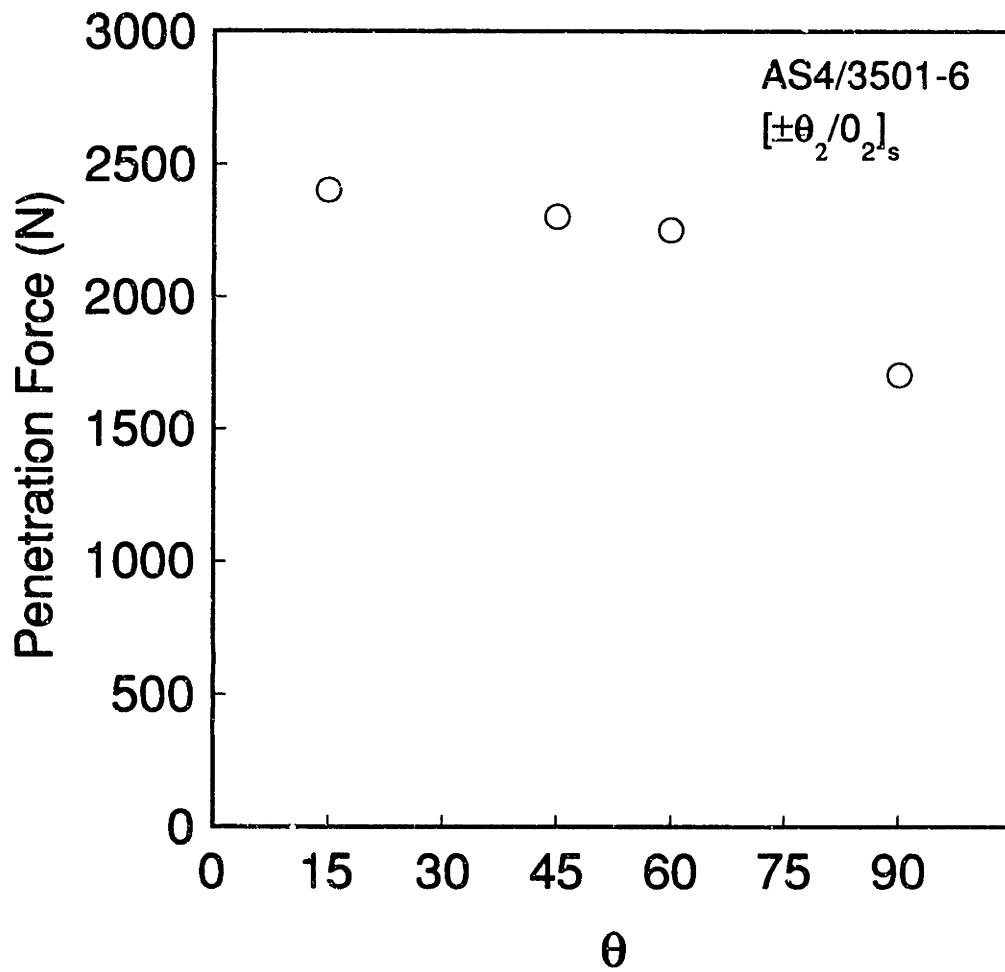
Figure 5.24 Penetration force versus layup angle for the 12-ply laminates of AS4/3501-6.

Penetration data were obtained for the 12-ply AS4/3501-6 laminates and are presented in Figure 5.24. It is noteworthy that the only fiber damage observed in the 12-ply AS4/3501-6 laminates occurred in the penetrated specimens. This is in contrast to the IM7G/X8553-50 specimens in which fiber damage occurred without penetration. The $[\pm 15_2/0_2]_s$ laminate has the highest penetration force (2400 N), followed by the $[\pm 45_2/0_2]_s$ and $[\pm 60_2/0_2]_s$ laminates (both approximately 2300 N) and the $[90_4/0_2]_s$ is the most easily penetrated (1700 N). It is obvious that this last laminate is much more easily penetrated than the other three. One explanation of this might be the number of ply interfaces within the laminate. There are only two interfaces in the $[90_4/0_2]_s$ laminate at which the ply angle changes, while the other laminates each have four interfaces. The $[90_4/0_2]_s$ laminate is essentially three unidirectional "sublaminates" of four plies each. This configuration allows matrix cracks to propagate through four plies at a time. In the other laminates, the outer four plies on each side of the laminate do not all have the same fiber direction, allowing matrix cracks in them to traverse only two plies before encountering an interface where the ply direction changes. Matrix cracking may lead to laminate penetration by allowing the impactor to penetrate each sublaminate by "wedging" it apart. This lack of inhibition to matrix cracking could be the reason that the penetration force was much lower in the $[90_4/0_2]_s$ laminate than in the other three laminates.

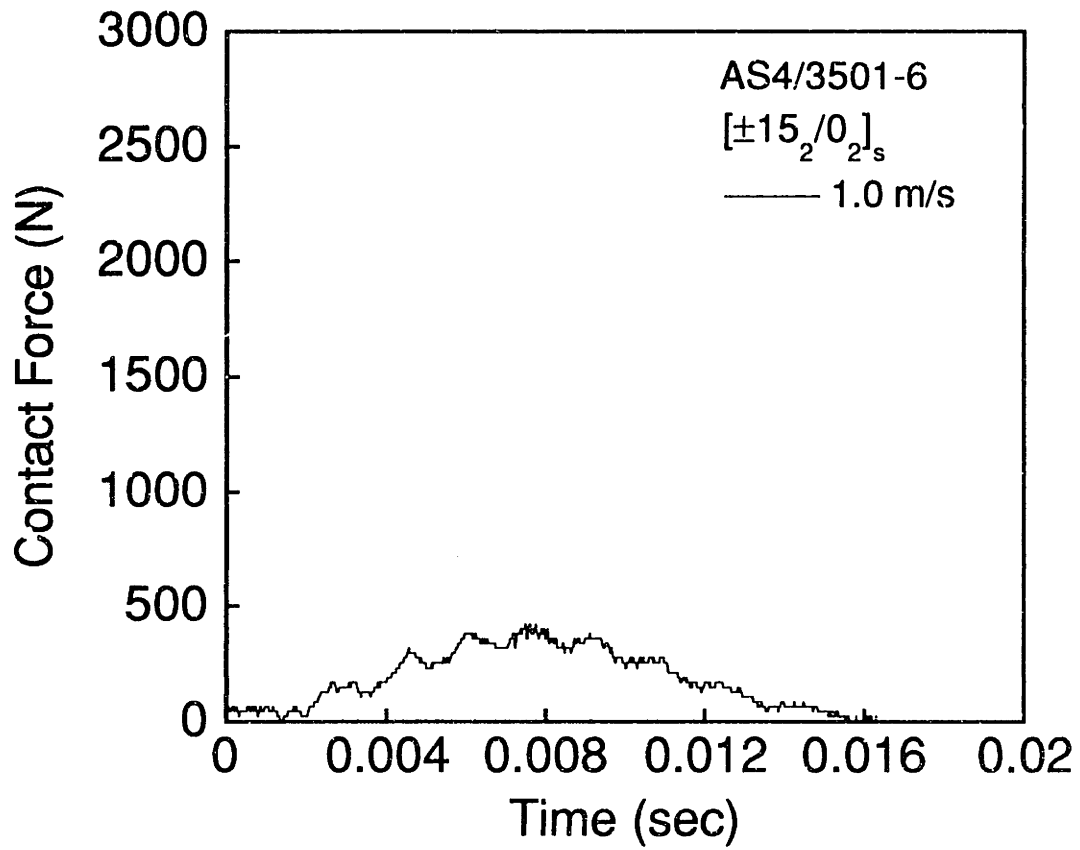
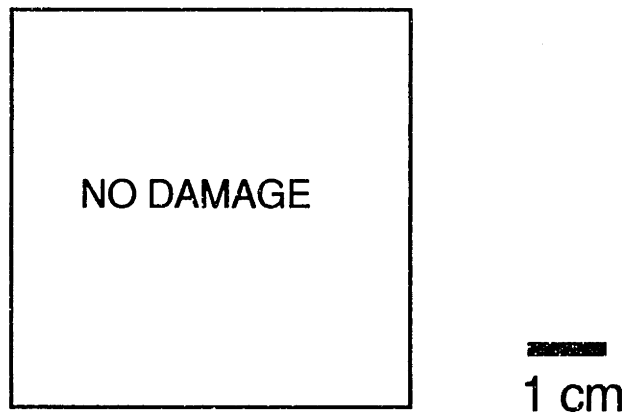
Figure A.1 (upper) Force versus time and (lower) X-ray photograph for AS4/3501-6 [±15₂/0₂]_s specimen impacted at 1.0 m/s.

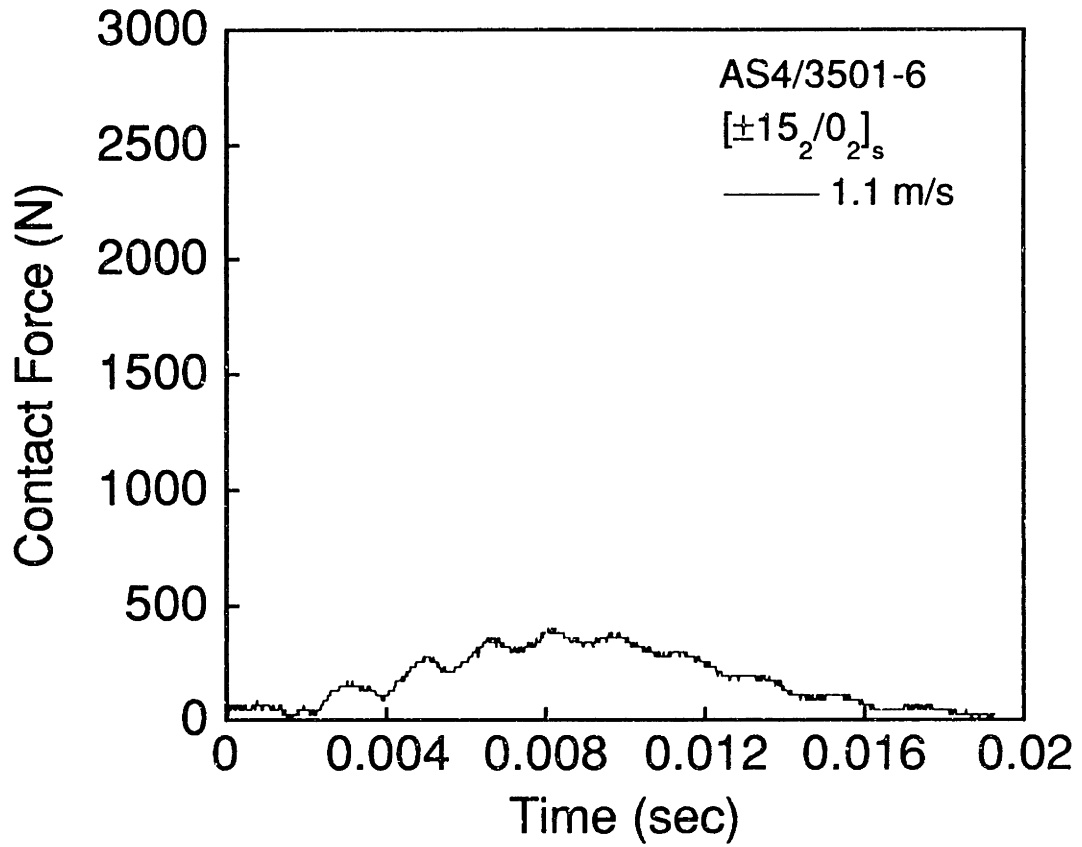
Figure A.2 (upper) Force versus time and (lower) X-ray photograph for AS4/3501-6 [±15₂/0₂]_s specimen impacted at 1.1 m/s.

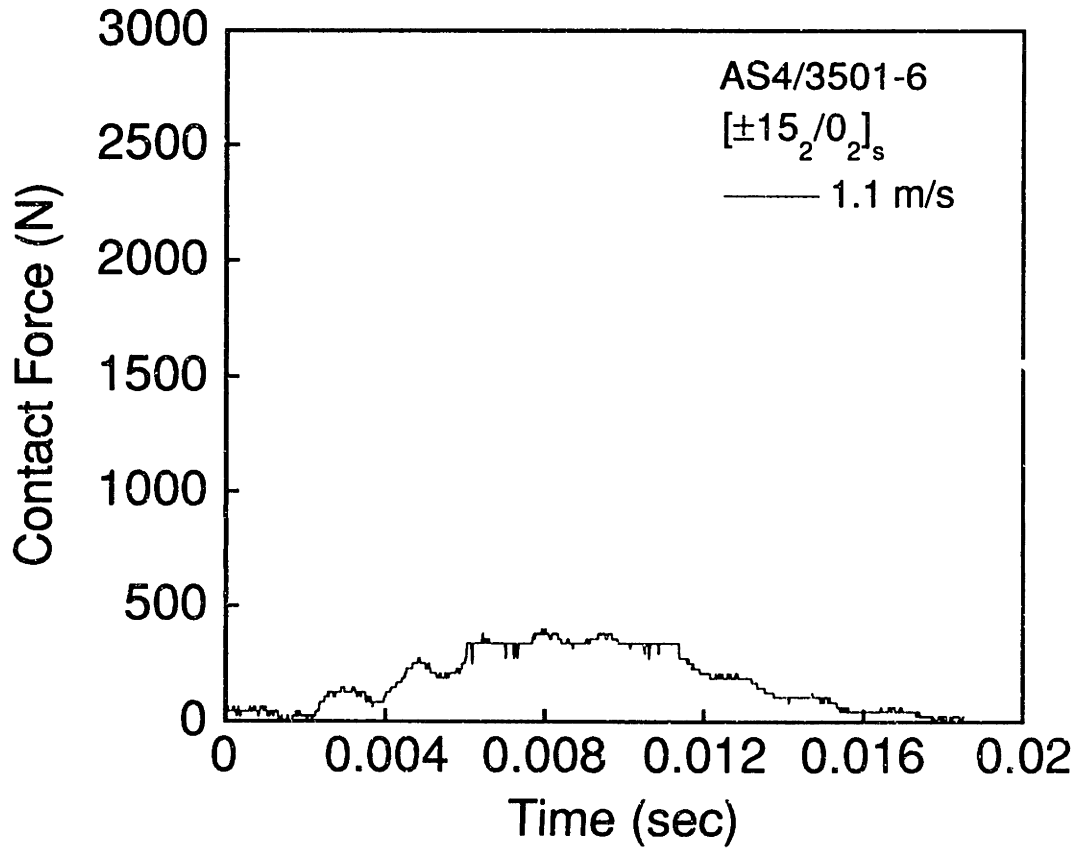
Figure A.3 (upper) Force versus time and (lower) X-ray photograph for AS4/3501-6 [±15₂/0₂]_s specimen impacted at 1.1 m/s.
