IMPACT DAMAGE MECHANISMS IN SEVERAL LAMINATED MATERIAL SYSTEMS

Submitted to the Department of Aeronautics and Astronautics in Partial
Fulfillment of the Requirements for the Degree of

MASTER OF SCIENCE

MASSACHUSETTS INSTITUTE OF TECHNOLOGY

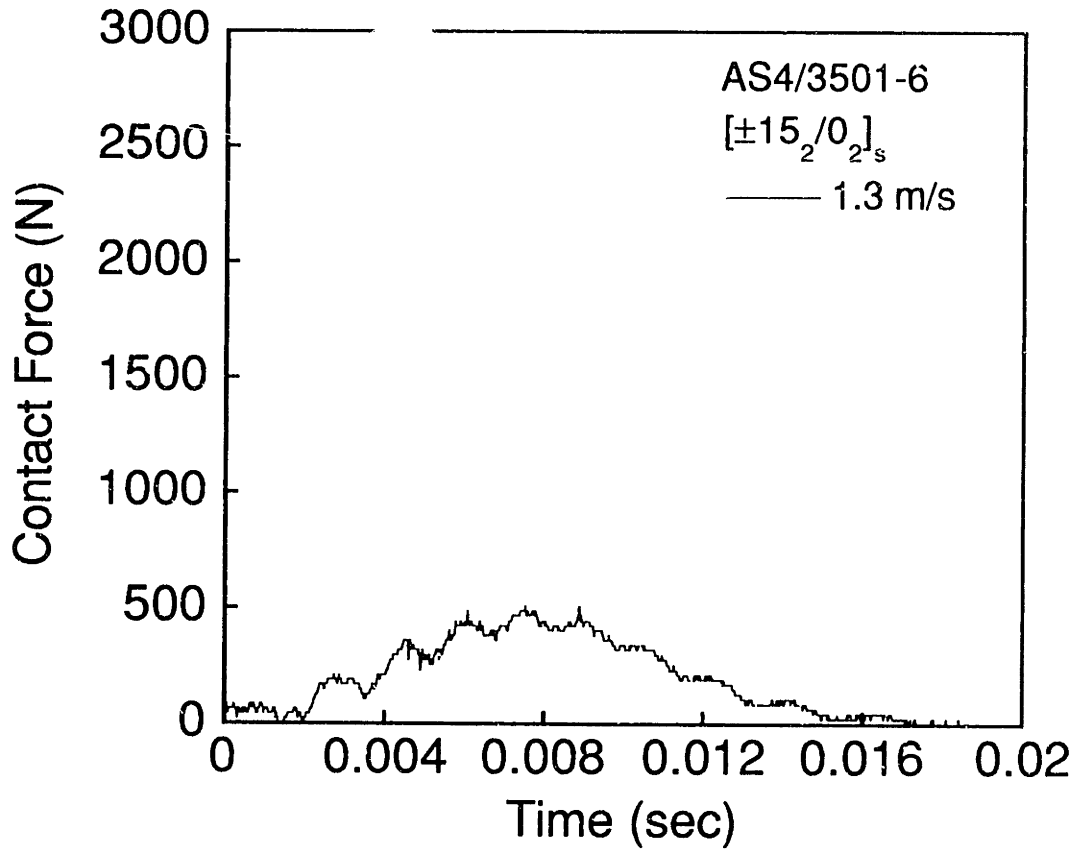
Figure A.4 (upper) Force versus time and (lower) X-ray photograph for AS4/3501-6 [±15₂/0₂]_s specimen impacted at 1.3 m/s.

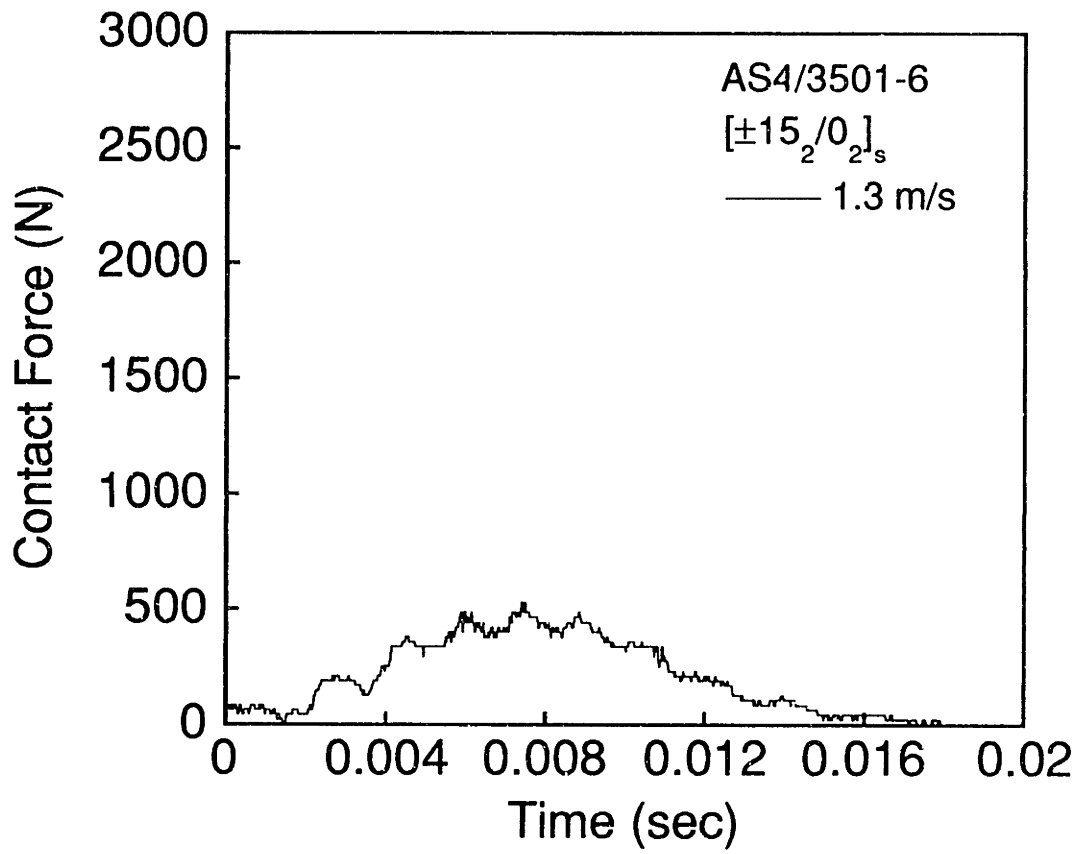
Figure A.5 (upper) Force versus time and (lower) X-ray photograph for AS4/3501-6 [±15₂/0₂]_s specimen impacted at 1.3 m/s.

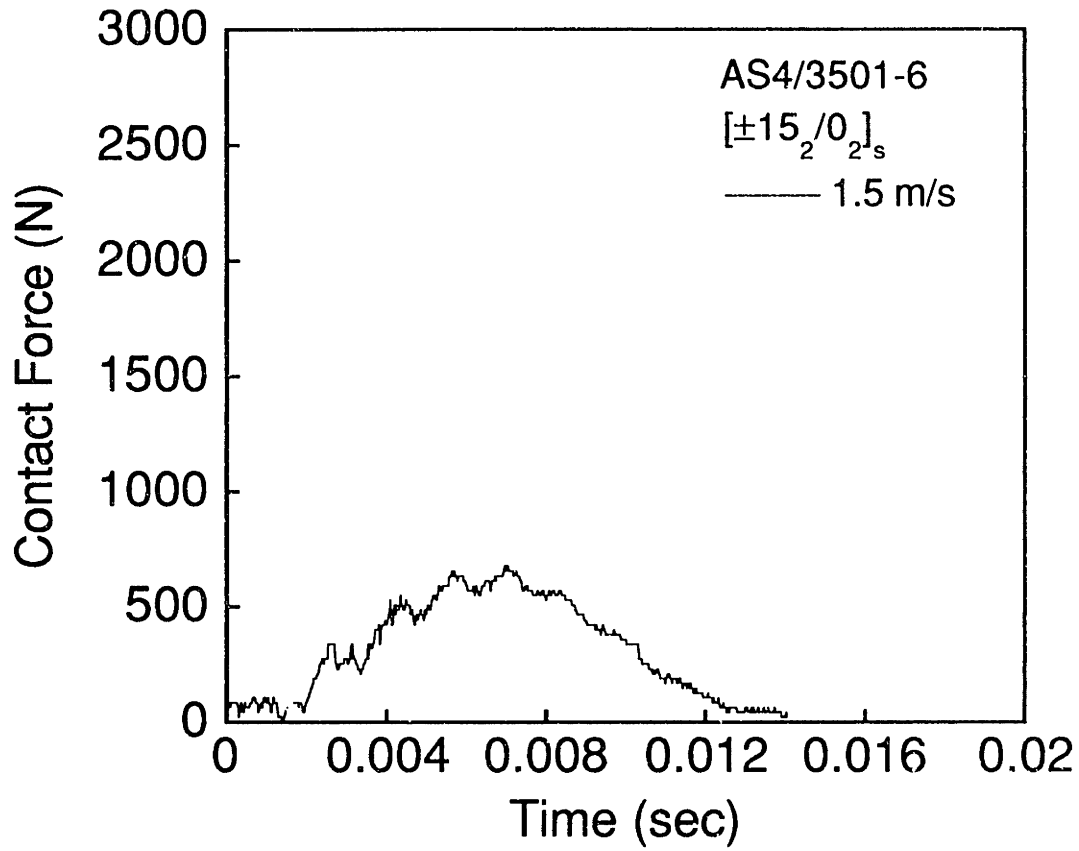
Figure A.6 (upper) Force versus time and (lower) X-ray photograph for AS4/3501-6 [±15₂/0₂]_s specimen impacted at 1.5 m/s.

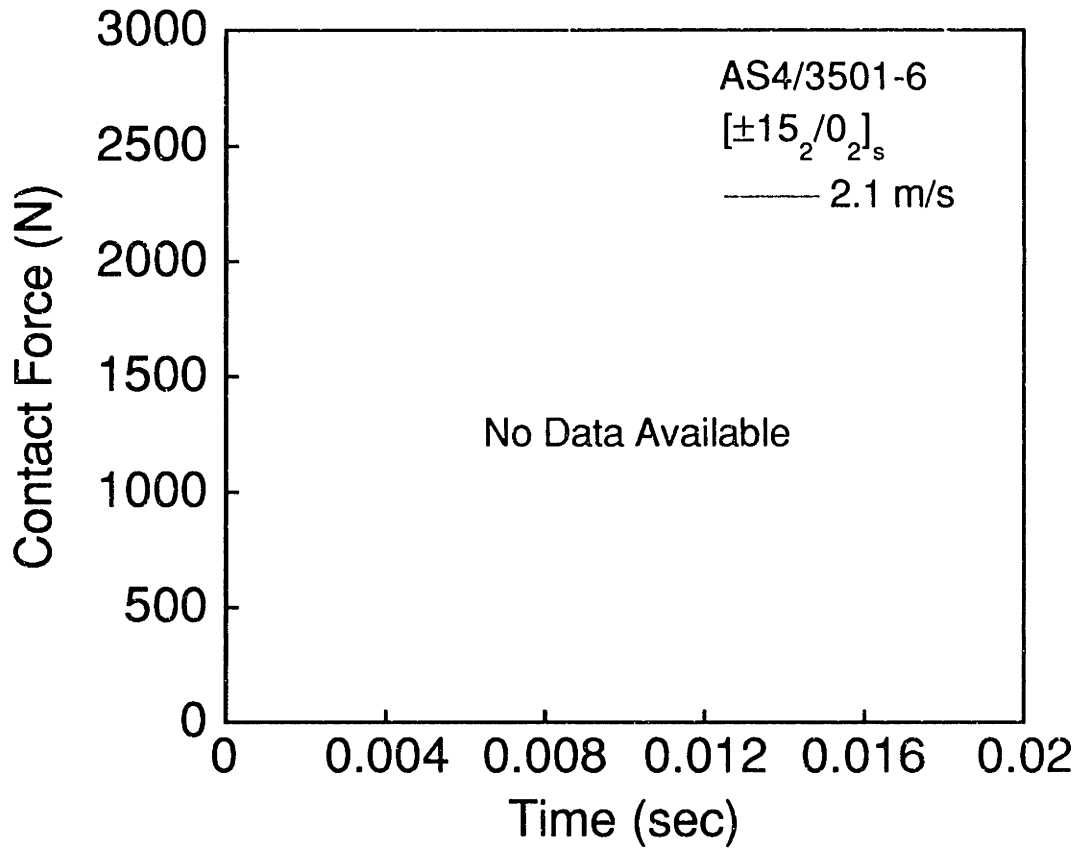
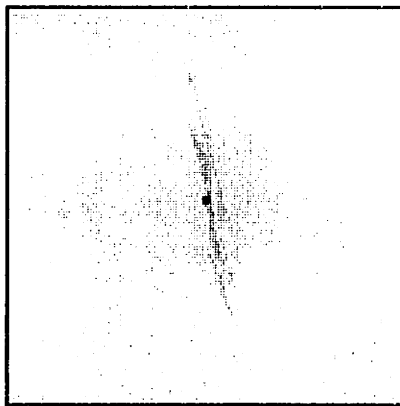
Figure A.7 X-ray photograph for AS4/3501-6 [±15₂/0₂]_s specimen impacted at 2.1 m/s.

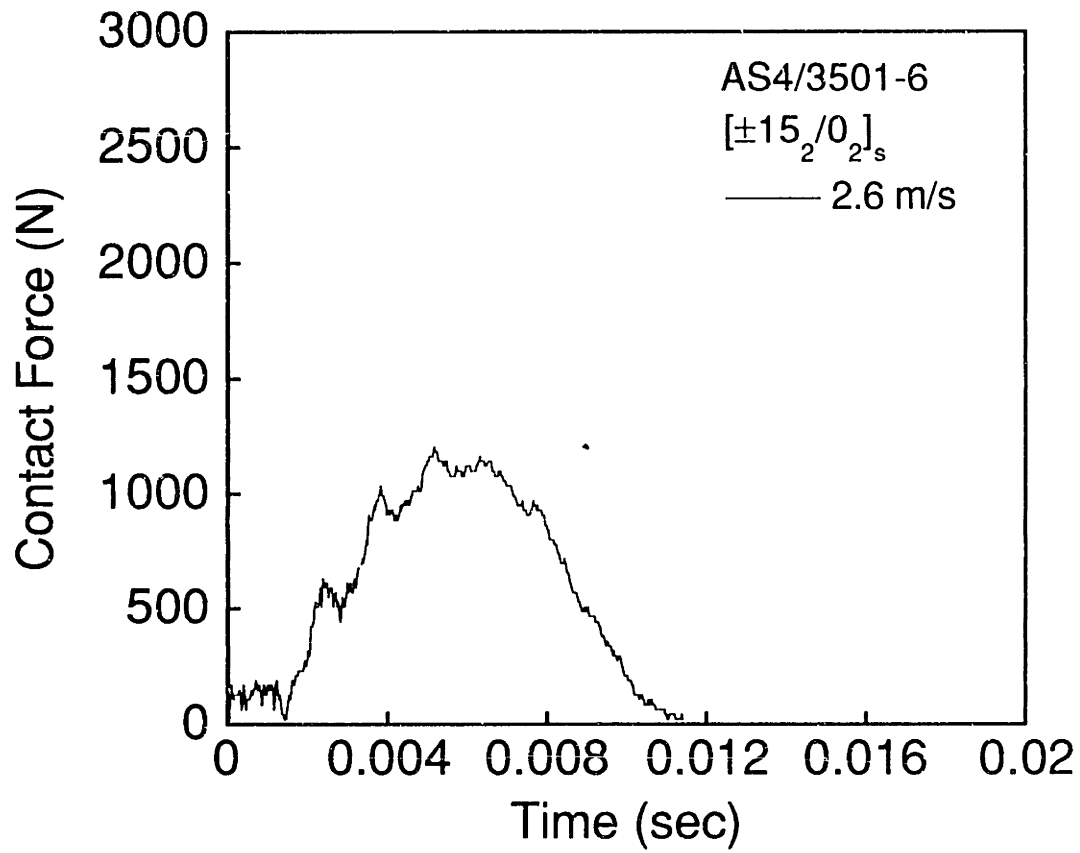
Figure A.8 (upper) Force versus time and (lower) X-ray photograph for AS4/3501-6 [±15₂/0₂]_s specimen impacted at 2.6 m/s.

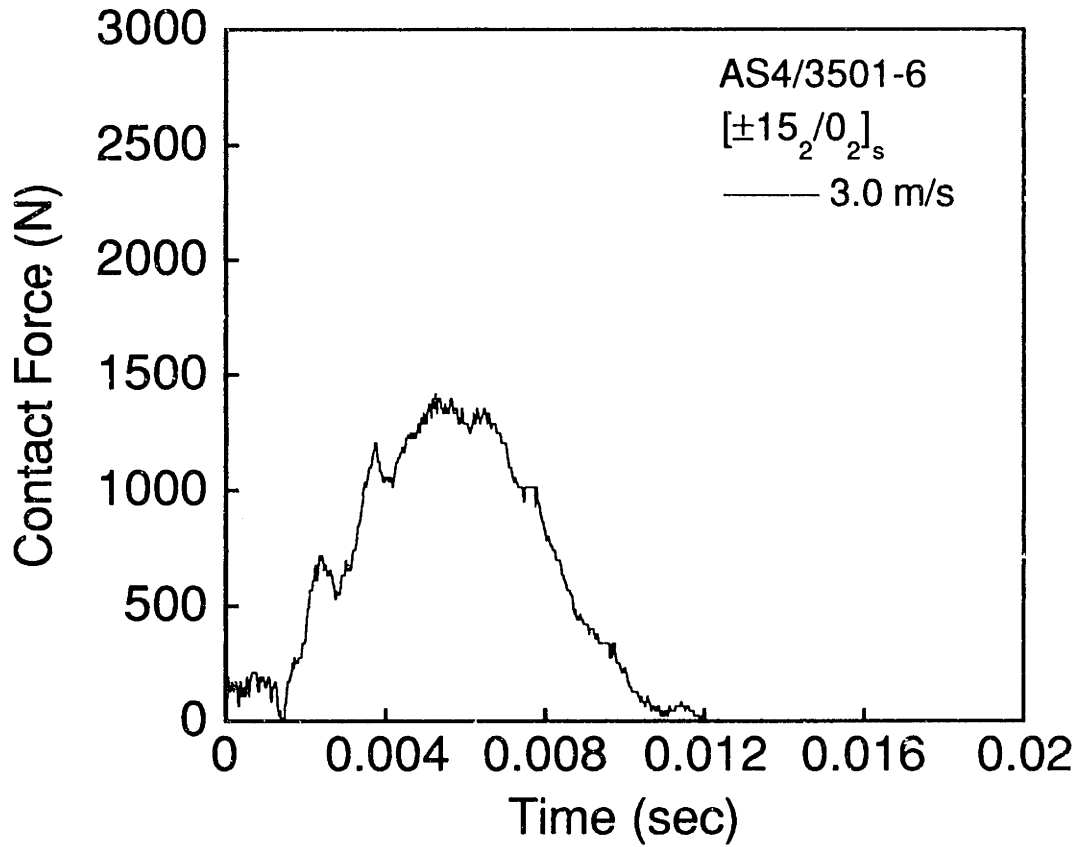
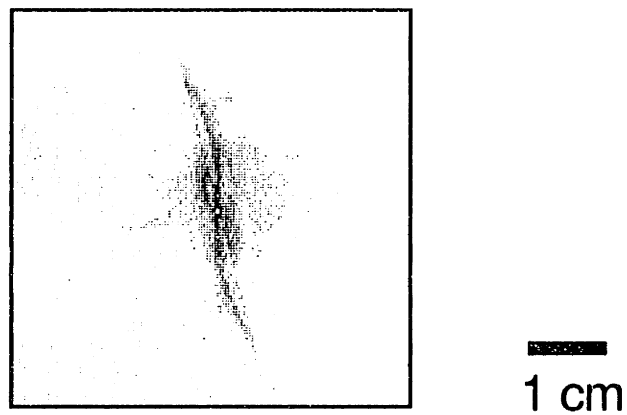
Figure A.9 (upper) Force versus time and (lower) X-ray photograph for AS4/3501-6 [±15₂/0₂]_s specimen impacted at 3.0 m/s.

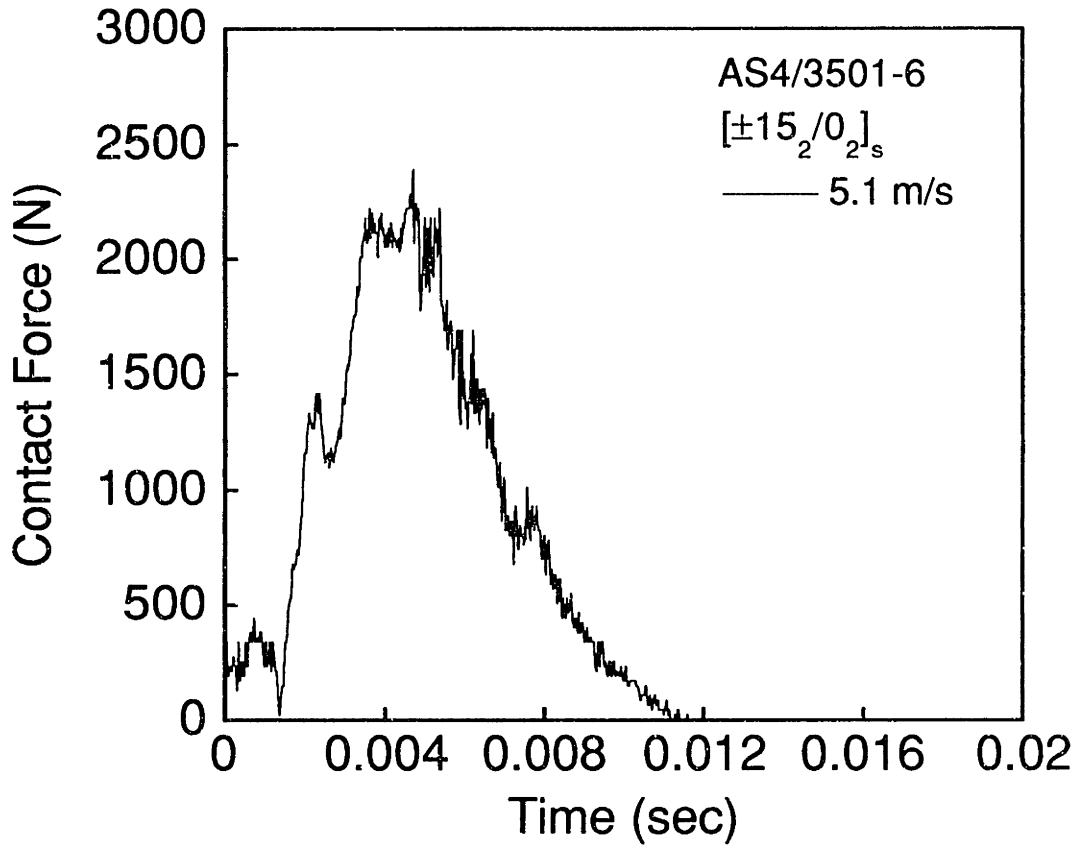
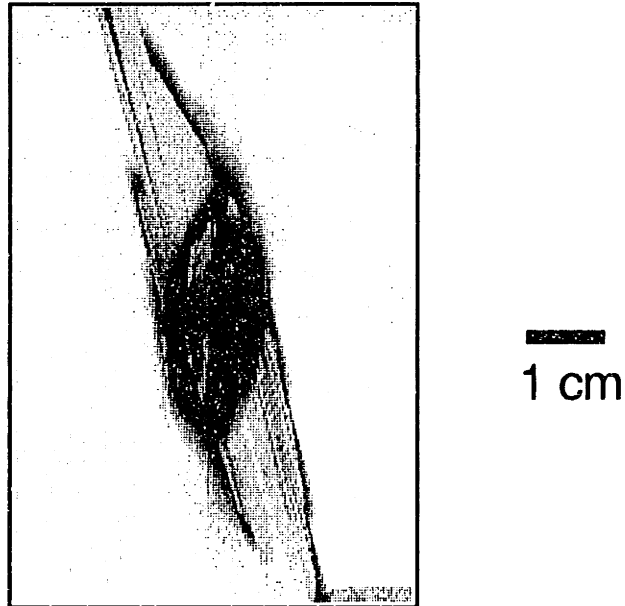
Figure A.10 (upper) Force versus time and (lower) X-ray photograph for AS4/3501-6 [±15₂/0₂]_s specimen impacted at 5.1 m/s.

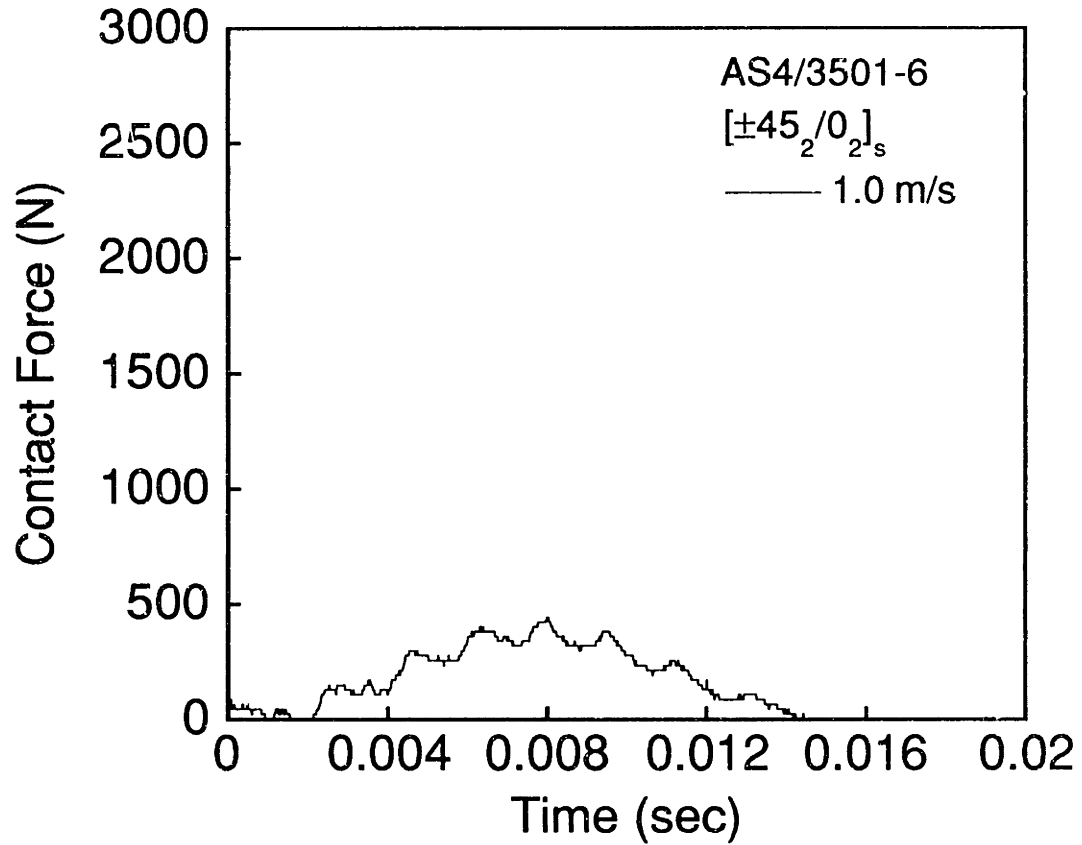
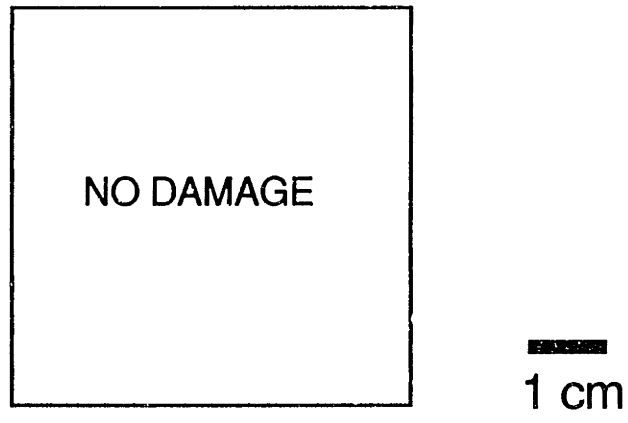
Figure A.11 (upper) Force versus time and (lower) X-ray photograph for AS4/3501-6 [±45₂/0₂]_s specimen impacted at 1.0 m/s.

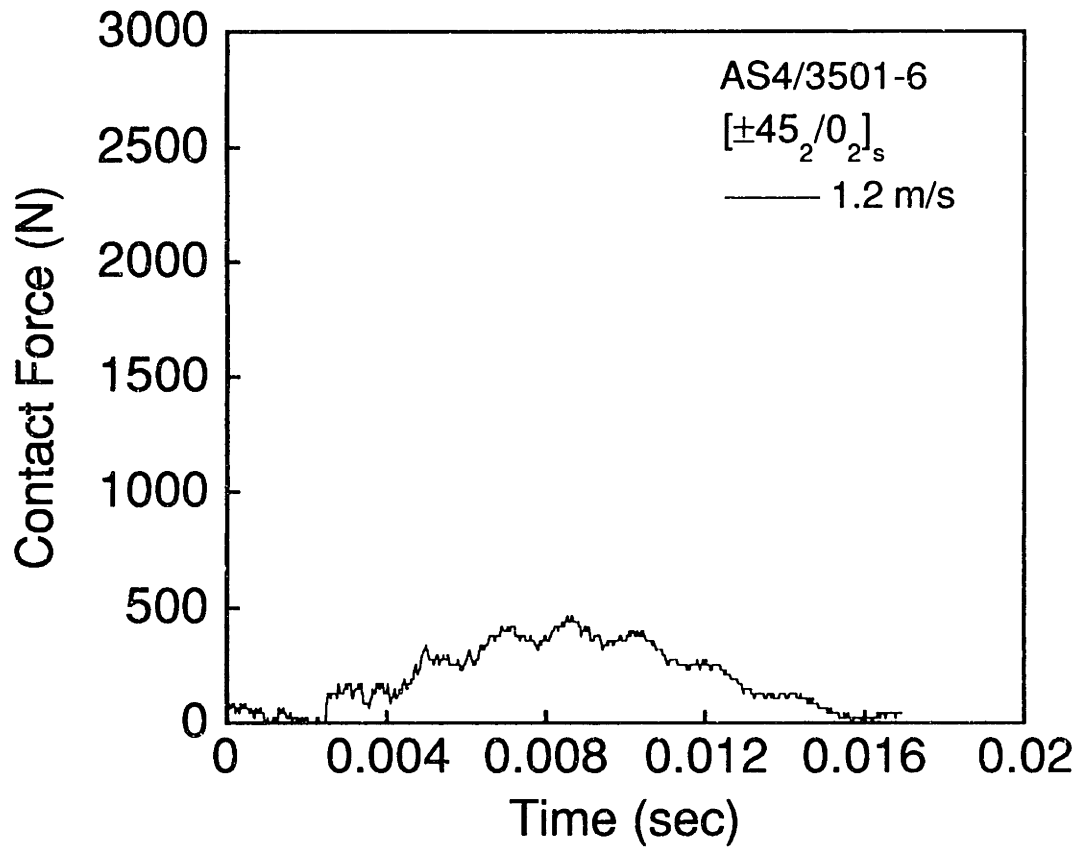
Figure A.12 (upper) Force versus time and (lower) X-ray photograph for AS4/3501-6 [±45₂/0₂]_s specimen impacted at 1.2 m/s.

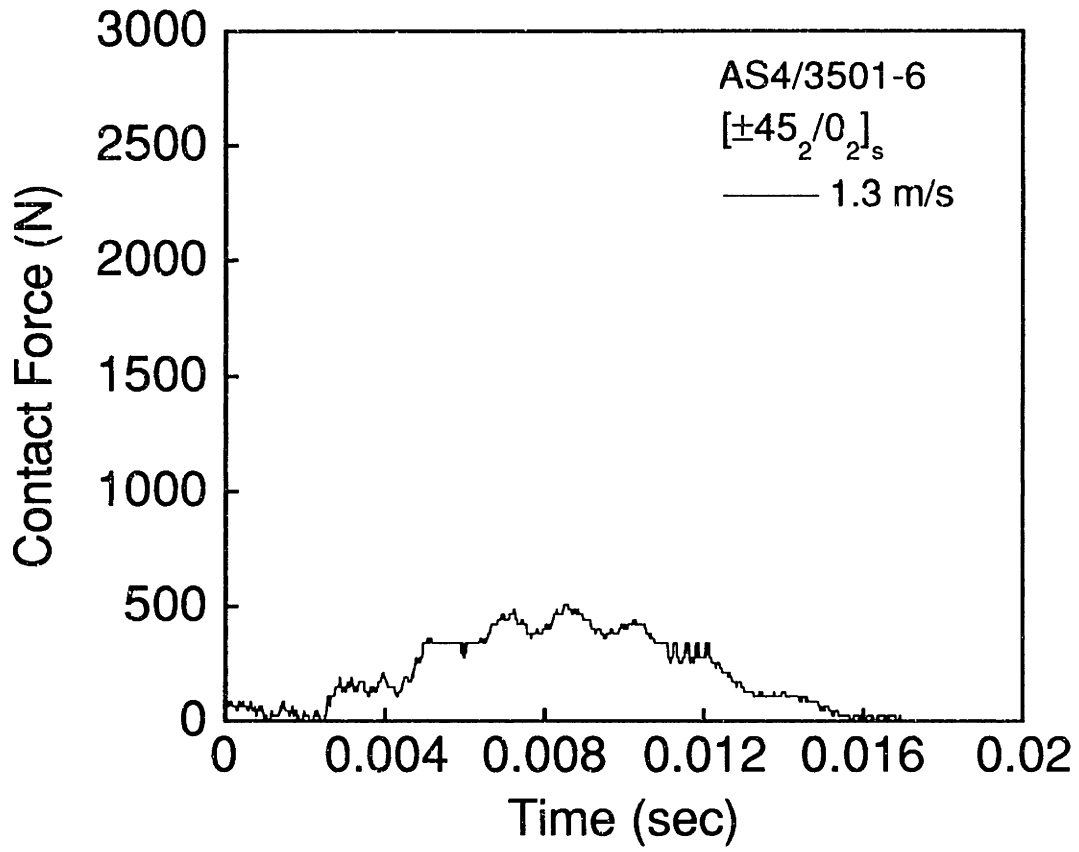
Figure A.13 (upper) Force versus time and (lower) X-ray photograph for AS4/3501-6 [±45₂/0₂]_s specimen impacted at 1.3 m/s.

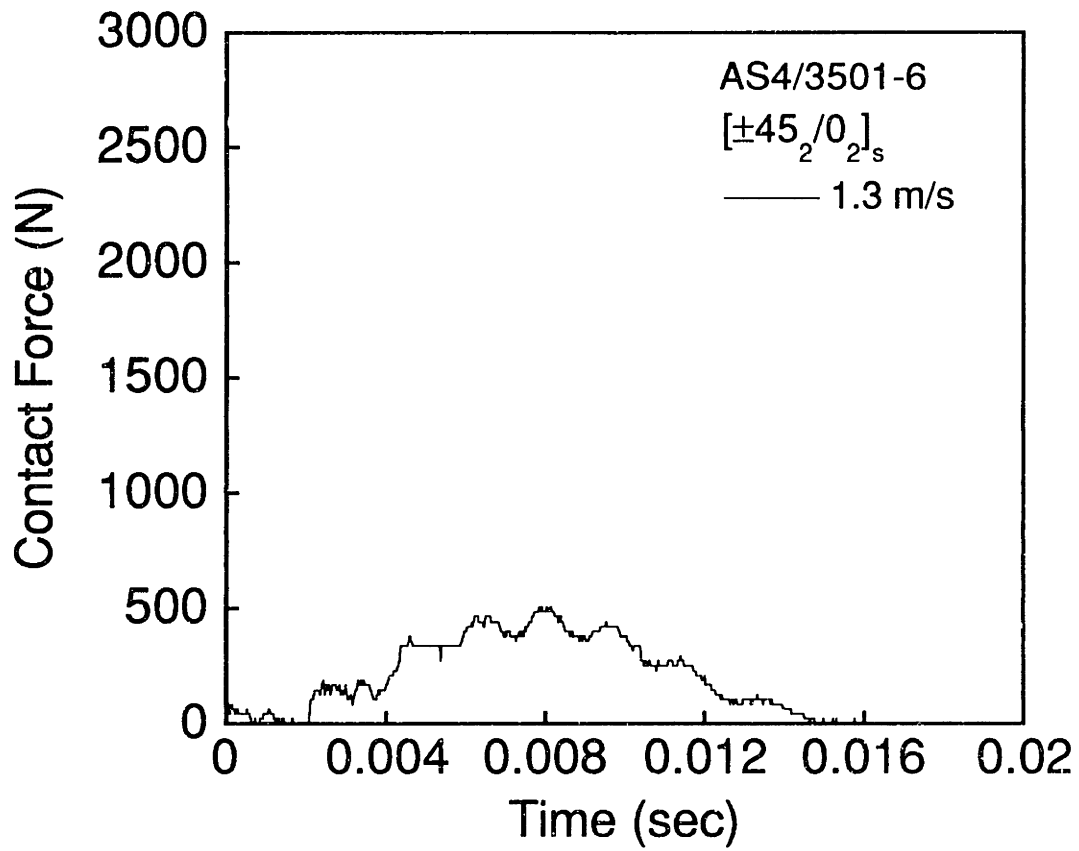
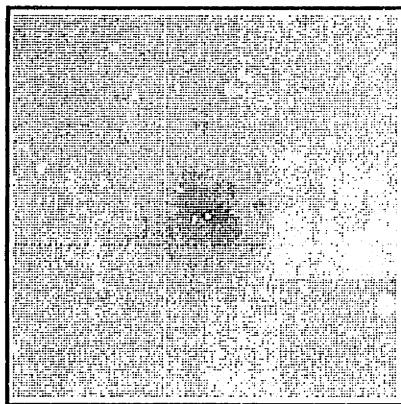
Figure A.14 (upper) Force versus time and (lower) X-ray photograph for AS4/3501-6 [±45₂/0₂]_s specimen impacted at 1.3 m/s.

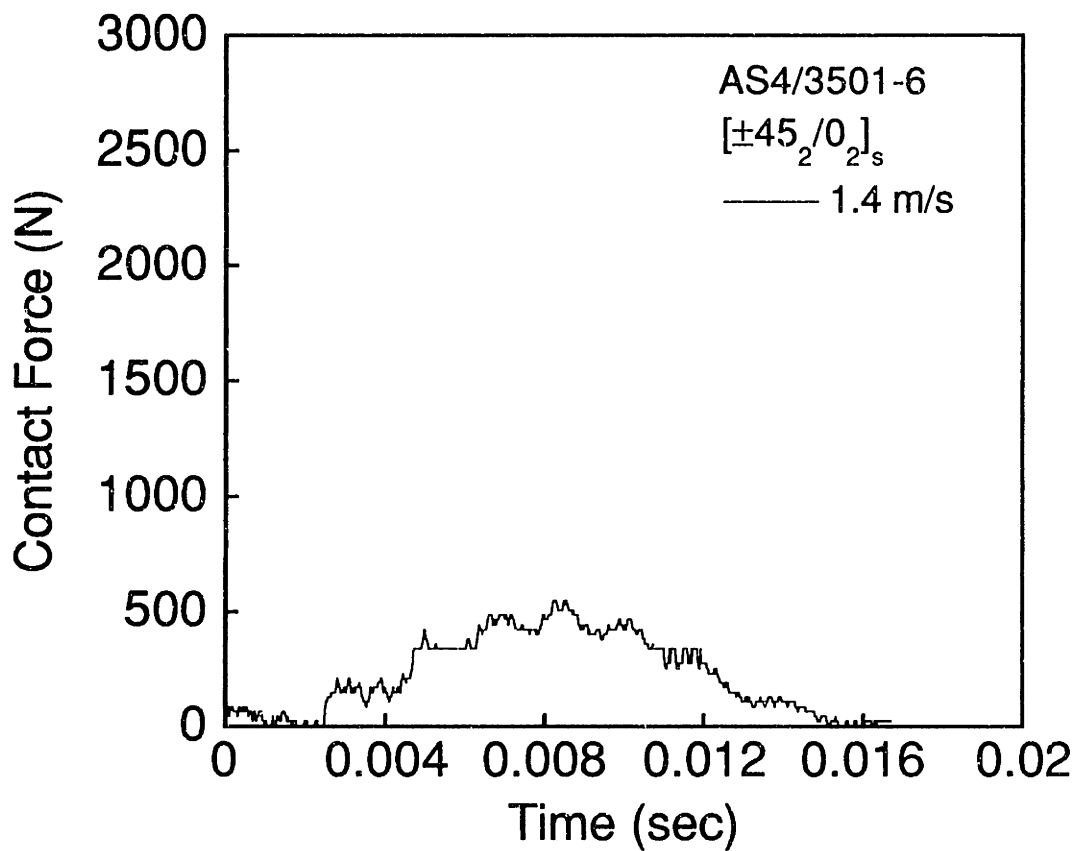
Figure A.15 (upper) Force versus time and (lower) X-ray photograph for AS4/3501-6 [±45₂/0₂]_s specimen impacted at 1.4 m/s.

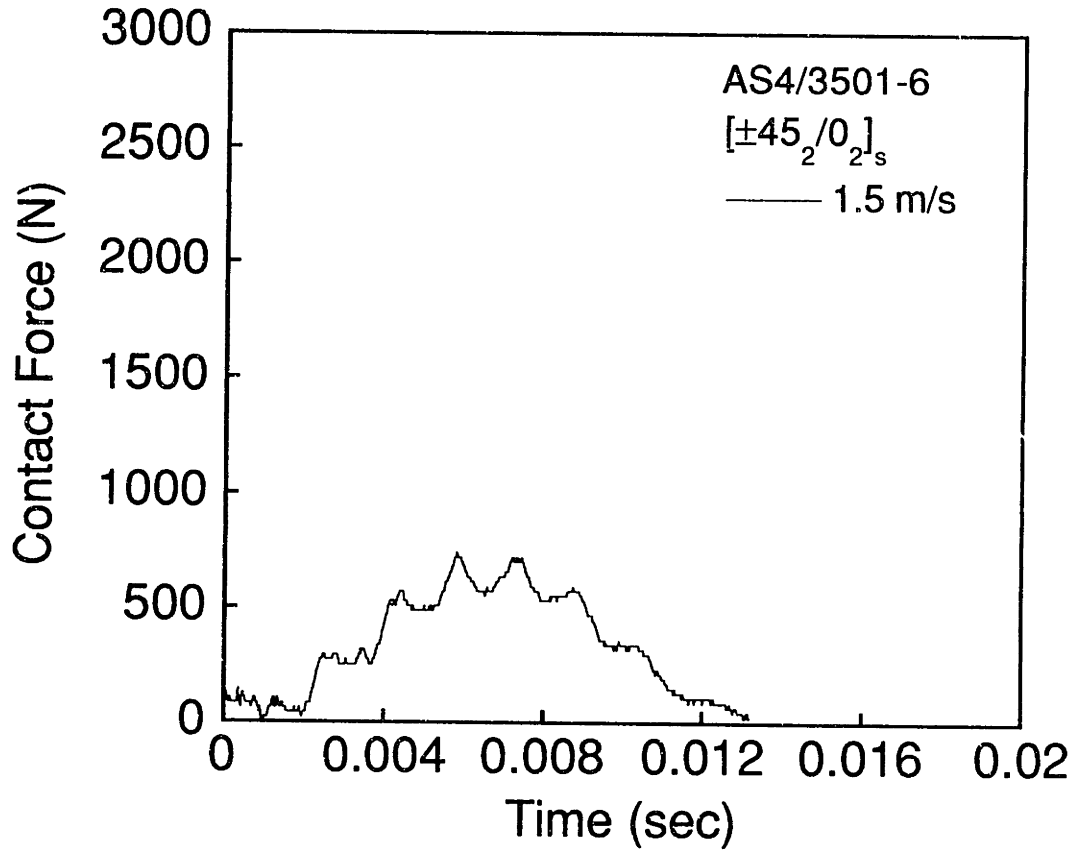
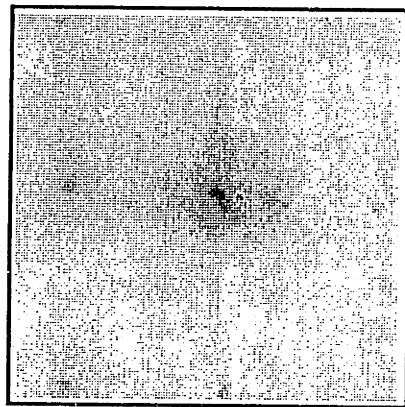
Figure A.16 (upper) Force versus time and (lower) X-ray photograph for AS4/3501-6 [±45₂/0₂]_s specimen impacted at 1.5 m/s.

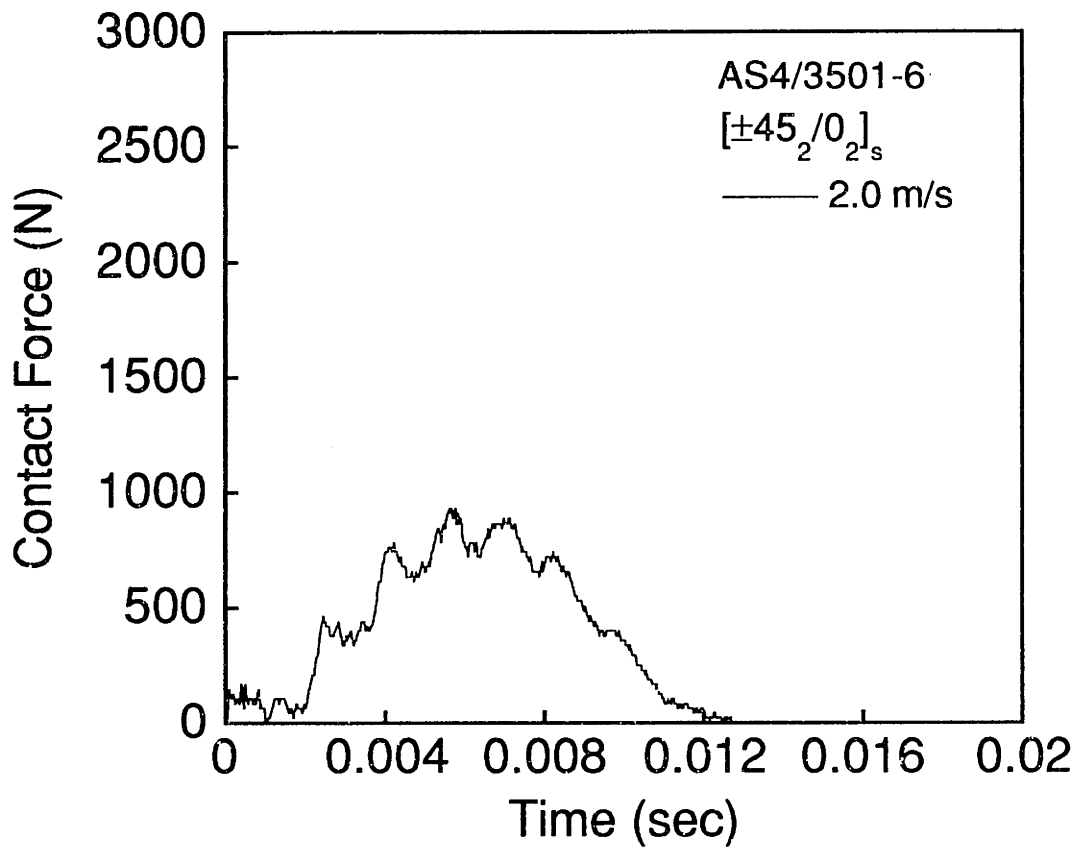
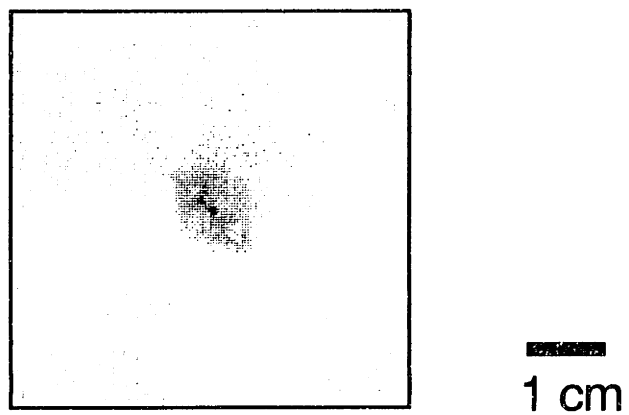
Figure A.17 (upper) Force versus time and (lower) X-ray photograph for AS4/3501-6 [±45₂/0₂]_s specimen impacted at 2.0 m/s.

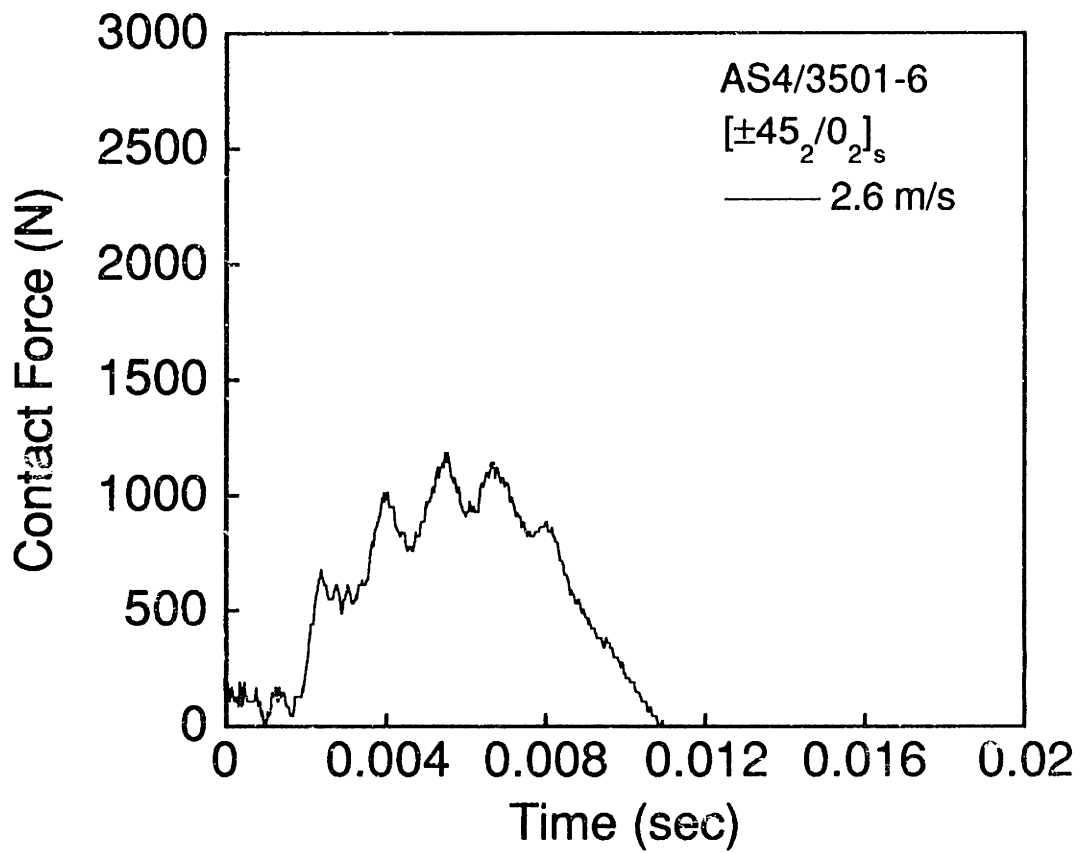
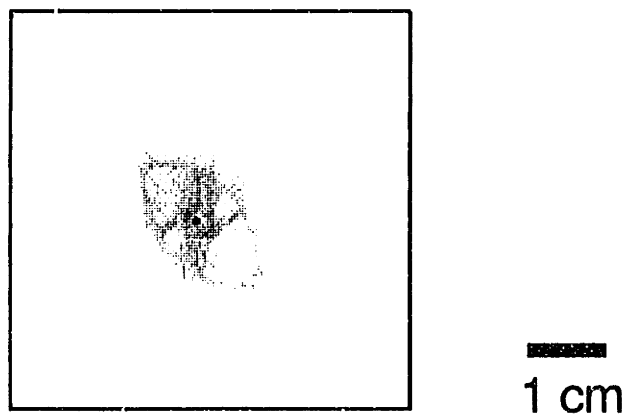
Figure A.18 (upper) Force versus time and (lower) X-ray photograph for AS4/3501-6 [±45₂/0₂]_s specimen impacted at 2.6 m/s.

All of the force-time data from this investigation are contained in this section. The force-time signature of each graphite/epoxy specimen is accompanied by an X-ray photograph of the damage state, or the words "NO DAMAGE", where damage could not be detected in the original X-ray photograph. The X-ray photographs shown here have been electronically scanned for reproduction purposes and some of the detail of the original photograph may be lost, especially in cases where the damage was very slight. The presence of an X-ray photograph (as opposed to the words "NO DAMAGE") indicates that damage was visible in the original X-ray photograph, even though it may not be apparent in the reproduction.

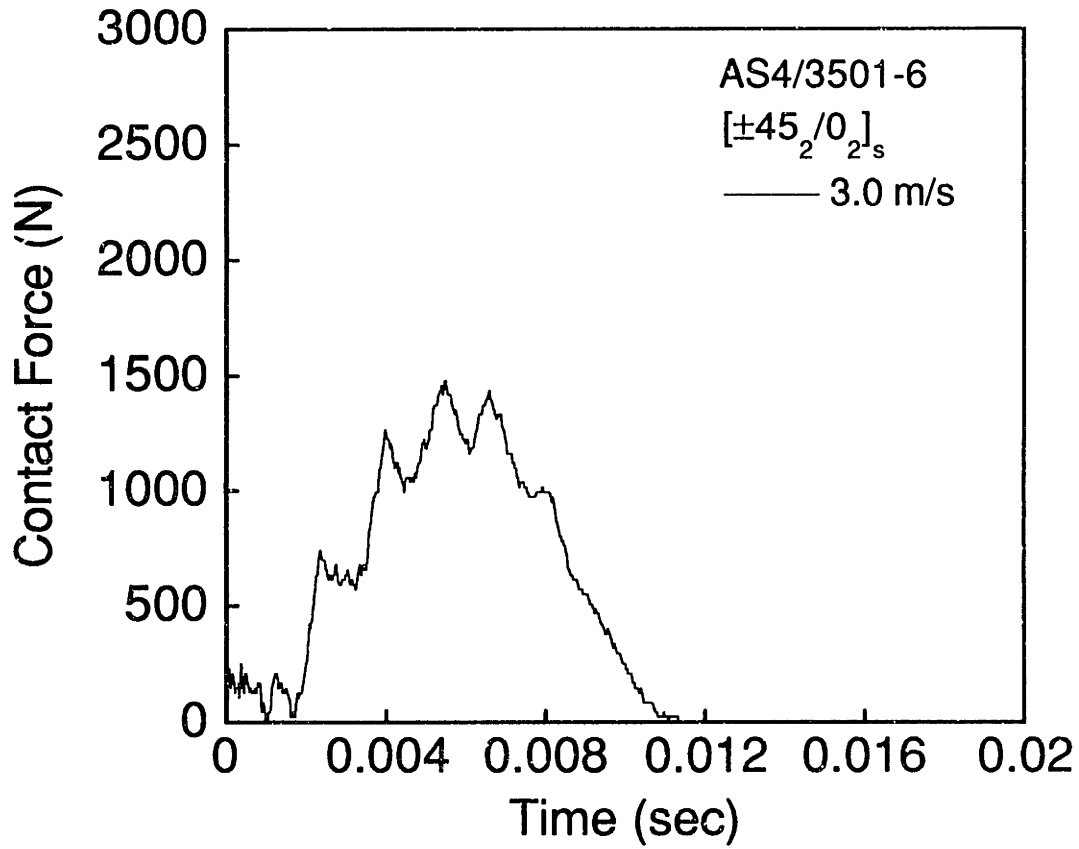
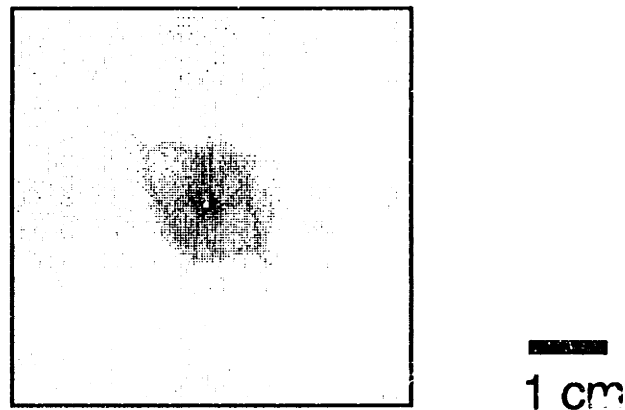
Figure A.19 (upper) Force versus time and (lower) X-ray photograph for AS4/3501-6 [±45₂/0₂]_s specimen impacted at 3.0 m/s.

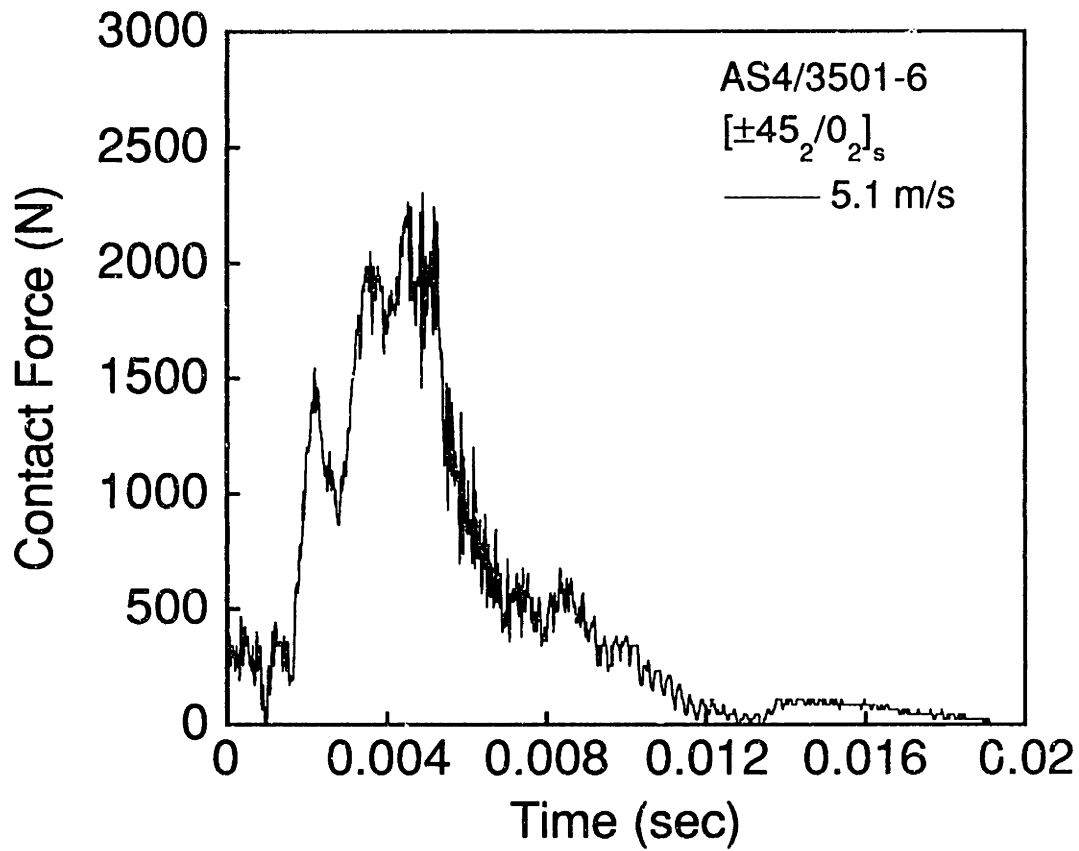
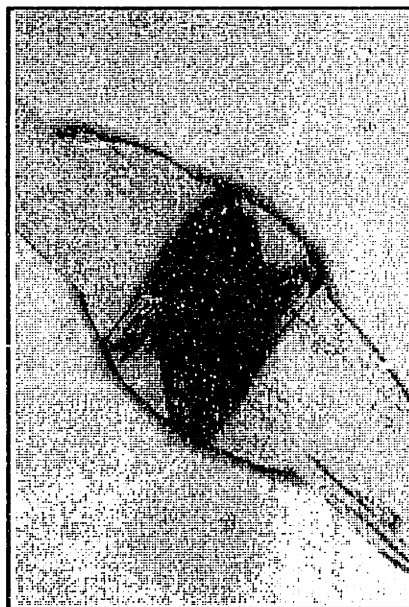
Figure A.20 (upper) Force versus time and (lower) X-ray photograph for AS4/3501-6 [±45₂/0₂]₈ specimen impacted at 5.1 m/s.

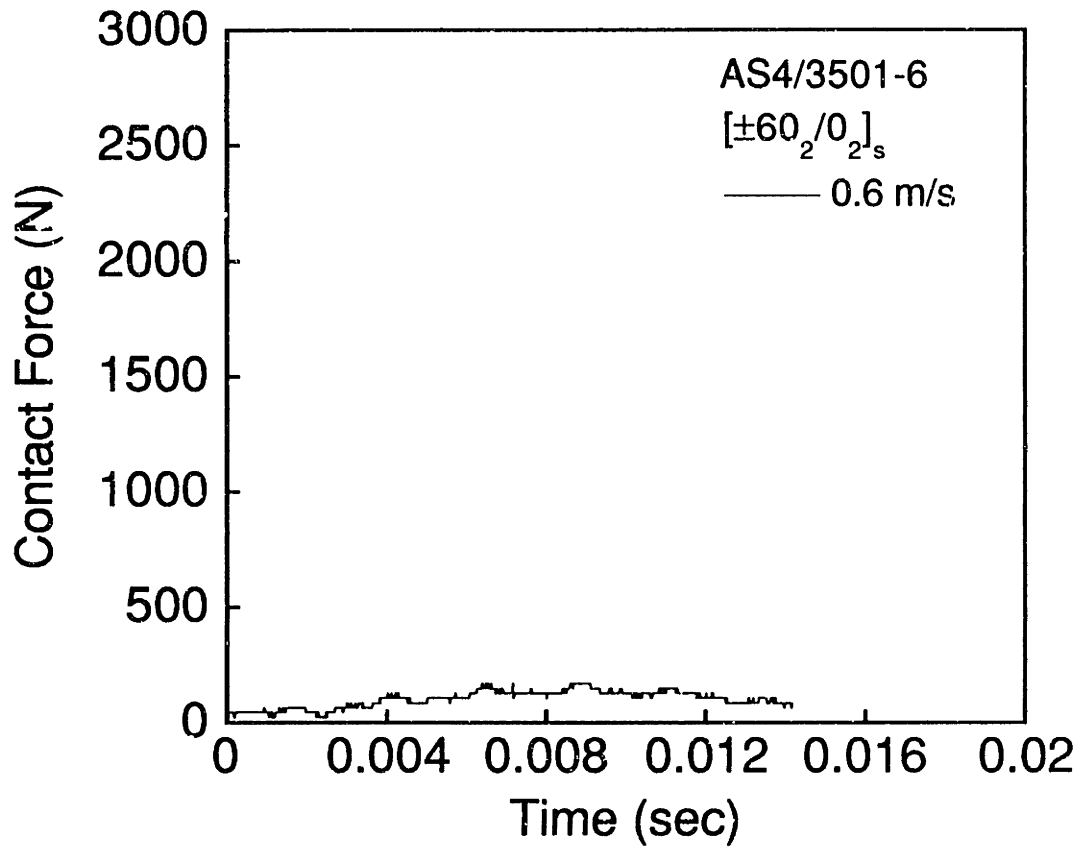
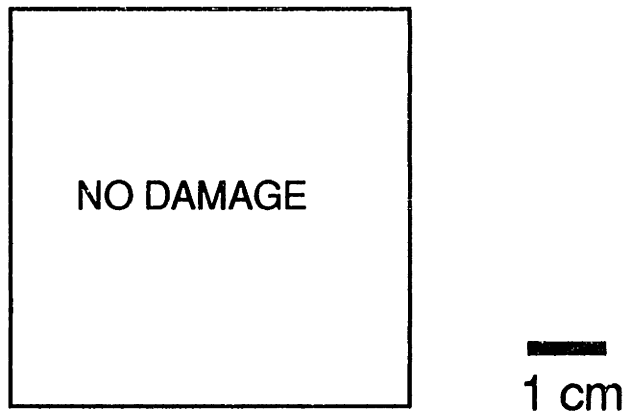
Figure A.21 (upper) Force versus time and (lower) X-ray photograph for AS4/3501-6 [±60₂/0₂]_s specimen impacted at 0.6 m/s.

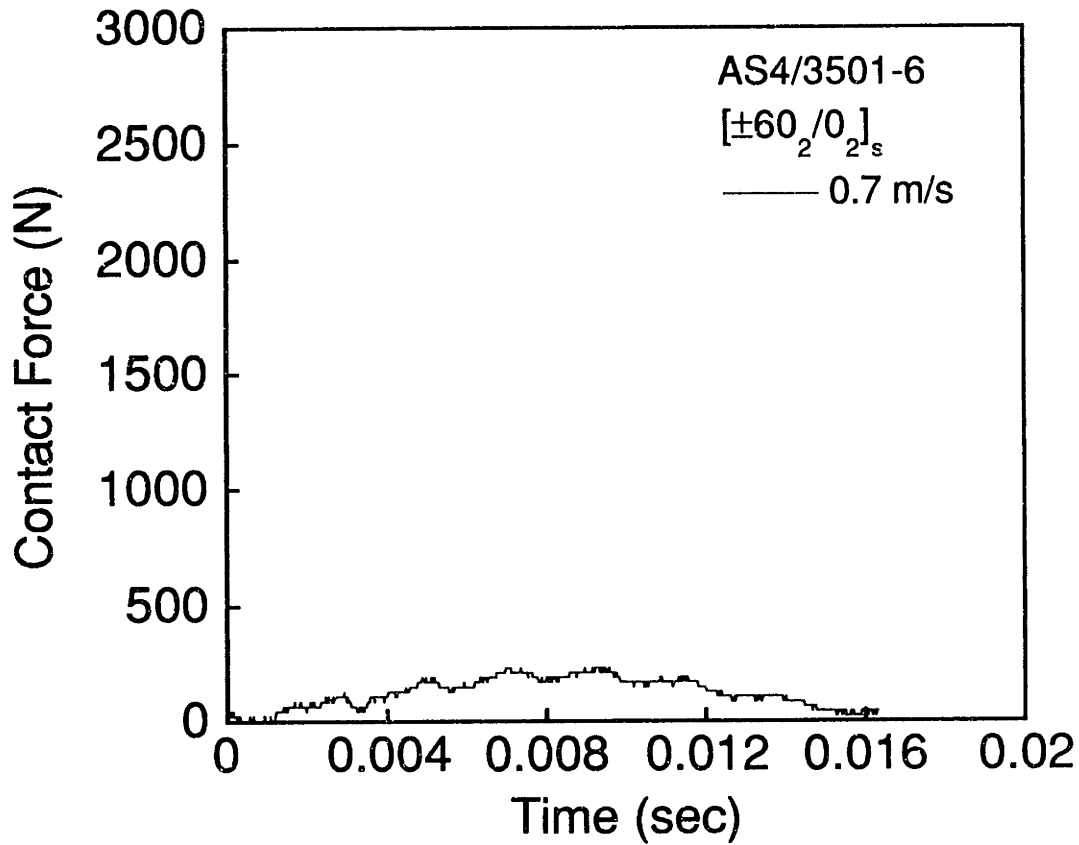
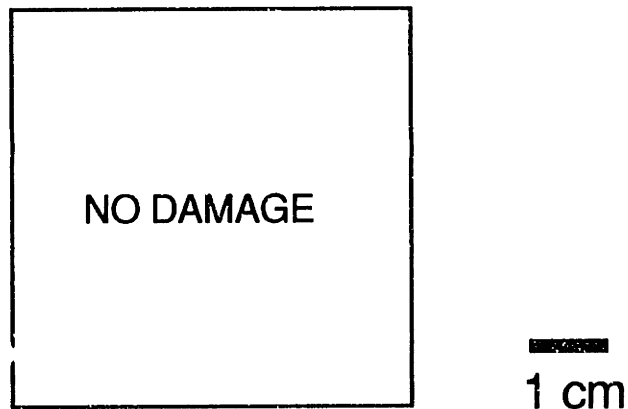
Figure A.22 (upper) Force versus time and (lower) X-ray photograph for AS4/3501-6 [±60₂/0₂]_s specimen impacted at 0.7 m/s.

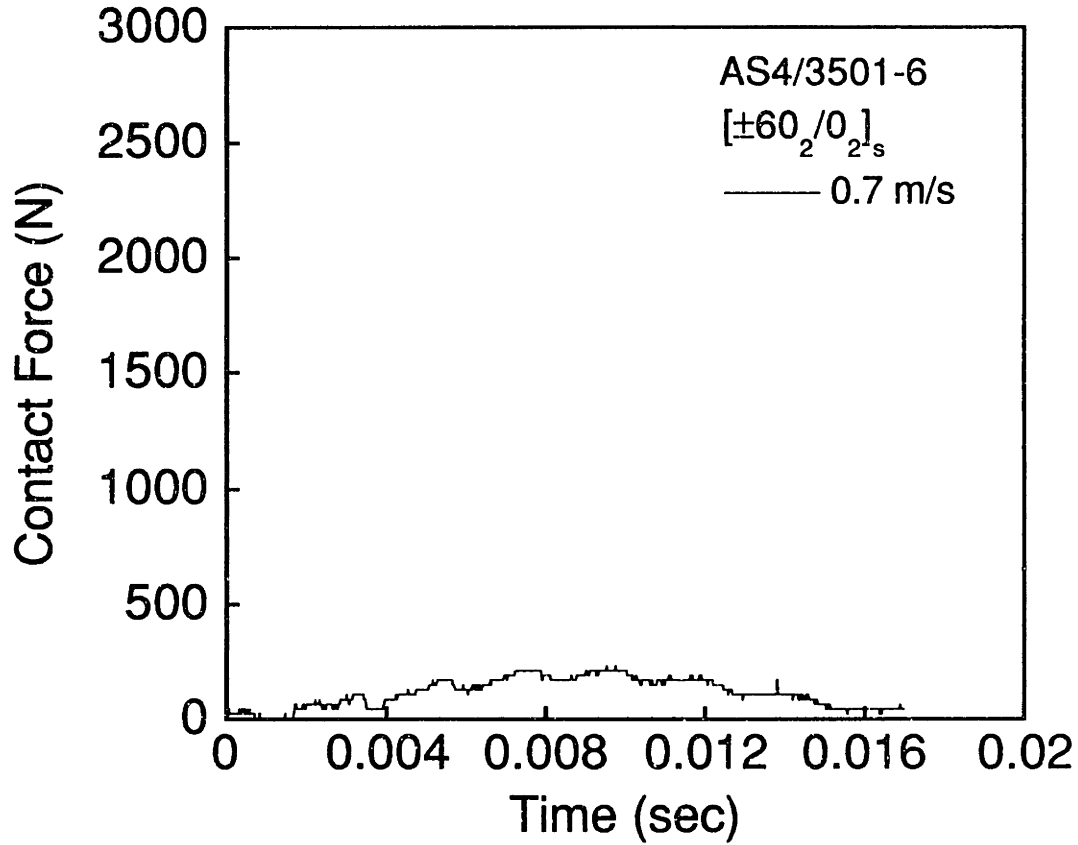
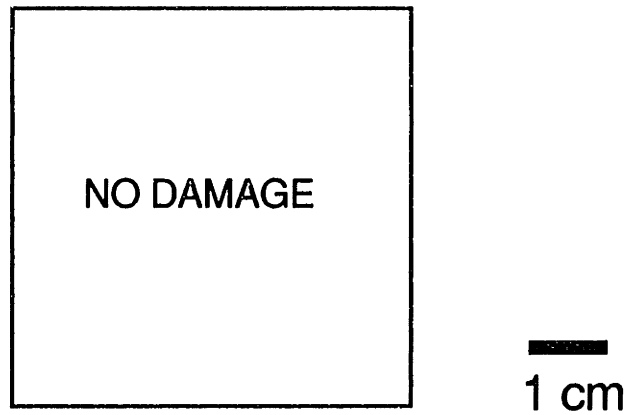
Figure A.23 (upper) Force versus time and (lower) X-ray photograph for AS4/3501-6 [±60₂/0₂]_s specimen impacted at 0.7 m/s.
