IMPACT DAMAGE MECHANISMS IN SEVERAL LAMINATED MATERIAL SYSTEMS

Submitted to the Department of Aeronautics and Astronautics in Partial
Fulfillment of the Requirements for the Degree of

MASTER OF SCIENCE

MASSACHUSETTS INSTITUTE OF TECHNOLOGY

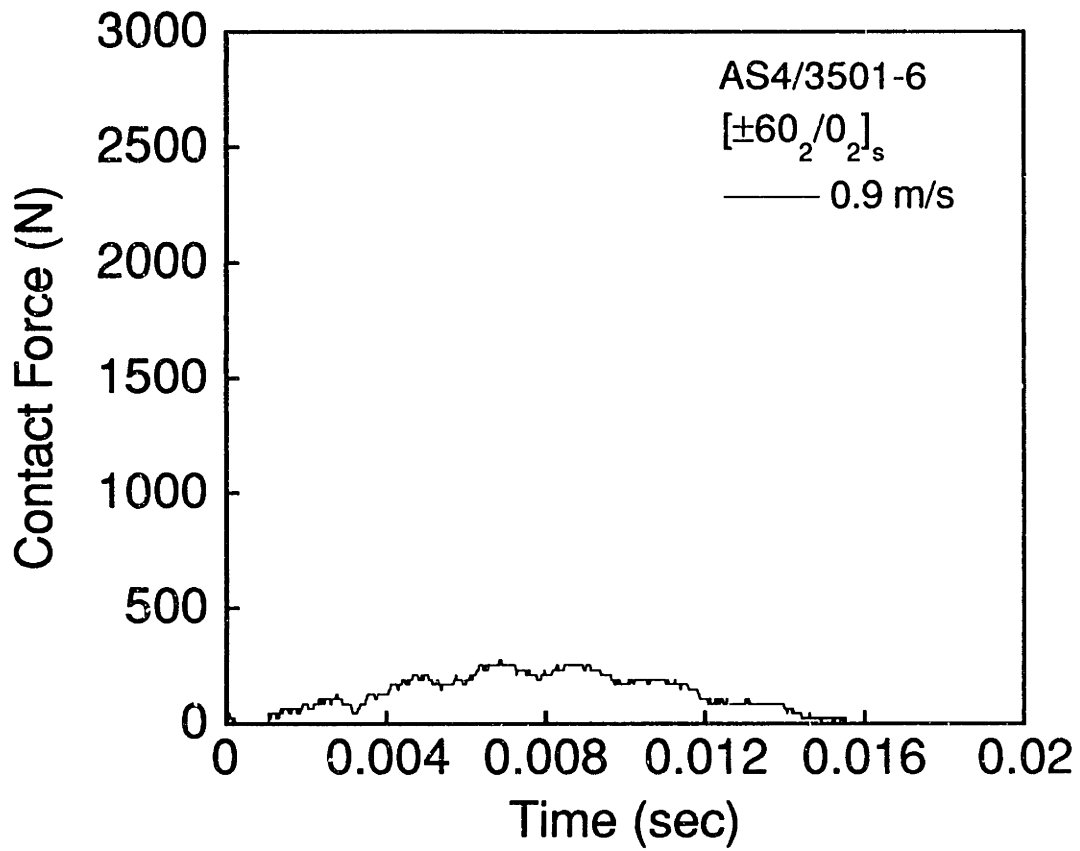
Figure A.24 (upper) Force versus time and (lower) X-ray photograph for AS4/3501-6 [±60₂/0₂]_s specimen impacted at 0.9 m/s.

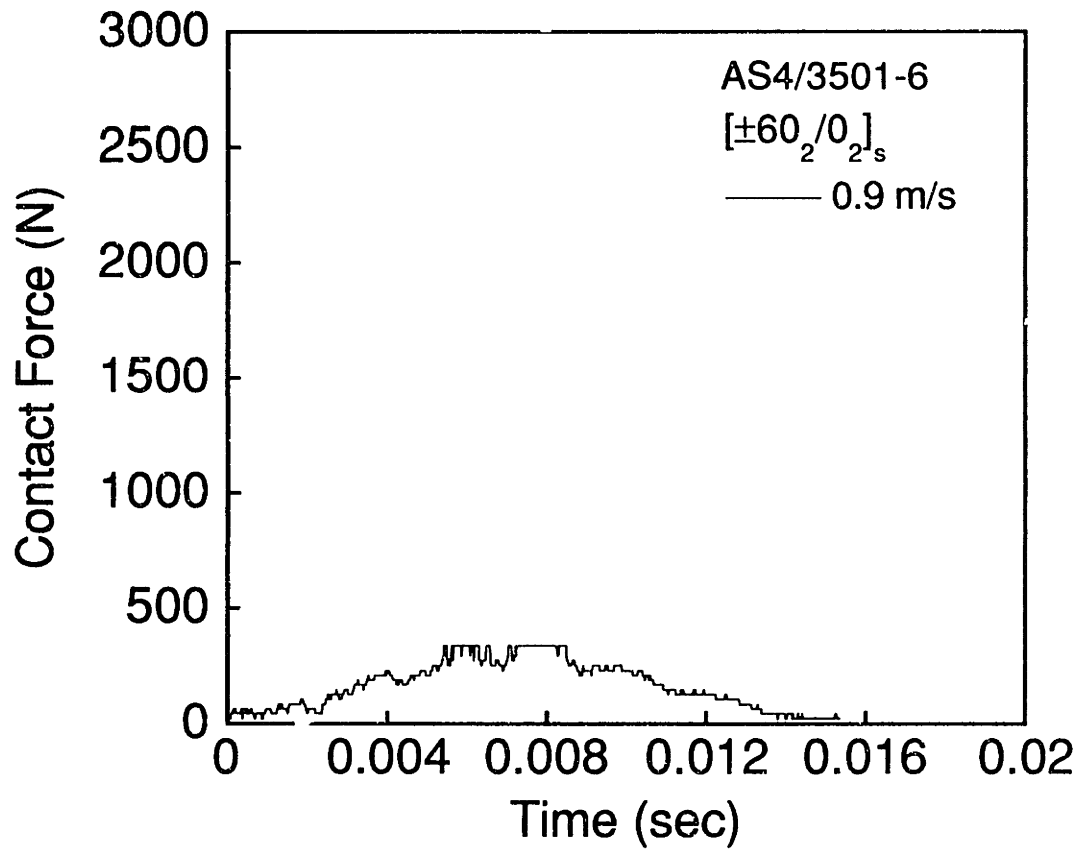
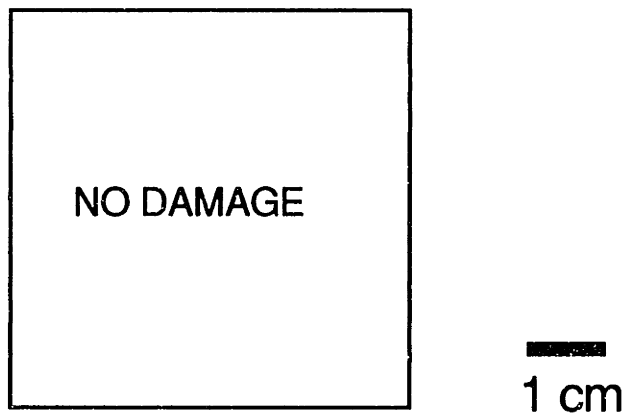
Figure A.25 (upper) Force versus time and (lower) X-ray photograph for AS4/3501-6 [±60₂/0₂]_s specimen impacted at 0.9 m/s.

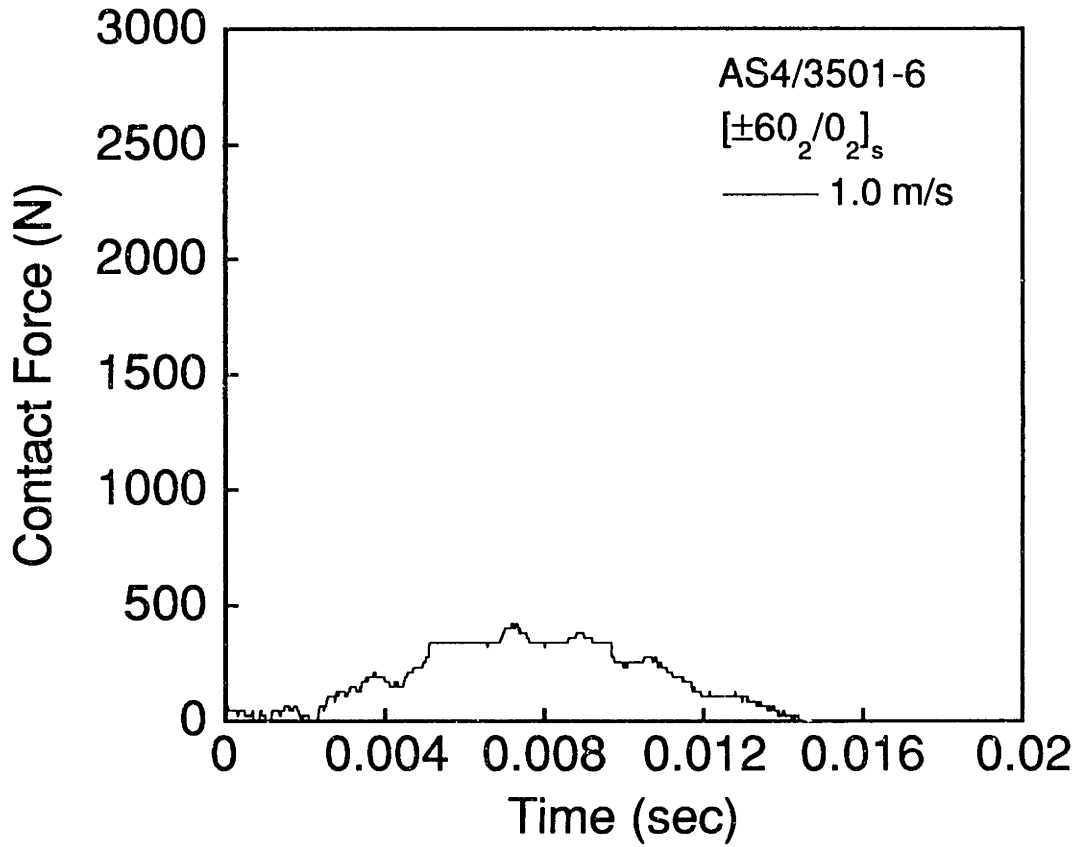
Figure A.26 (upper) Force versus time and (lower) X-ray photograph for AS4/3501-6 [±60₂/0₂]_s specimen impacted at 1.0 m/s.

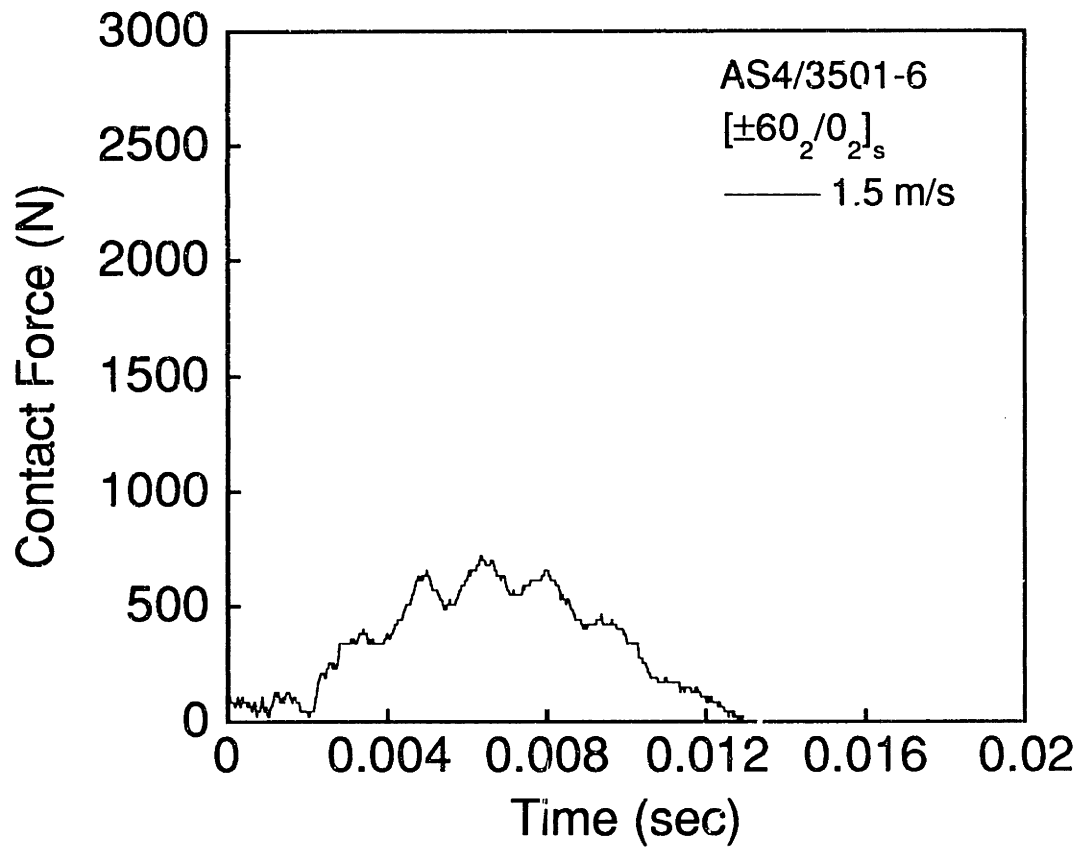
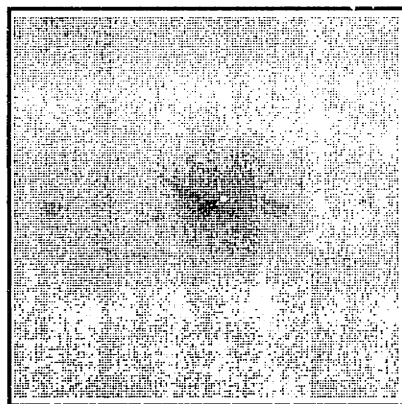
Figure A.27 (upper) Force versus time and (lower) X-ray photograph for AS4/3501-6 [±60₂/0₂]_s specimen impacted at 1.5 m/s.

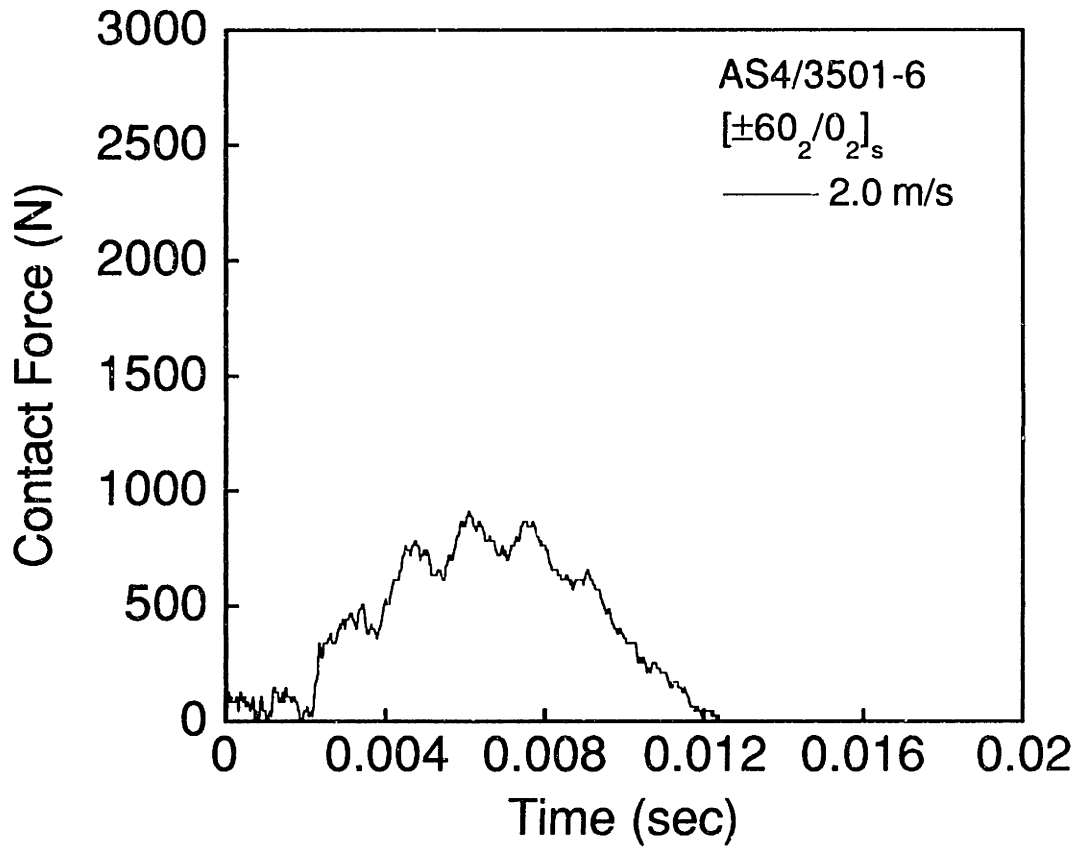
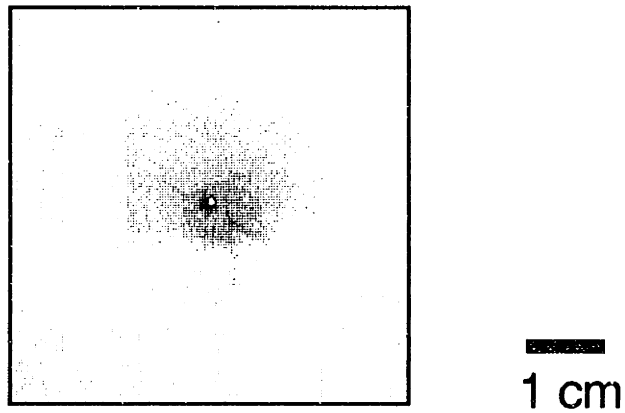
Figure A.28 (upper) Force versus time and (lower) X-ray photograph for AS4/3501-6 [±60₂/0₂]_s specimen impacted at 2.0 m/s.

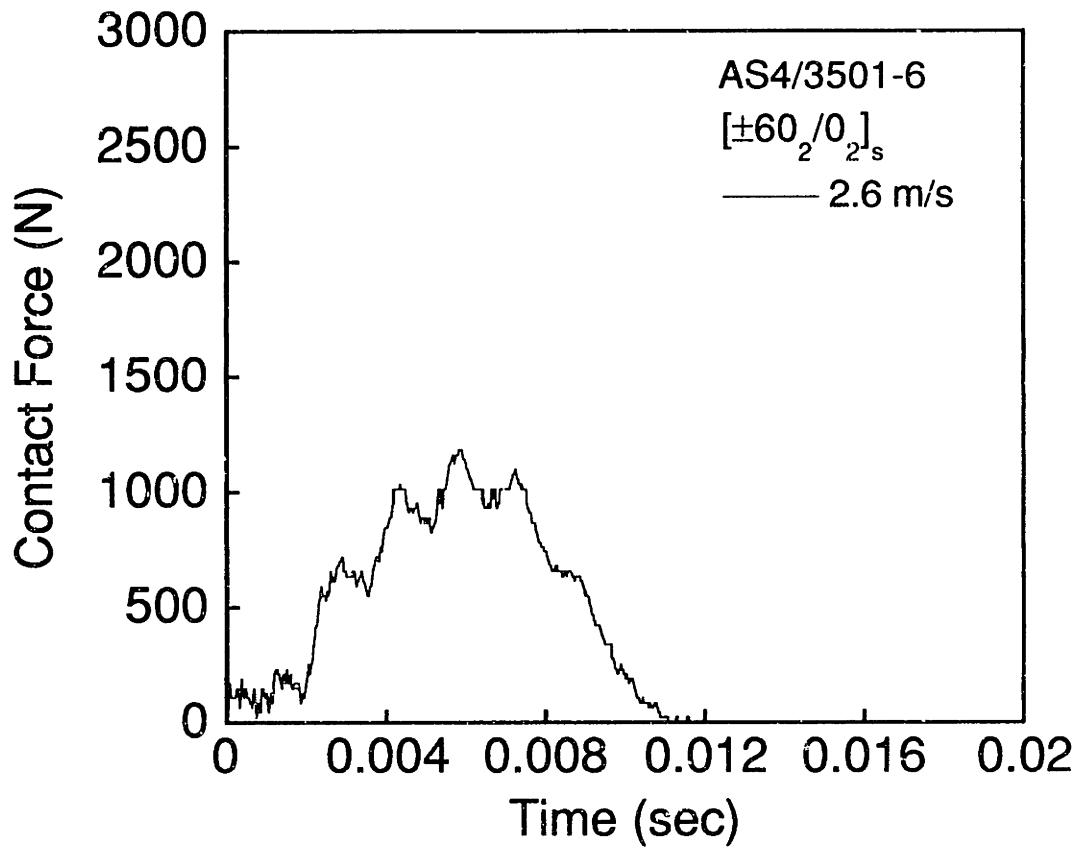
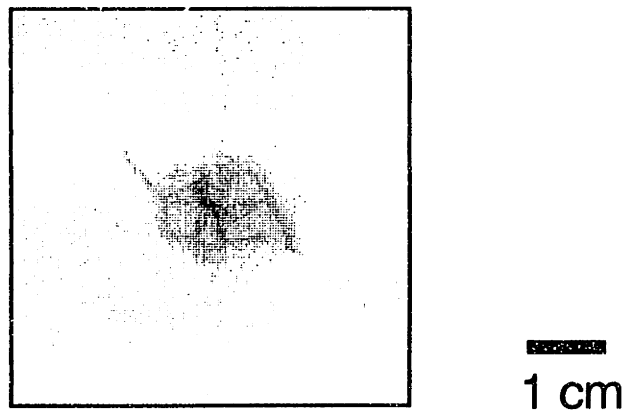
Figure A.29 (upper) Force versus time and (lower) X-ray photograph for AS4/3501-6 [±60₂/0₂]_s specimen impacted at 2.6 m/s.

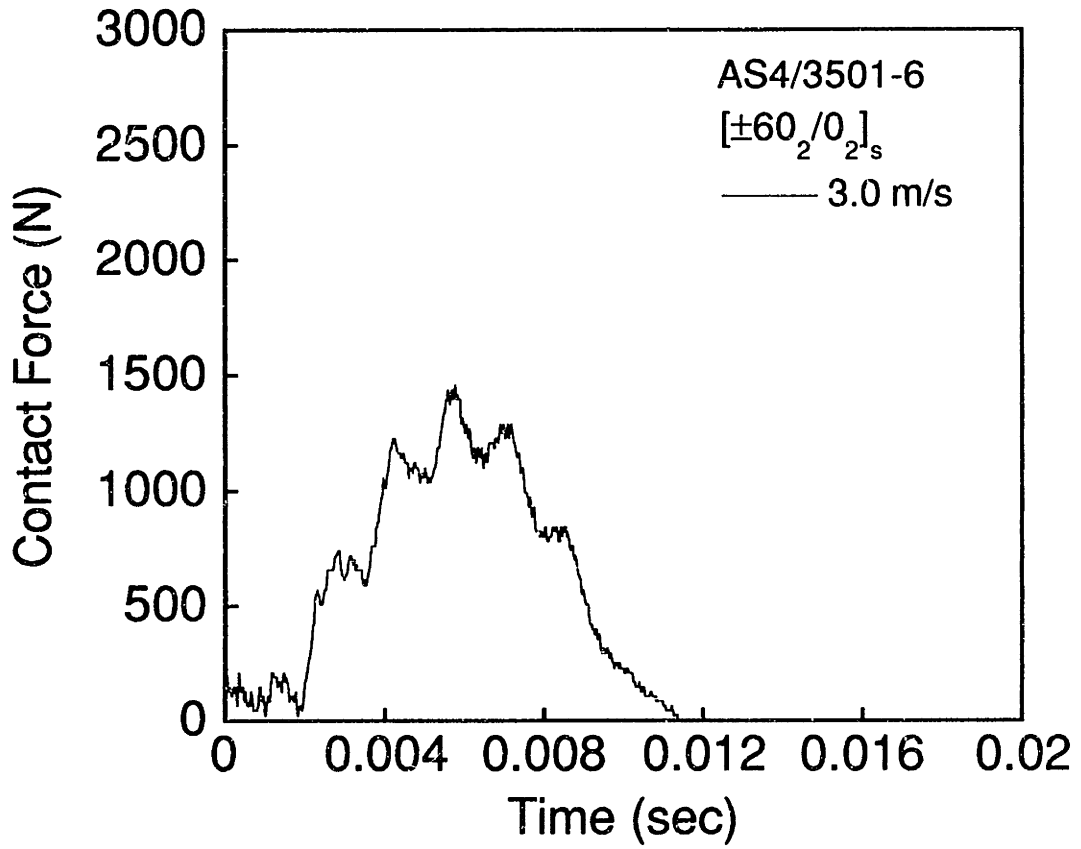
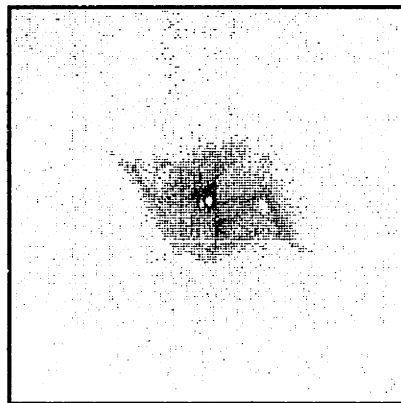
Figure A.30 (upper) Force versus time and (lower) X-ray photograph for AS4/3501-6 [±60₂/0₂]_s specimen impacted at 3.0 m/s.

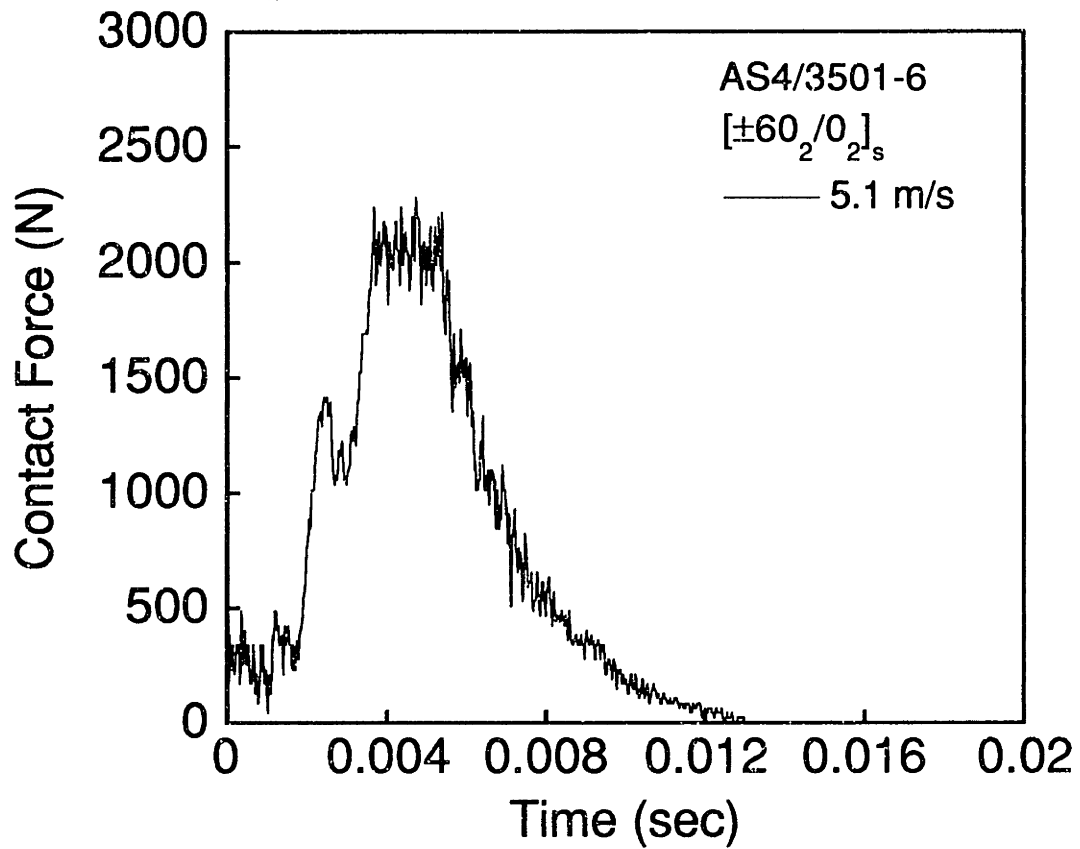
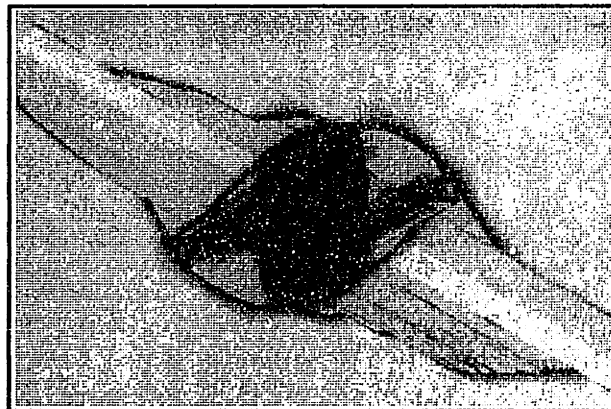
Figure A.31 (upper) Force versus time and (lower) X-ray photograph for AS4/3501-6 [±60₂/0₂]_s specimen impacted at 5.1 m/s.

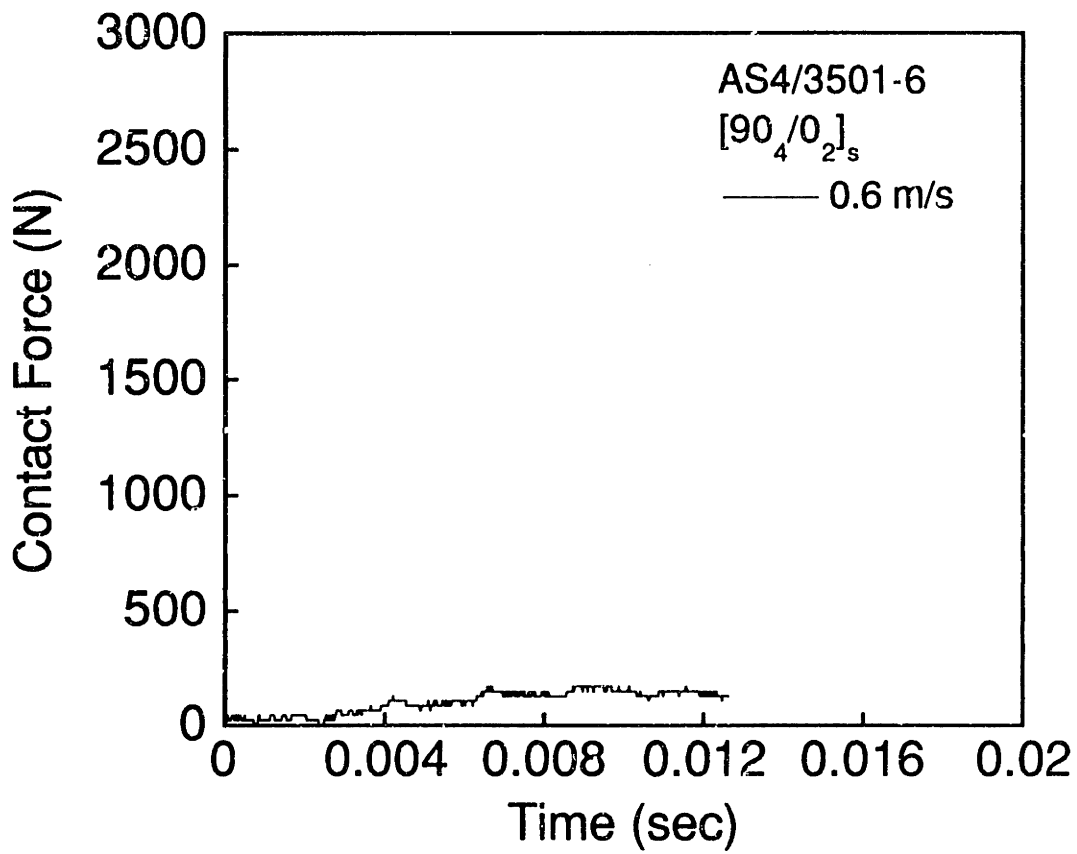
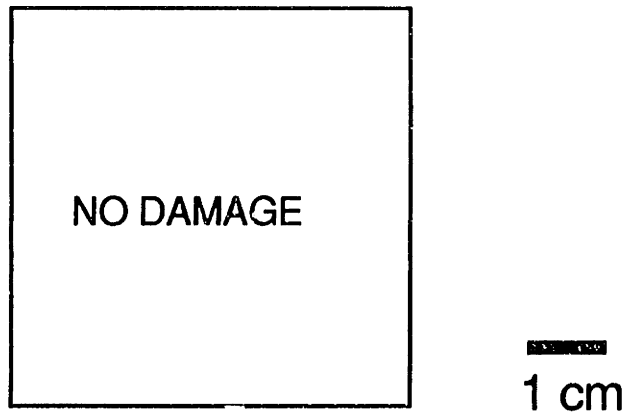
Figure A.32 (upper) Force versus time and (lower) X-ray photograph for AS4/3501-6 [90₄/0₂]_s specimen impacted at 0.6 m/s.

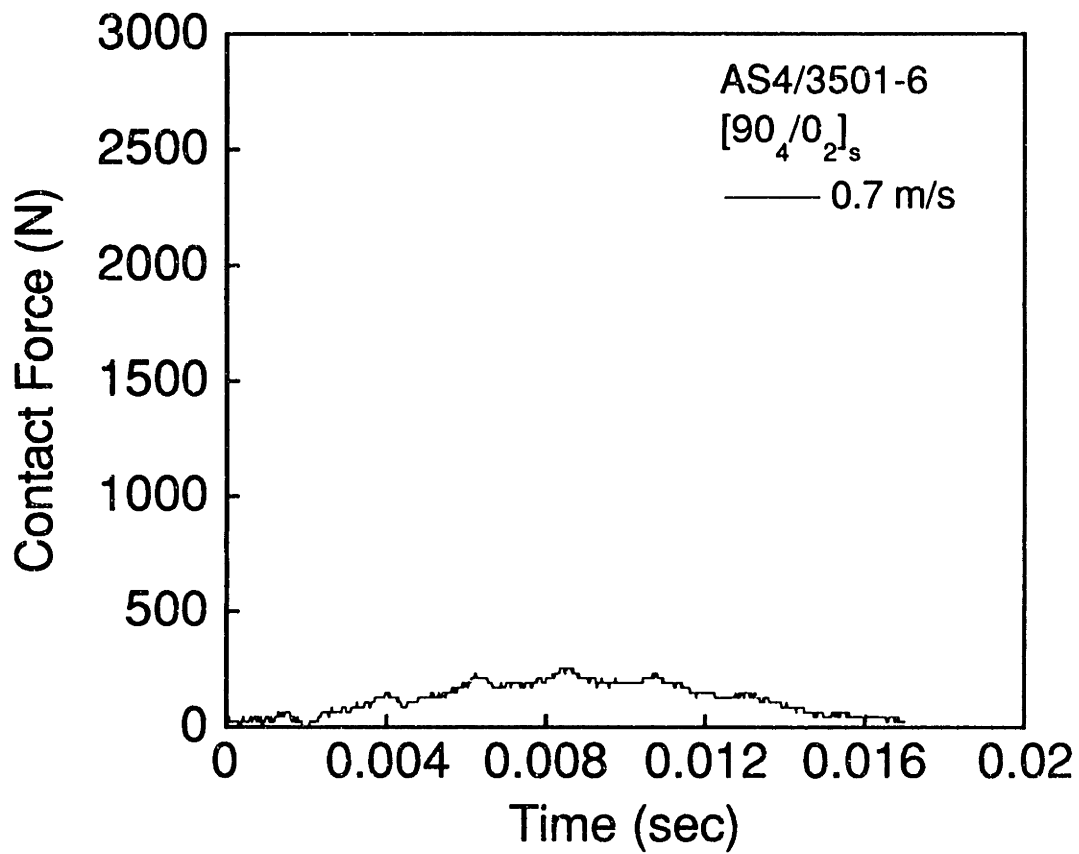
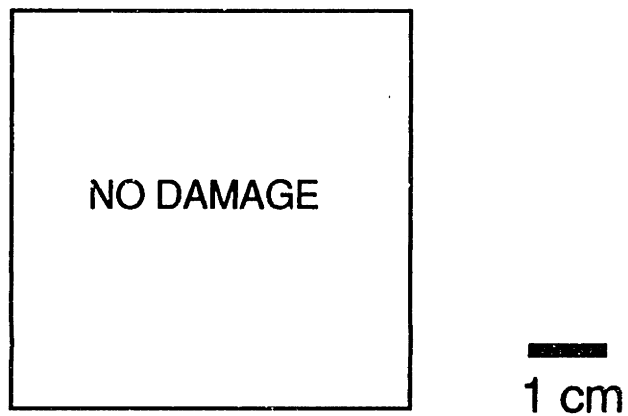
Figure A.33 (upper) Force versus time and (lower) X-ray photograph for AS4/3501-6 [90₄/0₂]_s specimen impacted at 0.7 m/s.

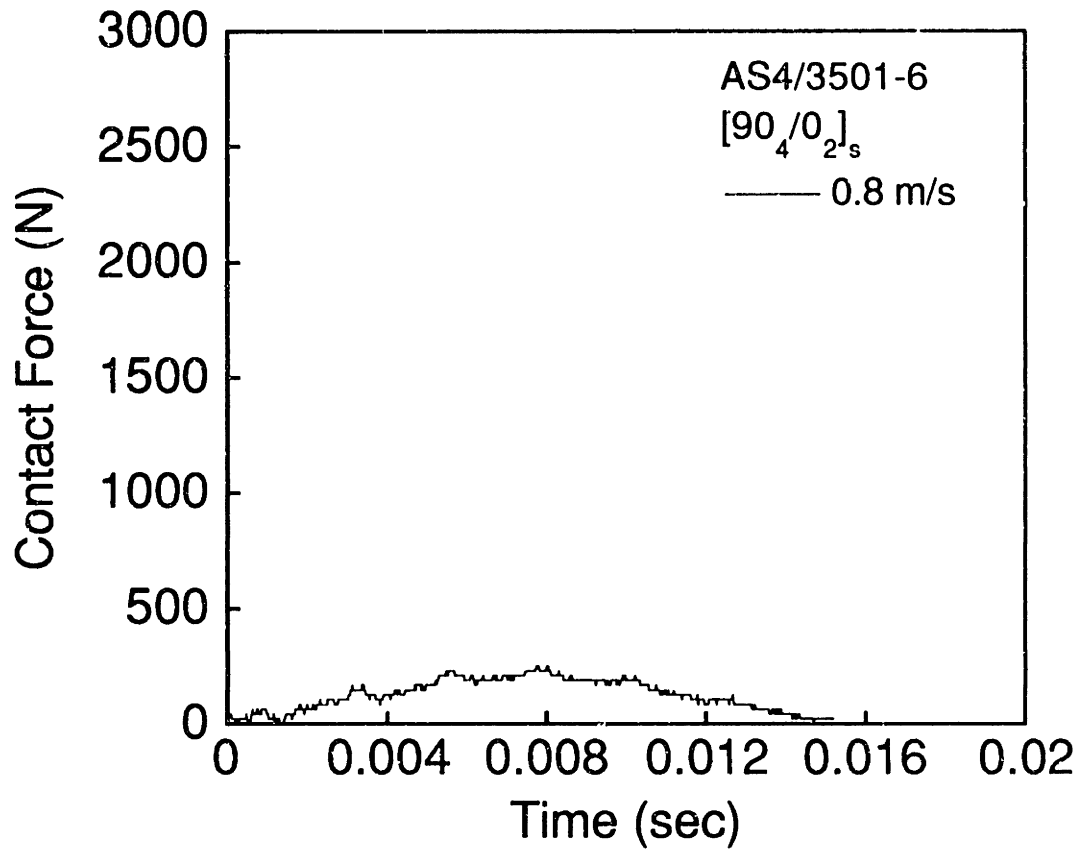
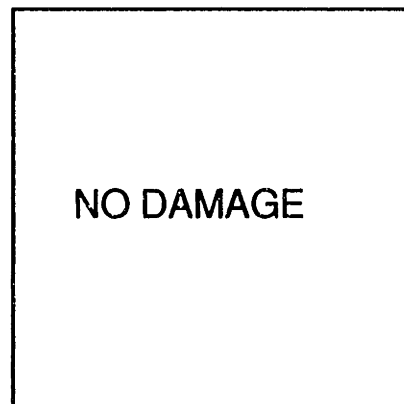
Figure A.34 (upper) Force versus time and (lower) X-ray photograph for AS4/3501-6 [90₄/0₂]_s specimen impacted at 0.8 m/s.

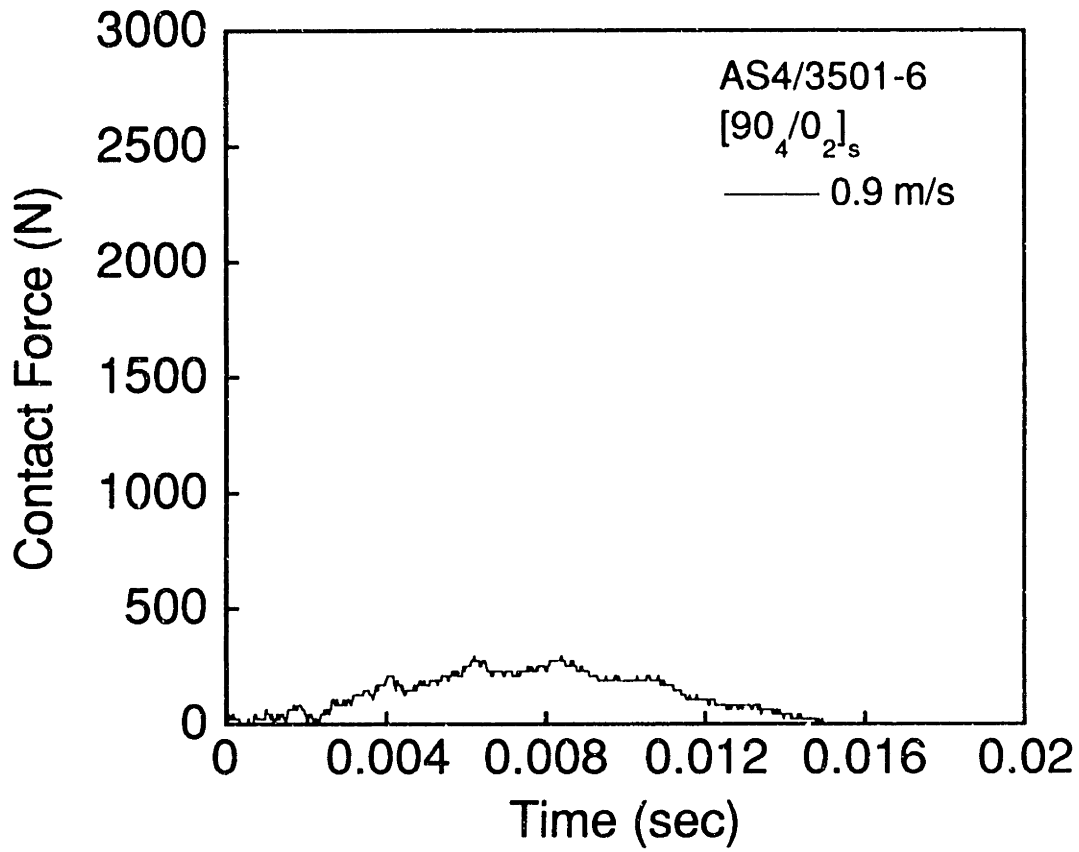
Figure A.35 (upper) Force versus time and (lower) X-ray photograph for AS4/3501-6 [90₄/0₂]_s specimen impacted at 0.9 m/s.

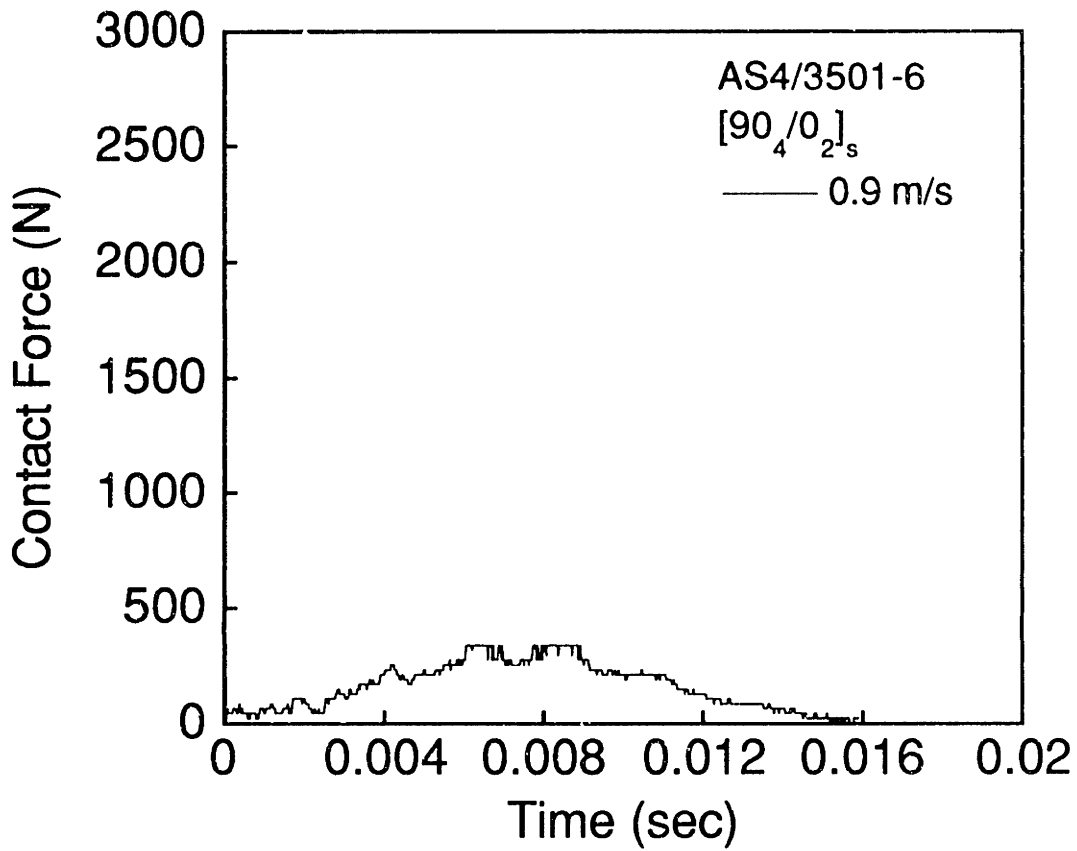
Figure A.36 (upper) Force versus time and (lower) X-ray photograph for AS4/3501-6 [90₄/0₂]_s specimen impacted at 0.9 m/s.

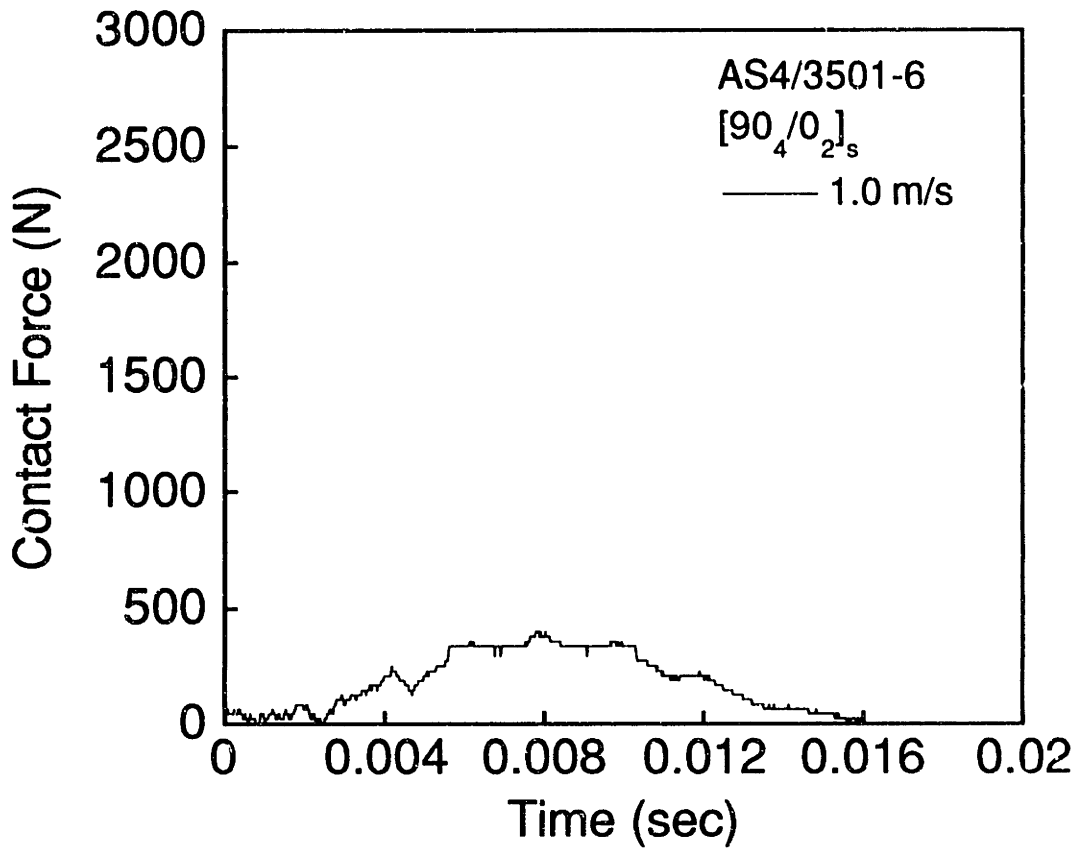
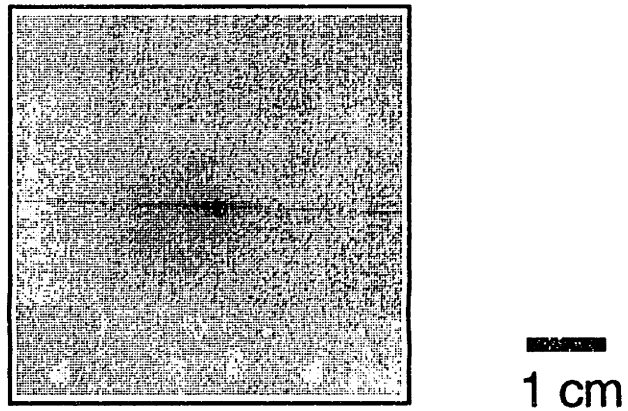
Figure A.37 (upper) Force versus time and (lower) X-ray photograph for AS4/3501-6 [90₄/0₂]_s specimen impacted at 1.0 m/s.

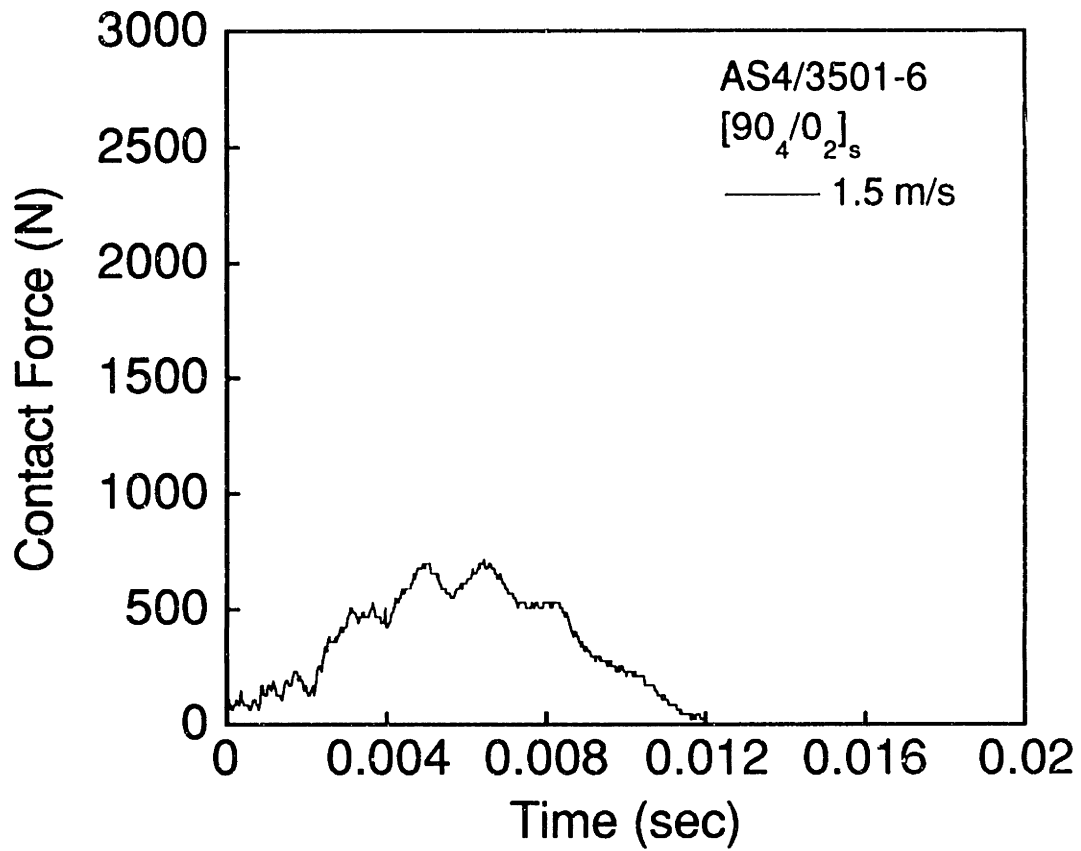
Figure A.38 (upper) Force versus time and (lower) X-ray photograph for AS4/3501-6 [90₄/0₂]_s specimen impacted at 1.5 m/s.

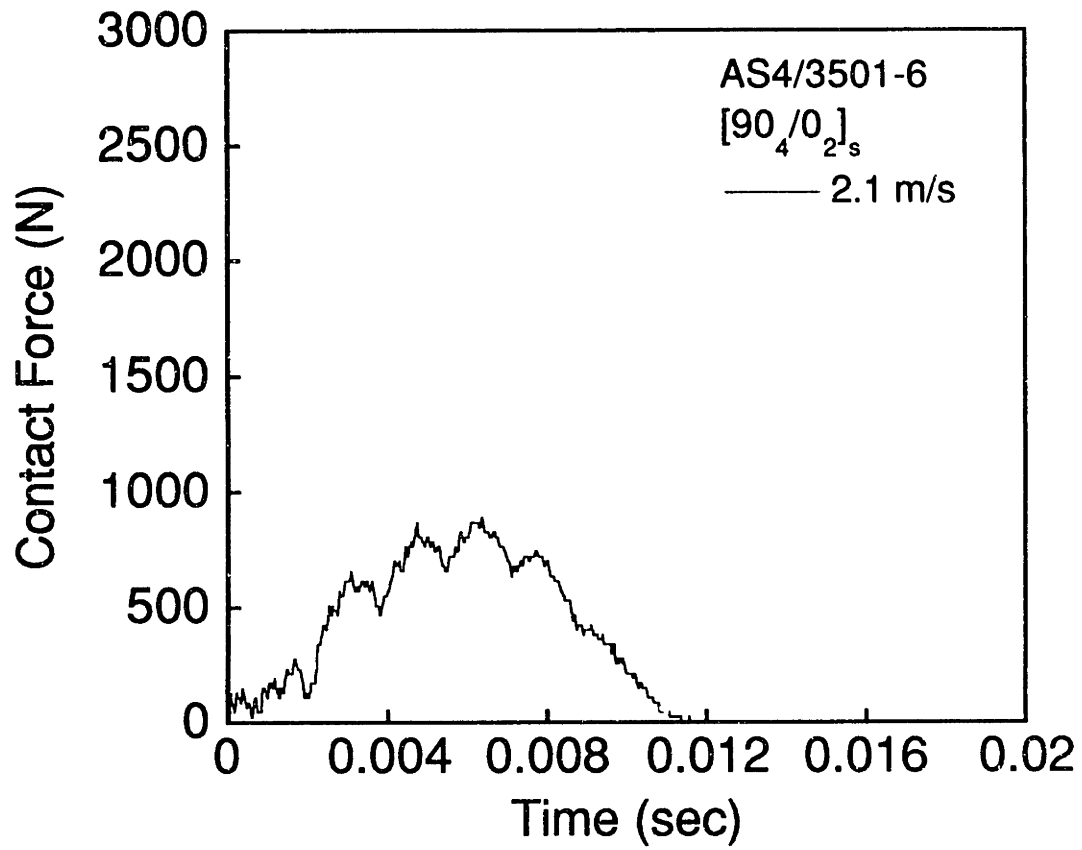
Figure A.39 (upper) Force versus time and (lower) X-ray photograph for AS4/3501-6 [90₄/0₂]_s specimen impacted at 2.1 m/s.

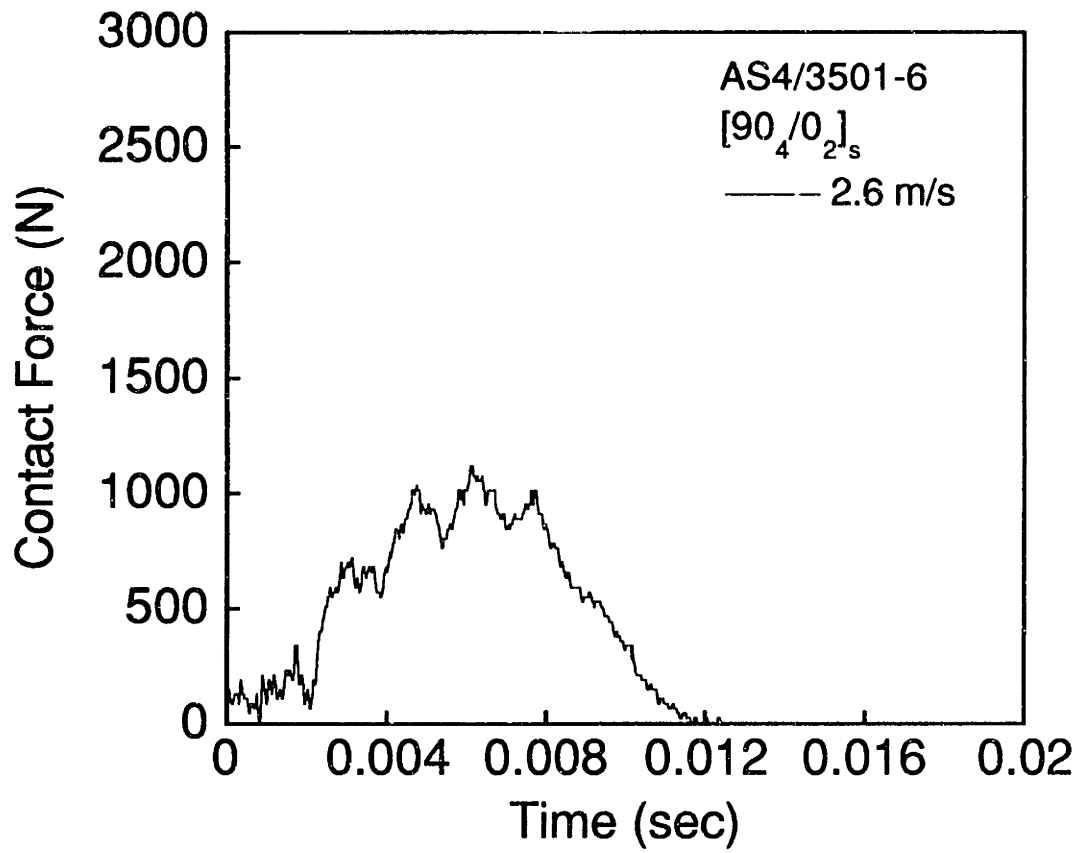
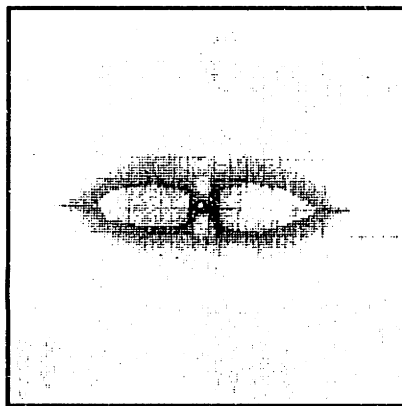
Figure A.40 (upper) Force versus time and (lower) X-ray photograph for AS4/3501-6 [90₄/0₂]_s specimen impacted at 2.6 m/s.

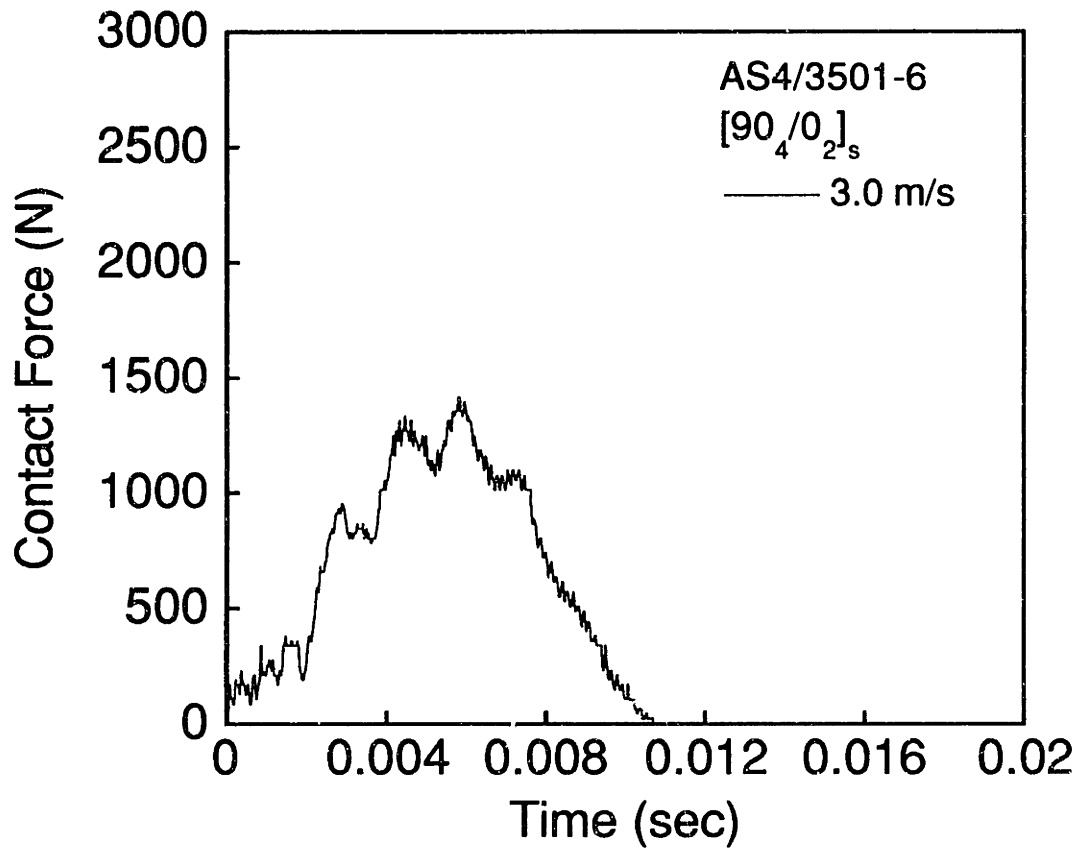
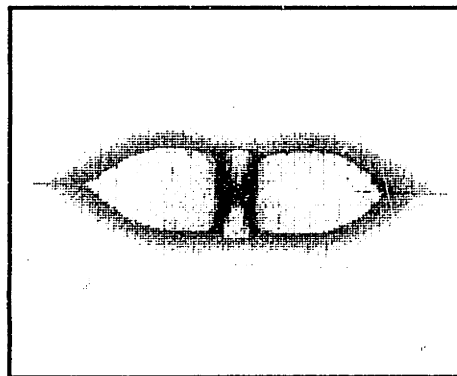
Figure A.41 (upper) Force versus time and (lower) X-ray photograph for AS4/3501-6 [90₄/0₂]_s specimen impacted at 3.0 m/s.

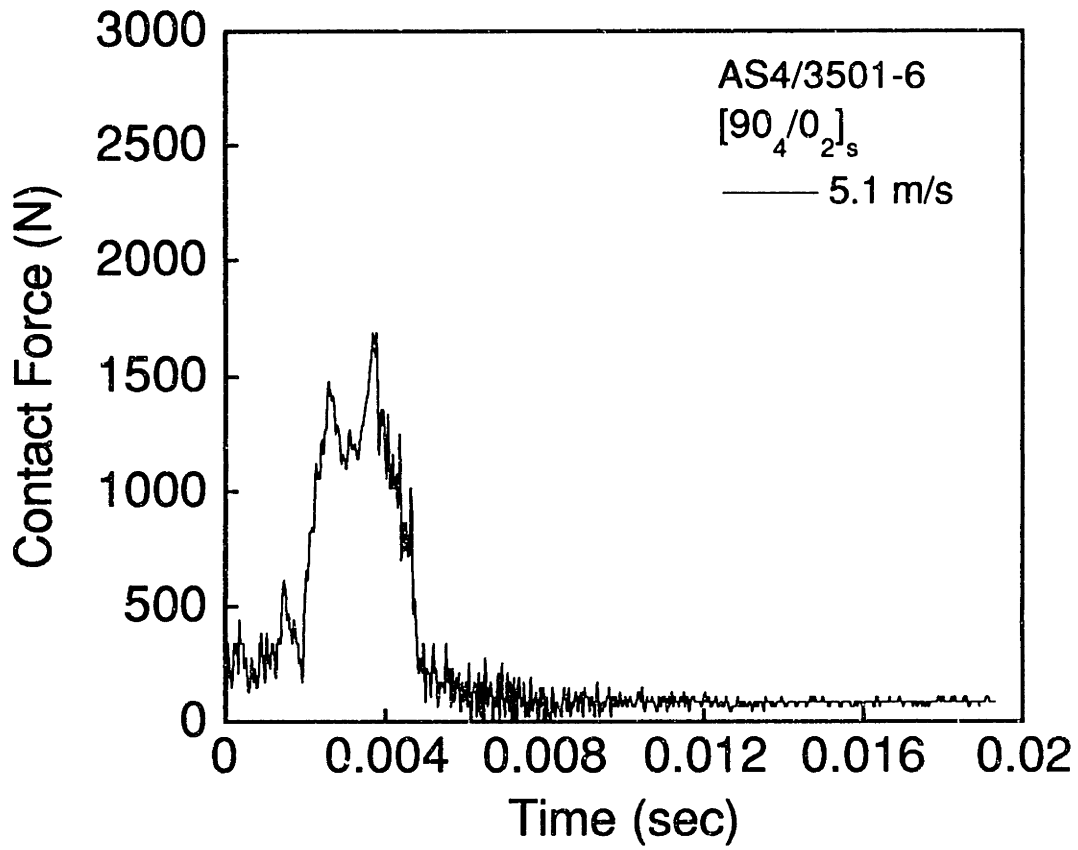
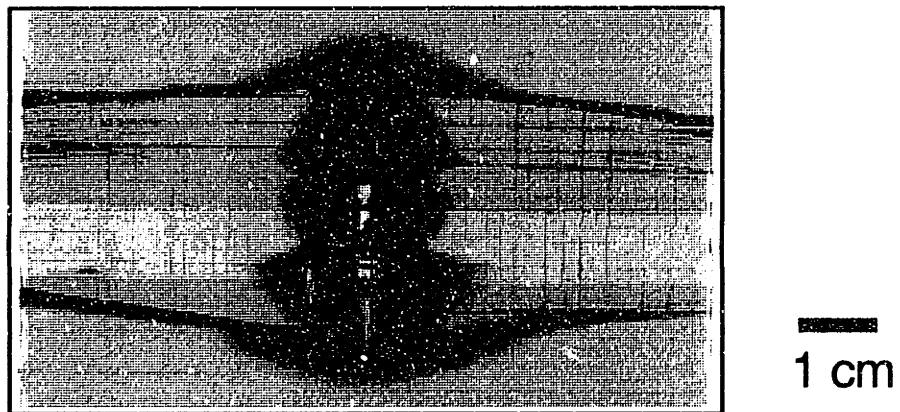
Figure A.42 (upper) Force versus time and (lower) X-ray photograph for AS4/3501-6 [90₄/0₂]_s specimen impacted at 5.1 m/s.

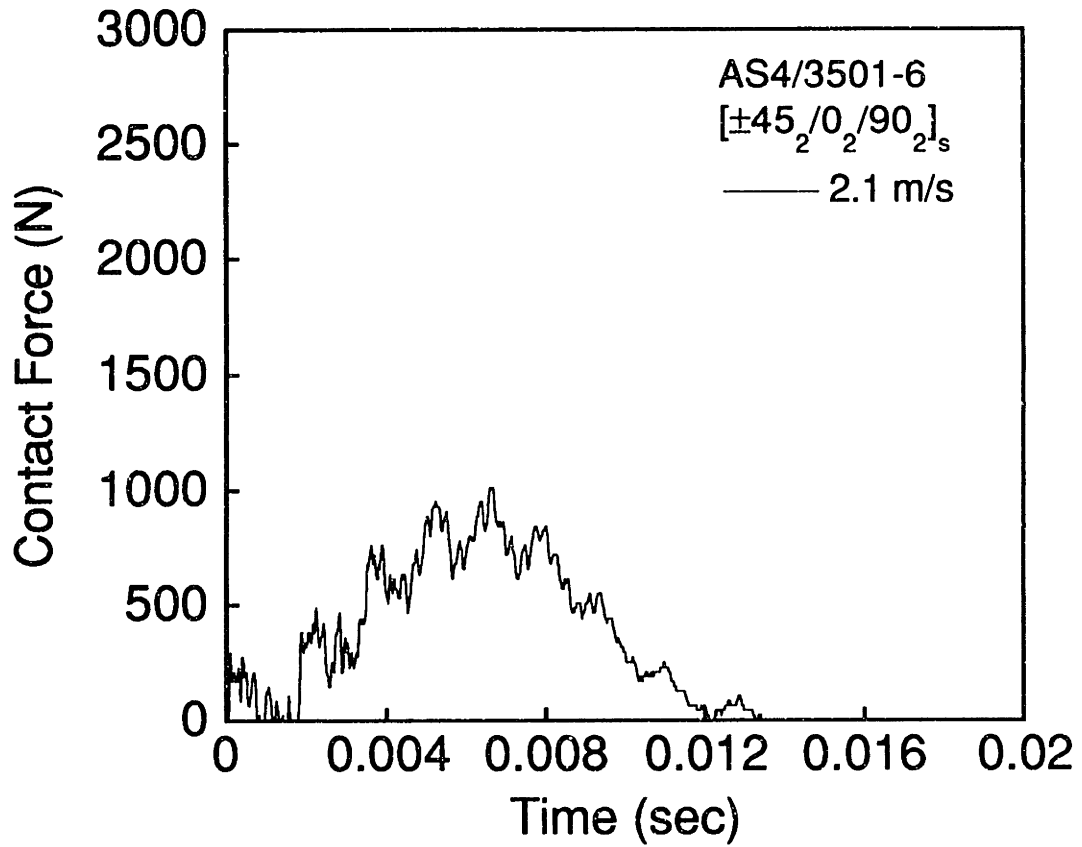
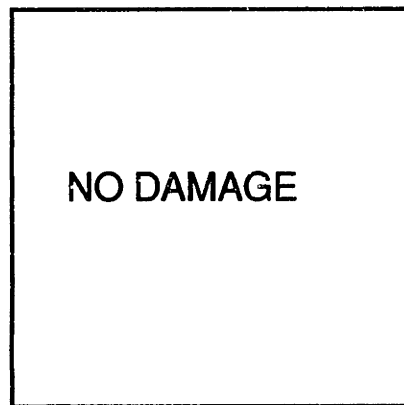
Figure A.43 (upper) Force versus time and (lower) X-ray photograph for AS4/3501-6 [±45₂/0₂/90₂]_s specimen impacted at 2.1 m/s.
