IMPACT DAMAGE MECHANISMS IN SEVERAL LAMINATED MATERIAL SYSTEMS

Submitted to the Department of Aeronautics and Astronautics in Partial
Fulfillment of the Requirements for the Degree of

MASTER OF SCIENCE

MASSACHUSETTS INSTITUTE OF TECHNOLOGY

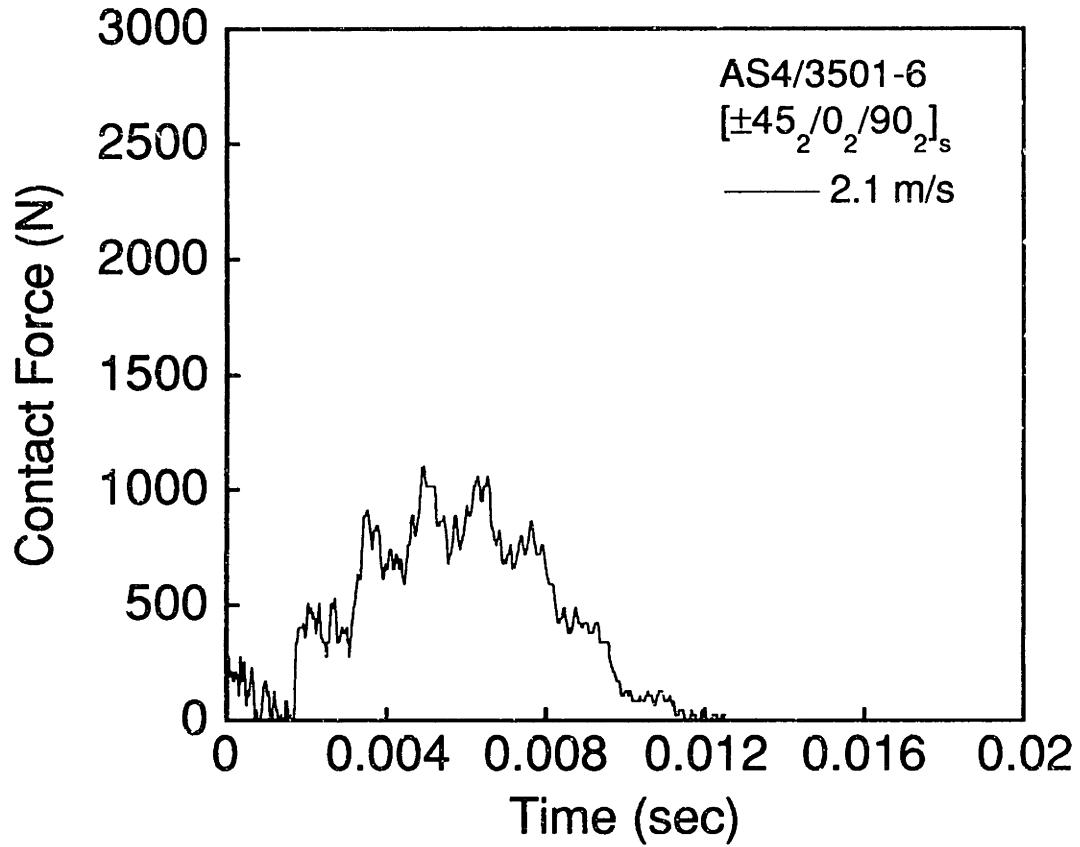
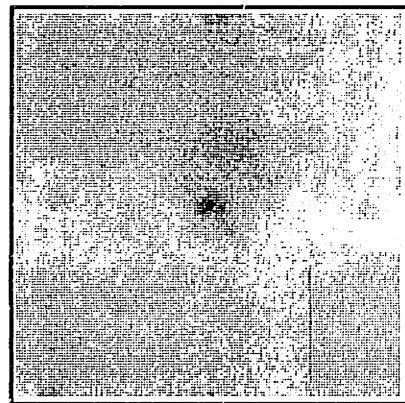
Figure A.44 (upper) Force versus time and (lower) X-ray photograph for AS4/3501-6 [±45₂/0₂/90₂]_s specimen impacted at 2.1 m/s.

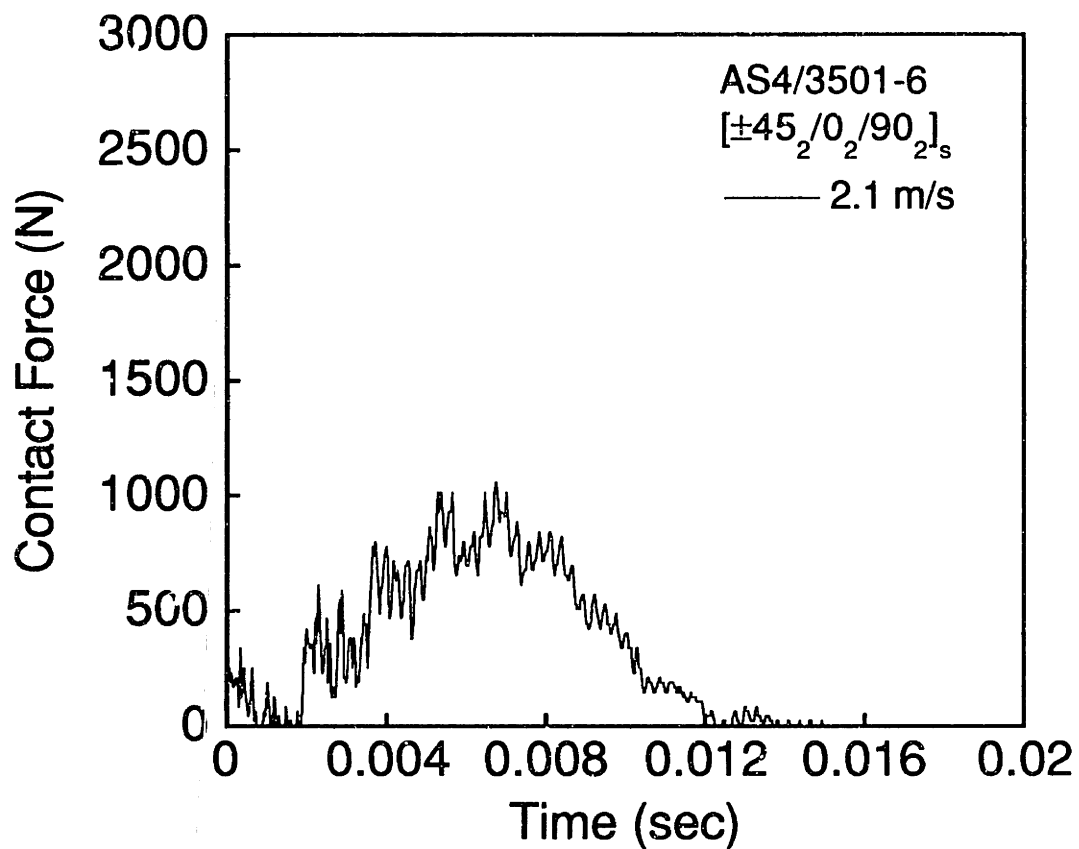
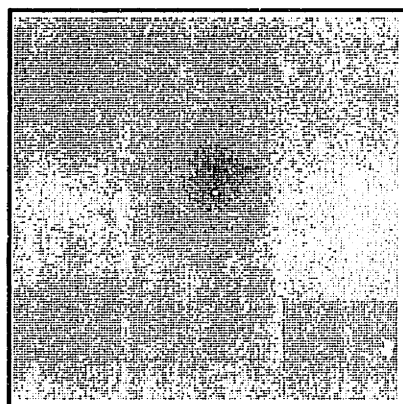
Figure A.45 (upper) Force versus time and (lower) X-ray photograph for AS4/3501-6 [±45₂/0₂/90₂]_s specimen impacted at 2.1 m/s.

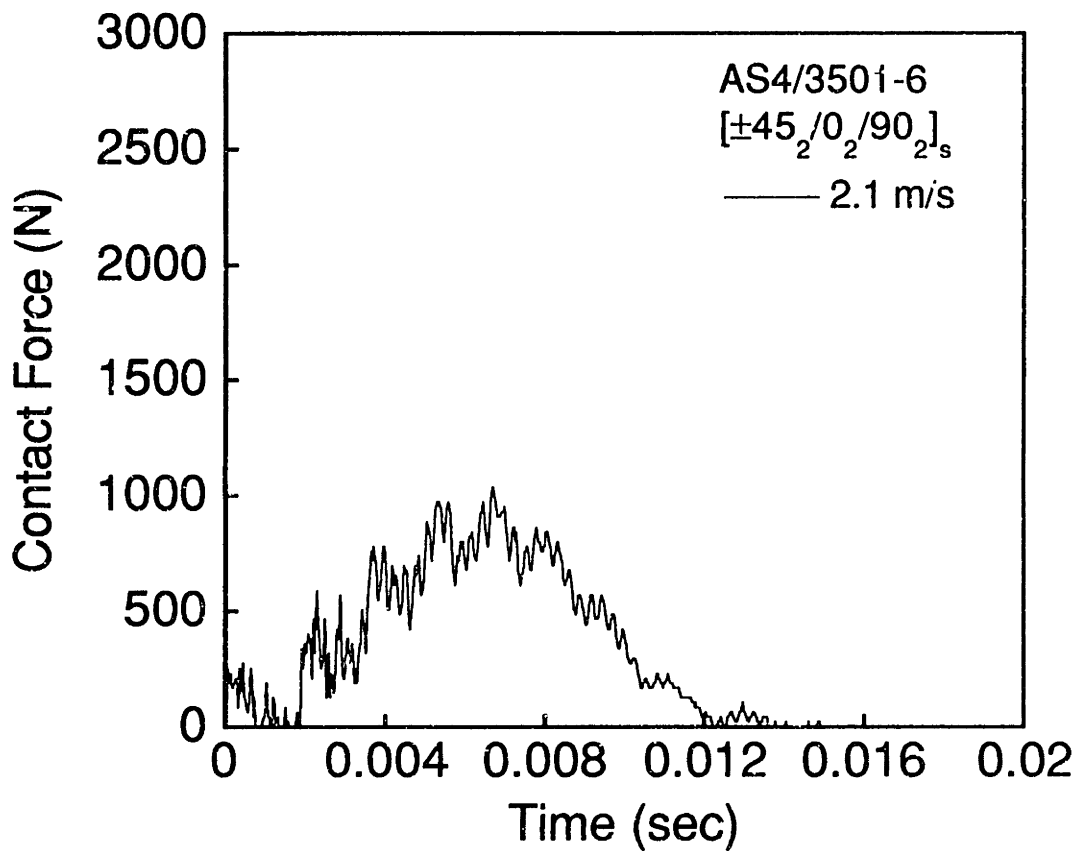
Figure A.46 (upper) Force versus time and (lower) X-ray photograph for AS4/3501-6 [±45₂/0₂/90₂]_s specimen impacted at 2.1 m/s.

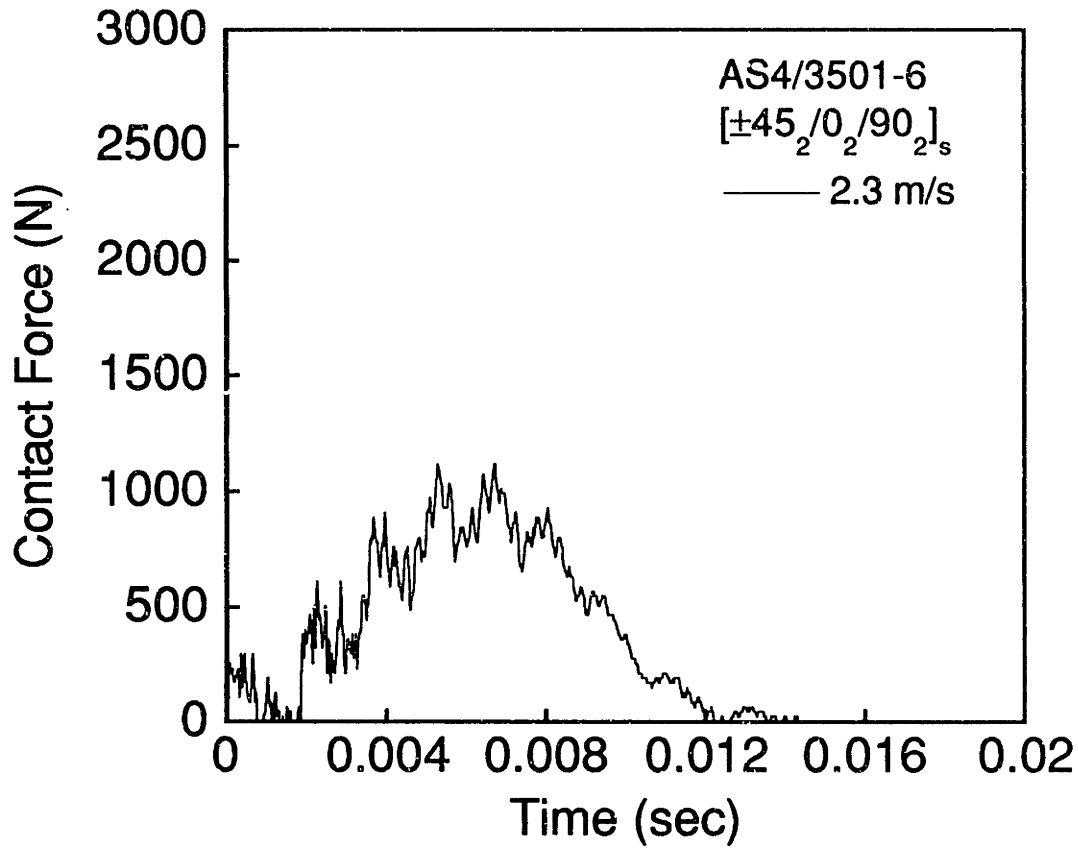
Figure A.47 (upper) Force versus time and (lower) X-ray photograph for AS4/3501-6 [±45₂/0₂/90₂]_s specimen impacted at 2.3 m/s.

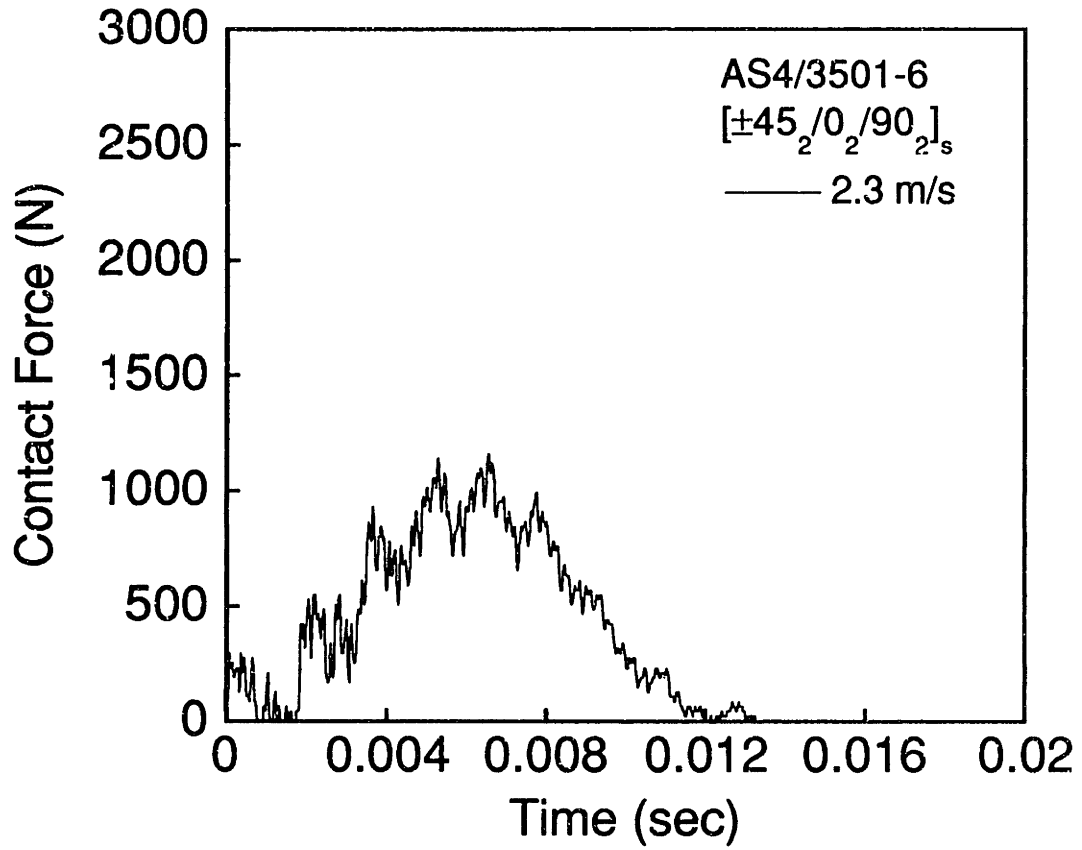
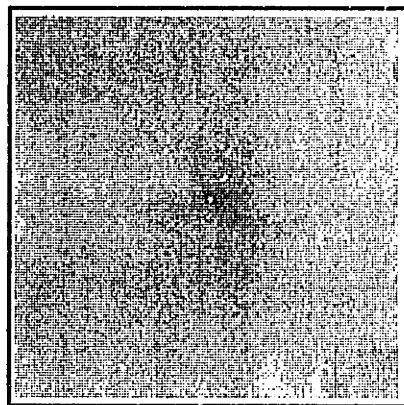
Figure A.48 (upper) Force versus time and (lower) X-ray photograph for AS4/3501-6 [±45₂/0₂/90₂]_s specimen impacted at 2.3 m/s.

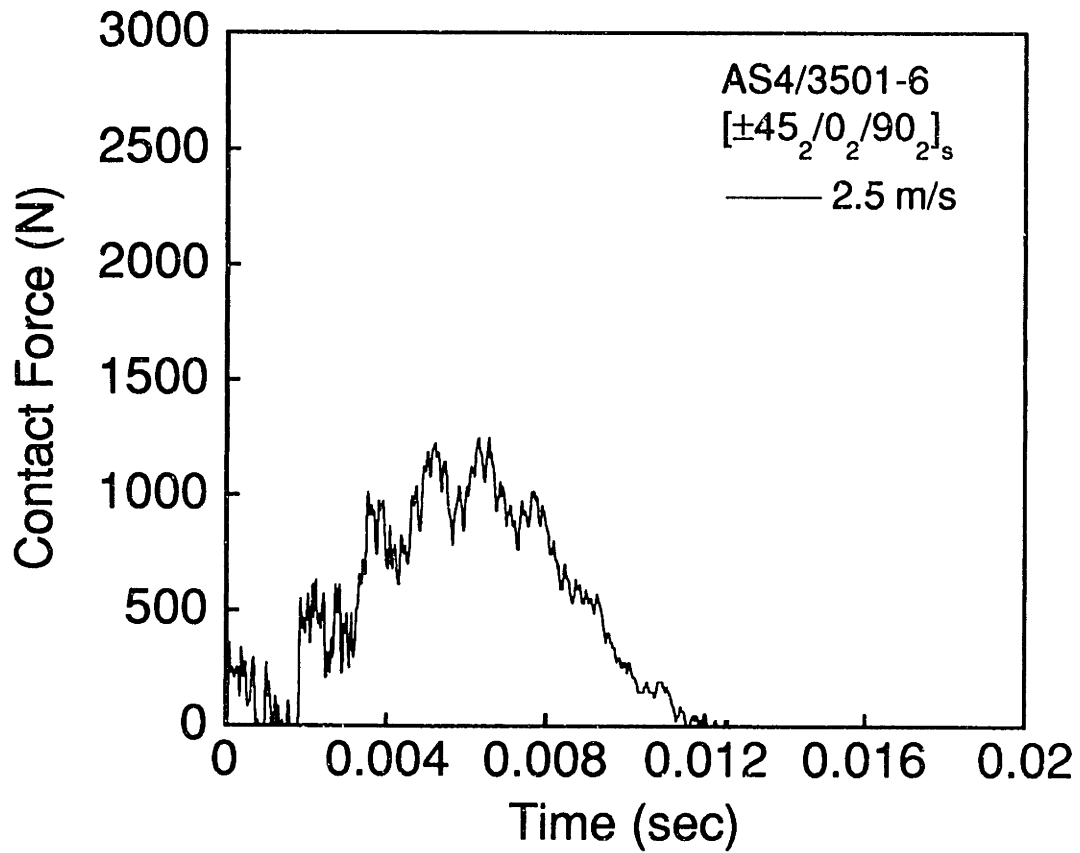
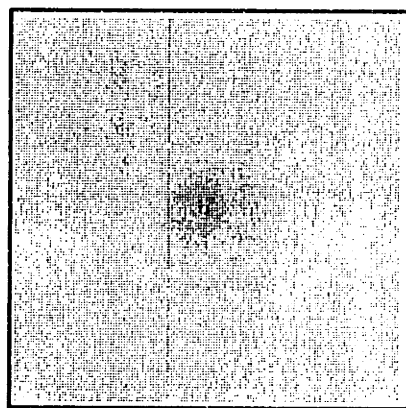
Figure A.49 (upper) Force versus time and (lower) X-ray photograph for AS4/3501-6 [±45₂/0₂/90₂]_s specimen impacted at 2.5 m/s.

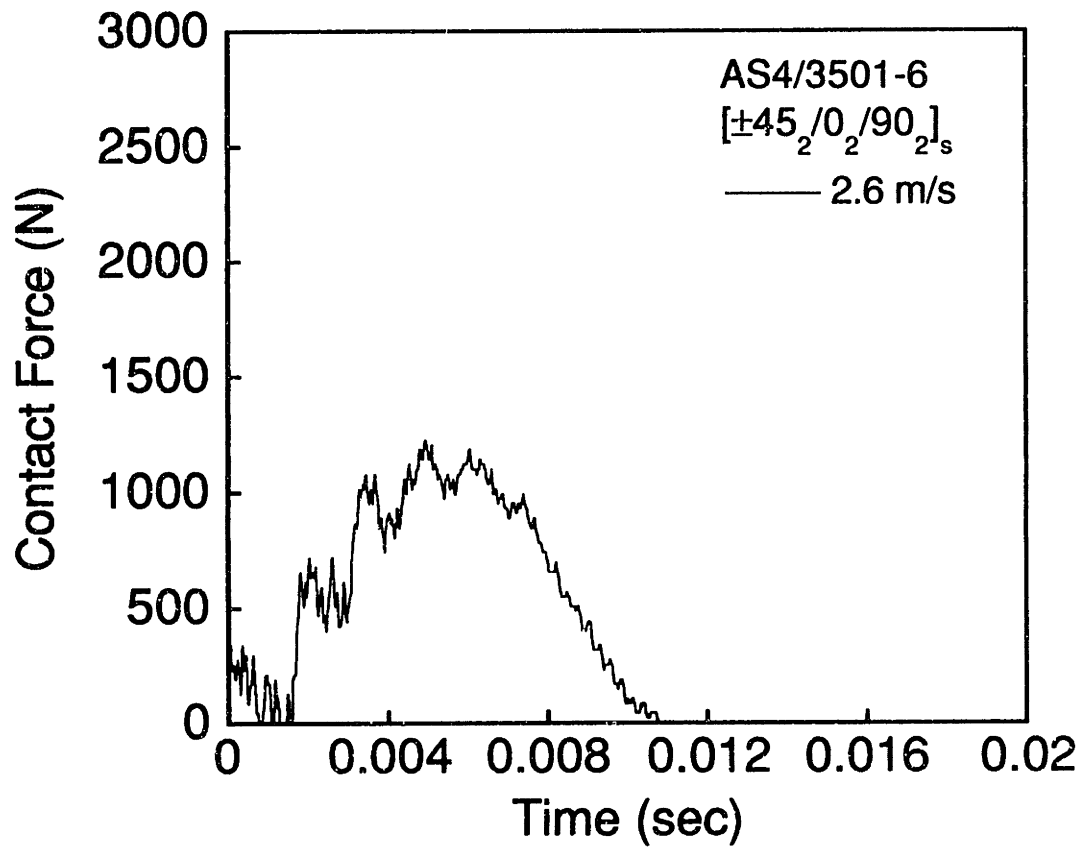
Figure A.50 (upper) Force versus time and (lower) X-ray photograph for AS4/3501-6 [±45₂/0₂/90₂]_s specimen impacted at 2.6 m/s.

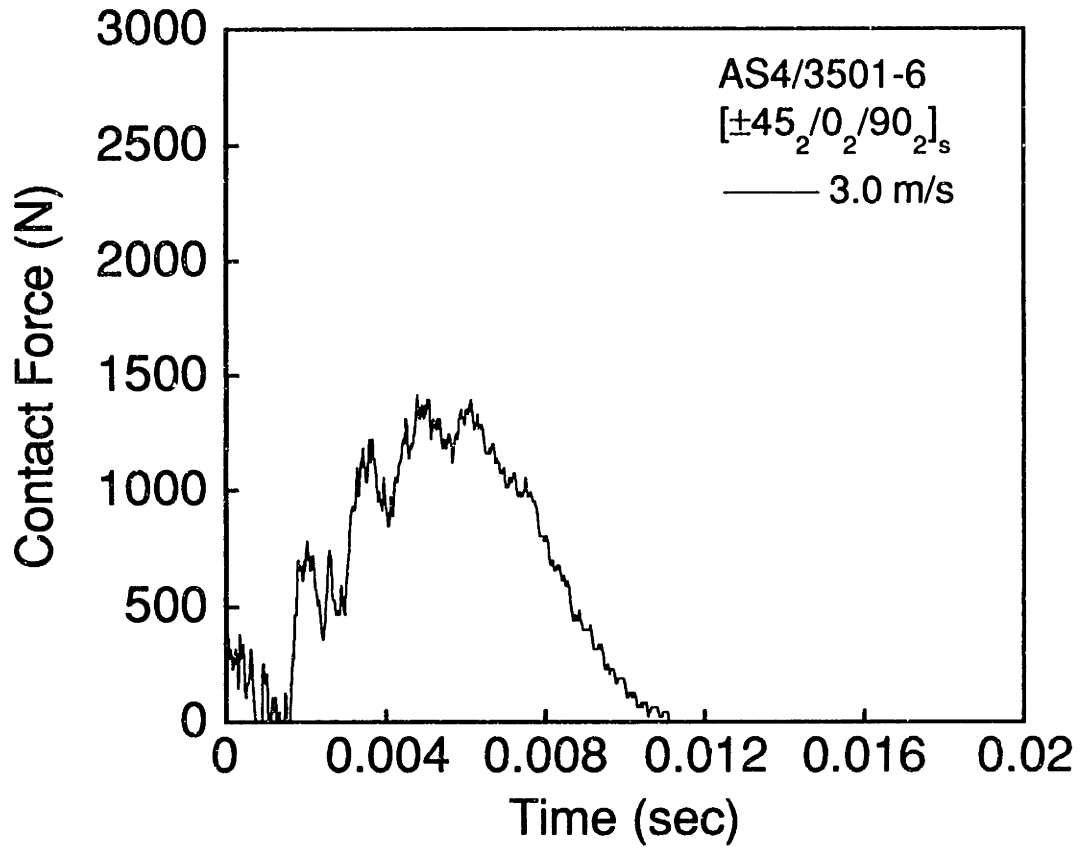
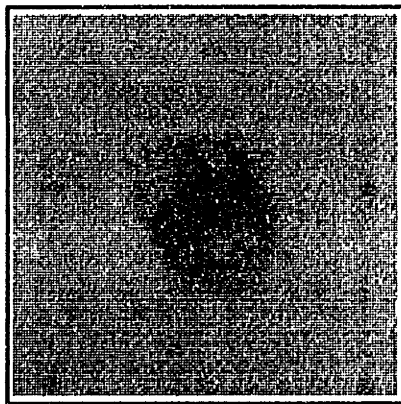
Figure A.51 (upper) Force versus time and (lower) X-ray photograph for AS4/3501-6 [±45₂/0₂/90₂]_s specimen impacted at 3.0 m/s.

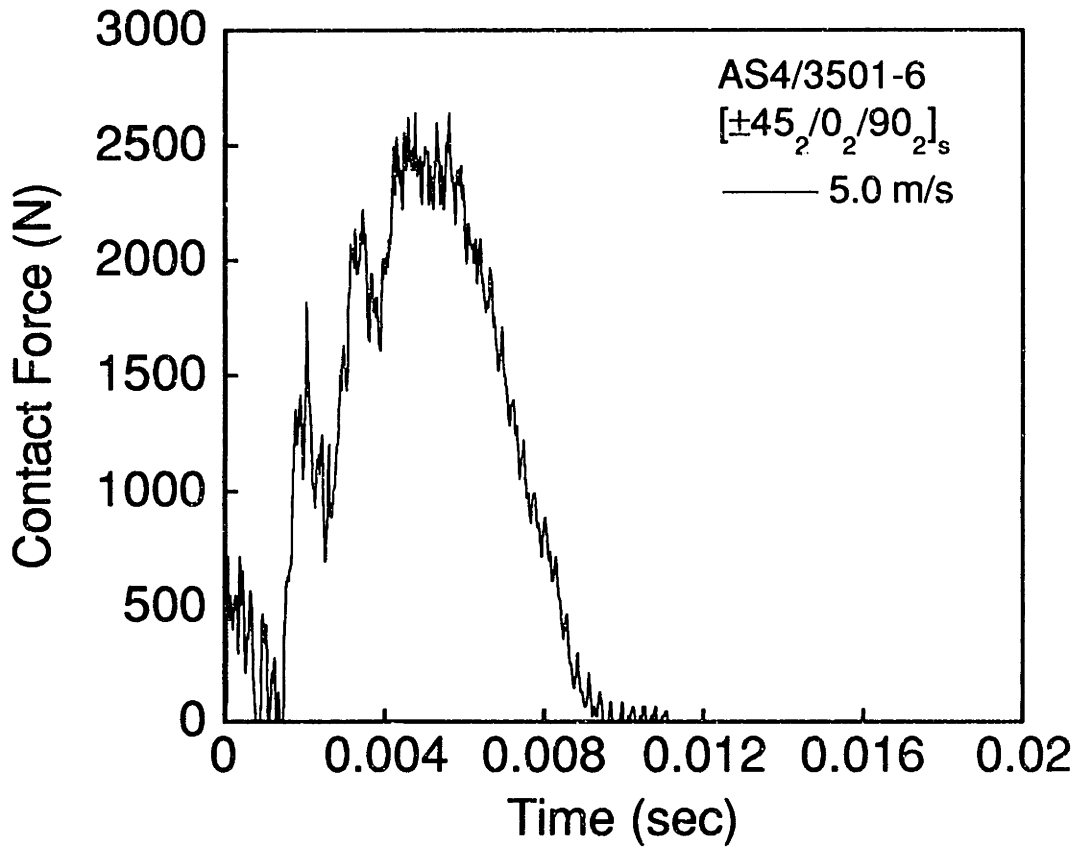
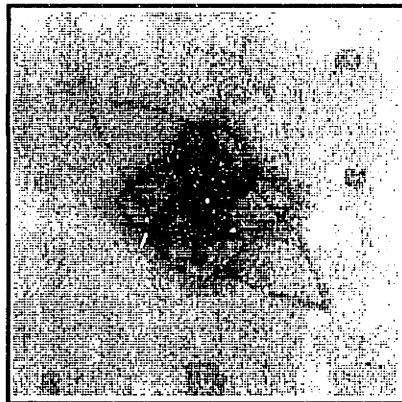
Figure A.52 (upper) Force versus time and (lower) X-ray photograph for AS4/3501-6 [±45₂/0₂/90₂]_s specimen impacted at 5.0 m/s.

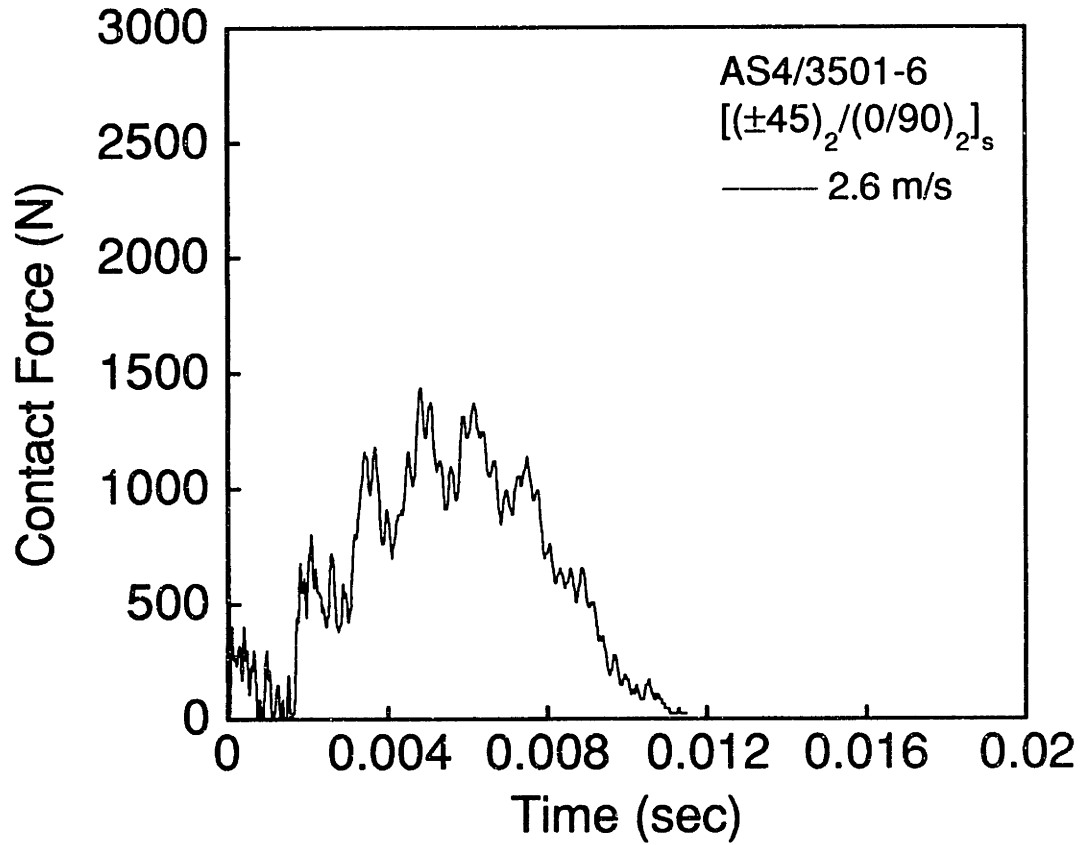
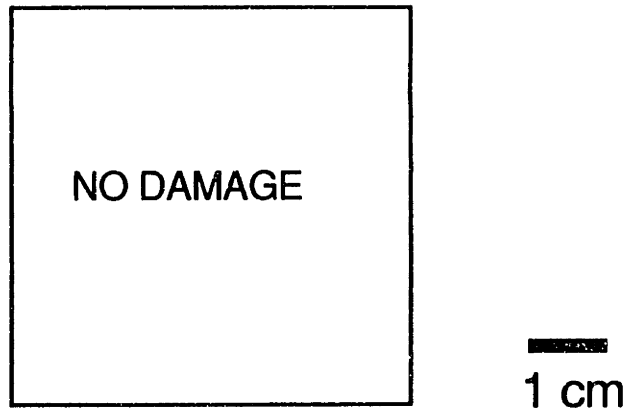
Figure A.53 (upper) Force versus time and (lower) X-ray photograph for AS4/3501-6 [(±45)₂/(0/90)₂]_s specimen impacted at 2.6 m/s.

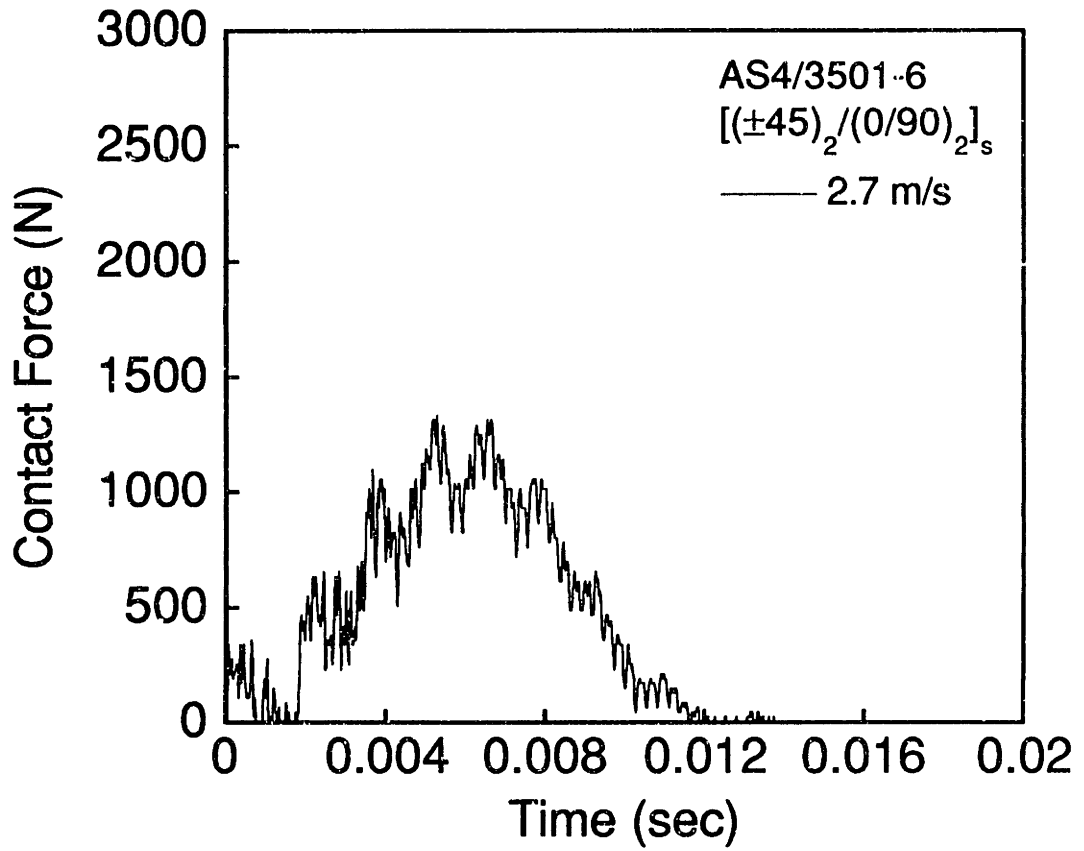
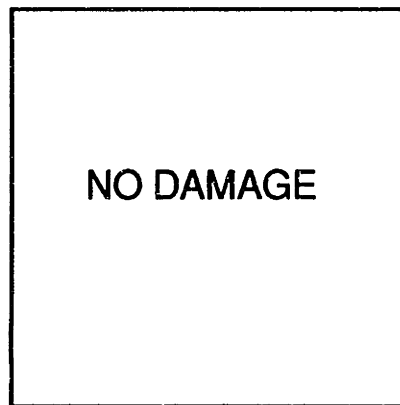
Figure A.54 (upper) Force versus time and (lower) X-ray photograph for AS4/3501-6 [(±45)₂/(0/90)₂]_s specimen impacted at 2.7 m/s.

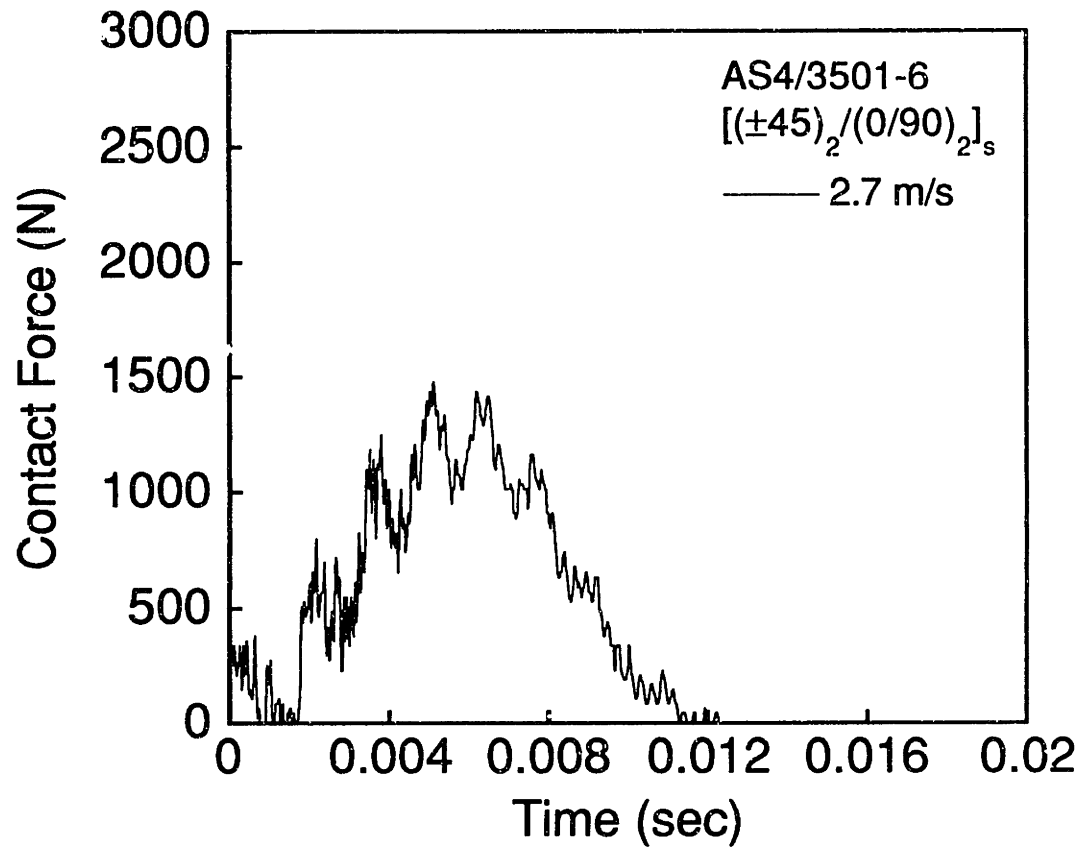
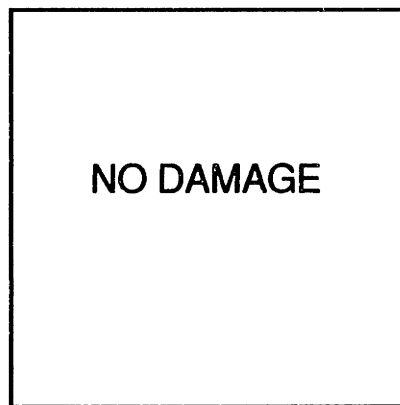
Figure A.55 (upper) Force versus time and (lower) X-ray photograph for AS4/3501-6 [(±45)₂/(0/90)₂]_s specimen impacted at 2.7 m/s.

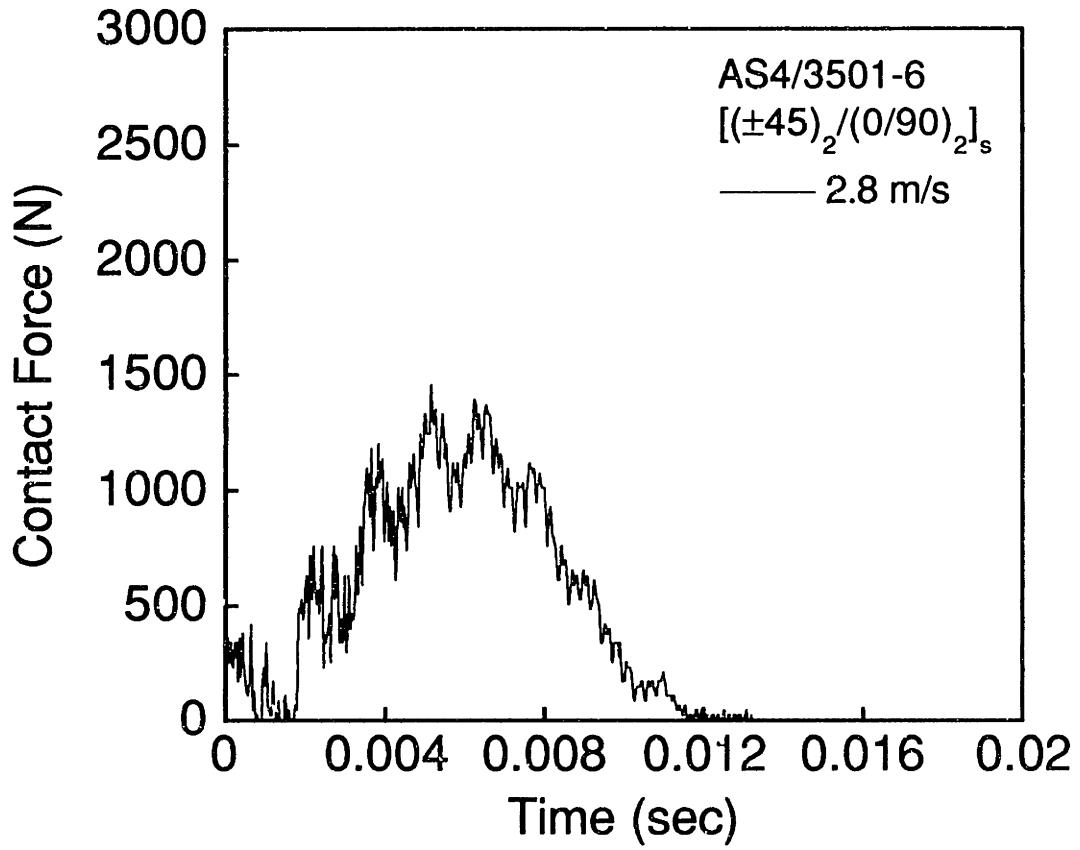
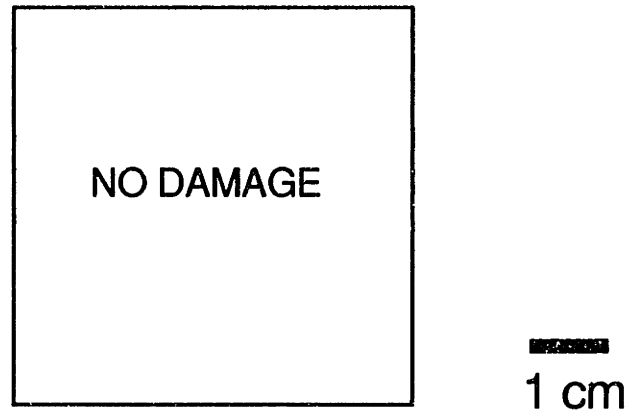
Figure A.56 (upper) Force versus time and (lower) X-ray photograph for AS4/3501-6 [(±45)₂/(0/90)₂]_s specimen impacted at 2.8 m/s.

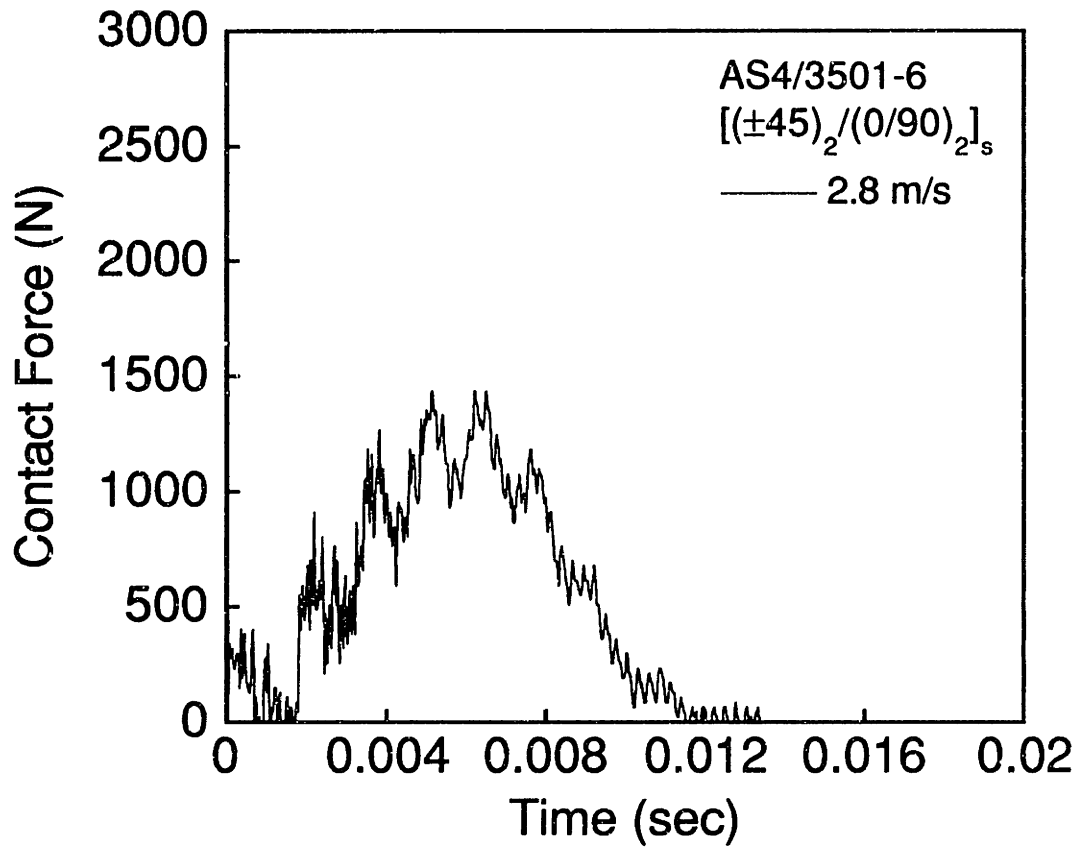
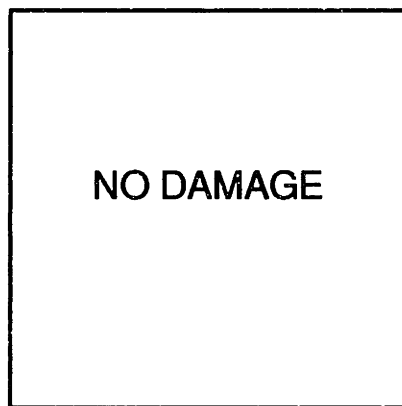
Figure A.57 (upper) Force versus time and (lower) X-ray photograph for AS4/3501-6 [(±45)₂/(0/90)₂]_s specimen impacted at 2.8 m/s.

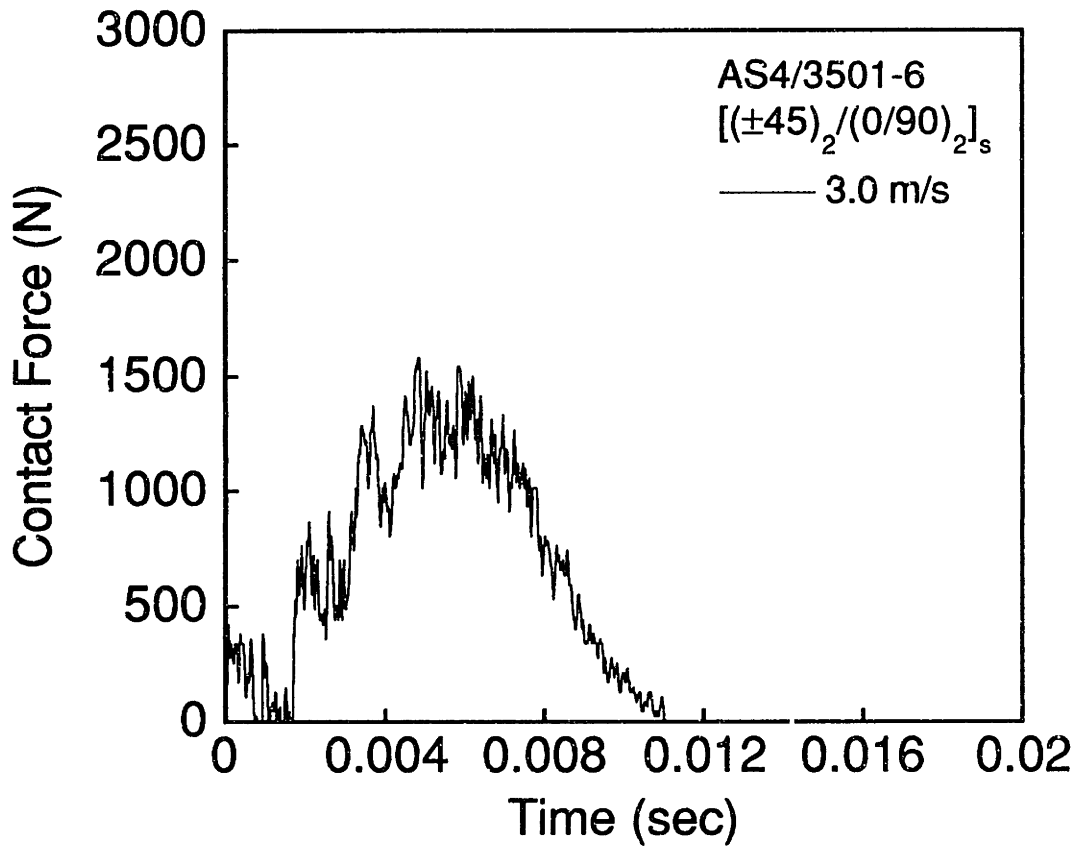
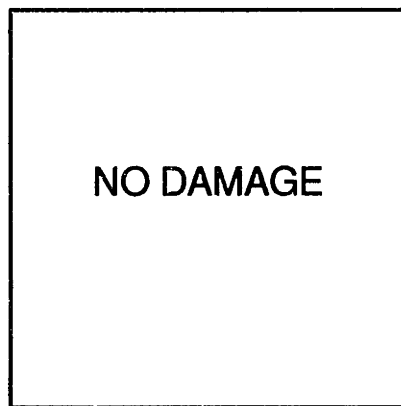
Figure A.58 (upper) Force versus time and (lower) X-ray photograph for AS4/3501-6 [(±45)₂/(0/90)₂]_s specimen impacted at 3.0 m/s.

All of the force-time data from this investigation are contained in this section. The force-time signature of each graphite/epoxy specimen is accompanied by an X-ray photograph of the damage state, or the words "NO DAMAGE", where damage could not be detected in the original X-ray photograph. The X-ray photographs shown here have been electronically scanned for reproduction purposes and some of the detail of the original photograph may be lost, especially in cases where the damage was very slight. The presence of an X-ray photograph (as opposed to the words "NO DAMAGE") indicates that damage was visible in the original X-ray photograph, even though it may not be apparent in the reproduction.

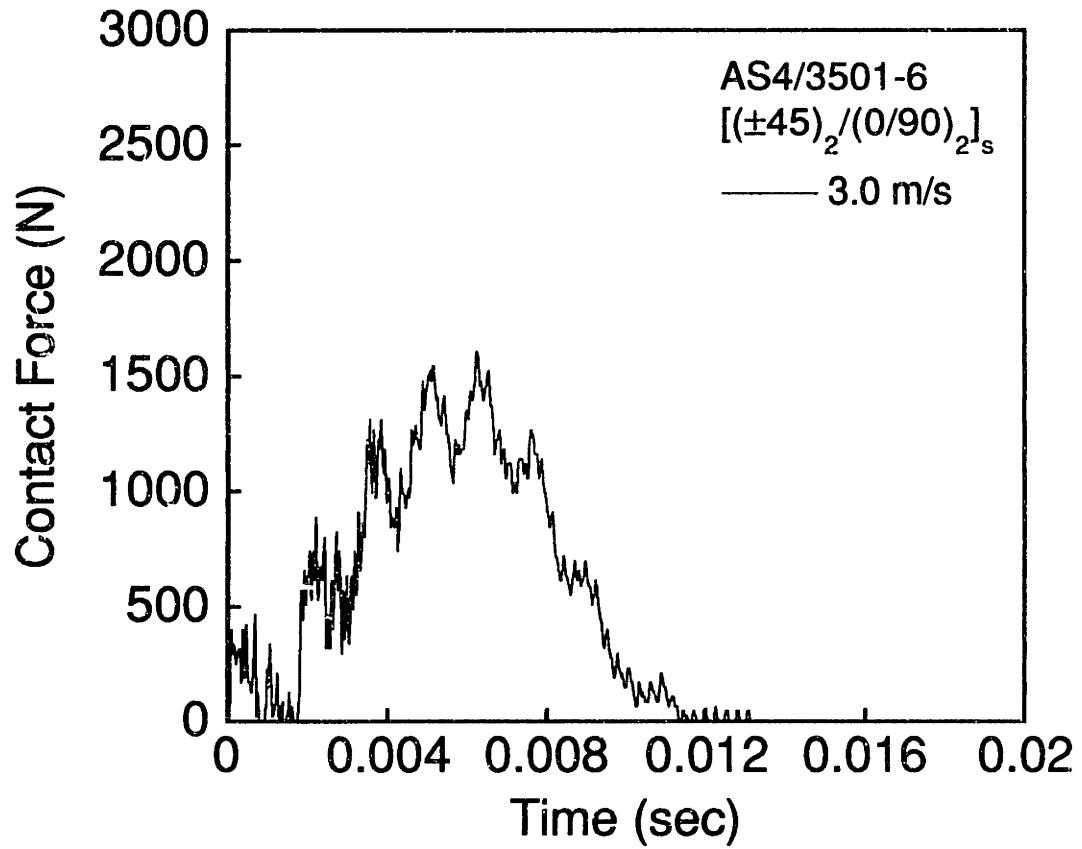
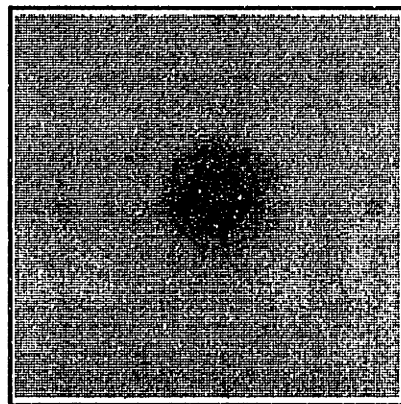
Figure A.59 (upper) Force versus time and (lower) X-ray photograph for AS4/3501-6 [(±45)₂/(0/90)₂]_s specimen impacted at 3.0 m/s.

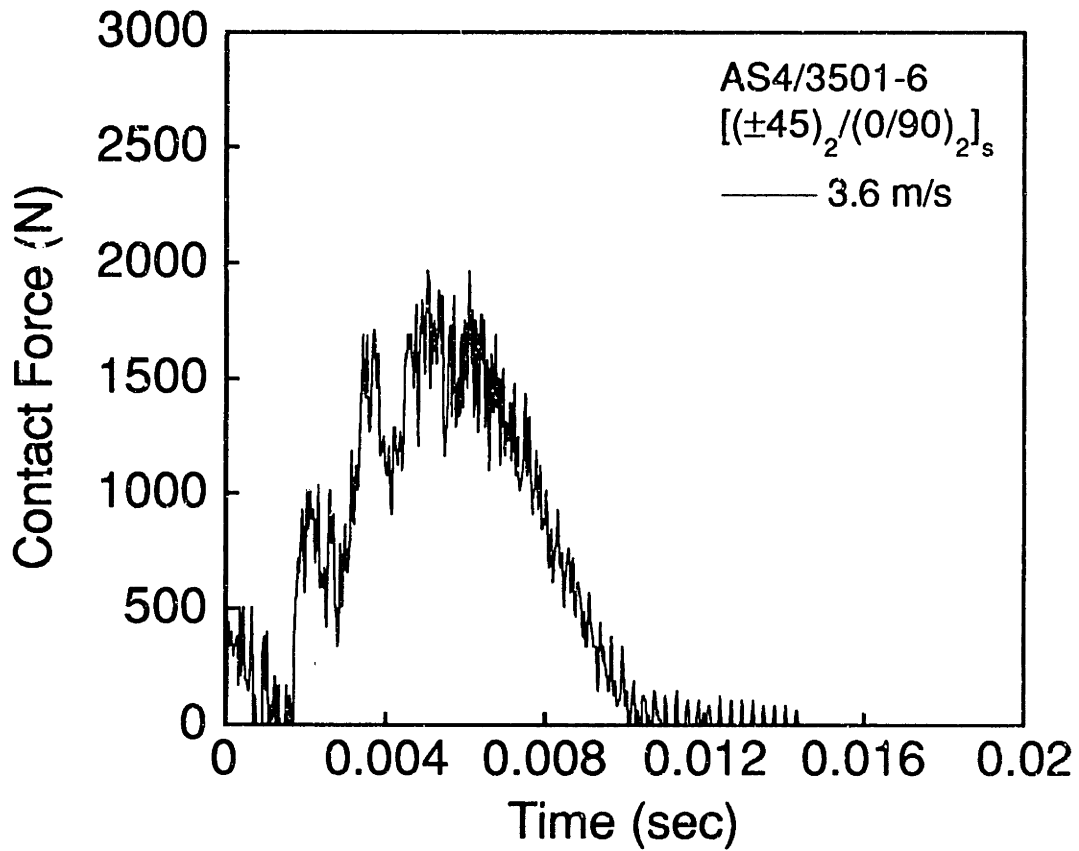
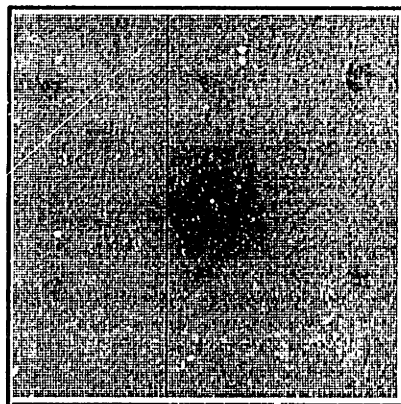
Figure A.60 (upper) Force versus time and (lower) X-ray photograph for AS4/3501-6 [(±45)₂/(0/90)₂]_s specimen impacted at 3.6 m/s.

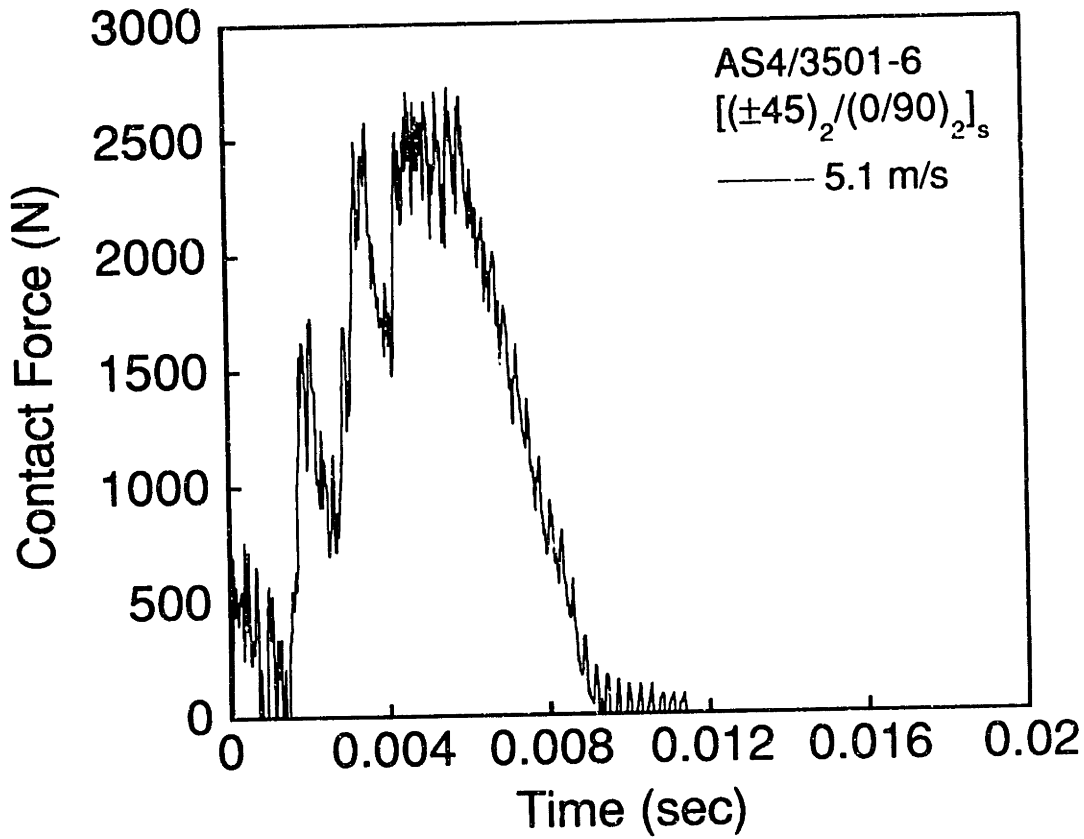
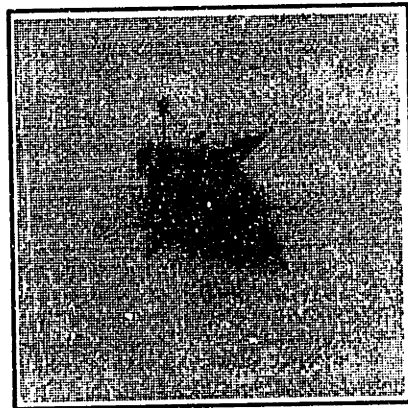
Figure A.61 (upper) Force versus time and (lower) X-ray photograph for AS4/3501-6 [(±45)₂/(0/90)₂]_s specimen impacted at 5.1 m/s.

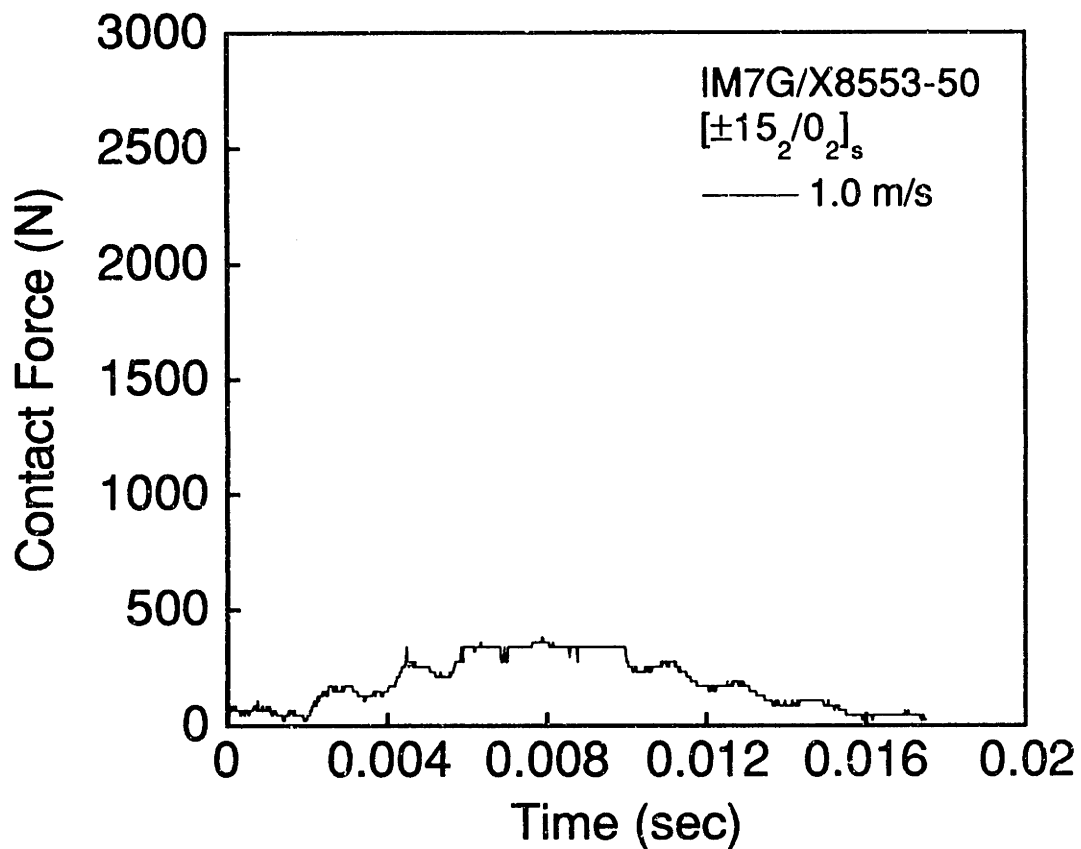
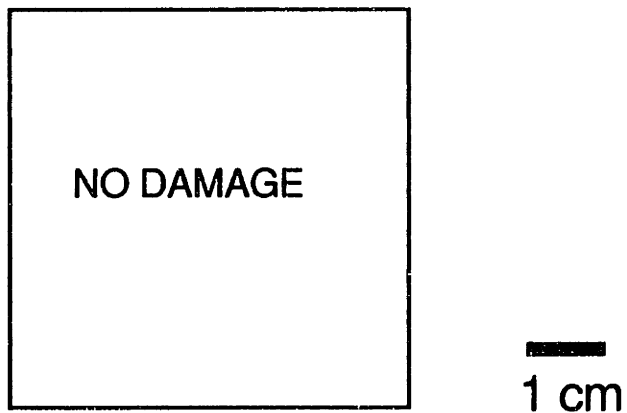
Figure A.62 (upper) Force versus time and (lower) X-ray photograph for IM7G/X8553-50 [±15₂/0₂]_s specimen impacted at 1.0 m/s.

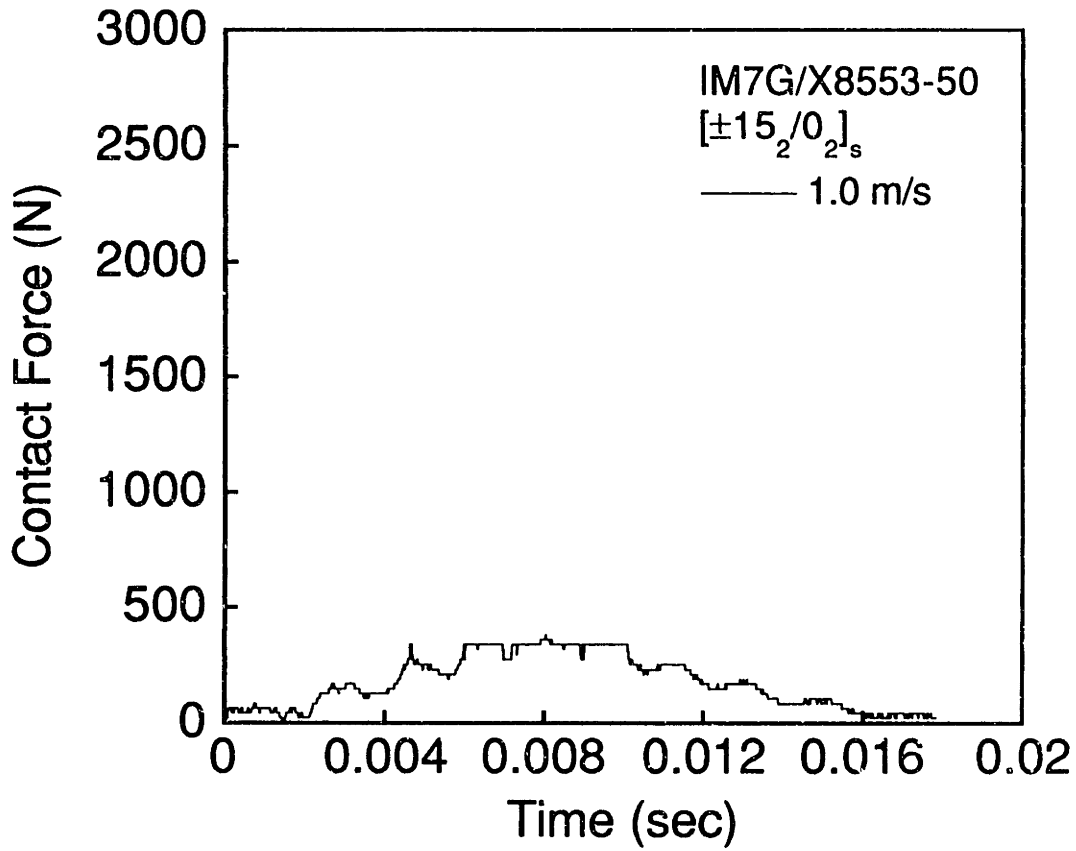
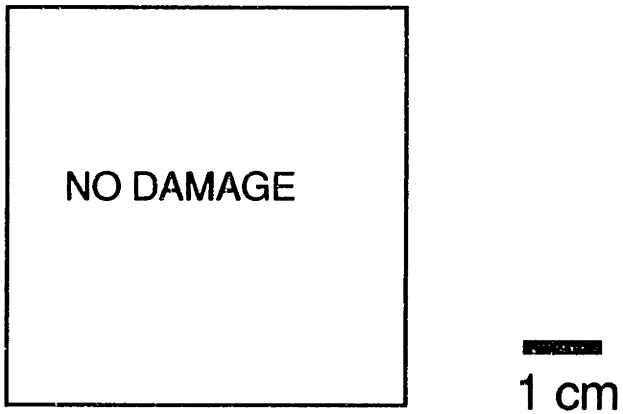
Figure A.63 (upper) Force versus time and (lower) X-ray photograph for IM7G/X8553-50 [±15₂/0₂]_s specimen impacted at 1.0 m/s.
