IMPACT DAMAGE MECHANISMS IN SEVERAL LAMINATED MATERIAL SYSTEMS

Submitted to the Department of Aeronautics and Astronautics in Partial
Fulfillment of the Requirements for the Degree of

MASTER OF SCIENCE

MASSACHUSETTS INSTITUTE OF TECHNOLOGY

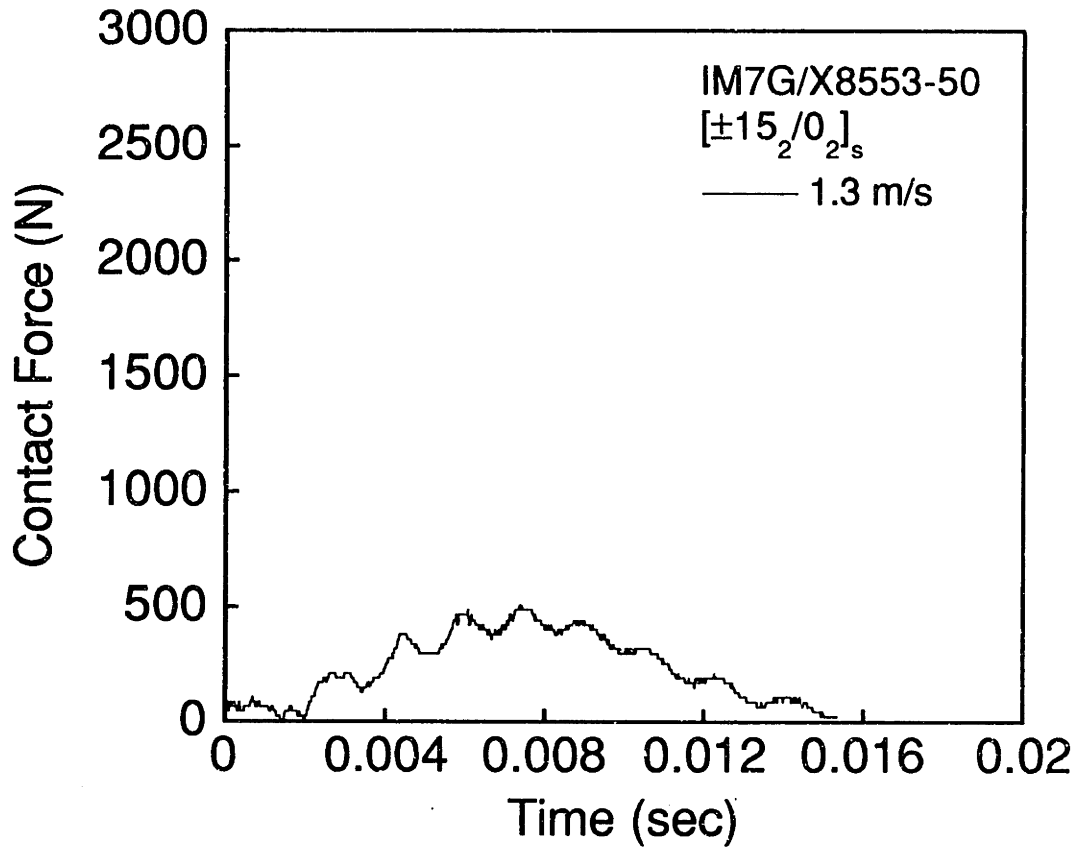
Figure A.64 (upper) Force versus time and (lower) X-ray photograph for IM7G/X8553-50 $[\pm 15_2/0_2]_s$ specimen impacted at 1.3 m/s.

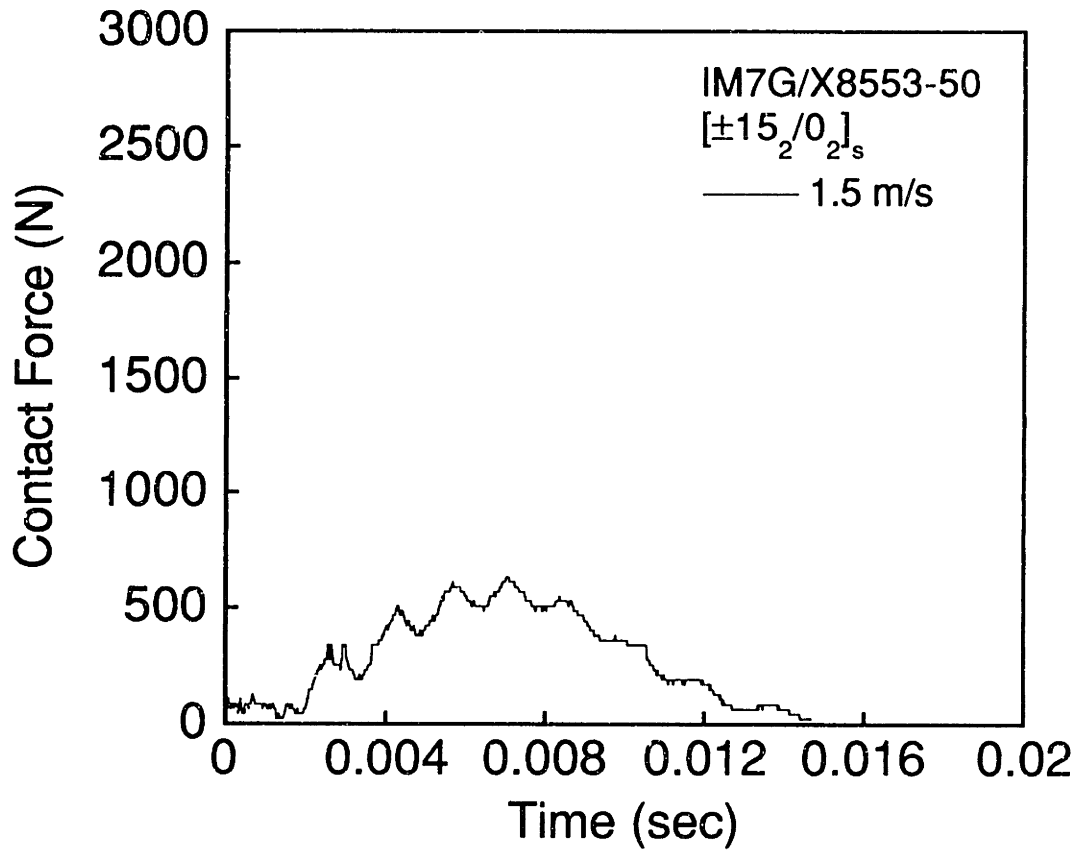
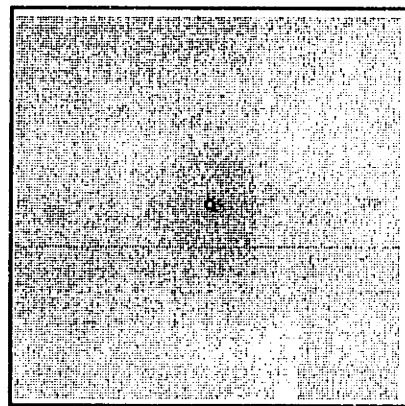
Figure A.65 (upper) Force versus time and (lower) X-ray photograph for IM7G/X8553-50 [±15₂/0₂]_s specimen impacted at 1.5 m/s.

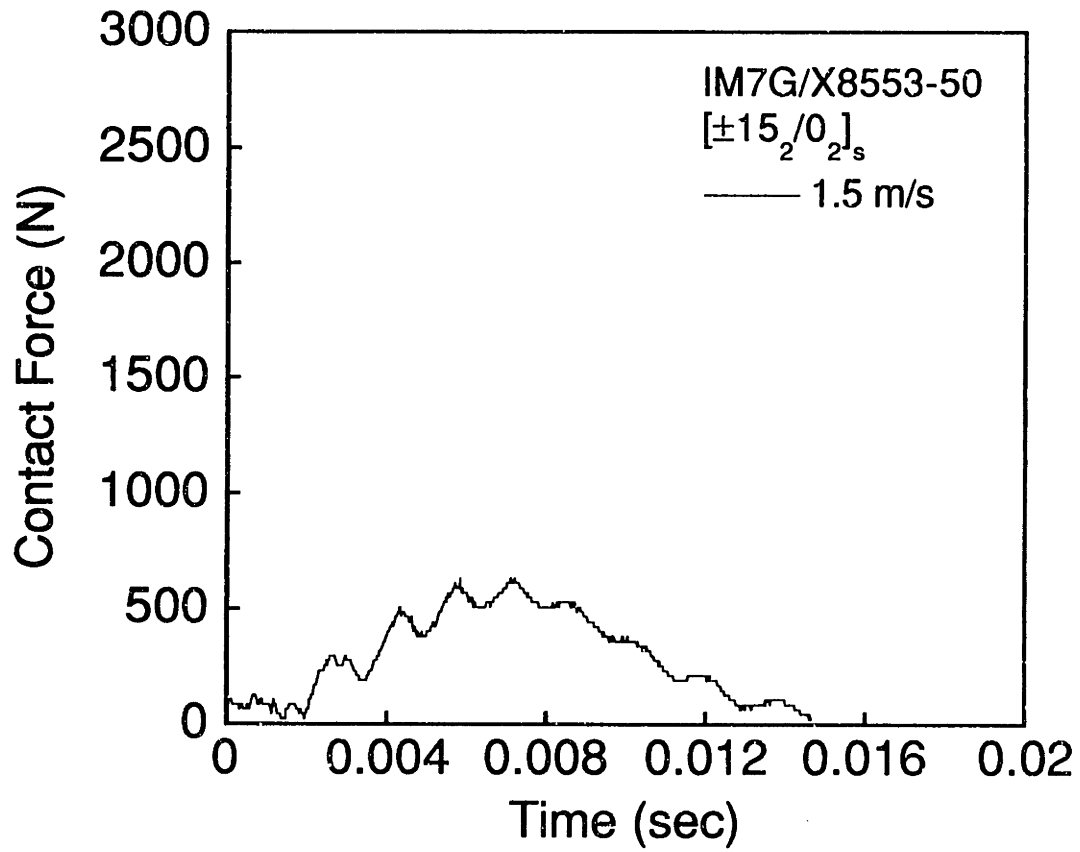
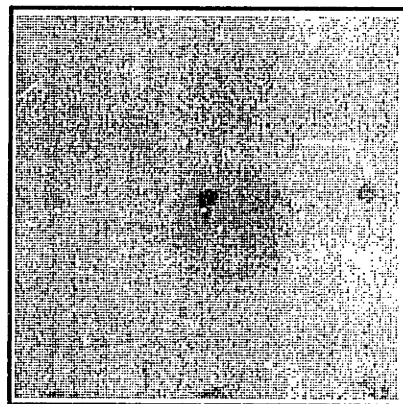
Figure A.66 (upper) Force versus time and (lower) X-ray photograph for IM7G/X8553-50 [±15₂/0₂]_s specimen impacted at 1.5 m/s.

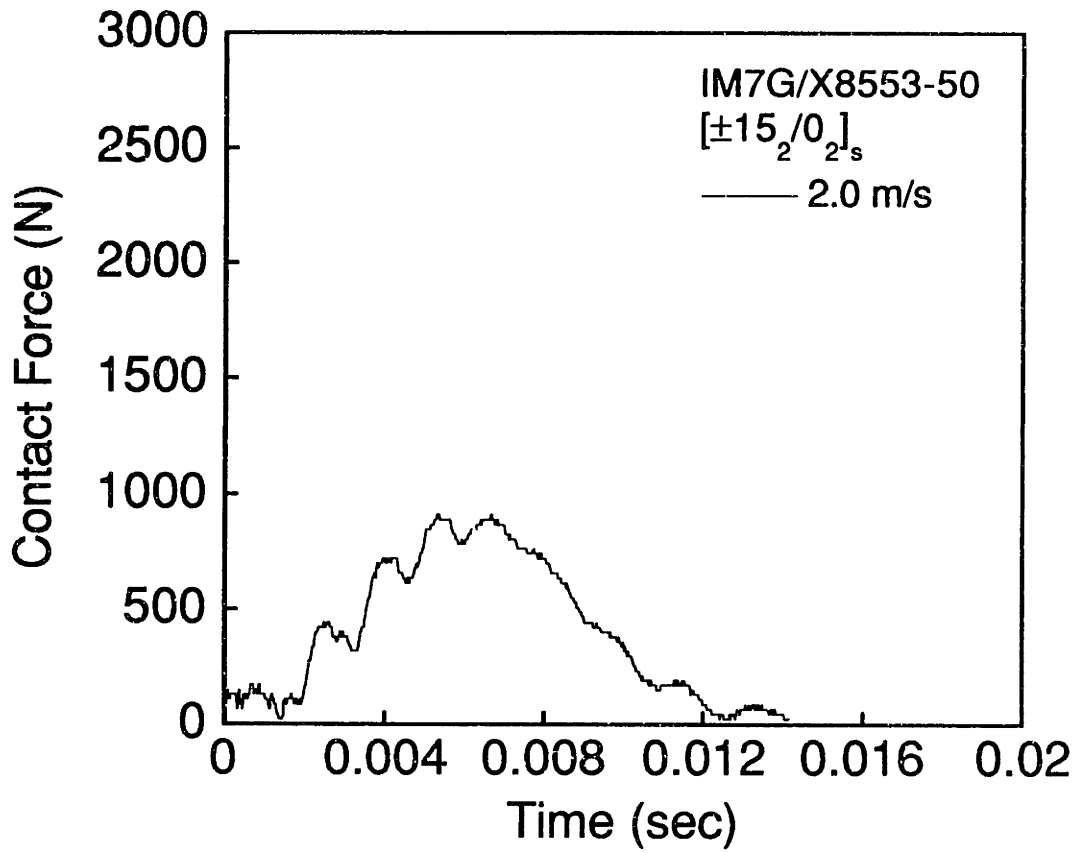
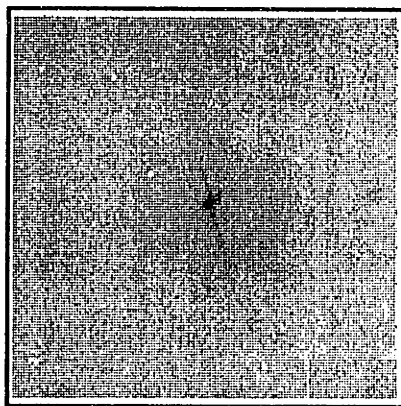
Figure A.67 (upper) Force versus time and (lower) X-ray photograph for IM7G/X8553-50 [±15₂/0₂]_s specimen impacted at 2.0 m/s.

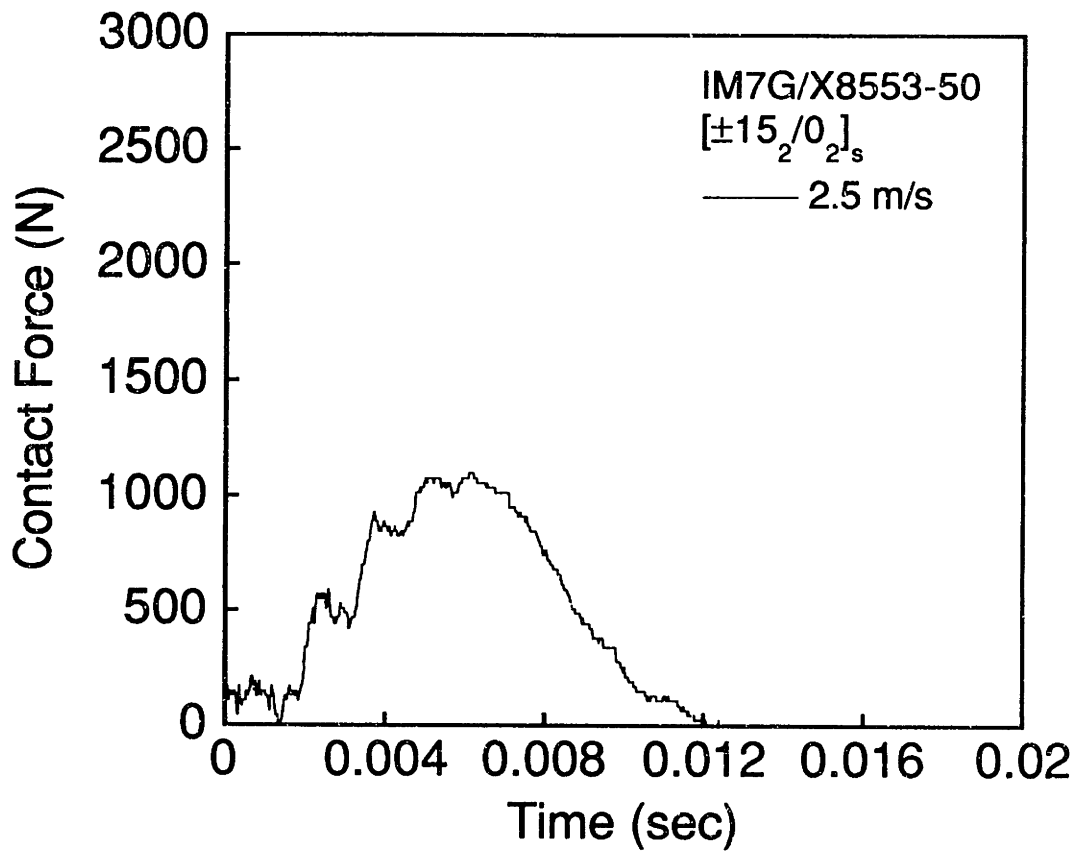
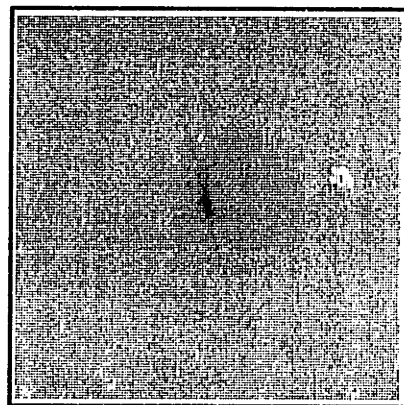
Figure A.68 (upper) Force versus time and (lower) X-ray photograph for IM7G/X8553-50 [±15₂/0₂]_s specimen impacted at 2.5 m/s.

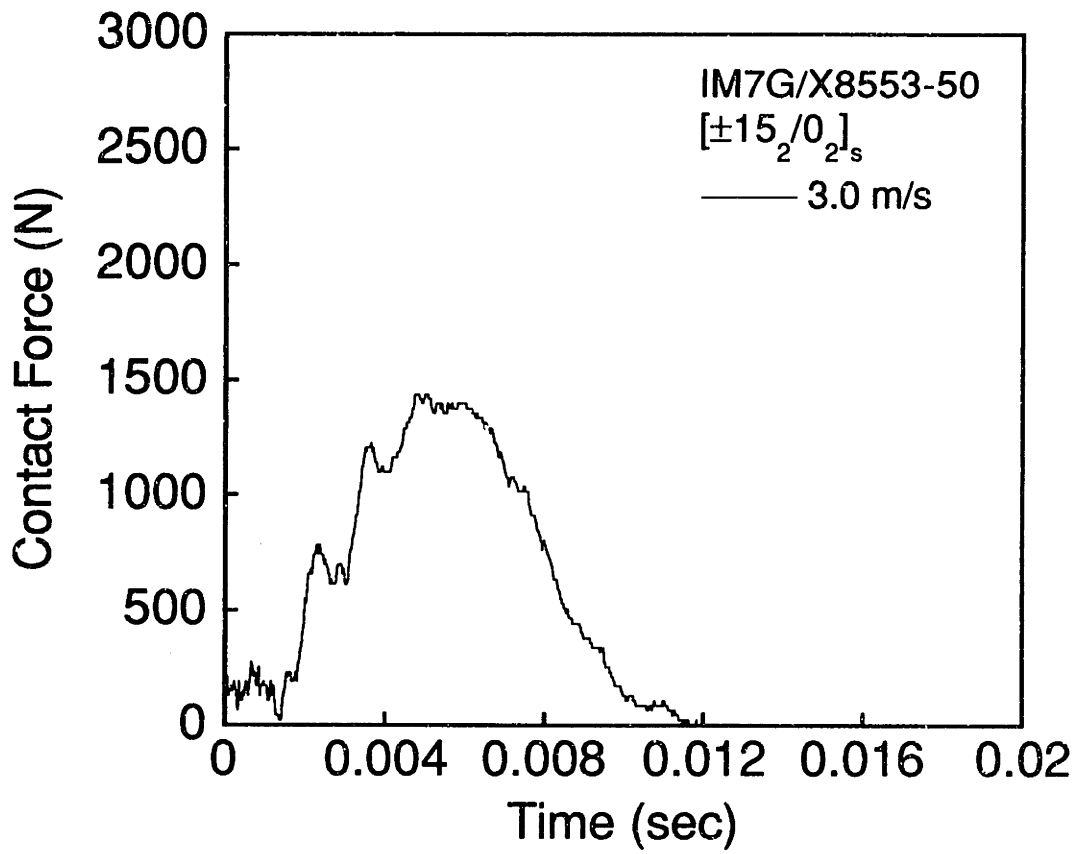
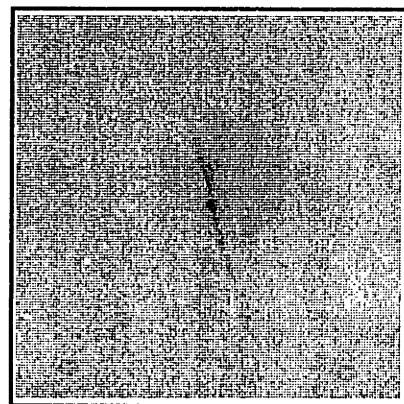
Figure A.69 (upper) Force versus time and (lower) X-ray photograph for IM7G/X8553-50 [±15₂/0₂]_s specimen impacted at 3.0 m/s.

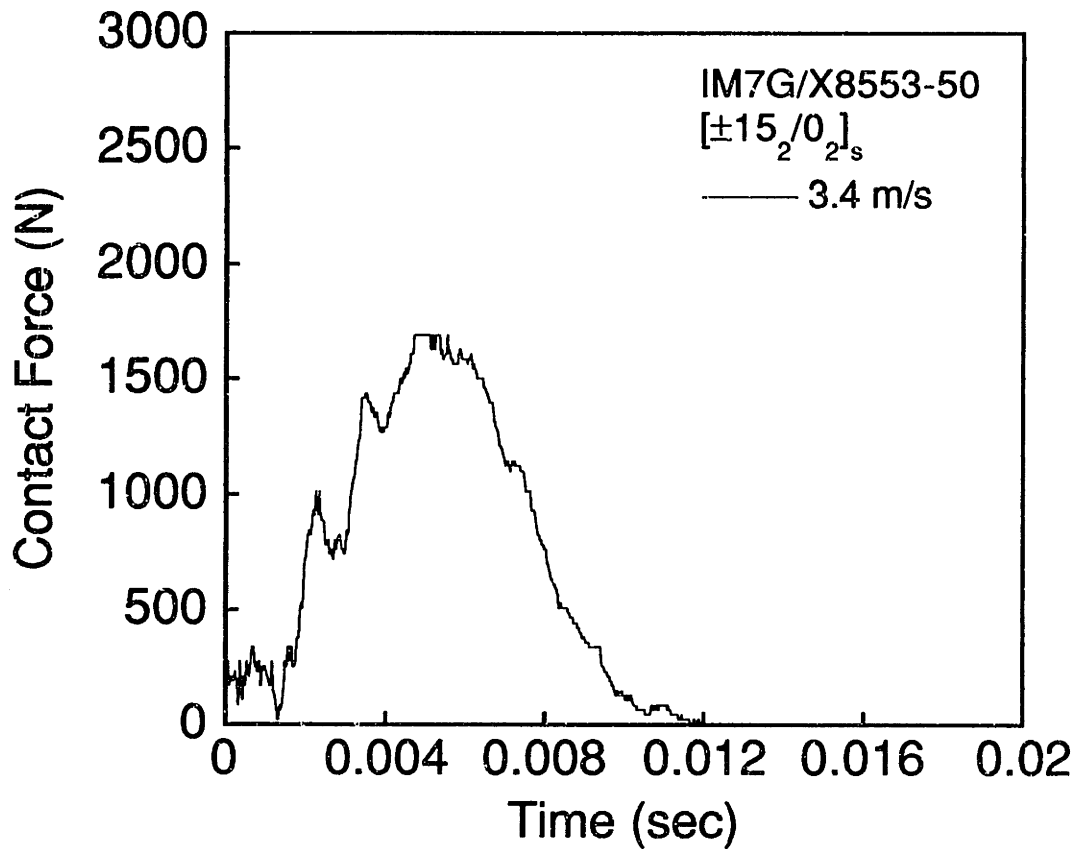
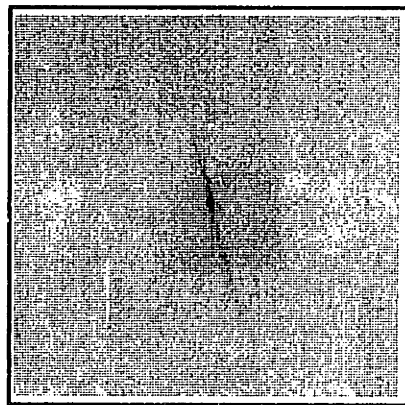
Figure A.70 (upper) Force versus time and (lower) X-ray photograph for IM7G/X8553-50 [±15₂/0₂]_s specimen impacted at 3.4 m/s.

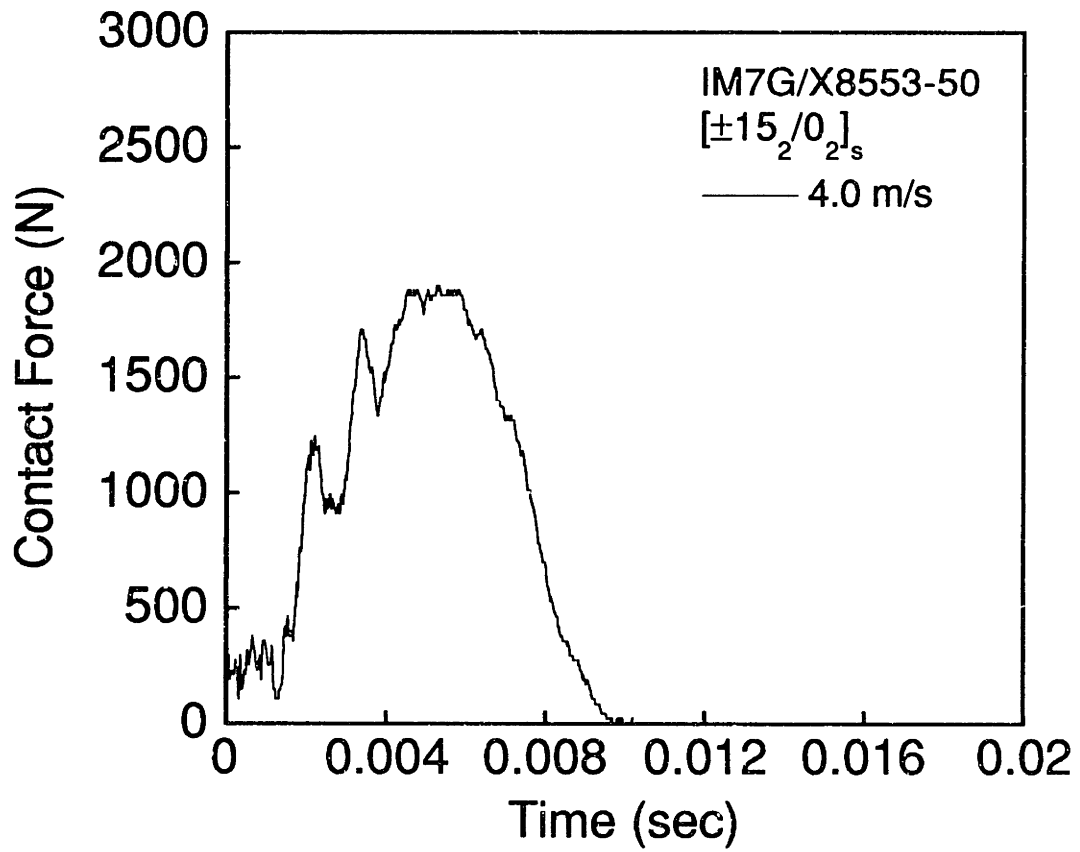
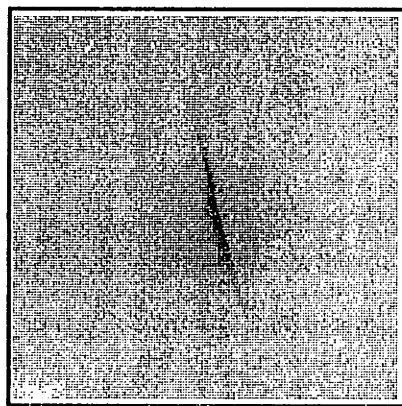
Figure A.71 (upper) Force versus time and (lower) X-ray photograph for IM7G/X8553-50 [±15₂/0₂]_s specimen impacted at 4.0 m/s.

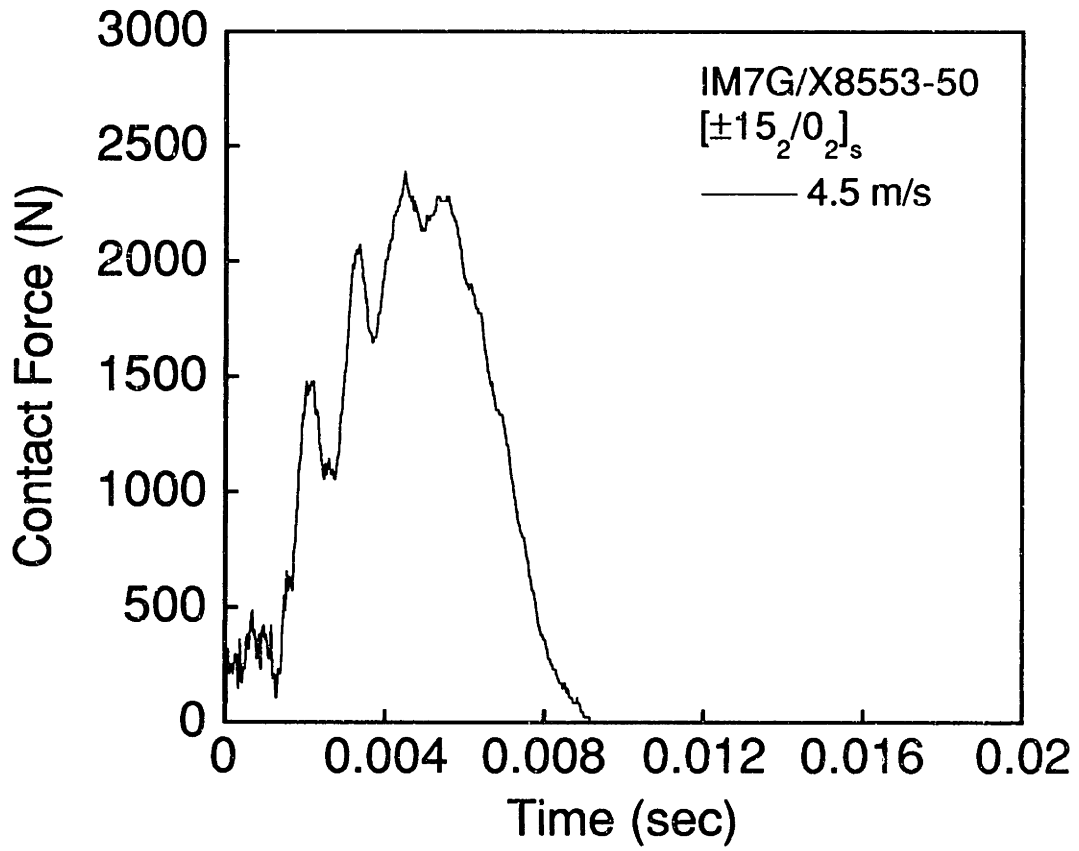
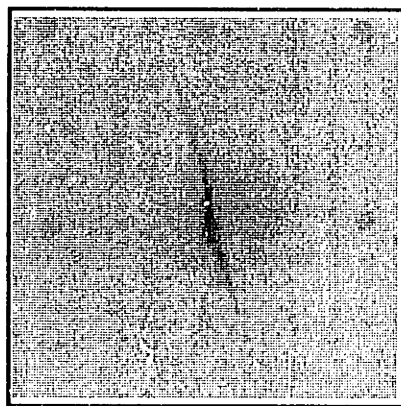
Figure A.72 (upper) Force versus time and (lower) X-ray photograph for IM7G/X8553-50 [±15₂/0₂]_s specimen impacted at 4.5 m/s.

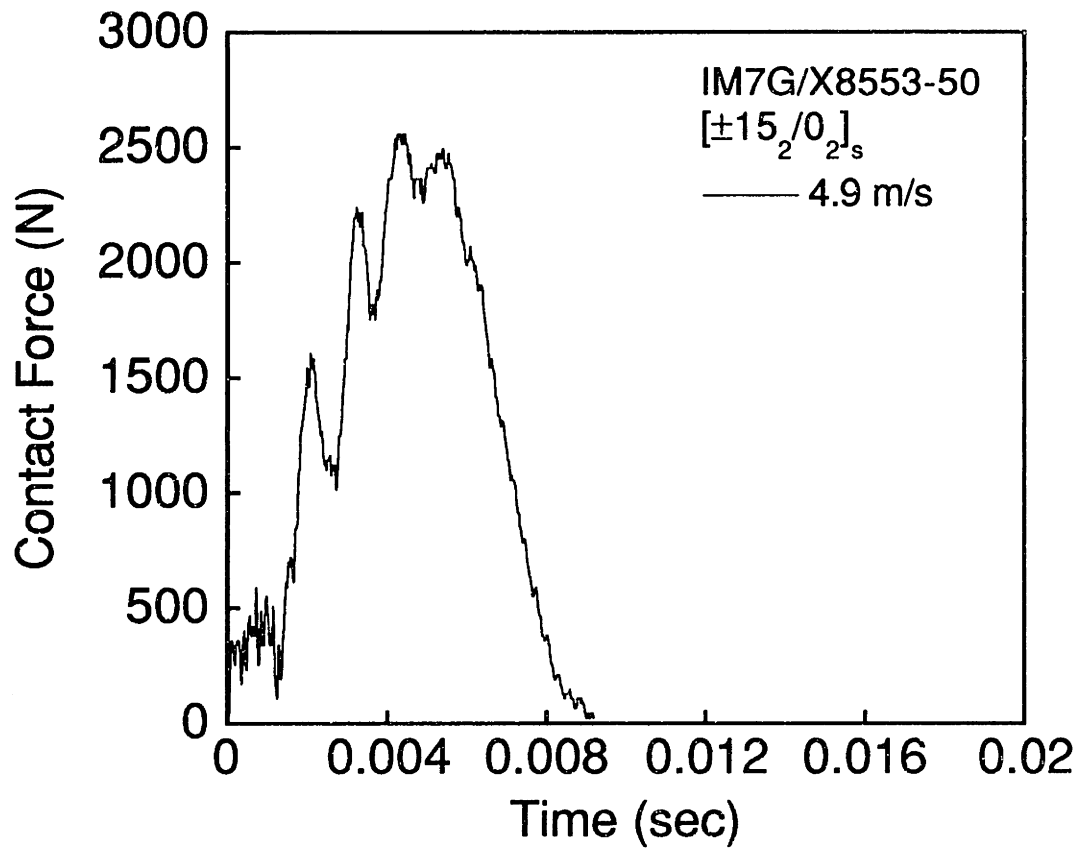
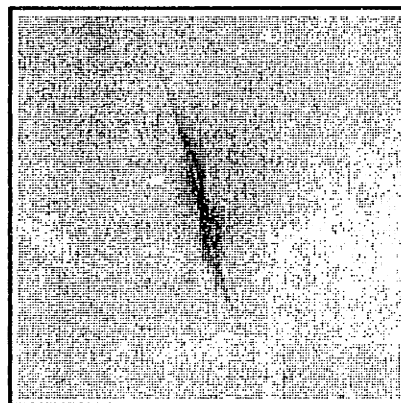
Figure A.73 (upper) Force versus time and (lower) X-ray photograph for IM7G/X8553-50 [±15₂/0₂]_s specimen impacted at 4.9 m/s.

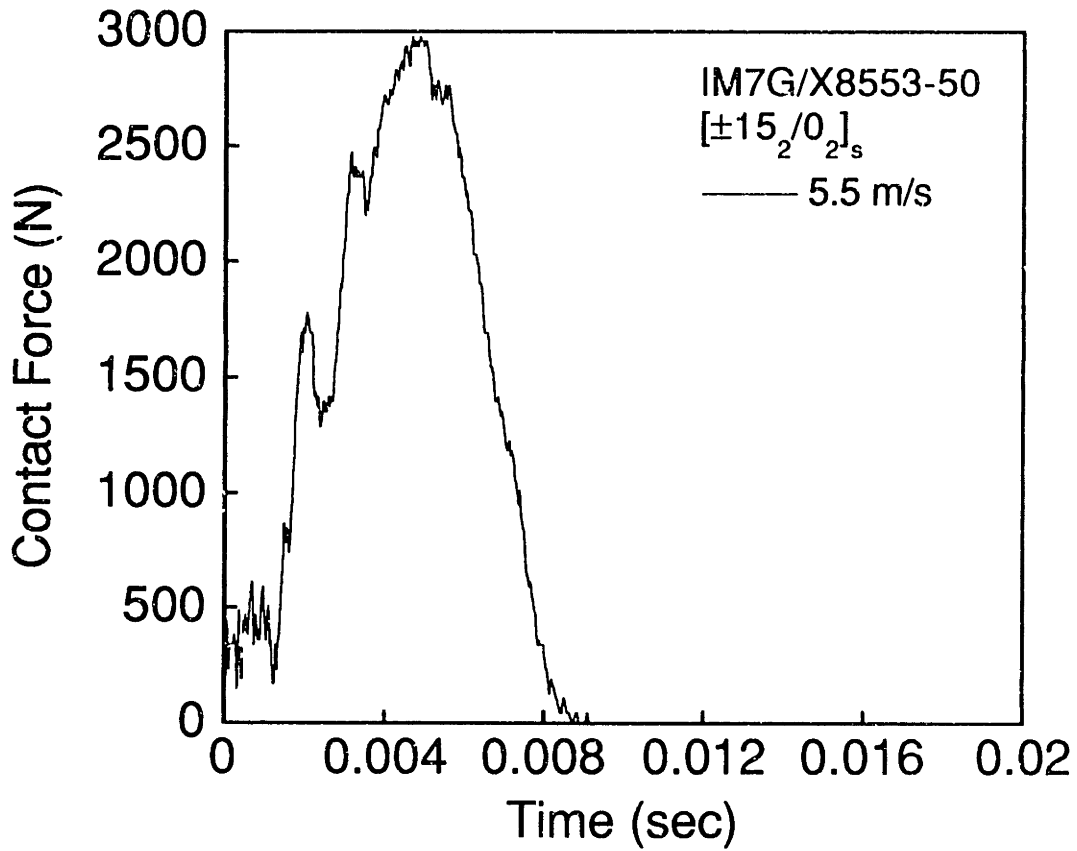
Figure A.74 (upper) Force versus time and (lower) X-ray photograph for IM7G/X8553-50 [±15₂/0₂]_s specimen impacted at 5.5 m/s.

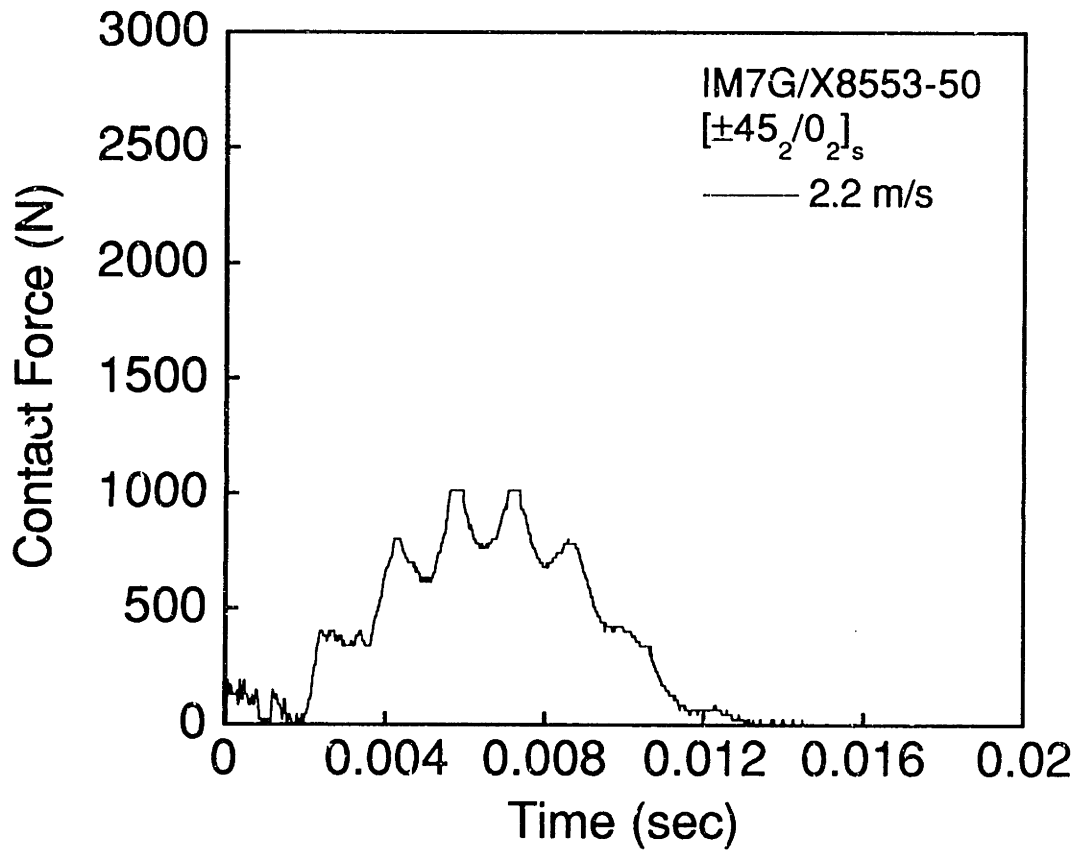
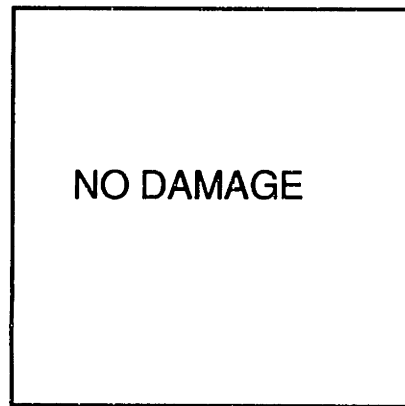
Figure A.75 (upper) Force versus time and (lower) X-ray photograph for IM7G/X8553-50 [±45₂/0₂]_s specimen impacted at 2.2 m/s.

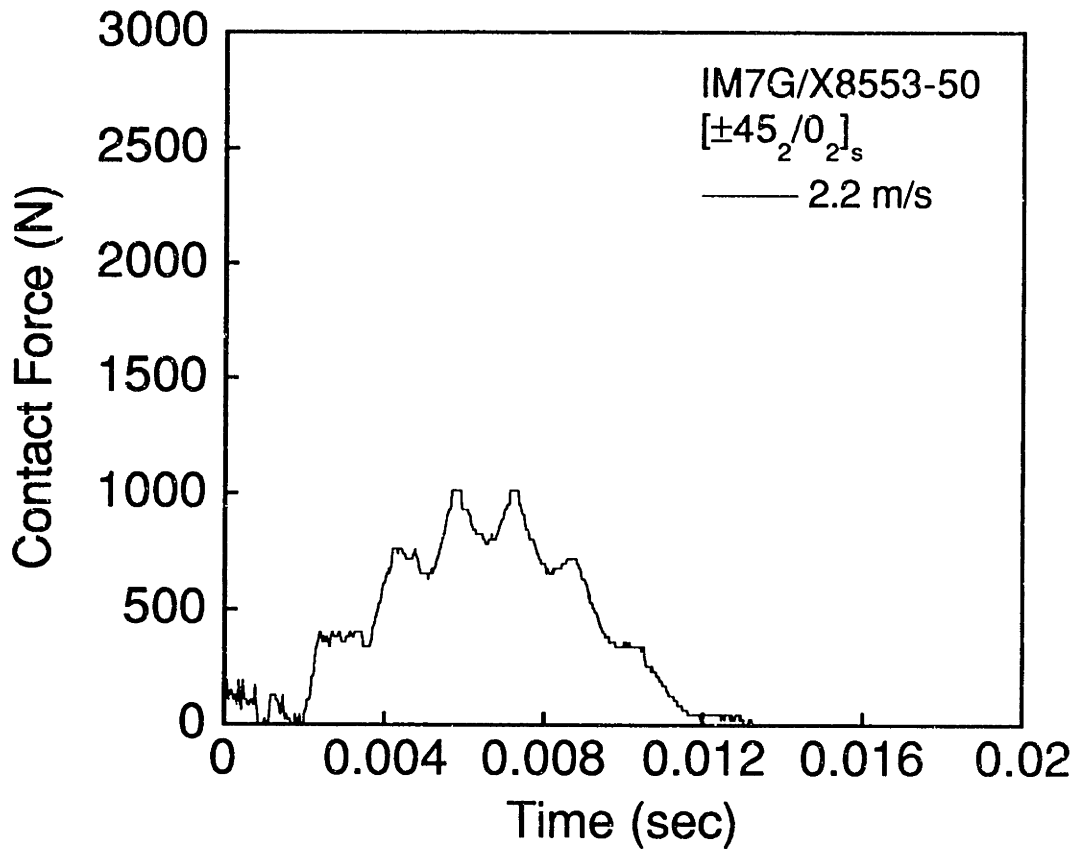
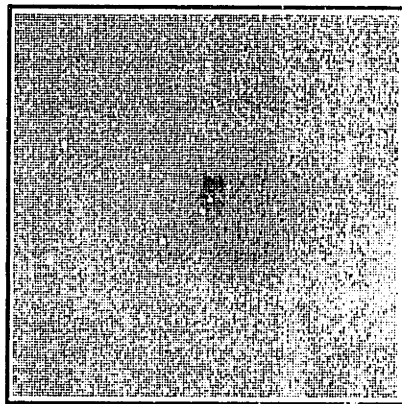
Figure A.76 (upper) Force versus time and (lower) X-ray photograph for IM7G/X8553-50 [±45₂/0₂]_s specimen impacted at 2.2 m/s.

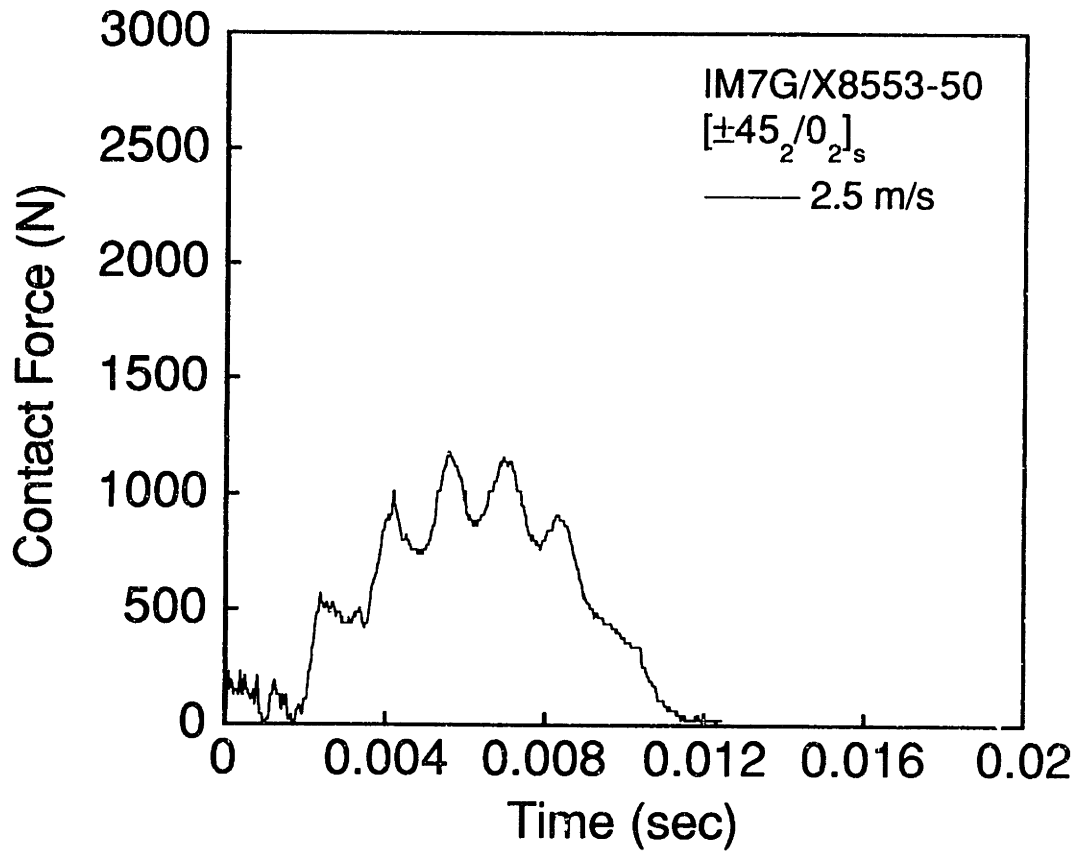
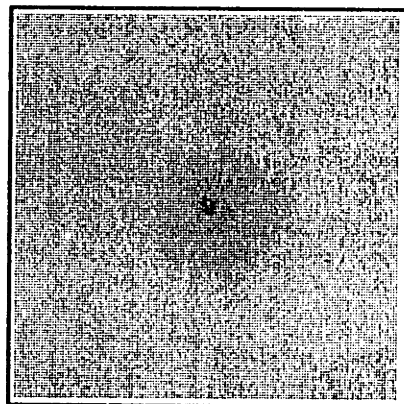
Figure A.77 (upper) Force versus time and (lower) X-ray photograph for IM7G/X8553-50 [±45₂/0₂]_s specimen impacted at 2.5 m/s.

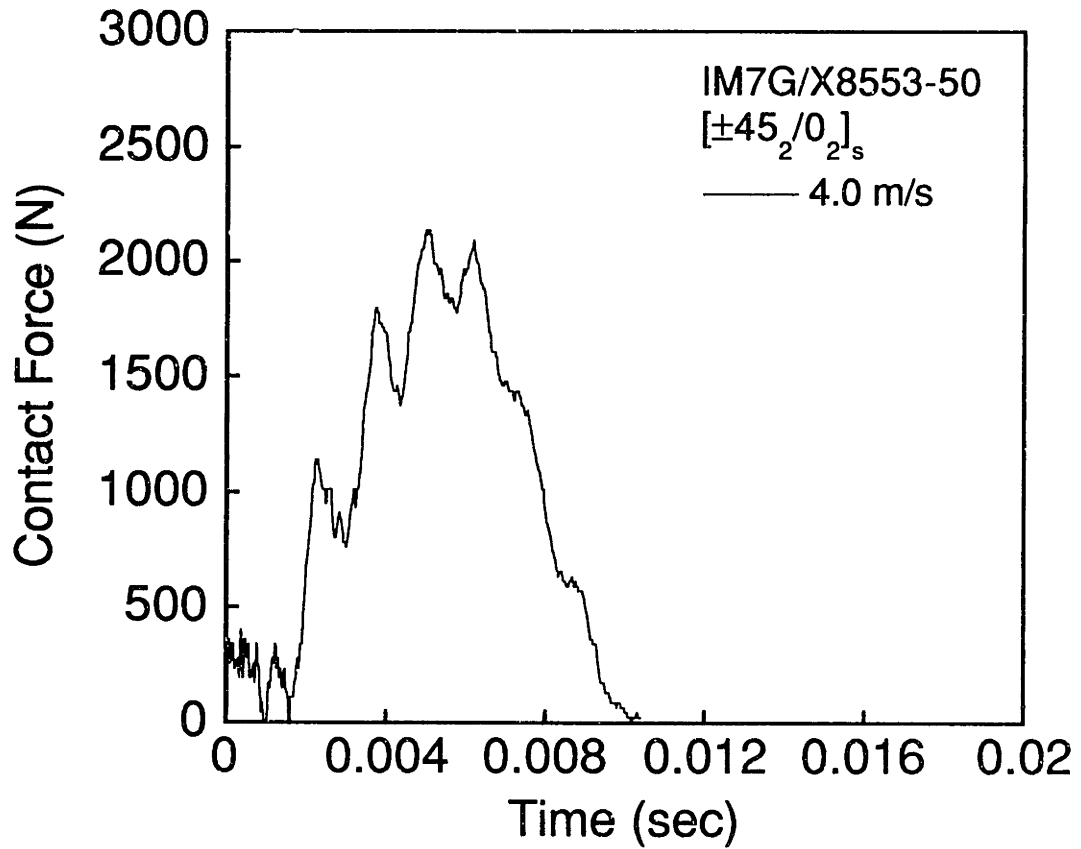
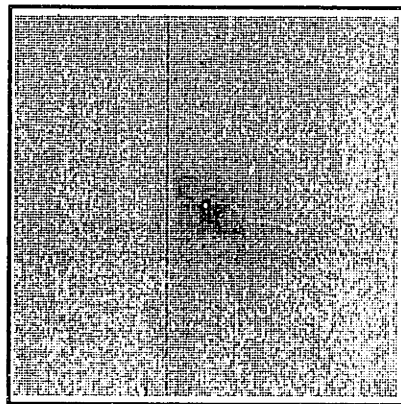
Figure A.80 (upper) Force versus time and (lower) X-ray photograph for IM7G/X8553-50 [±45₂/0₂]_s specimen impacted at 4.0 m/s.

All of the force-time data from this investigation are contained in this section. The force-time signature of each graphite/epoxy specimen is accompanied by an X-ray photograph of the damage state, or the words "NO DAMAGE", where damage could not be detected in the original X-ray photograph. The X-ray photographs shown here have been electronically scanned for reproduction purposes and some of the detail of the original photograph may be lost, especially in cases where the damage was very slight. The presence of an X-ray photograph (as opposed to the words "NO DAMAGE") indicates that damage was visible in the original X-ray photograph, even though it may not be apparent in the reproduction.

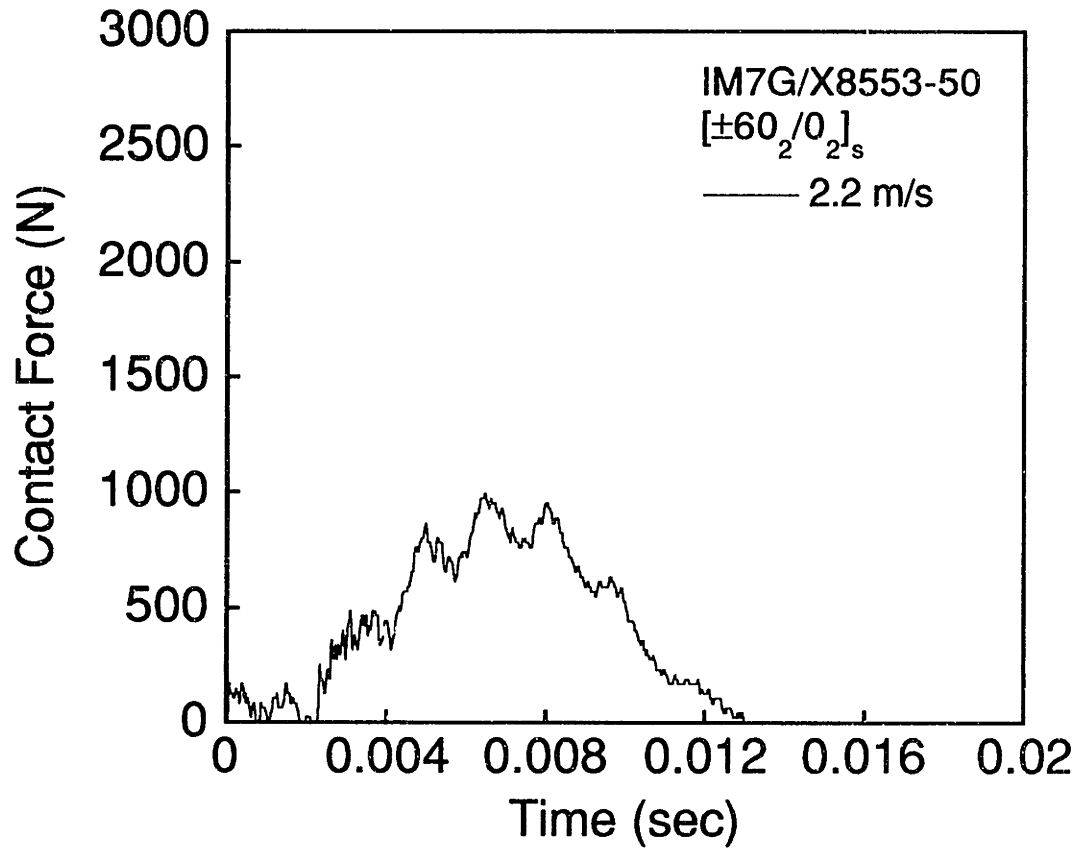
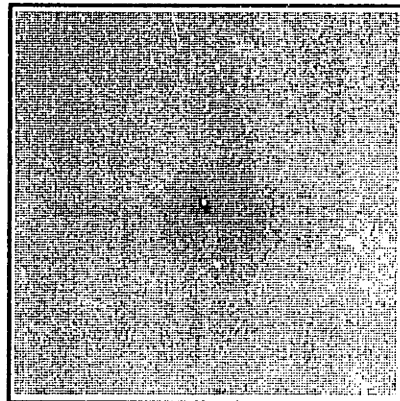
Figure A.86 (upper) Force versus time and (lower) X-ray photograph for IM7G/X8553-50 [±60₂/0₂]_s specimen impacted at 2.2 m/s.

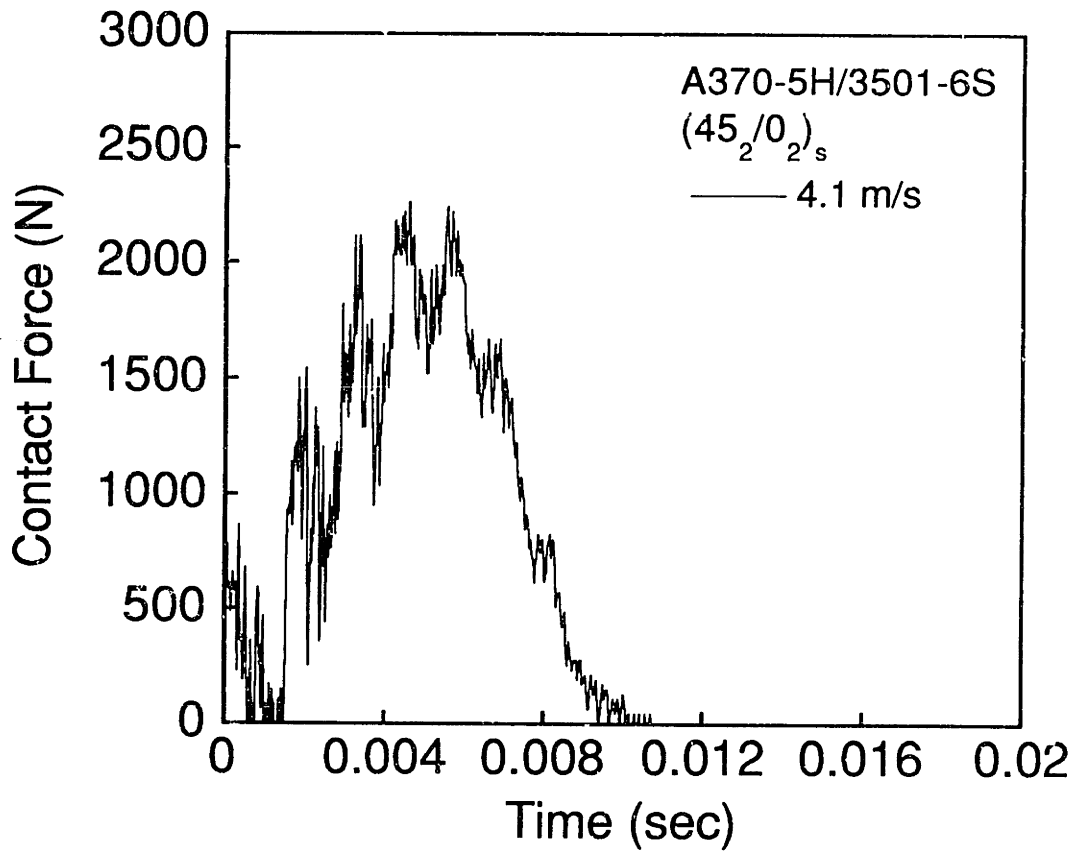
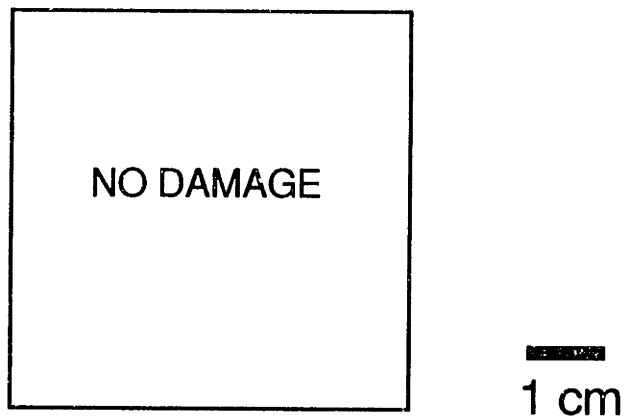
Figure A.106 (upper) Force versus time and (lower) X-ray photograph for A370-5H/3501-6S (45₂/0₂)_s specimen impacted at 4.1 m/s.

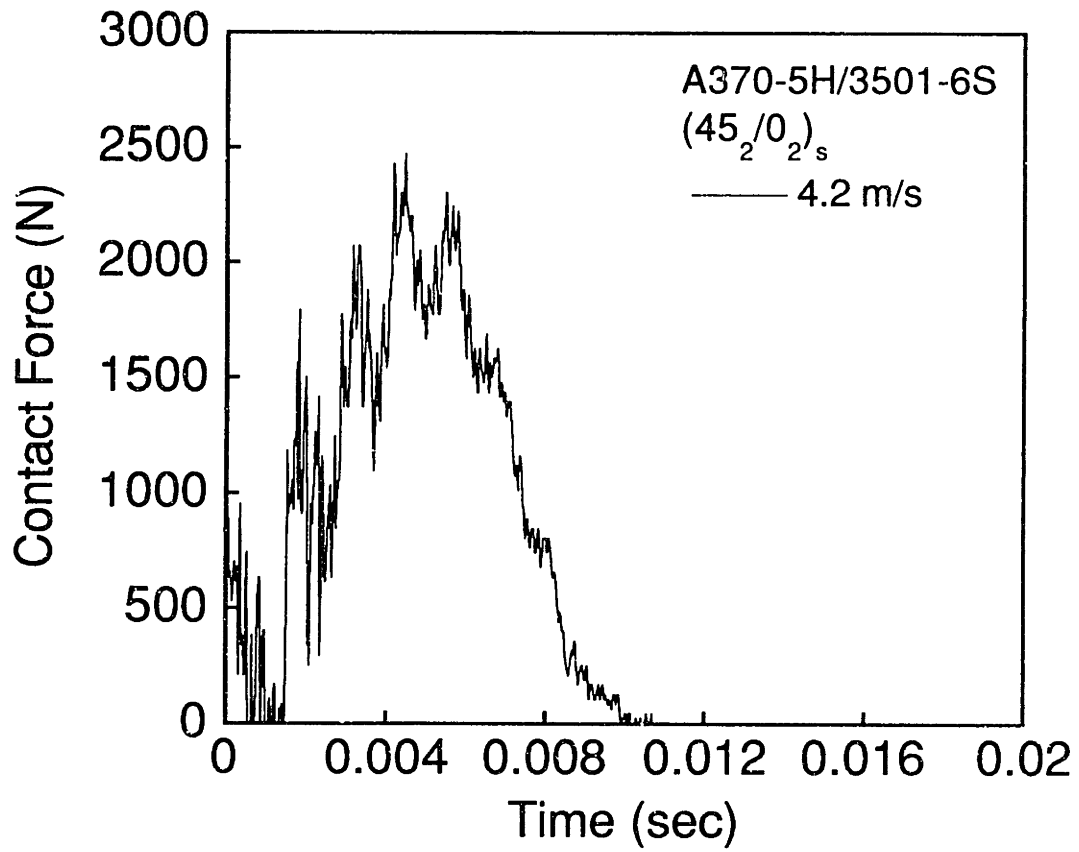
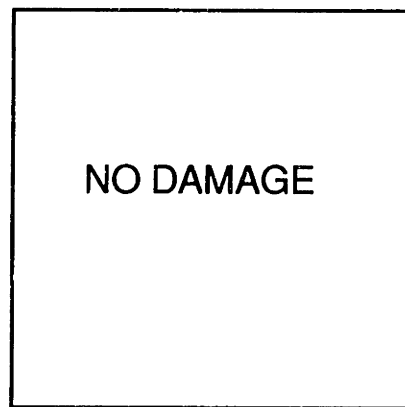
Figure A.108 (upper) Force versus time and (lower) X-ray photograph for A370-5H/3501-6S (45₂/0₂)_s specimen impacted at 4.2 m/s.

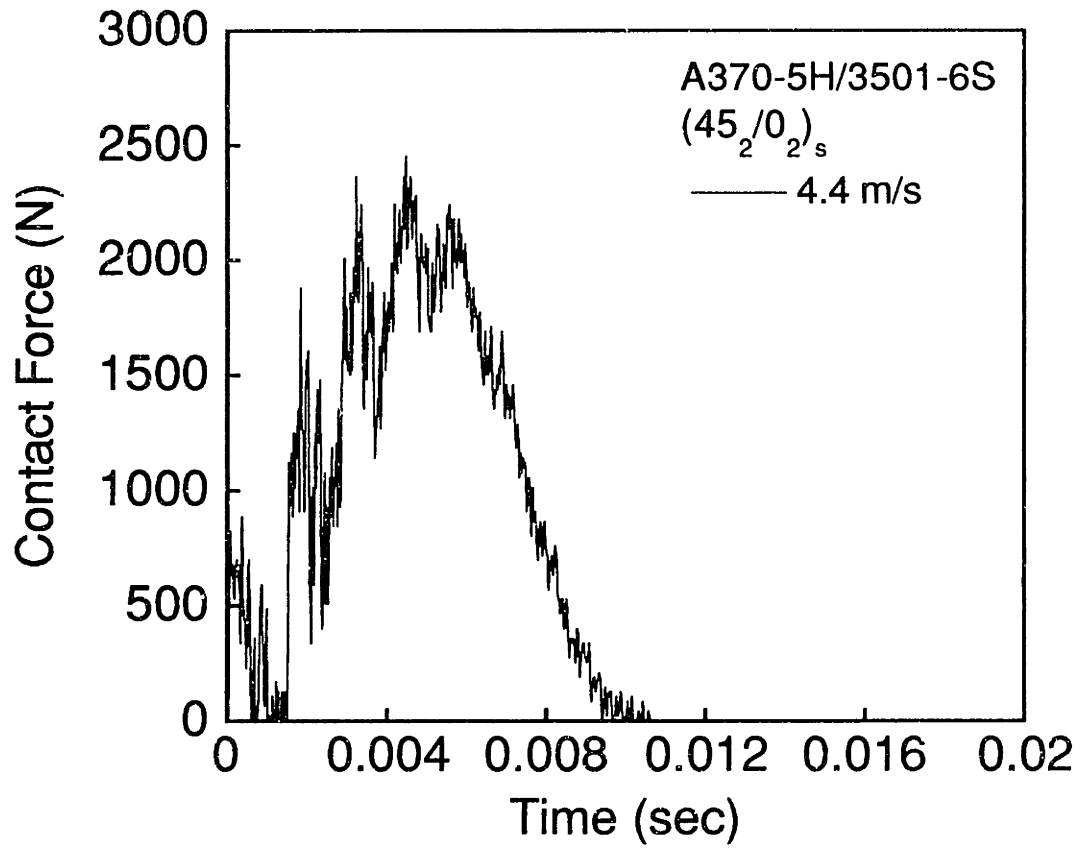
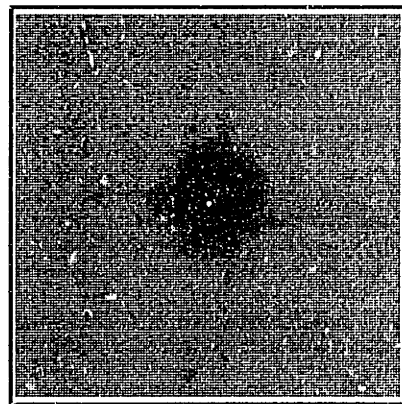
Figure A.110 (upper) Force versus time and (lower) X-ray photograph for A370-5H/3501-6S (45₂/0₂)_s specimen impacted at 4.4 m/s.

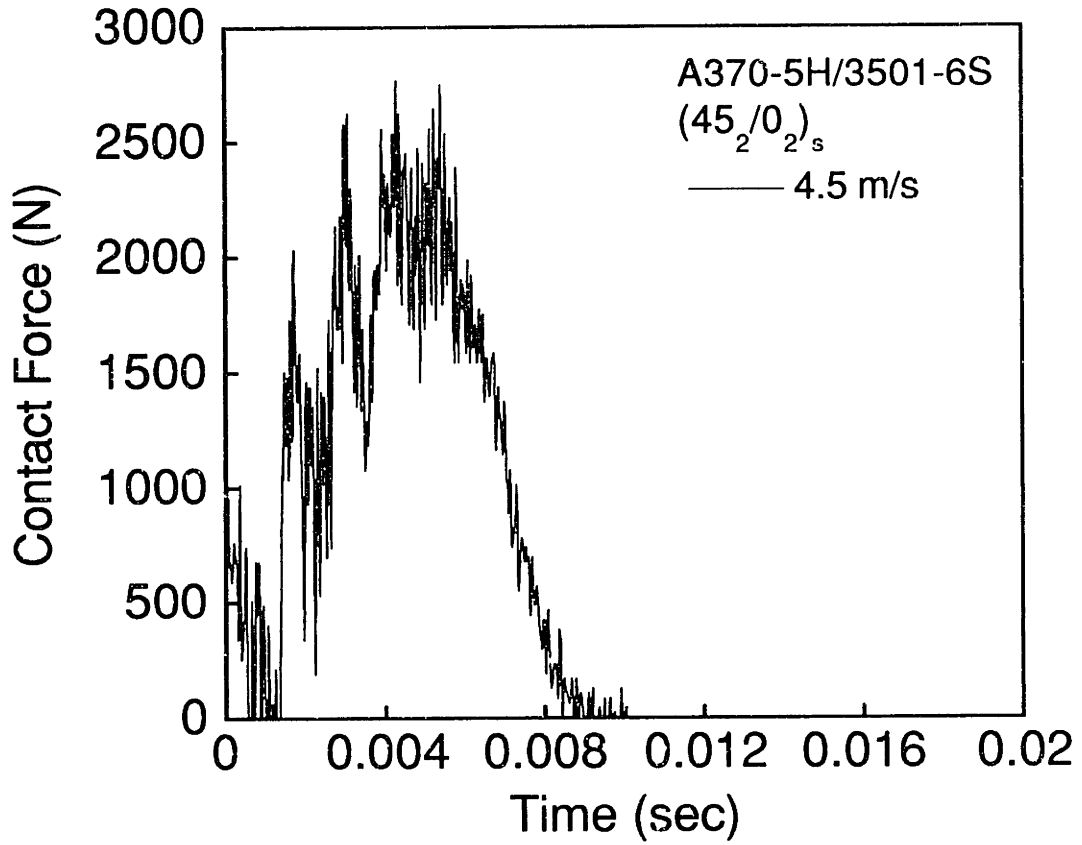
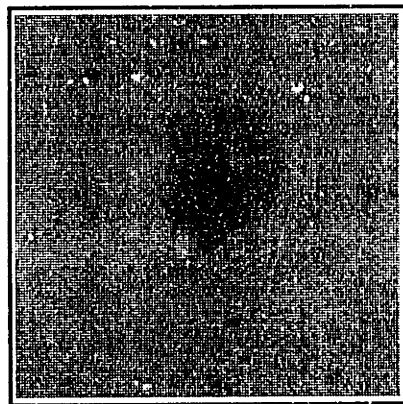
Figure A.111 (upper) Force versus time and (lower) X-ray photograph for A370-5H/3501-6S (45₂/0₂)_s specimen impacted at 4.4 m/s.
