IMPACT DAMAGE MECHANISMS IN SEVERAL LAMINATED MATERIAL SYSTEMS

Submitted to the Department of Aeronautics and Astronautics in Partial
Fulfillment of the Requirements for the Degree of

MASTER OF SCIENCE

MASSACHUSETTS INSTITUTE OF TECHNOLOGY

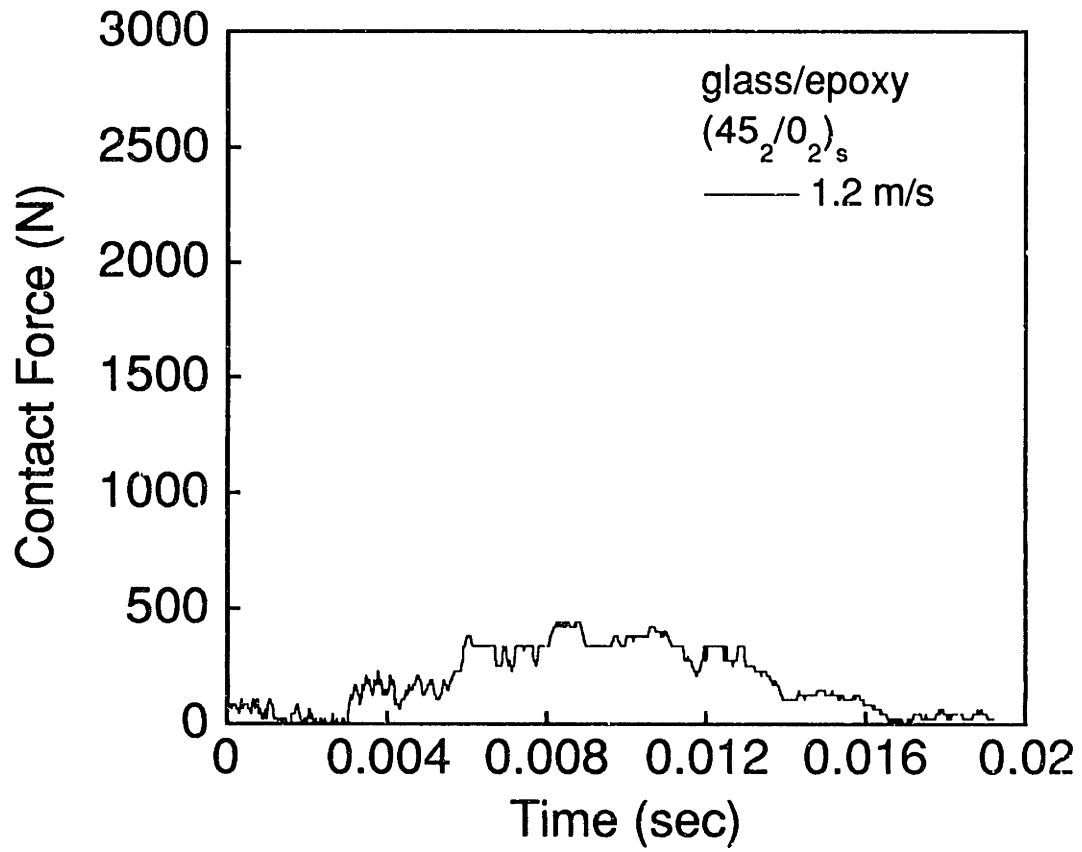
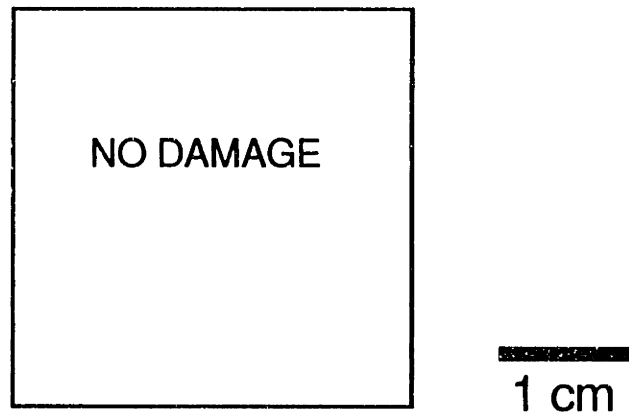
Figure A.115 (upper) Force versus time and (lower) photograph for glass/epoxy (45₂/0₂)_s specimen impacted at 1.2 m/s.

For the glass/epoxy specimens, each force-time signature is accompanied by a photograph of the damage state in the cases where the damage was extensive enough to be photographed. Where damage to the specimen was very slight, the damage was detected visually on the specimens, but was not easily photographed. Therefore, photographs of the damage states of these specimens are not provided. Instead, the words "SLIGHT DAMAGE" appear.

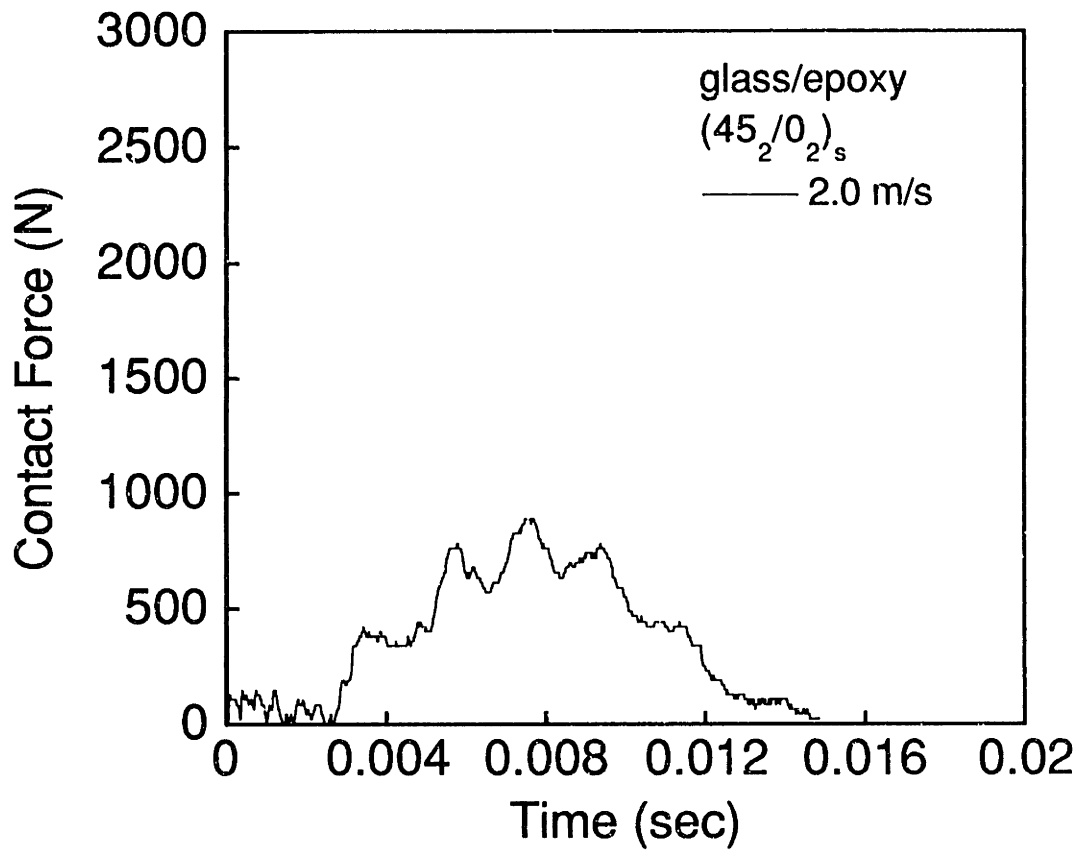
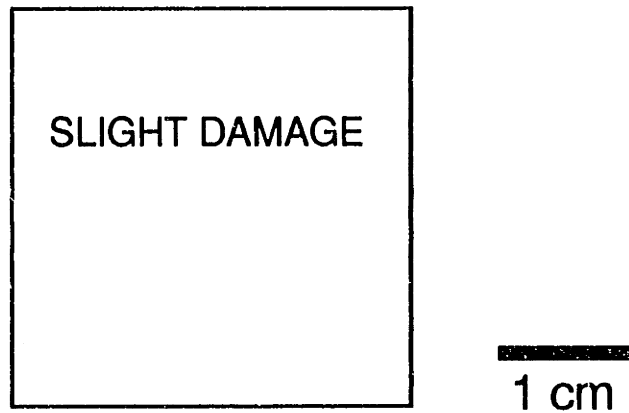
Figure A.118 (upper) Force versus time and (lower) photograph for glass/epoxy (45₂/0₂)_s specimen impacted at 2.0 m/s.

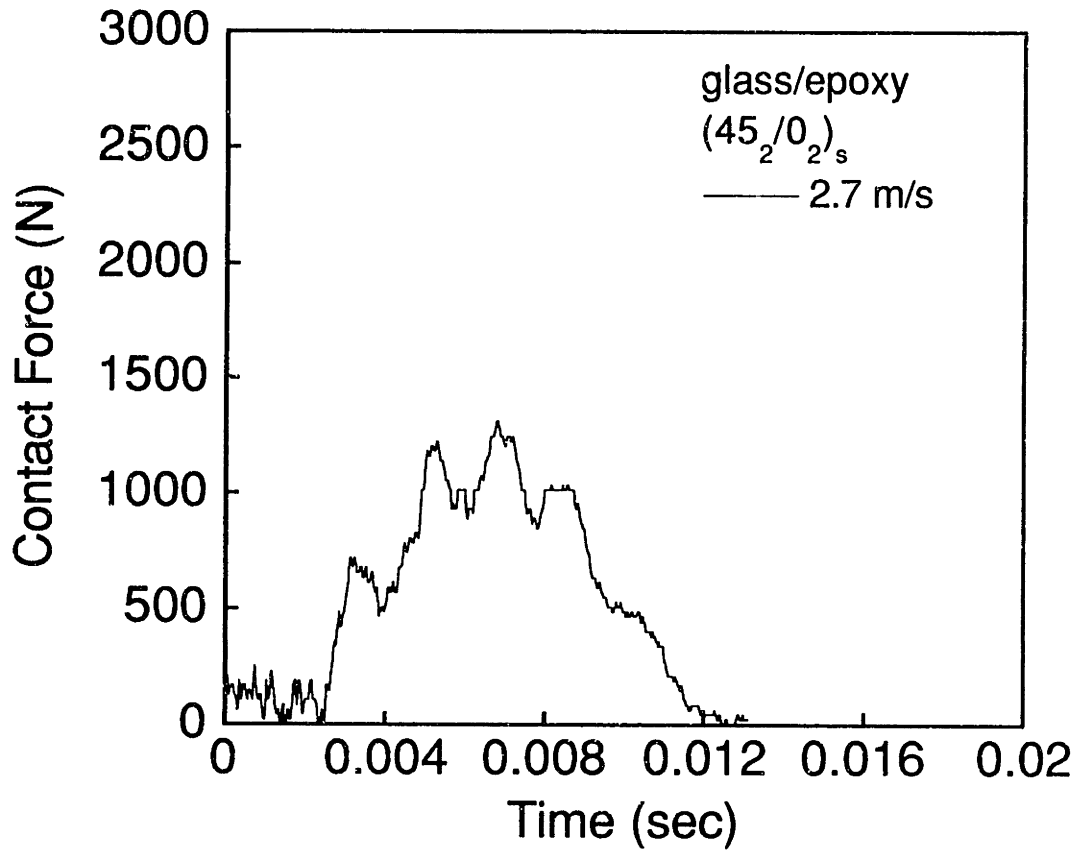
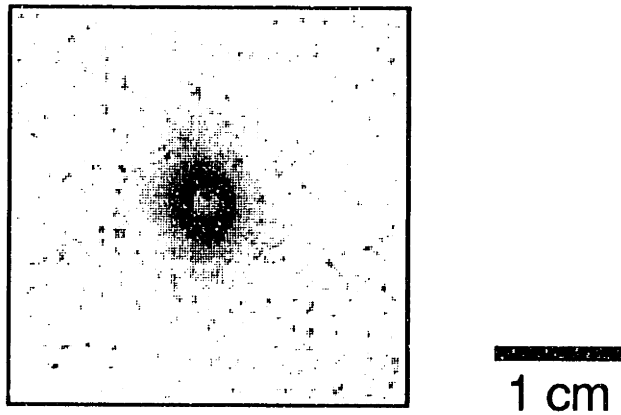
Figure A.119 (upper) Force versus time and (lower) photograph for glass/epoxy (45₂/0₂)_s specimen impacted at 2.7 m/s.

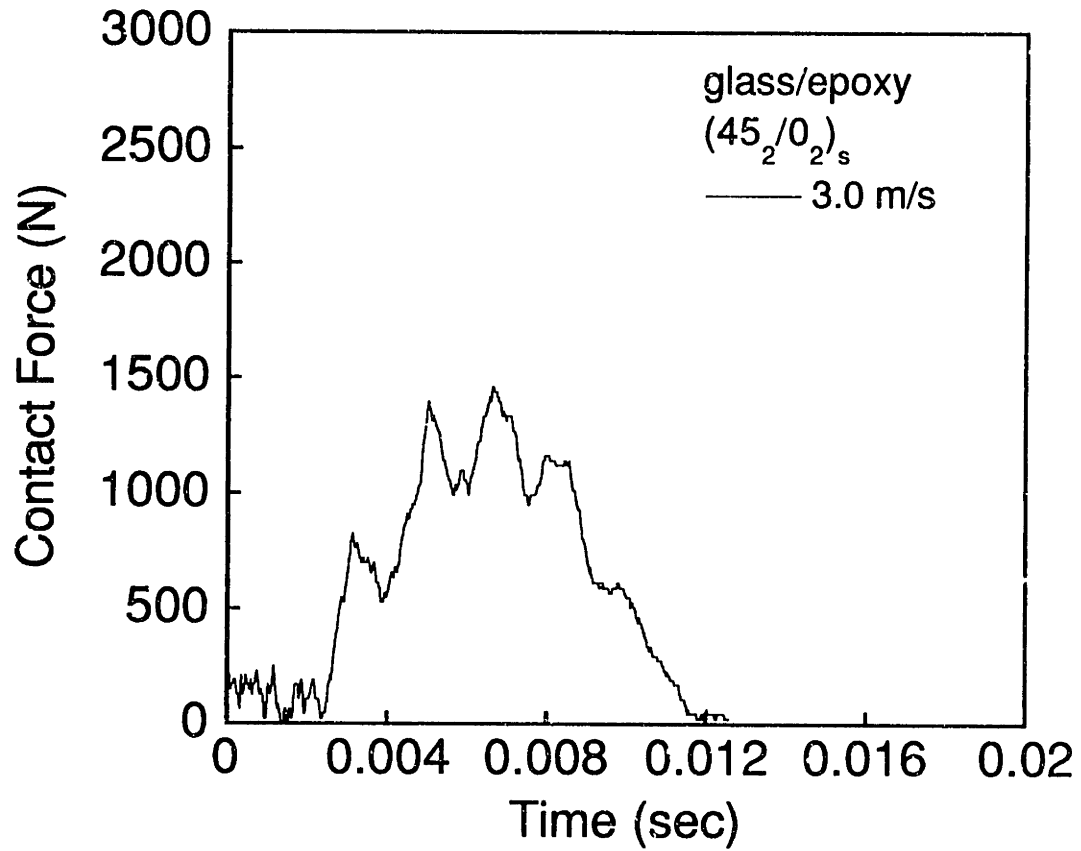
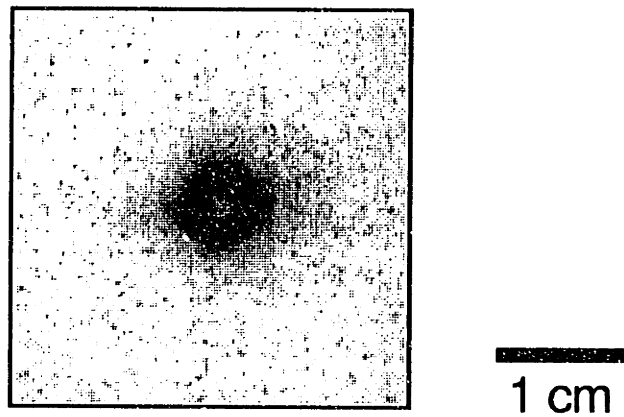
Figure A.120 (upper) Force versus time and (lower) photograph for glass/epoxy (45₂/0₂)_s specimen impacted at 3.0 m/s.

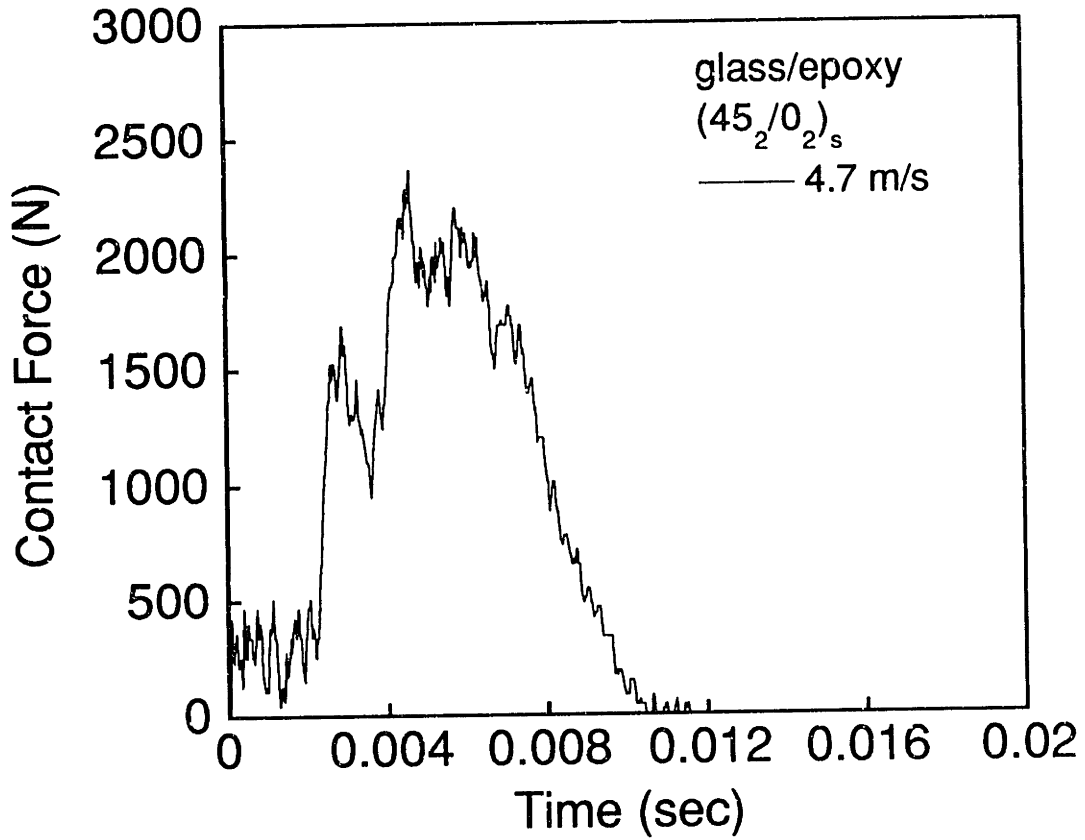
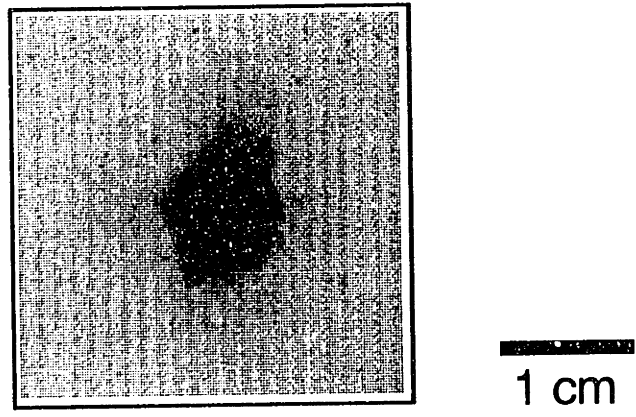
Figure A.121 (upper) Force versus time and (lower) photograph for glass/epoxy (45₂/0₂)_s specimen impacted at 4.7 m/s.

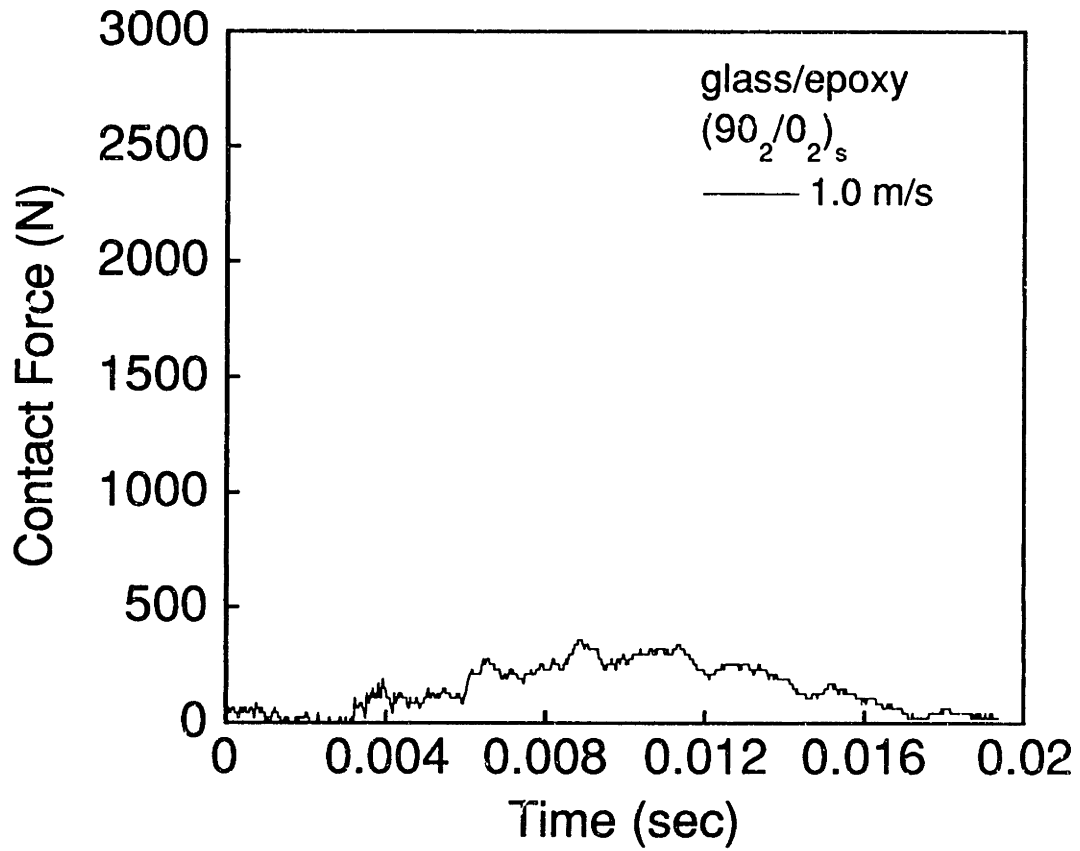
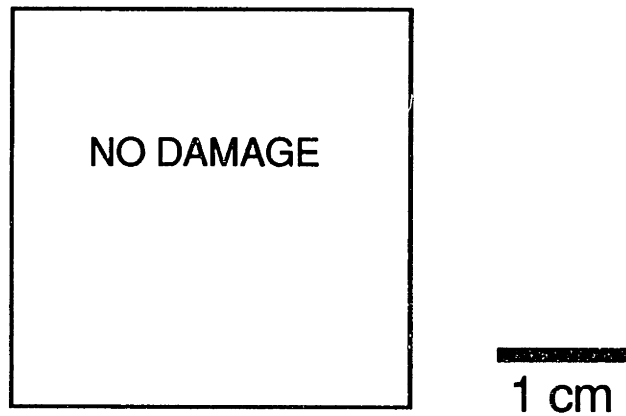
Figure A.122 (upper) Force versus time and (lower) photograph for glass/epoxy (90₂/0₂)_s specimen impacted at 1.0 m/s.

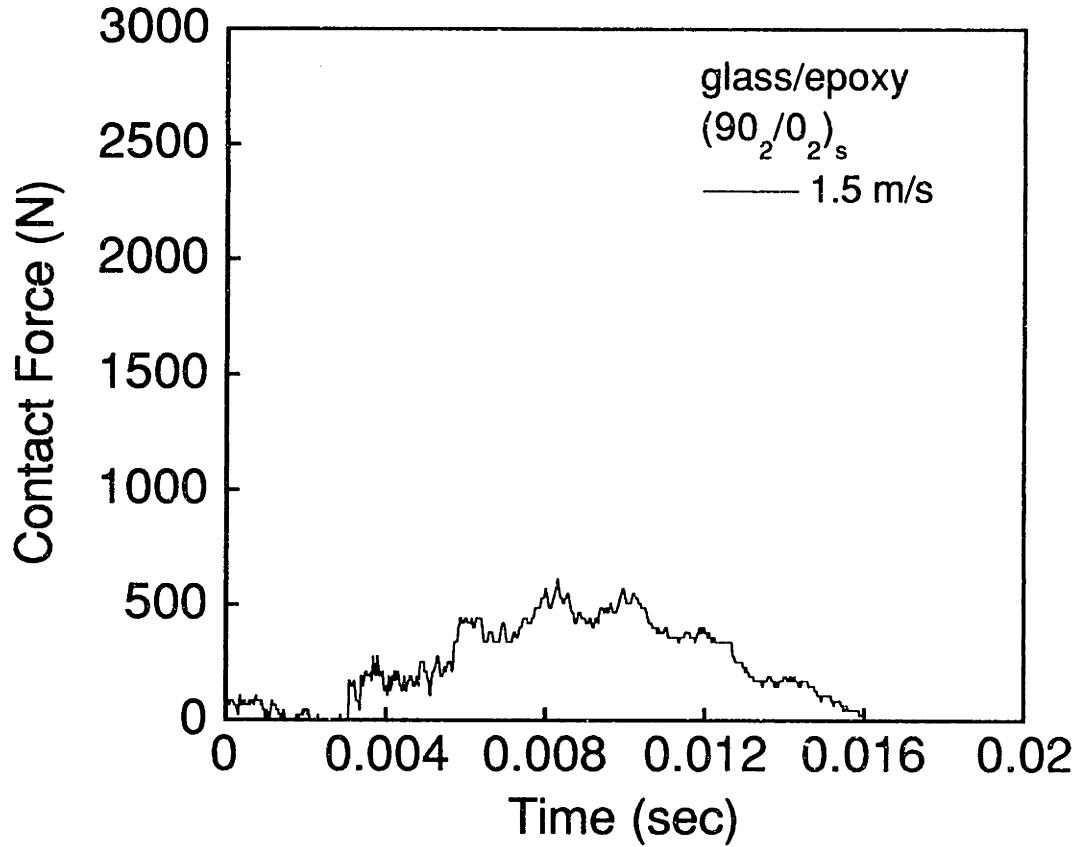
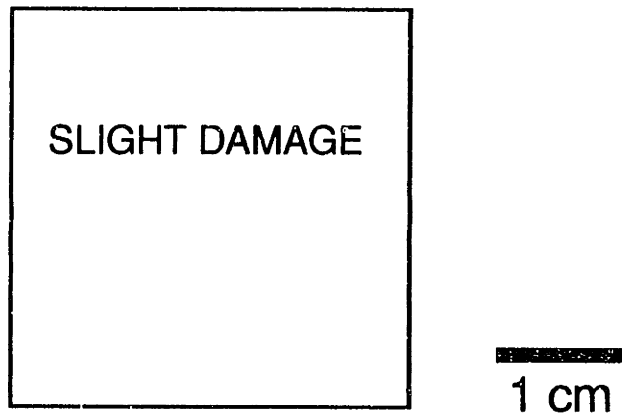
Figure A.123 (upper) Force versus time and (lower) photograph for glass/epoxy (90₂/0₂)_s specimen impacted at 1.5 m/s.

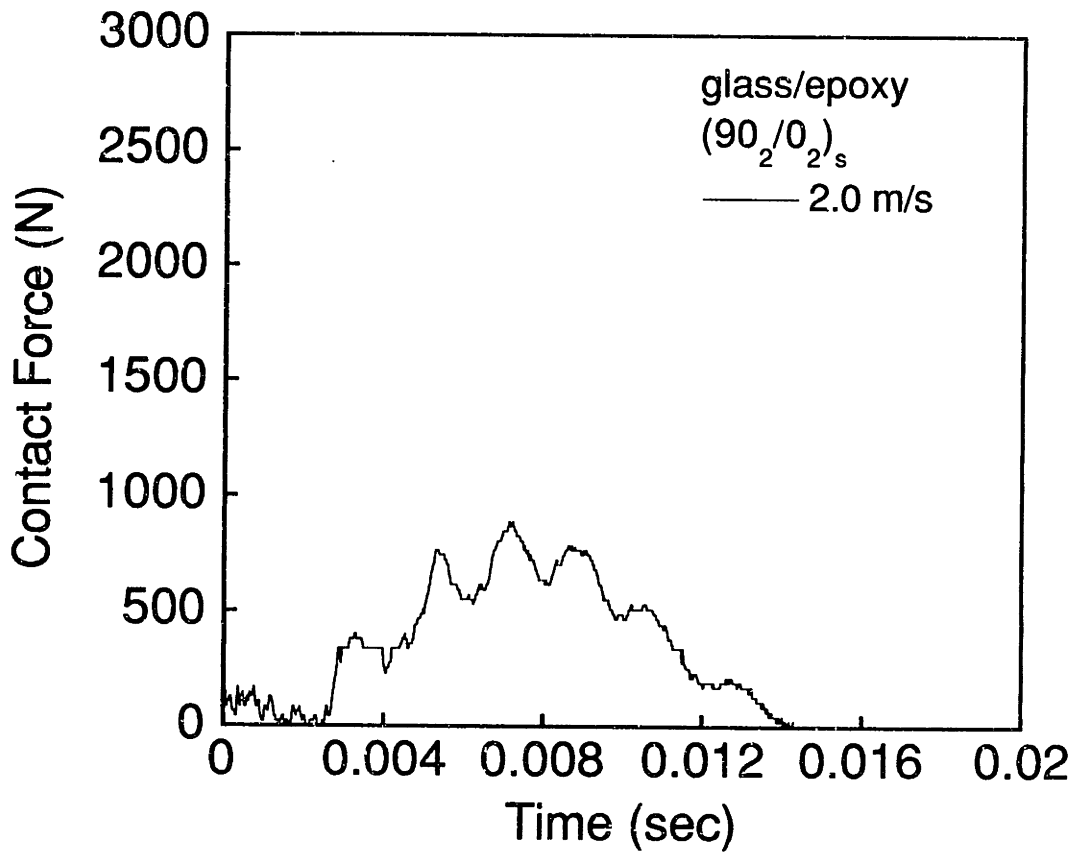
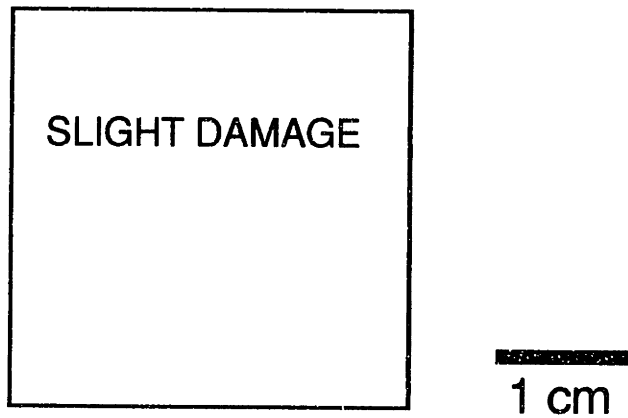
Figure A.124 (upper) Force versus time and (lower) photograph for glass/epoxy (90₂/0₂)_s specimen impacted at 2.0 m/s.

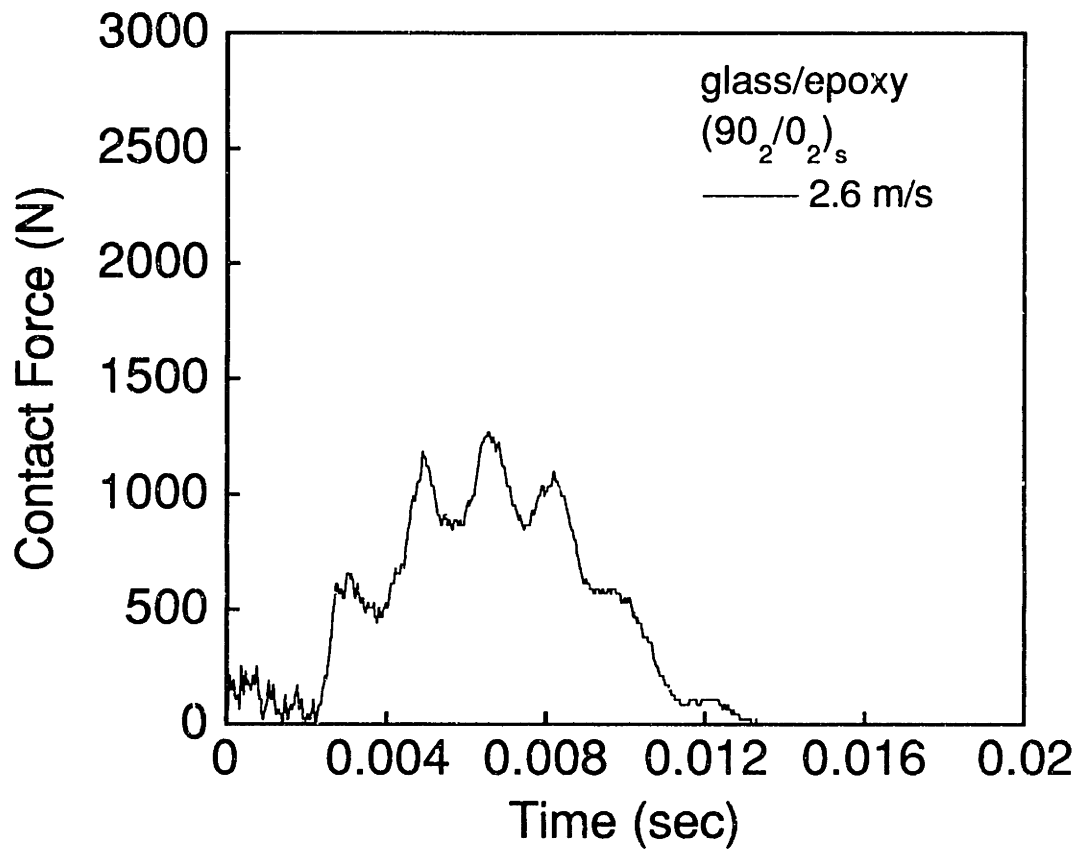
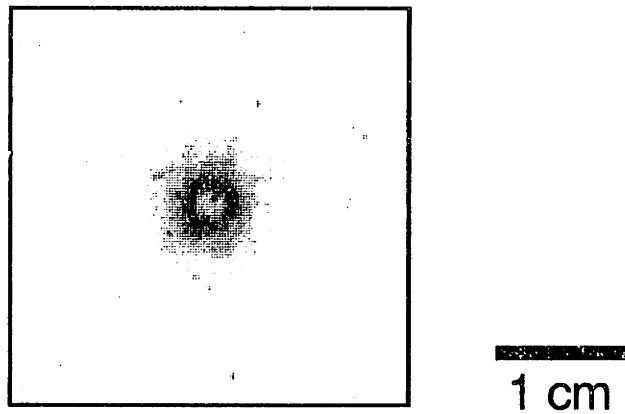
Figure A.125 (upper) Force versus time and (lower) photograph for glass/epoxy (90₂/0₂)_s specimen impacted at 2.6 m/s.

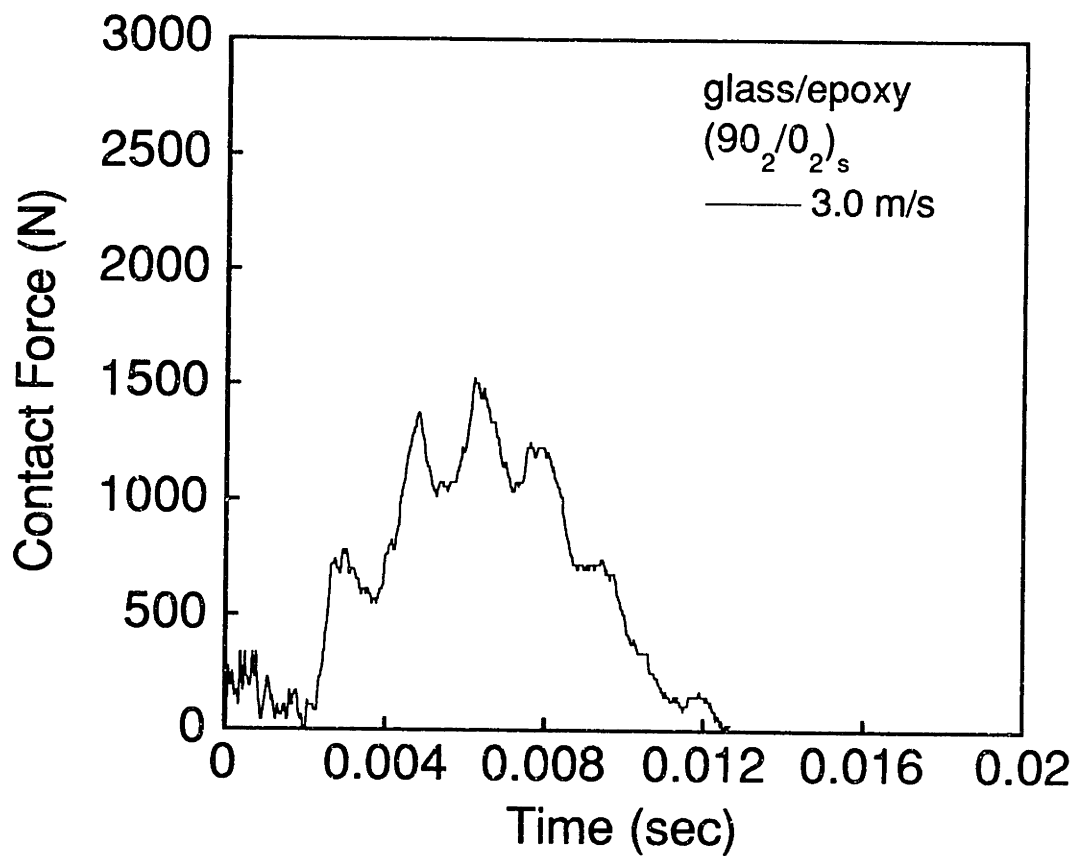
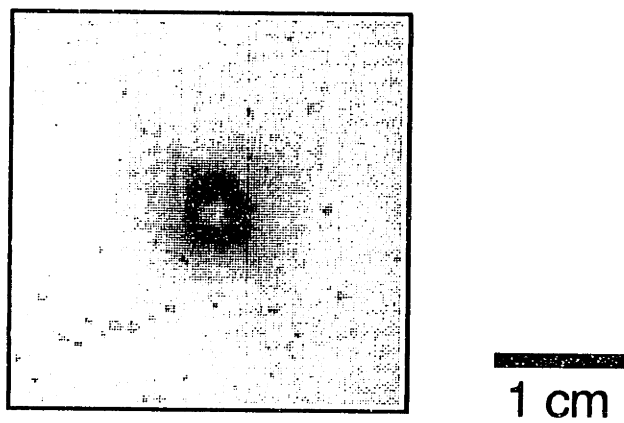
Figure A.126 (upper) Force versus time and (lower) photograph for glass/epoxy (90₂/0₂)_s specimen impacted at 3.0 m/s.

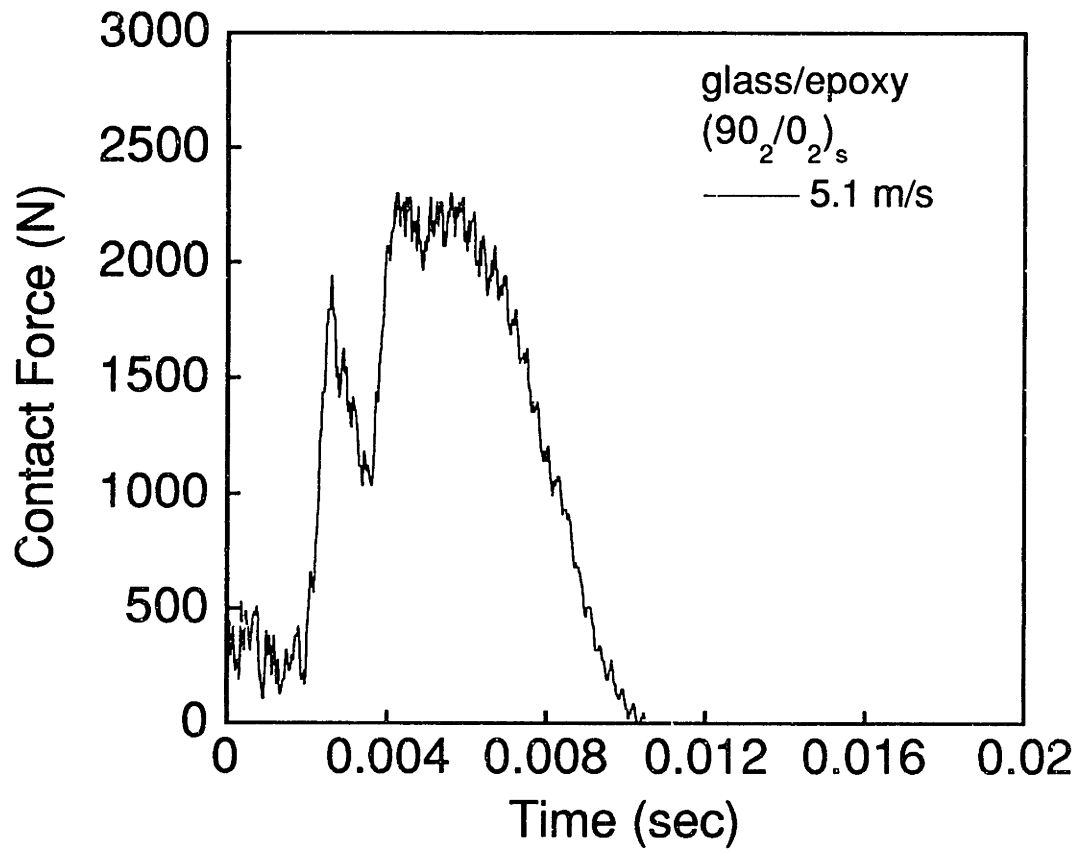
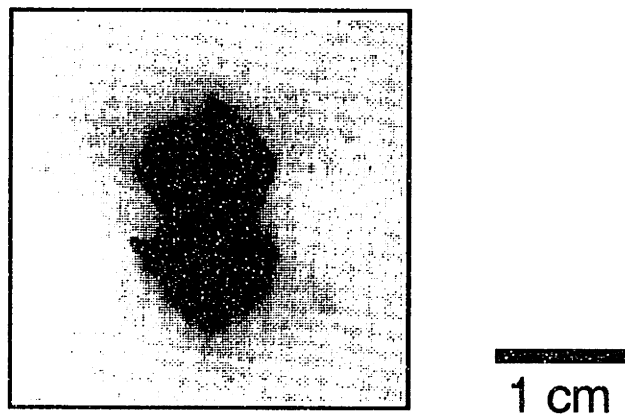
Figure A.127 (upper) Force versus time and (lower) photograph for glass/epoxy (90₂/0₂)_s specimen impacted at 5.1 m/s.

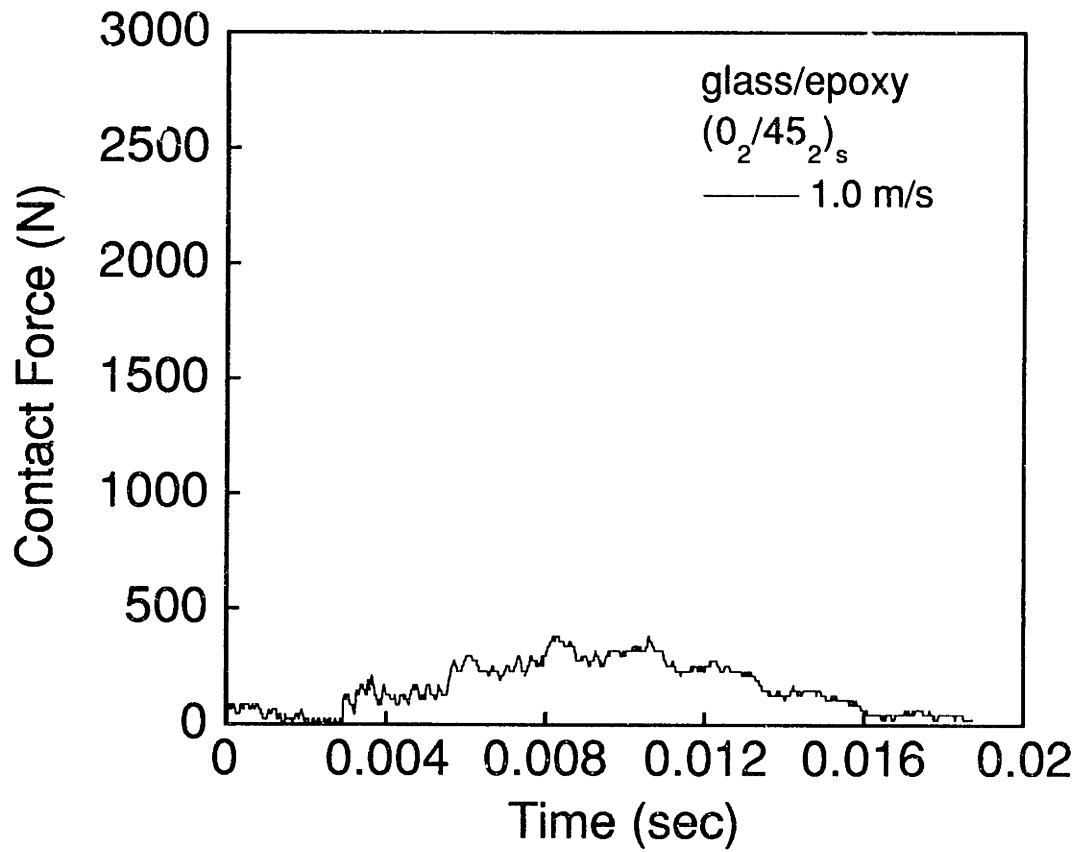
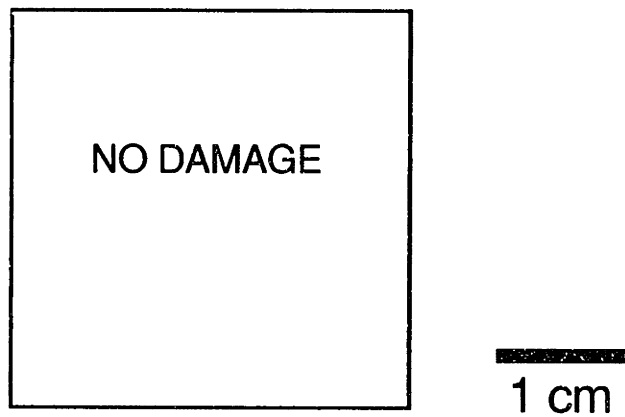
Figure A.128 (upper) Force versus time and (lower) photograph for glass/epoxy (0₂/45₂)_s specimen impacted at 1.0 m/s.

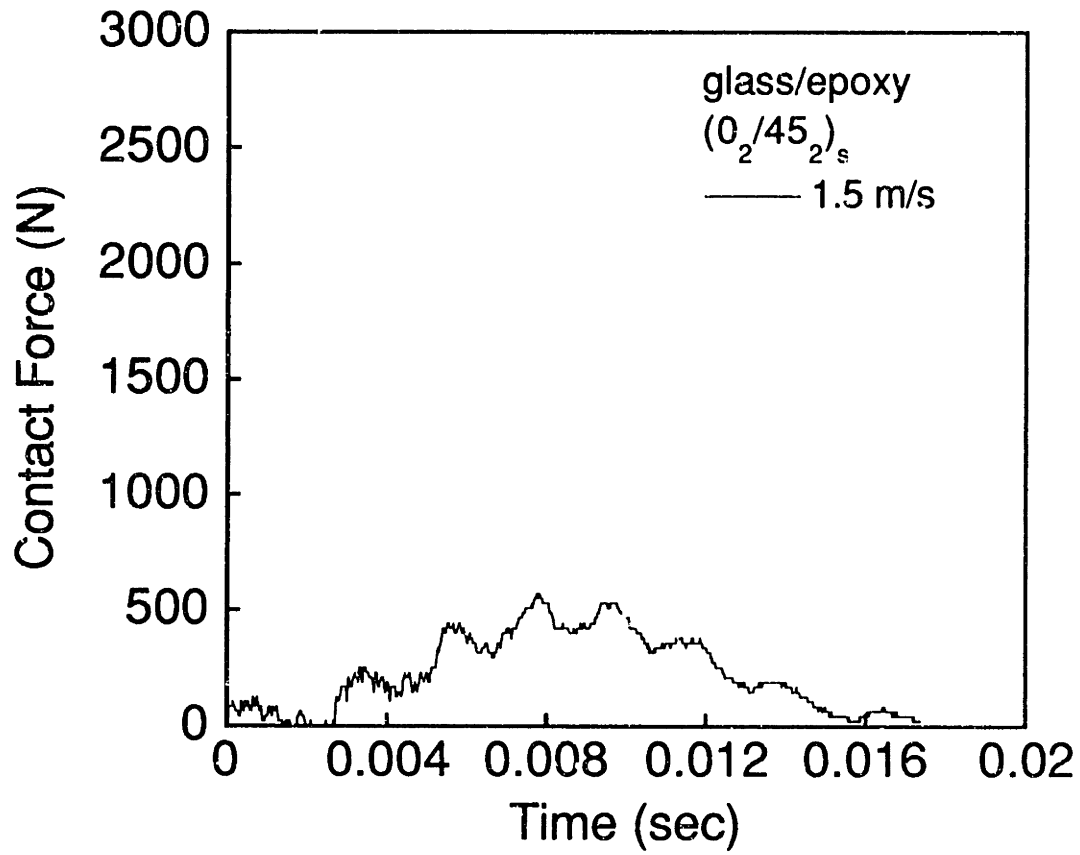
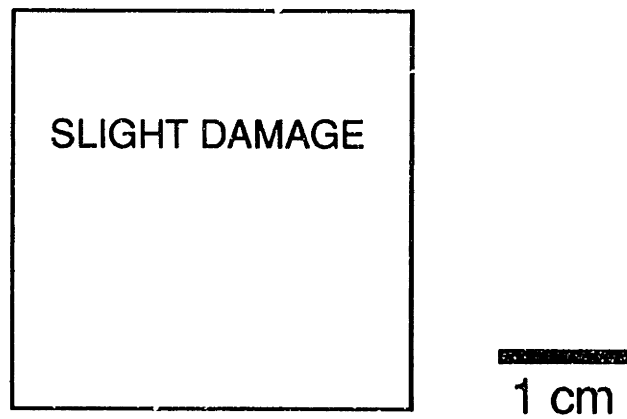
Figure A.129 (upper) Force versus time and (lower) photograph for glass/epoxy (0₂/45₂)_s specimen impacted at 1.5 m/s.

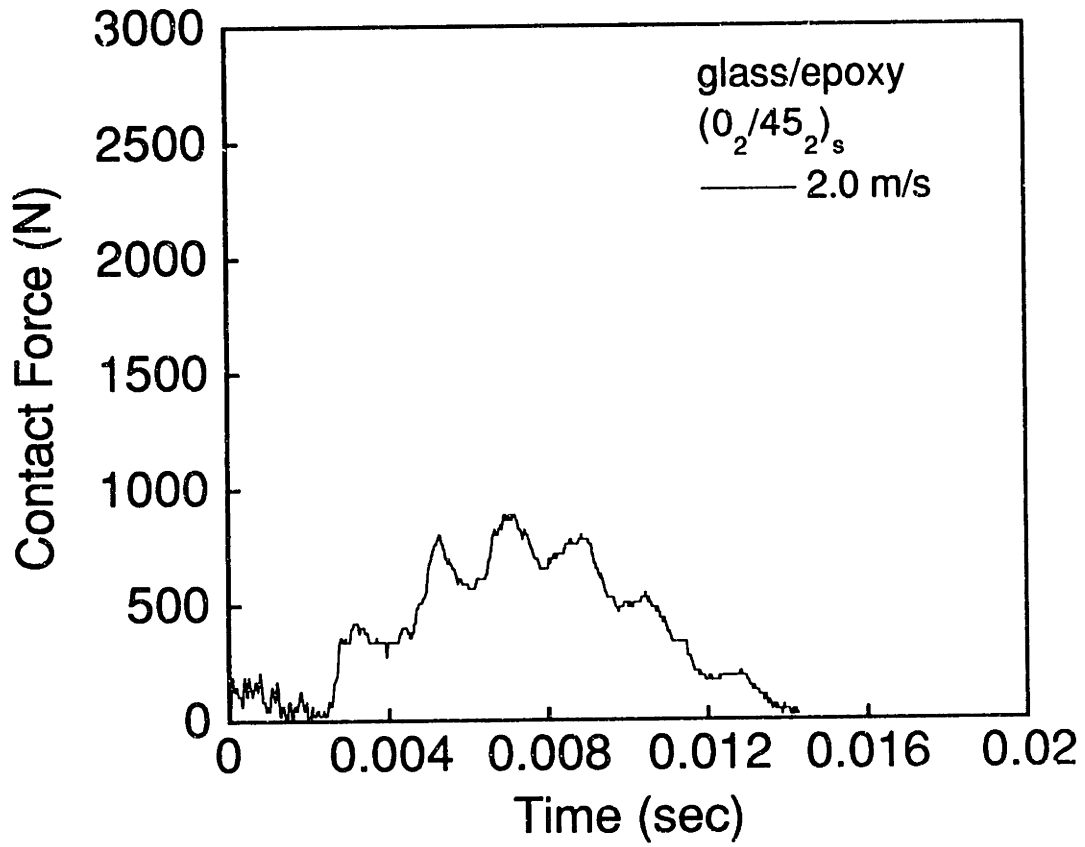
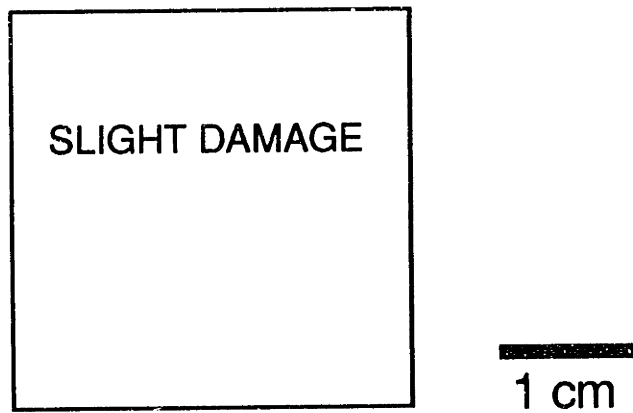
Figure A.130 (upper) Force versus time and (lower) photograph for glass/epoxy (0₂/45₂)_s specimen impacted at 2.0 m/s.

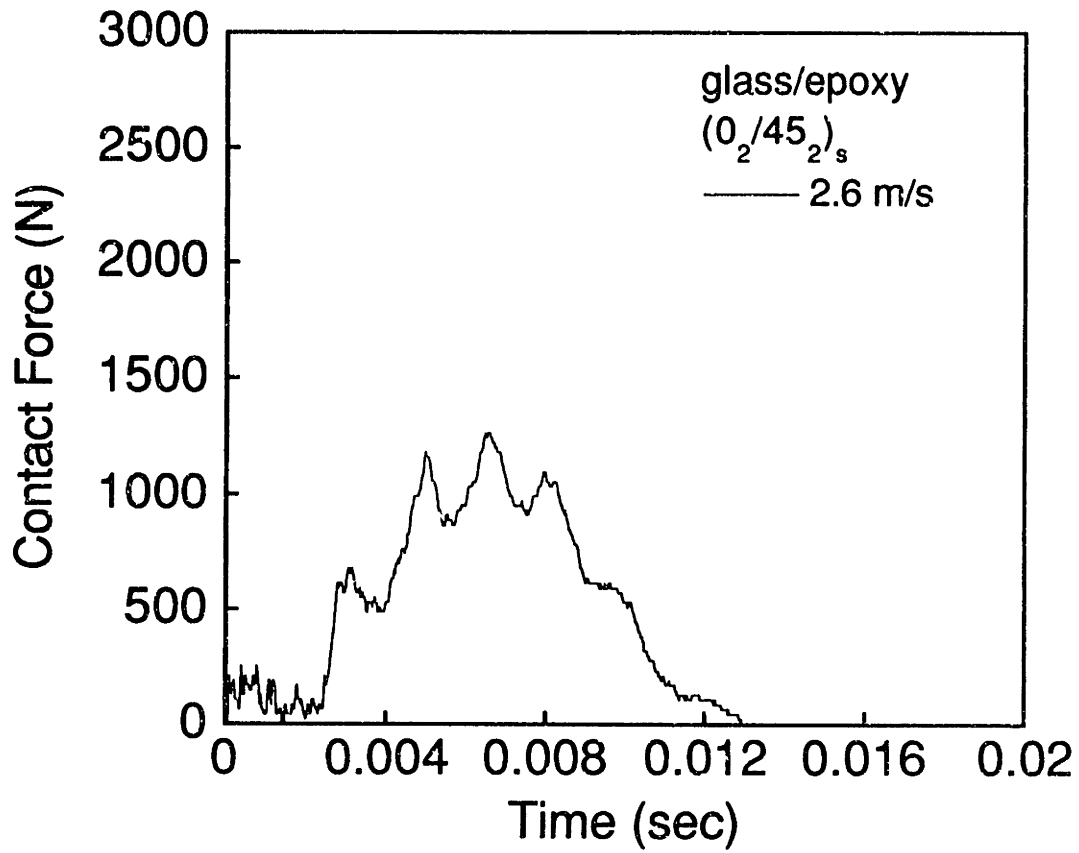
Figure A.131 (upper) Force versus time and (lower) photograph for glass/epoxy (0₂/45₂)_s specimen impacted at 2.6 m/s.

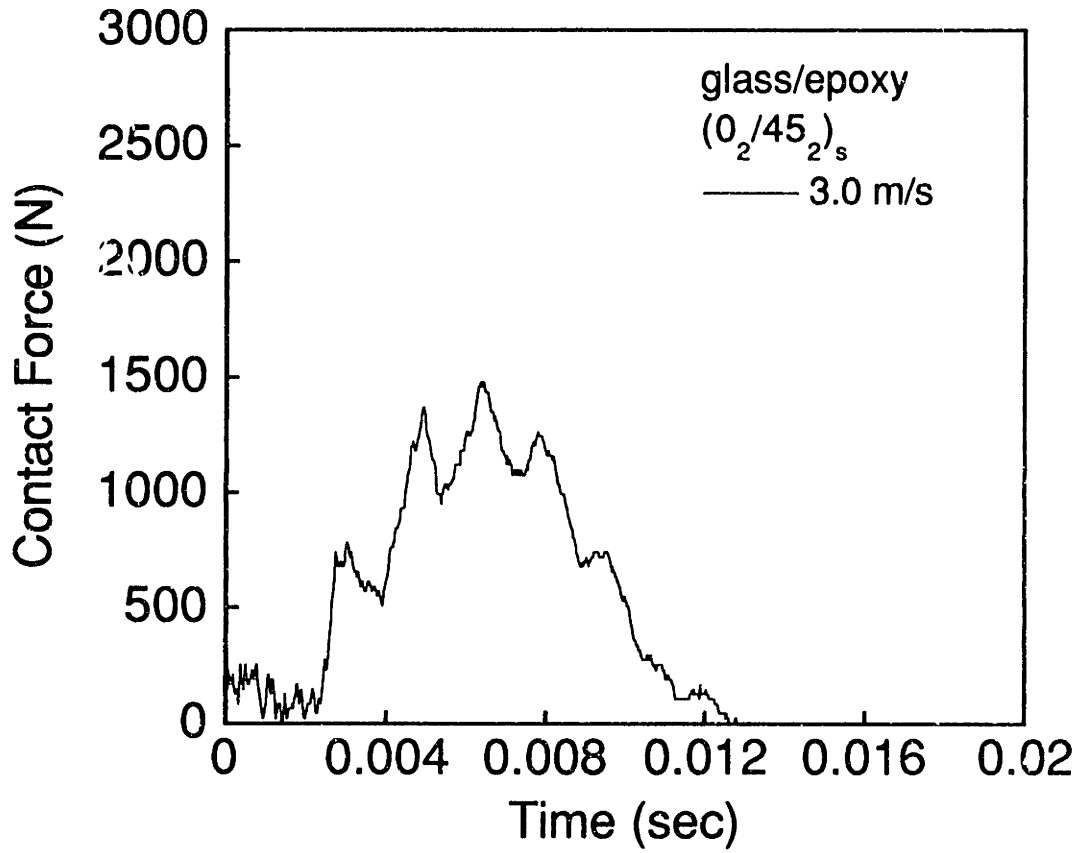
Figure A.132 (upper) Force versus time and (lower) photograph for glass/epoxy (0₂/45₂)_s specimen impacted at 3.0 m/s.

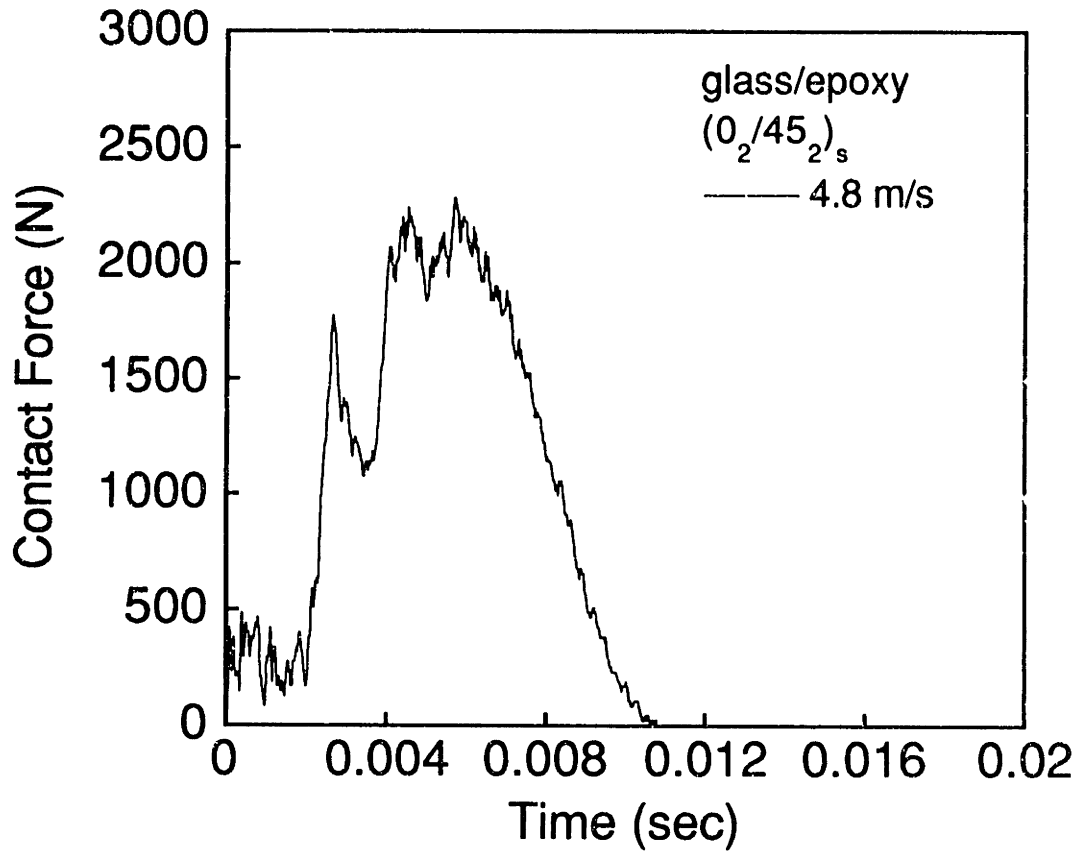
Figure A.133 (upper) Force versus time and (lower) photograph for glass/epoxy (O₂/45₂)_s specimen impacted at 4.8 m/s.

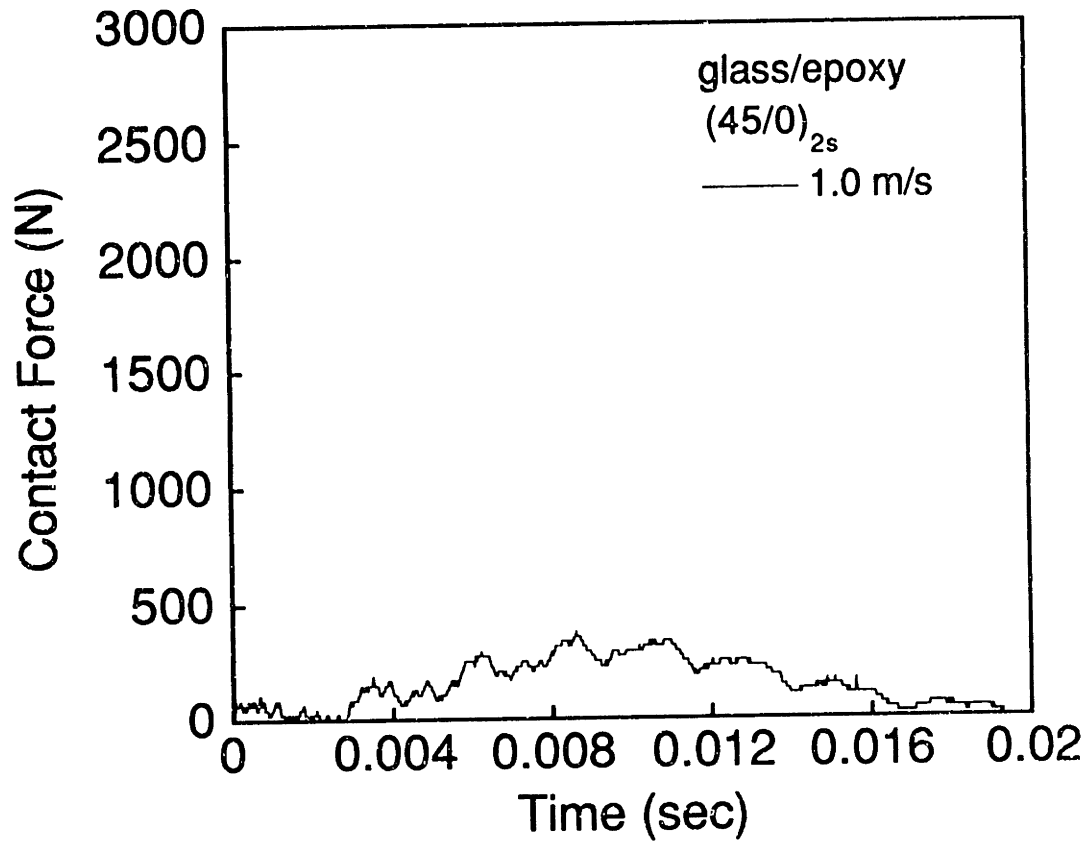
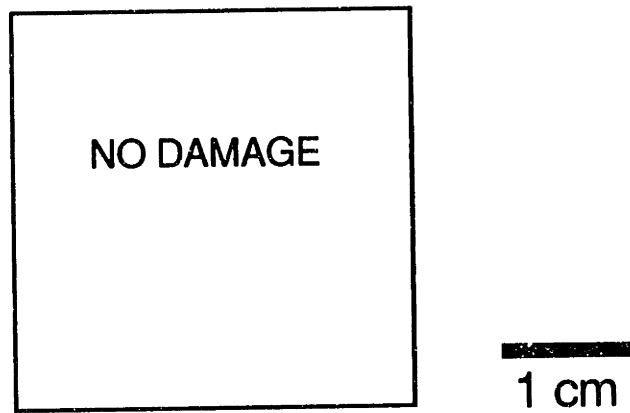
Figure A.134 (upper) Force versus time and (lower) photograph for glass/epoxy (45/0)_{2s} specimen impacted at 1.0 m/s.

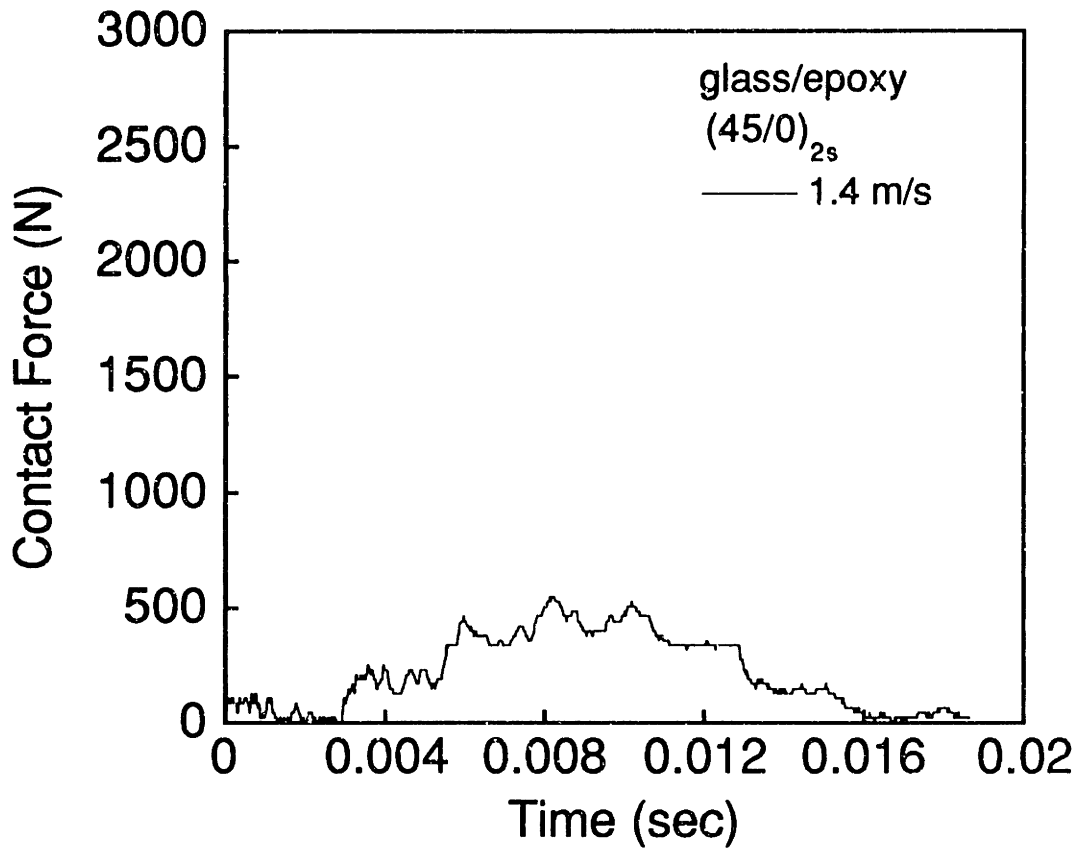
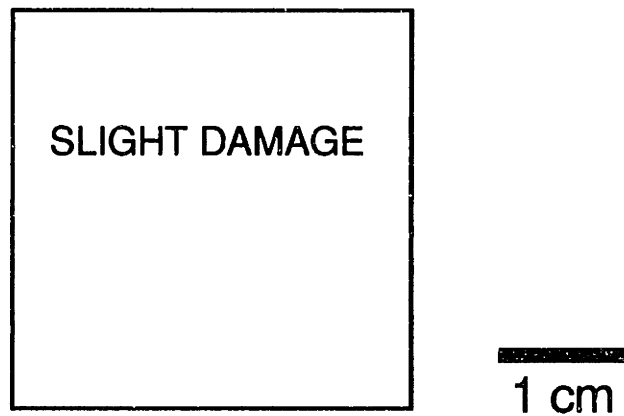
Figure A.135 (upper) Force versus time and (lower) photograph for glass/epoxy (45/0)_{2s} specimen impacted at 1.4 m/s.
