IMPACT DAMAGE MECHANISMS IN SEVERAL LAMINATED MATERIAL SYSTEMS

Submitted to the Department of Aeronautics and Astronautics in Partial
Fulfillment of the Requirements for the Degree of

MASTER OF SCIENCE

MASSACHUSETTS INSTITUTE OF TECHNOLOGY

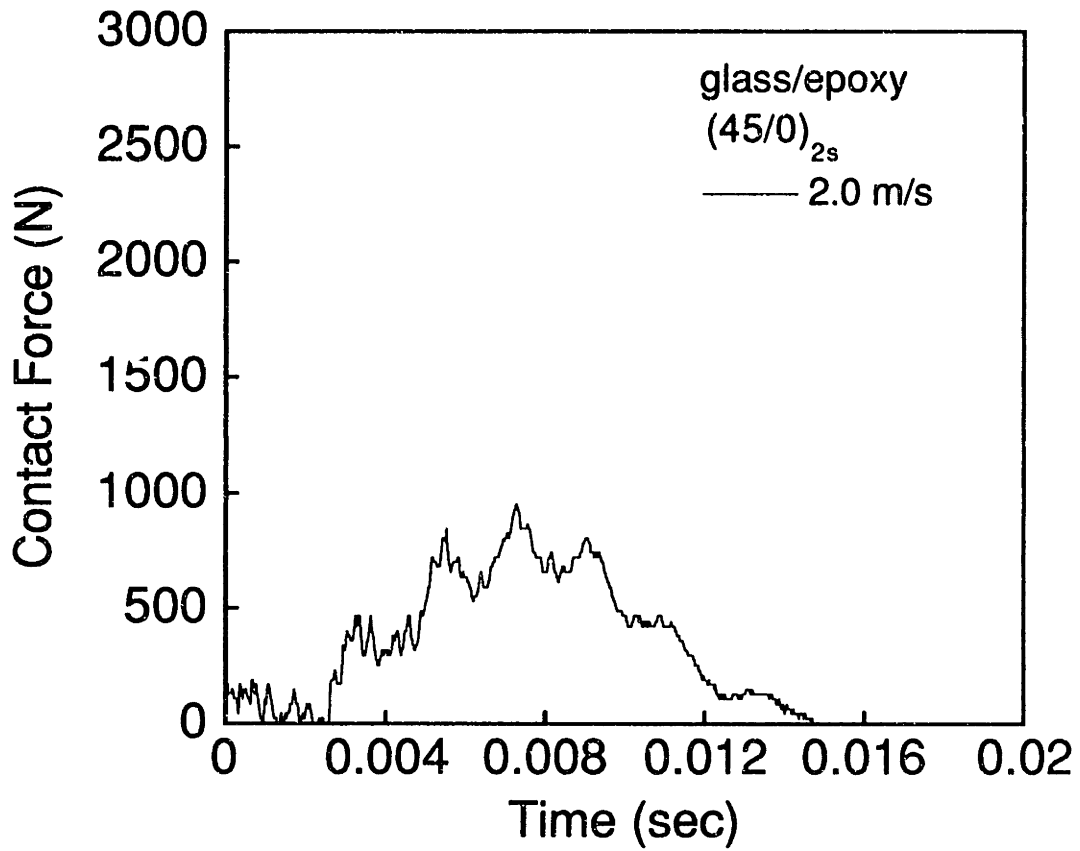
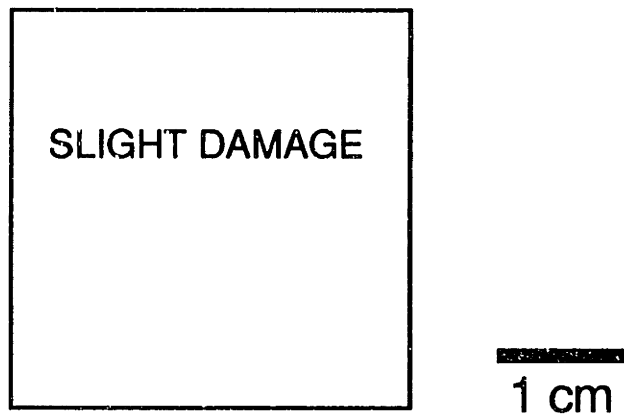
Figure A.136 (upper) Force versus time and (lower) photograph for glass/epoxy (45/0)_{2s} specimen impacted at 2.0 m/s.

For the glass/epoxy specimens, each force-time signature is accompanied by a photograph of the damage state in the cases where the damage was extensive enough to be photographed. Where damage to the specimen was very slight, the damage was detected visually on the specimens, but was not easily photographed. Therefore, photographs of the damage states of these specimens are not provided. Instead, the words "SLIGHT DAMAGE" appear.

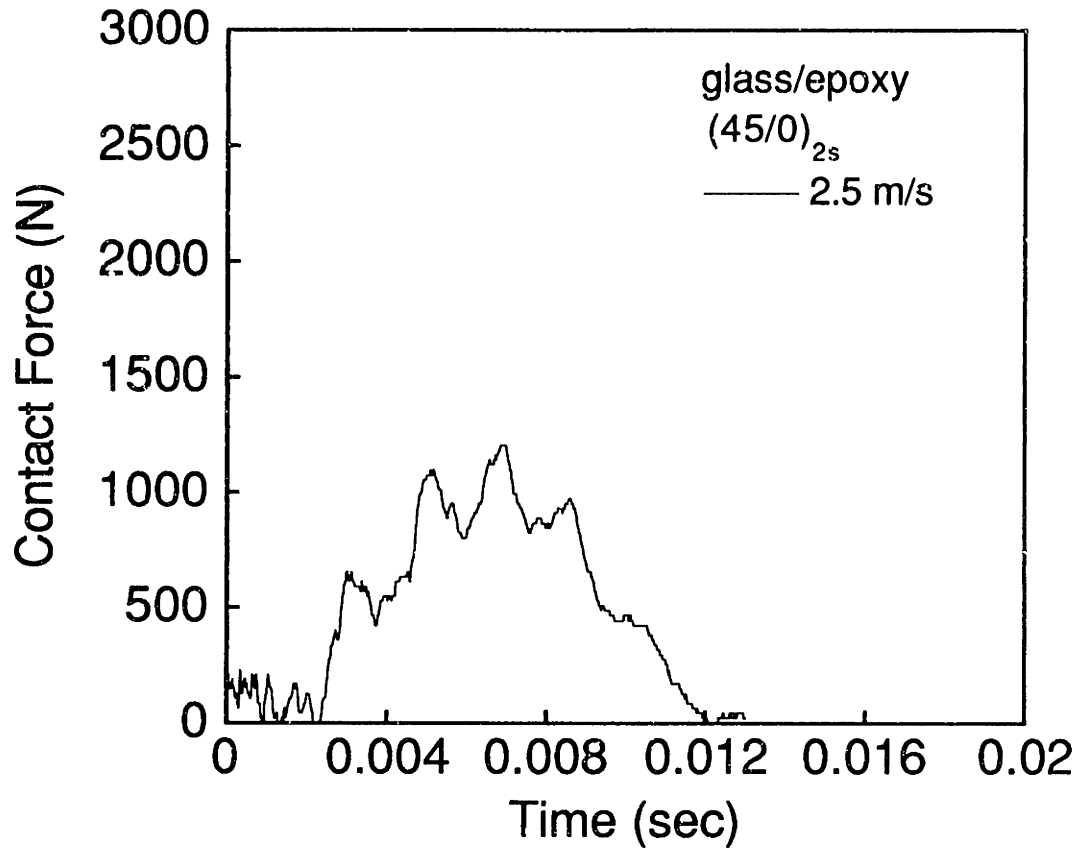
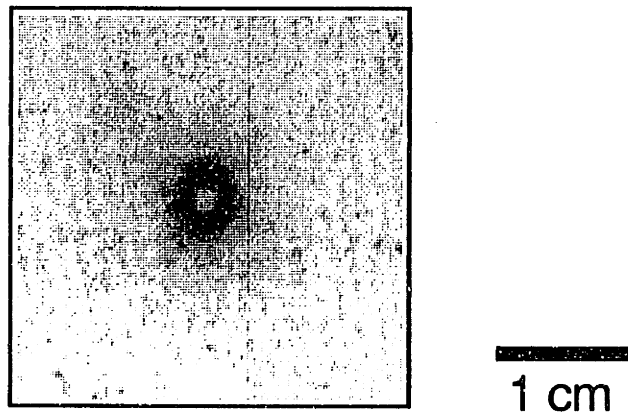
Figure A.137 (upper) Force versus time and (lower) photograph for glass/epoxy (45/0)_{2s} specimen impacted at 2.5 m/s.

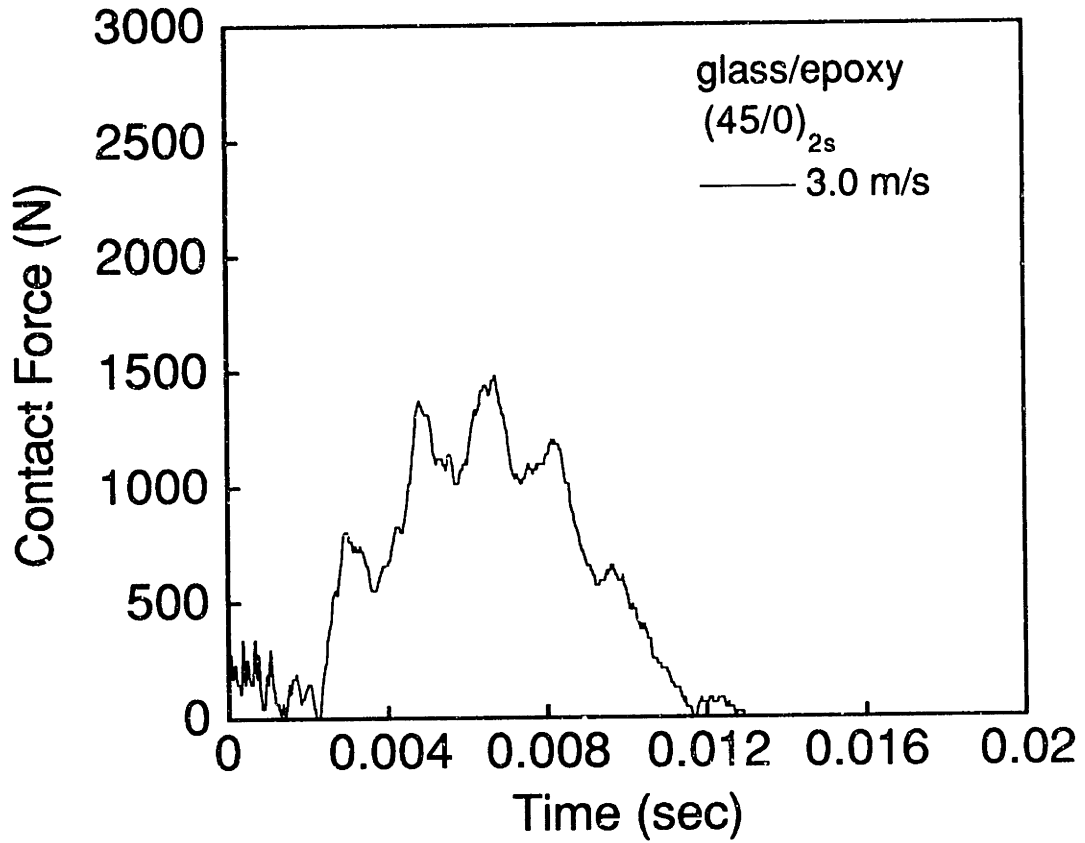
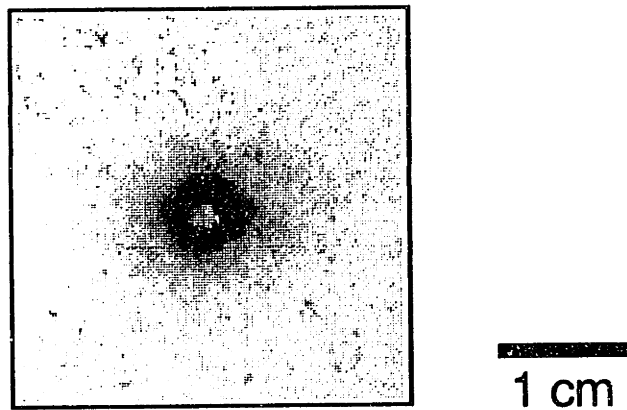
Figure A.138 (upper) Force versus time and (lower) photograph for glass/epoxy (45/0)_{2s} specimen impacted at 3.0 m/s.

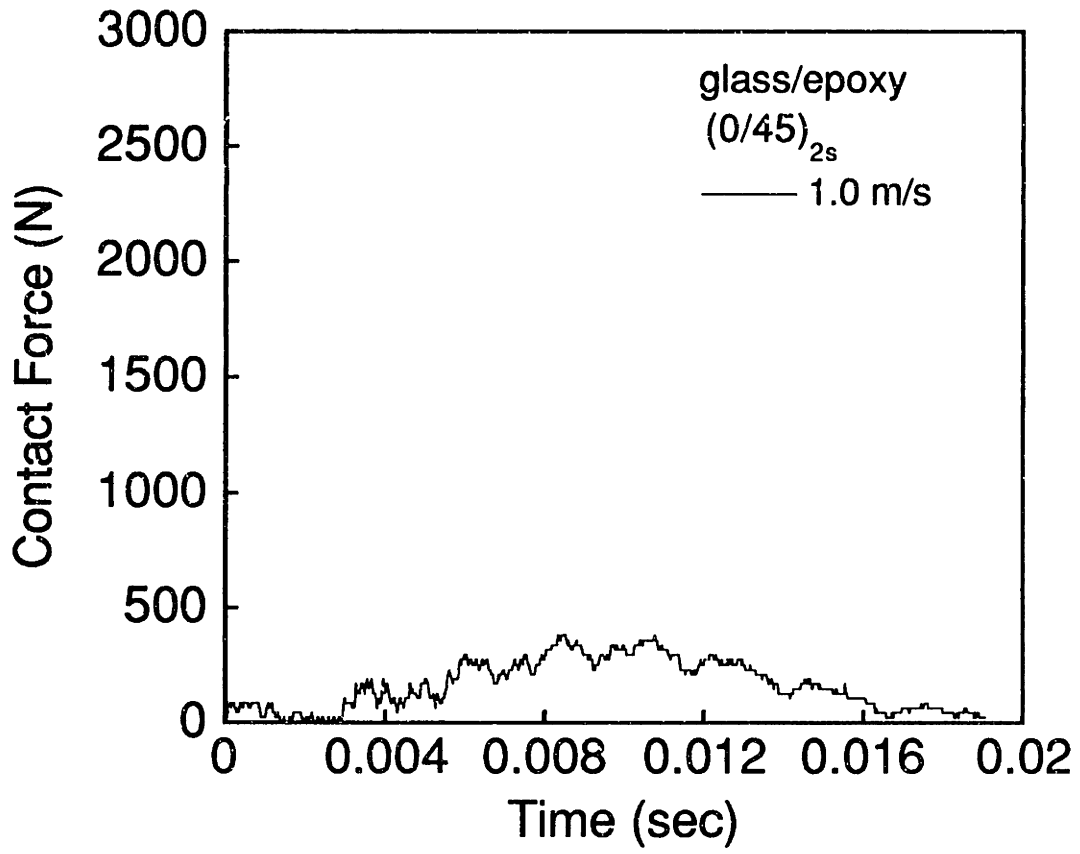
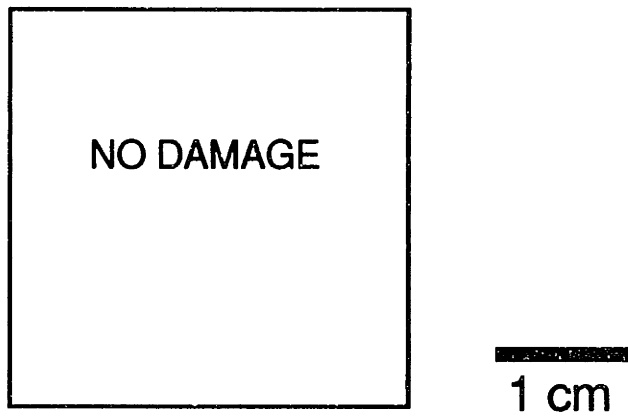
Figure A.139 (upper) Force versus time and (lower) photograph for glass/epoxy (0/45)_{2s} specimen impacted at 1.0 m/s.

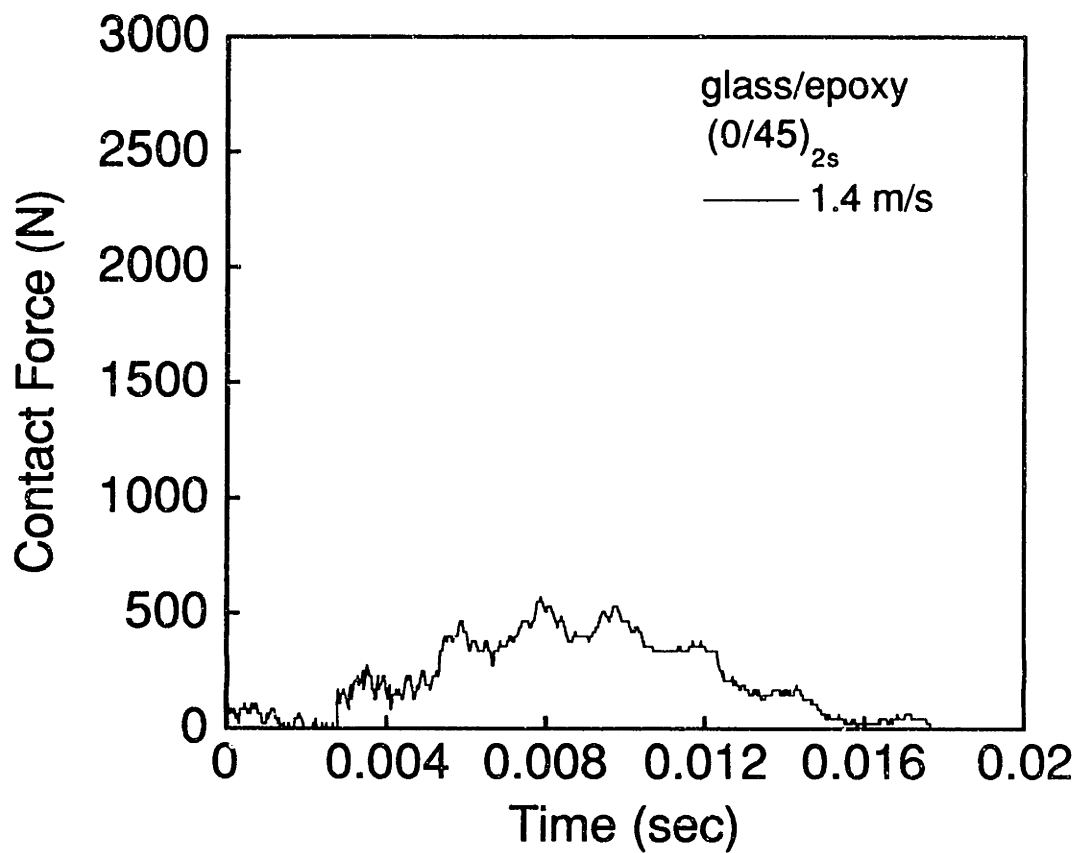
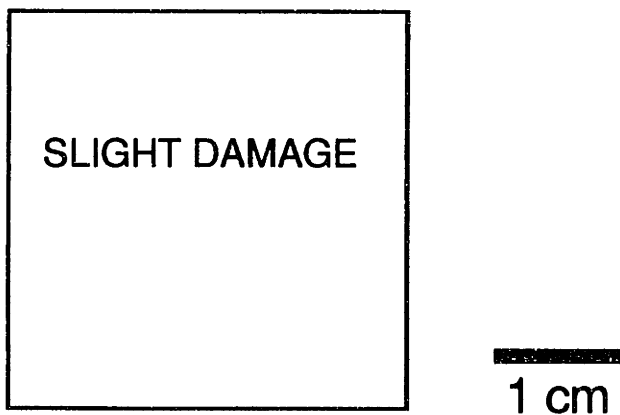
Figure A.140 (upper) Force versus time and (lower) photograph for glass/epoxy (0/45)_{2s} specimen impacted at 1.4 m/s.

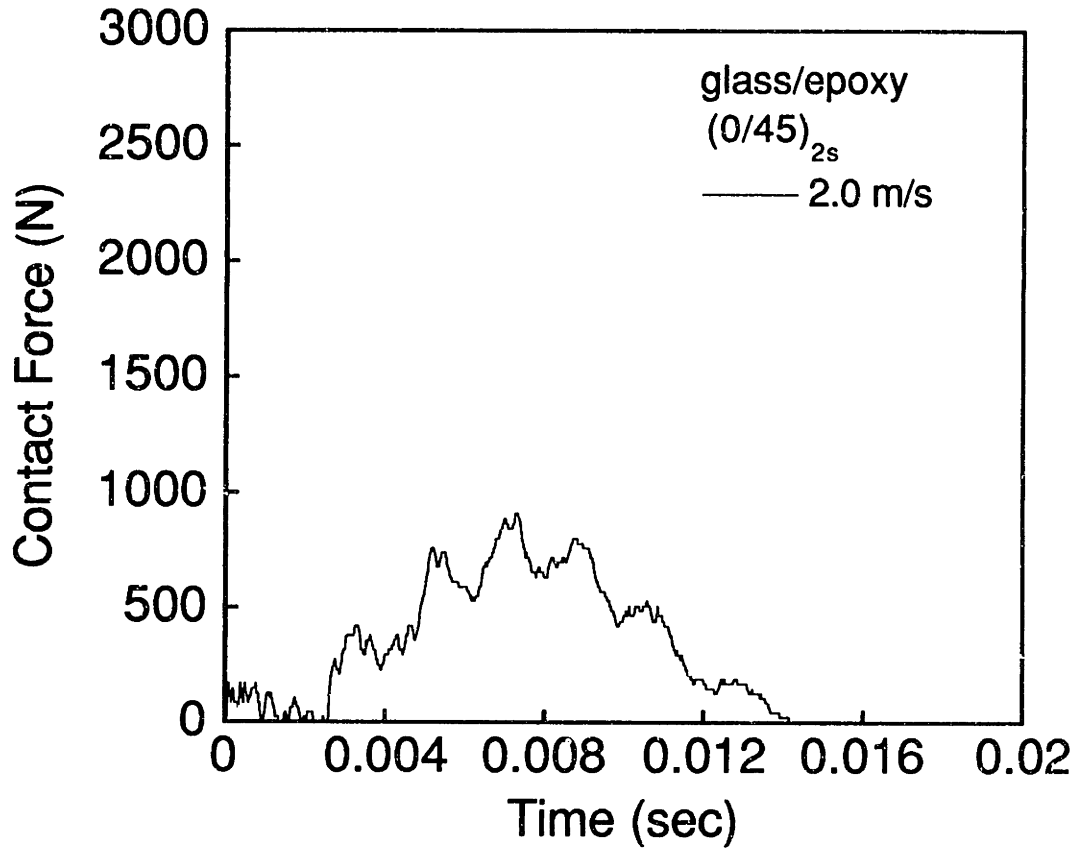
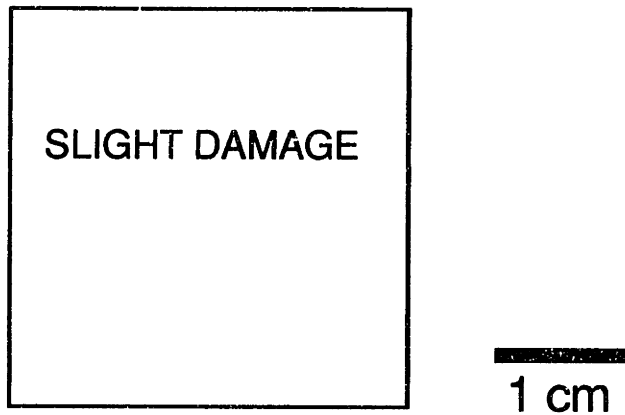
Figure A.141 (upper) Force versus time and (lower) photograph for glass/epoxy (0/45)_{2s} specimen impacted at 2.0 m/s.

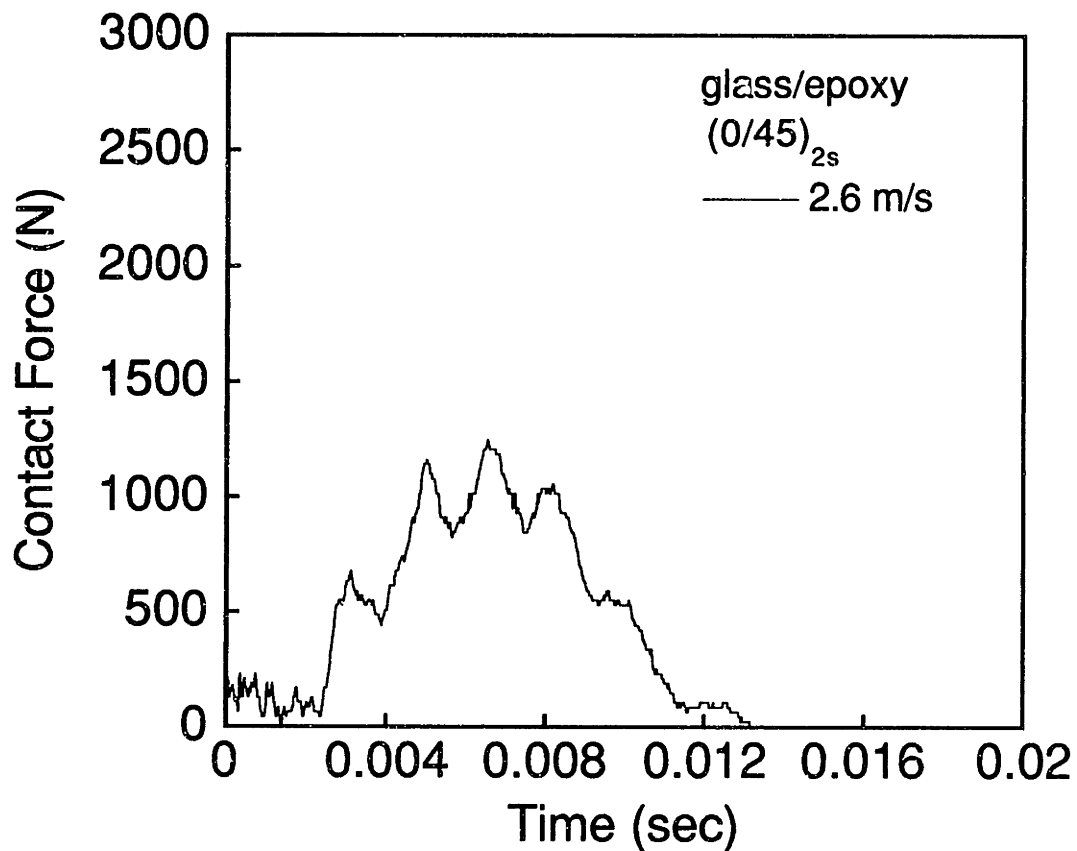
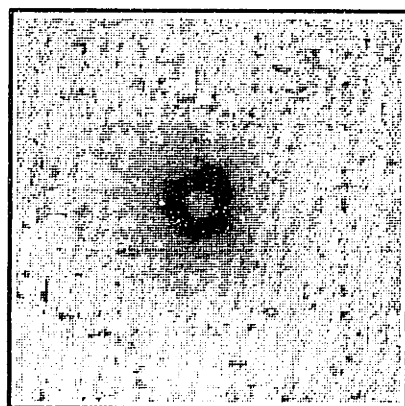
Figure A.142 (upper) Force versus time and (lower) photograph for glass/epoxy (0/45)_{2s} specimen impacted at 2.6 m/s.

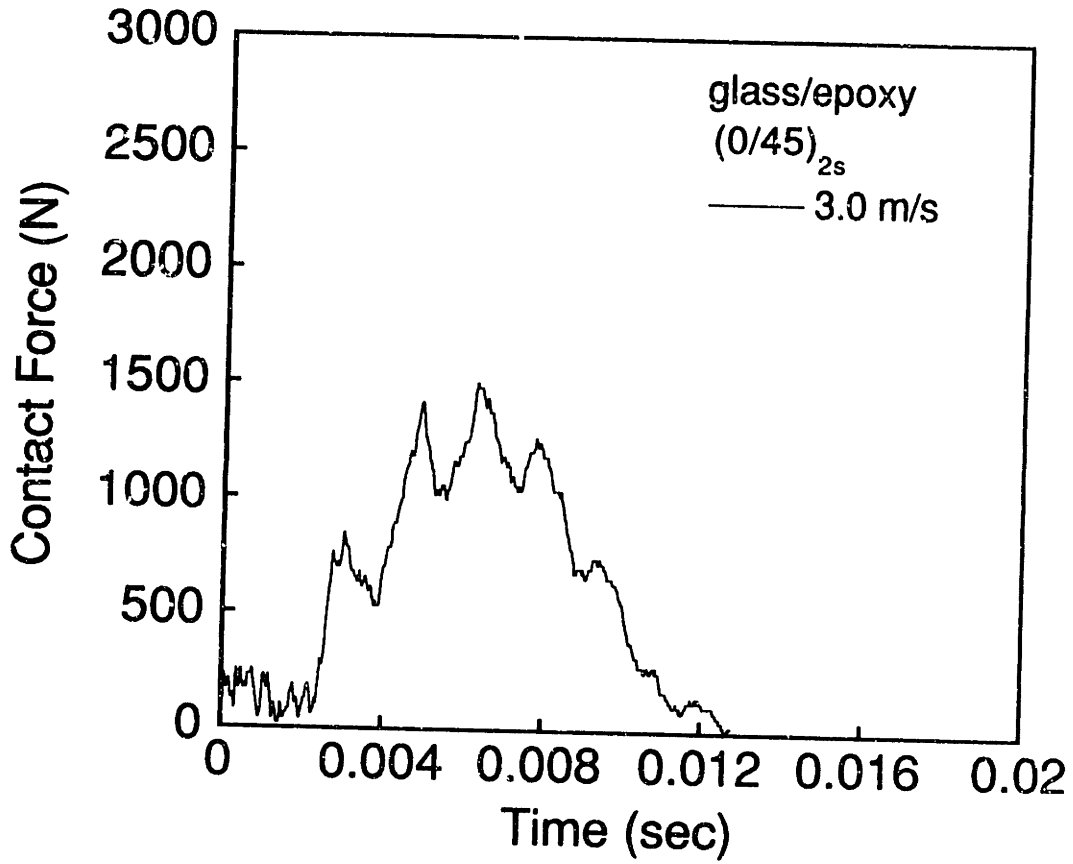
Figure A.143 (upper) Force versus time and (lower) photograph for glass/epoxy $(0/45)_{2s}$ specimen impacted at 3.0 m/s.

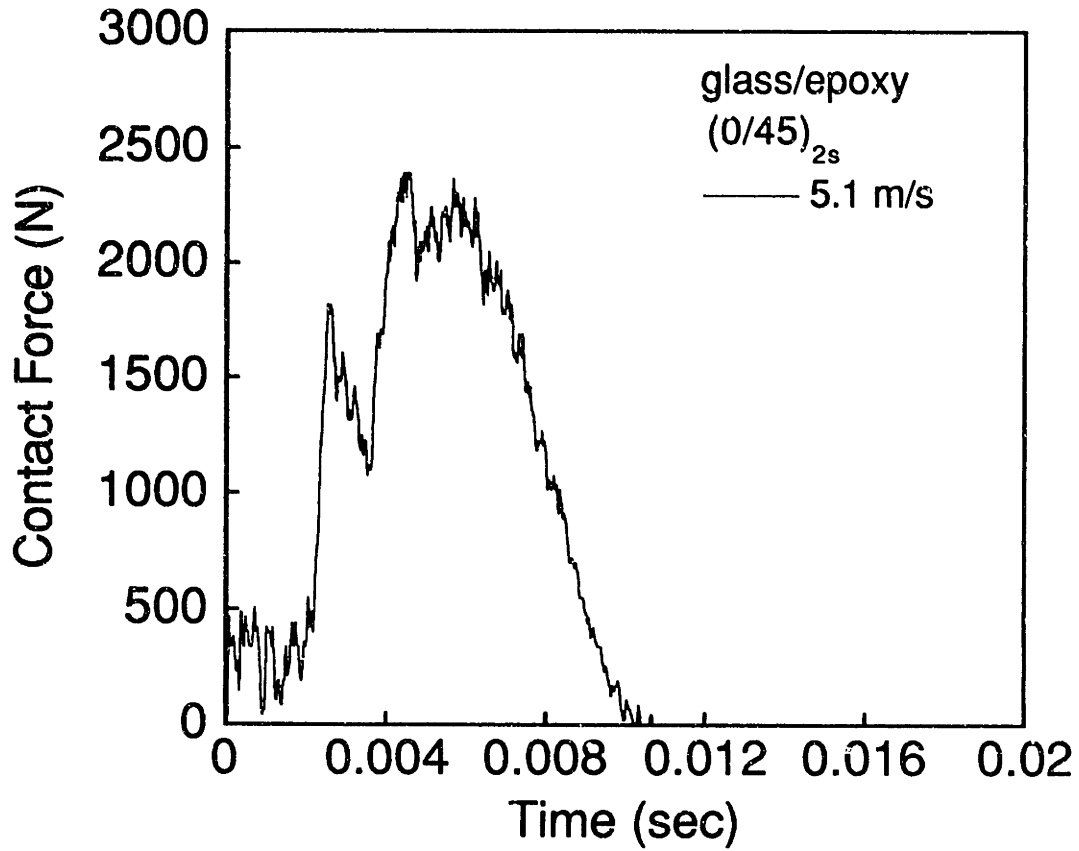
Figure A.144 (upper) Force versus time and (lower) photograph for glass/epoxy (0/45)_{2s} specimen impacted at 5.1 m/s.
