THE FRACTOGRAPHY OF INORGANIC GLASS

Submitted in partial fulfillment of the requirements
for the degree of

MASTER OF SCIENCE

Massachusetts Institute of Technology

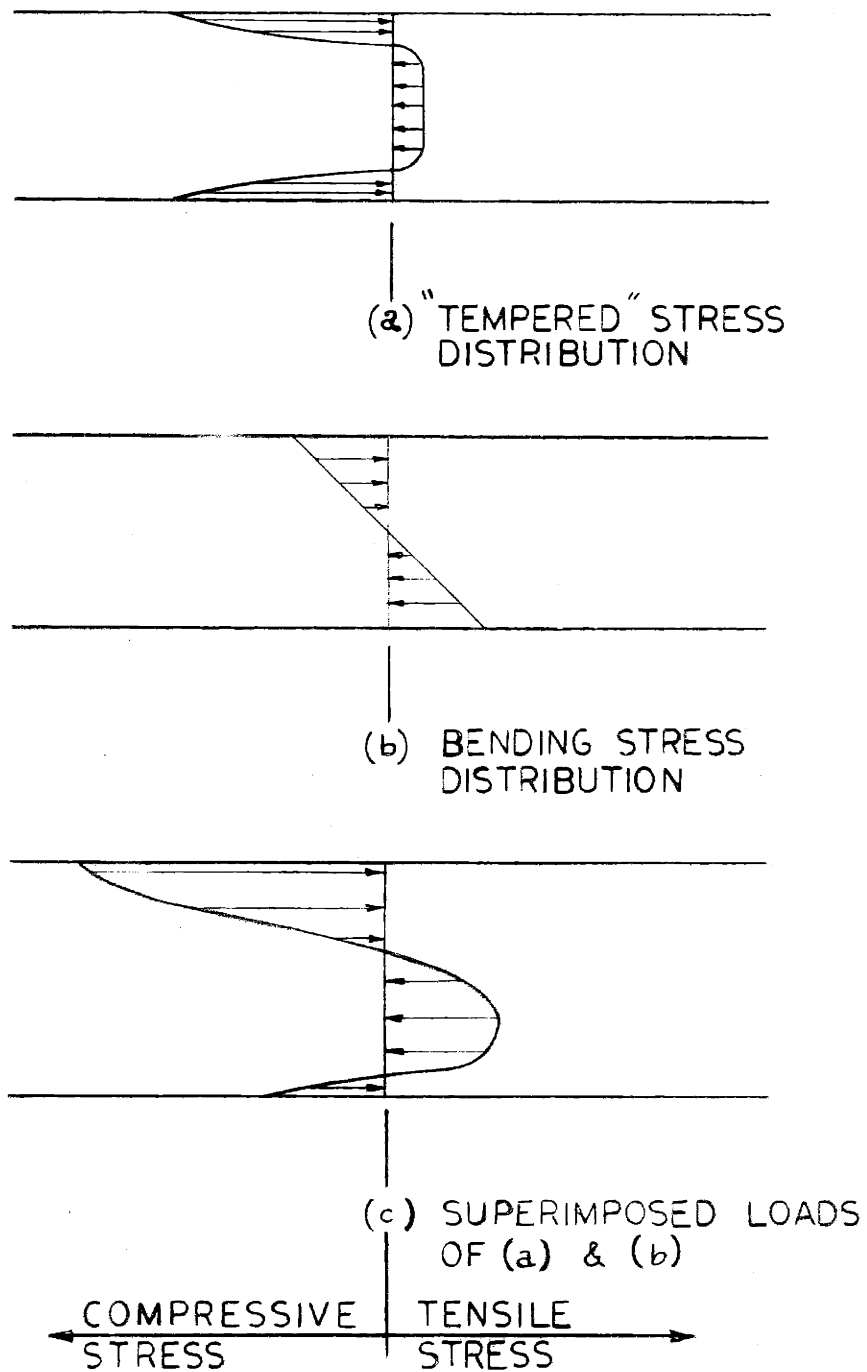
FIGURE 3: MECHANICAL & RESIDUAL STRESS DISTRIBUTIONS

body is still above T_g , and hence fluid. In this state, stresses can relax out in the liquid interior. When the central region eventually cools and becomes rigid its molecular structure densifies producing compressive stresses in the surface and tensile stresses in the interior. The stress distribution is as shown in Figure 3a. Compressive stresses as high as 10,000 to 15,000 psi can easily be achieved by this method. In use, no tensile stress will be produced in the glass surface until the residual compressive stress is overcome, as shown in Figure 3c where the bending stress shown in Figure 3b is superimposed on the residual stress of 3a.

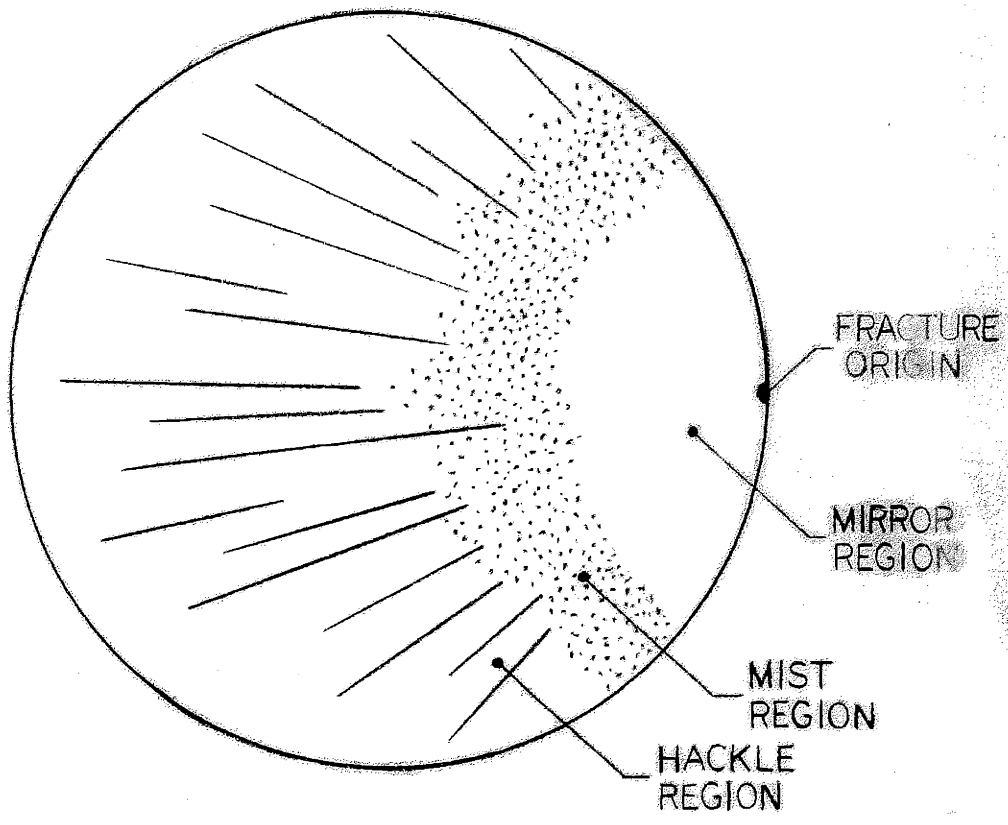
FIGURE 4: TYPICAL FRACTURE SURFACE MORPHOLOGY

There are generally three distinct zones adjacent to the point of origin as illustrated in Figure 4 and Photo 1. The region nearest the origin is a smooth area marked by small ripples which are visible in reflected light. This region, known as the mirror, is bounded by a narrow band of hazy surface, known as mist, which in turn gives way to a very coarse hackled region. Higher magnification shows that the surface irregularities in the mist region resemble those in the hackled region, but on a smaller scale, and so are termed micro-hackle. The mist region represents an insipient stage in the progression of surface roughness from mirror to hackle. The coarse hackles are oriented parallel to the direction of crack advance. The sequence of mirror to hackle portrays the crack front's response to an increasing rate in the release of elastic strain energy during the fracture process. As the crack tip enters a region of high elastic energy release rate, it tends to maximize the fracture surface area created in an attempt to

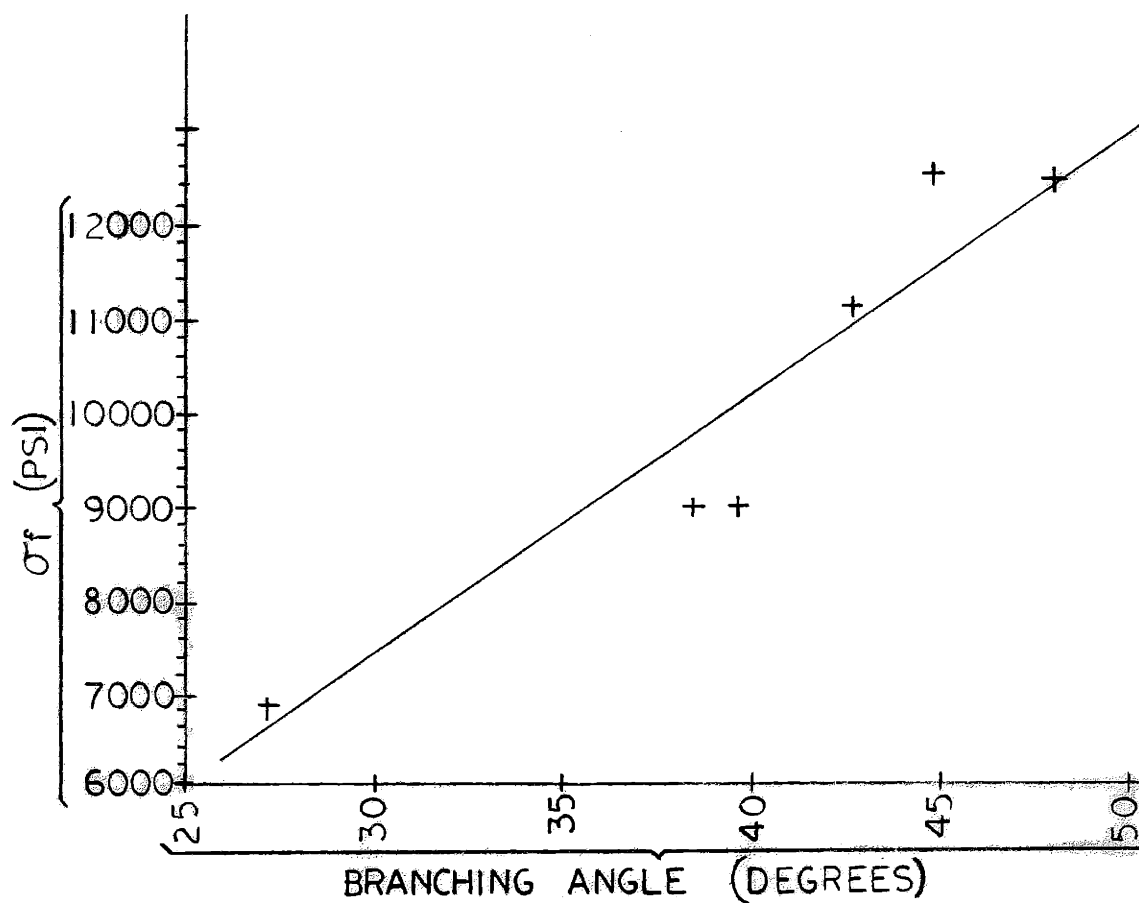
FIGURE 13 : ANGLE OF CRACK BRANCHING VS. FRACTURE STRESS (σ_f) FOR ANNEALED GLASS FRACTURED BY BENDING

Preston's research on the angle of crack branching as an indicator of the stress system was discussed in Section III above. He showed that the angle at which the crack front diverges is related to the ratio of the biaxial stress components in thin plates. This research suggests a further correlation between the angle of branching and the magnitude of the breaking stress, as illustrated in Figure 13. The angle of branching for a mechanically fractured lath is shown in Photo 13.

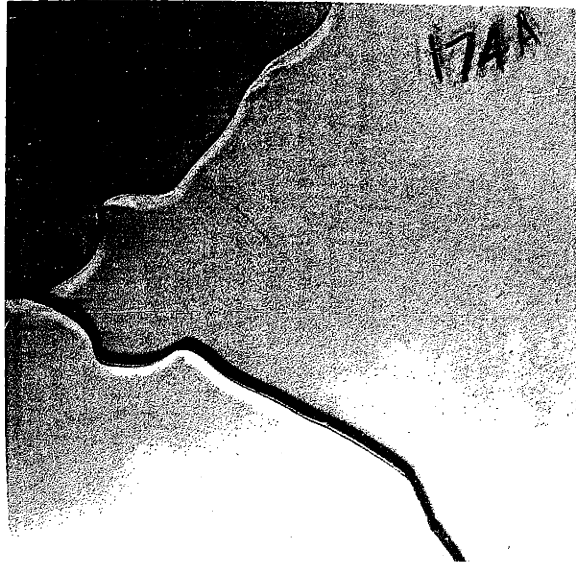
Photos 21 & 22 - Thermal Crack Patterns

The direction of thermal fracture paths was extremely varied, although all samples were heated in a similar manner. Photos 21-23 show the variety of crack patterns in plates that had no mechanical stresses superimposed on them. Initially, the crack proceeded perpendicular to the tensile stresses at the edge. Shortly after emerging from the recessed edge the cracks in most of the samples began to deflect radially about the center of heat application as shown in Photo 21. At this point the crack path became wholly unpredictable. In some cases, the fracture course changed radically and the crack turned back on itself and proceeded directly into the central heated zone as shown by the fractures in Photo 22. The reason for the crack path's tendency to redirect its propagation into the central heated region is not, as yet, understood. It is the opinion of this researcher that the alteration in path is the result of a major

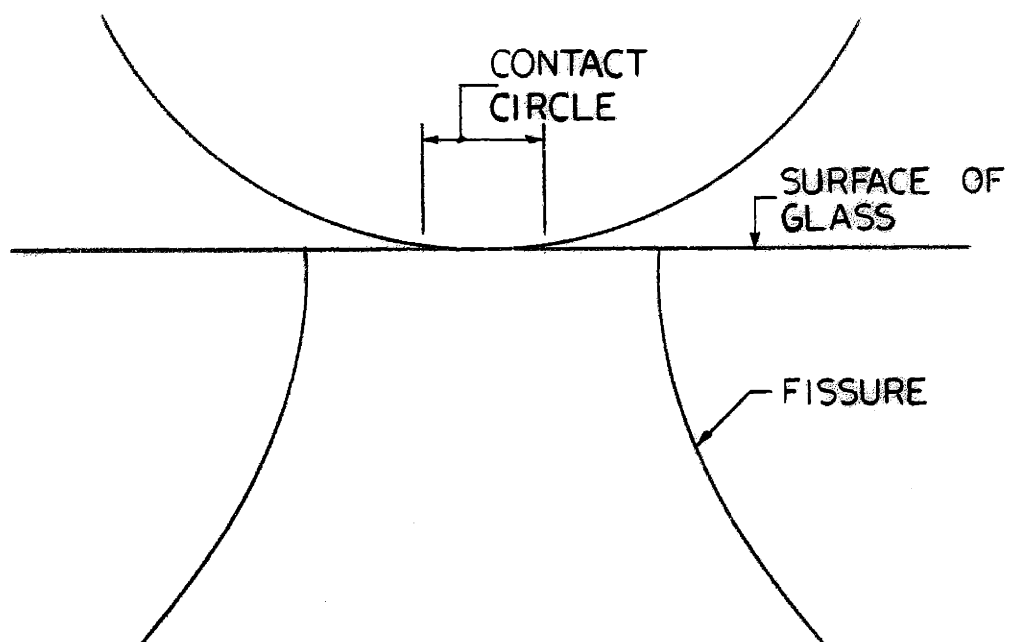
FIGURE 22 : "CONE" FRACTURE DUE TO CONTACT STRESSES IN THIN PLATES

Contact stresses are highly dependent on the shape and hardness of the impacting object. In general, a hard spherical object in contact with a flat plate will create radial tensile stresses on the contact surface at the perimeter of the contact circle and parallel to the surface of the plate. Fracture will therefore originate at the perimeter of the contact circle and perpendicular to the surface as illustrated in Figure 22. The fracture initially propagates in a cylindrical form into the body of the glass. As the fracture nears the opposite free surface of the plate the crack front develops into the classic "cone" shown in Figure 22. If the plate is thin the cylindrical portion of the fracture is negligible. A cone of fracture may also appear on the impact surface due to pulverization of the glass at the impact point.
