Nondestructive Evaluation and Underwater Repair of Composite Structures

NAVAL ENGINEER
and
MASTER OF SCIENCE IN MECHANICAL ENGINEERING

MASSACHUSETTS INSTITUTE OF TECHNOLOGY

June 2008

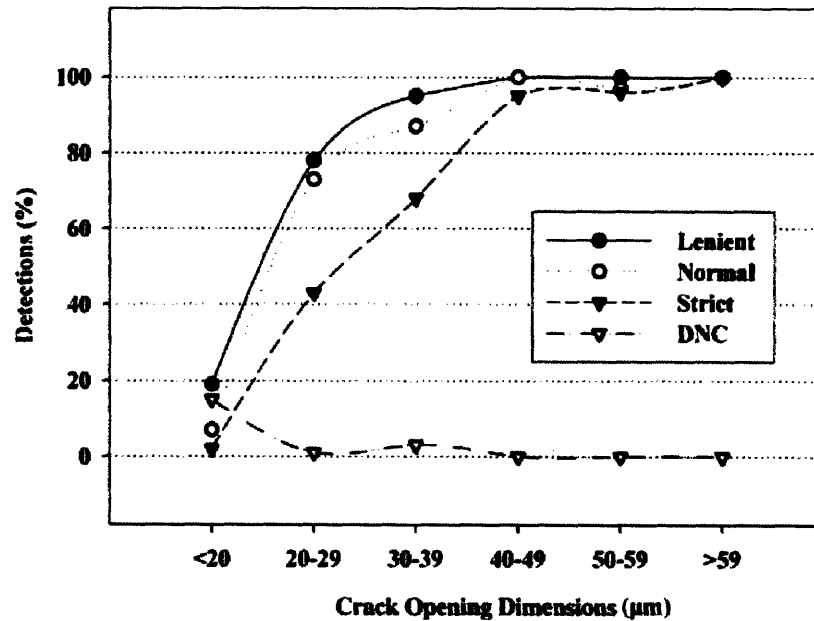
An underwater evaluation of remote visual testing (video camera) methods has found crack width or defect size to be the primary factor in success of visual inspection [38]. This evaluation was conducted in a nuclear facility using ceramic specimens. Figure 1 shows results according to the observer’s certainty level: positive crack, possible crack, probable - no crack, and definite - no crack (DNC). Lenient counted all positive,

possible, and probable flaw indications. Normal counted both definite cracks and possible cracks. Strict counted only definite cracks. These results highlight the possibility of detecting cracks underwater versus the crack width.

Figure 1: Crack width versus detection underwater [38].

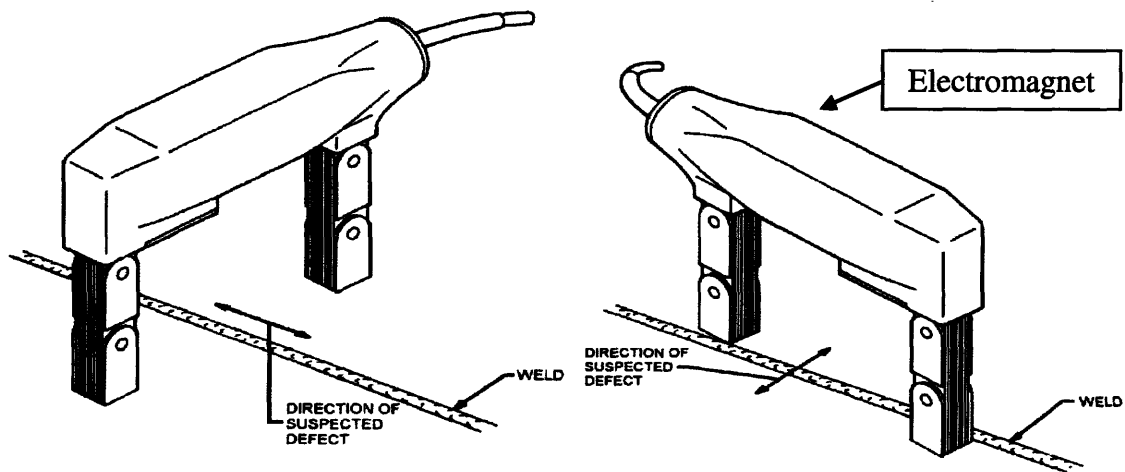
but is particularly suited for ferritic weld inspections. Several references incorrectly state magnetic particle testing's incompatibility in the wet environment [31, 32]. Orientation of a magnet will reveal cracks in a direction perpendicular to the flux field as demonstrated in Figure 2. By using heavy magnetic particles observable in water, the defect will attract the particles when electricity is applied to the magnet.

Figure 2: Magnetic Particle Weld Inspection [5].

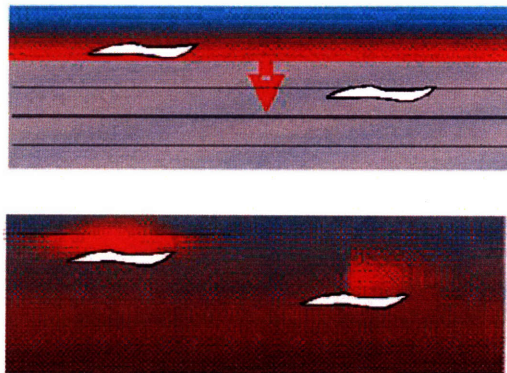
The Infrared thermography technique is one of the fastest growing and most widely accepted methods used in aerospace fields today where thin aerospace composites are used extensively [26, 29, 37, 101]. When a composite material is subjected to radiant heat, heat energy will diffuse through the skin uniformly if no delaminations, foreign matter, or disbonds exist. This temperature diffusion can be easily observed with the use of an IR camera capable of greater than 60 Hz frame rates to capture images of heat diffusing through the material skin. If a defect or impurity does exist, heat transfer will be inhibited causing the IR thermography to produce a high temperature indication or hot spot on the heated side and a cold spot on the back surface [27, 52].

Figure 3: IR Thermography Defect Location [29].

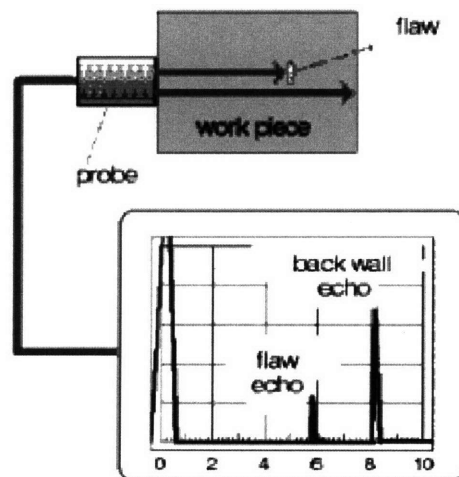
The pulse-echo ultrasonic method is the most common for portable applications; through transmission methods require two-sided access [25]. In addition to defect depth or material thickness, the pulse-echo method is particularly suited to observe both matrix cracking and subsurface porosity [37]. Ultrasonic methods occur in three different image types: A, B, and C-scans [25, 52]. Simple thickness measurements or defect location are known as “A-scan.” A combination of A-scans correlated to location along the surface to determine the areal extent of defects or damage is termed “B-scan.” The most complex image is called “C-scan.” C-scans produce a picture of the internal structure at differing depths by varying the data acquisition time. Figure 4 illustrates the pulse-echo method and provides a display of the expected A-scan CRT image at the defect location.

Figure 4: Pulse-echo inspection method [41].

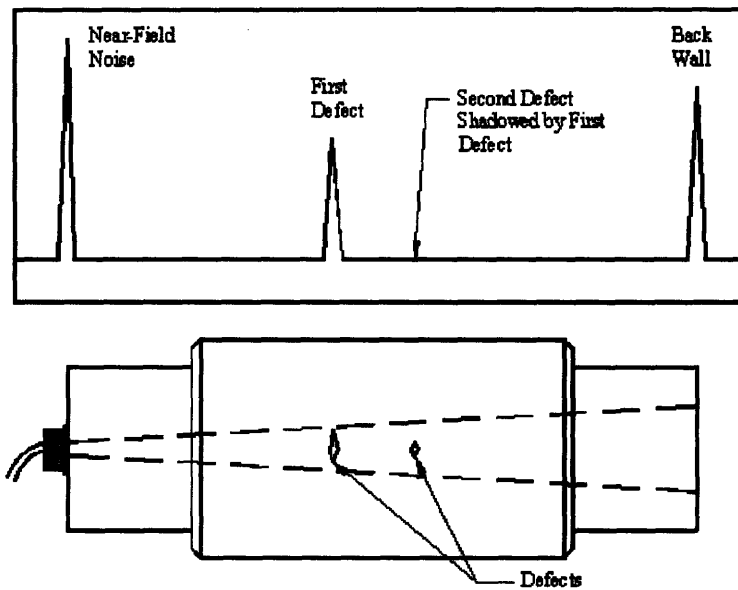
Ultrasonics, while thoroughly tested and widely accepted, have several shortfalls. Figure 5 provides an example of a particular specimen containing multiple defects and the shadowing of one defect by another in the wave transmission path [52]. Honeycomb structures present similar problems due to the different impedances between air and structural materials [25]. Additionally, kissing-disbonds (delaminations without air gaps) are difficult to detect with ultrasonics, as is moisture ingression due to the absorption of energy, preventing wave reflection or transmission.

Figure 5: Pulse-Echo Defect Masking [42].

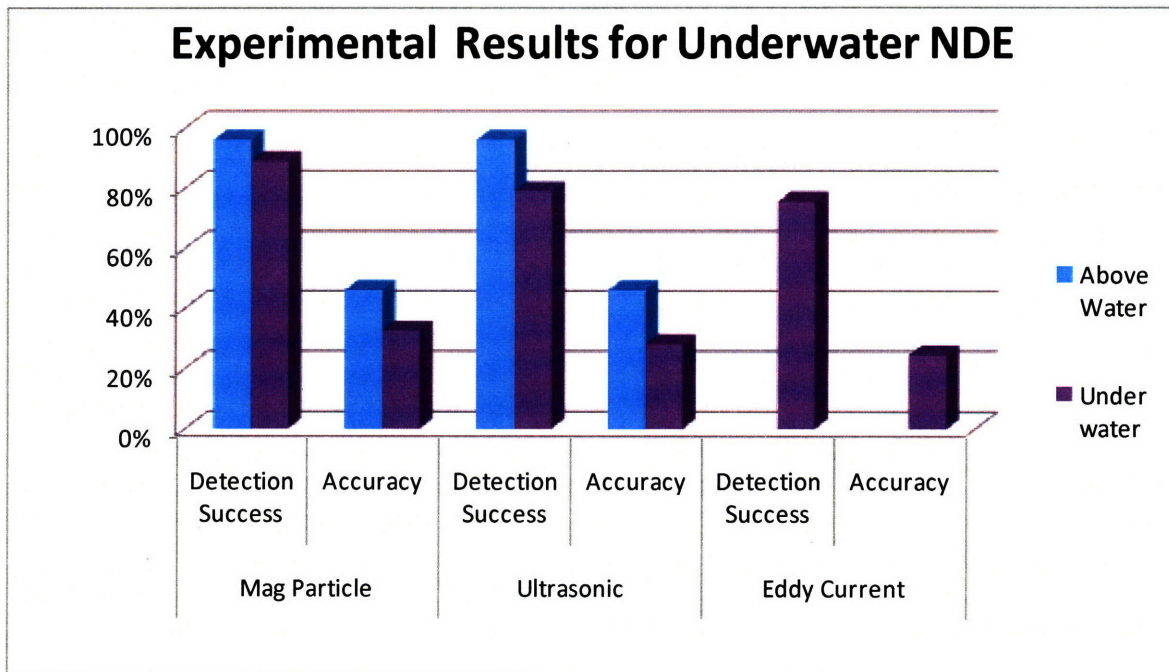
Figure 7: Comparison of underwater methods to above water results [35].

Figure 6 provides underwater detection results. Defect size and location for one specimen, as determined by destructive testing, is shown at the top and compared to above-water and underwater nondestructive inspections with multiple manufacturer's equipment. The accuracy was then calculated by comparing the underwater results with destructive observations for each specimen. Averaged data from the experimental results discussed in this experiment have been provided in Figure 7. The above water inspections show higher rates of detection and accuracy.

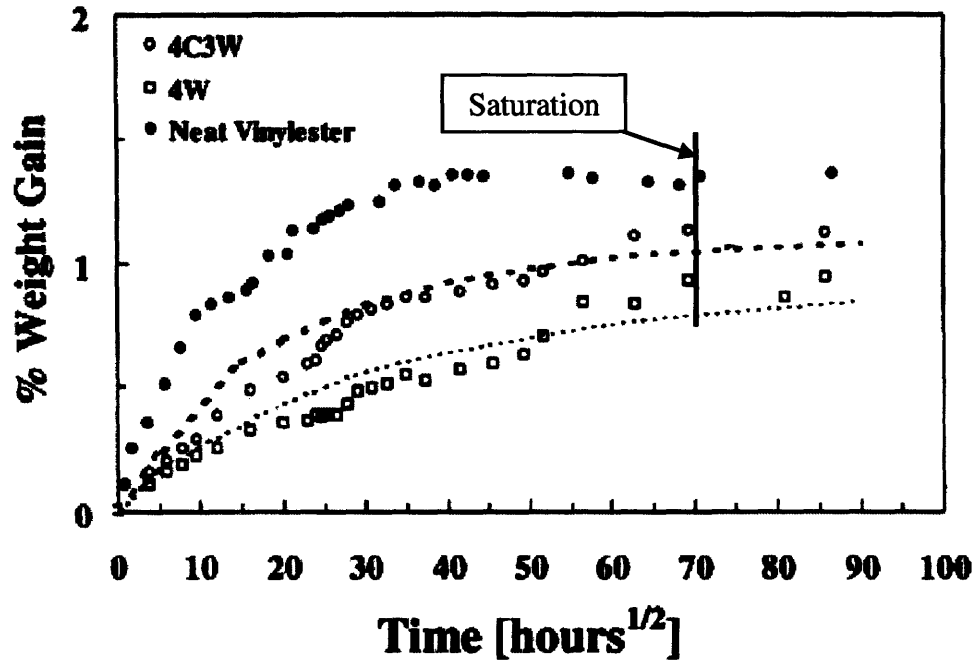
Figure 8 provides experimental data for the mass gain as a function of time for *E-glass / vinyl ester*, 3-layer woven roving sandwiched between 4-layer chopped strand mat (4C3W), 4-layer woven roving (4W), and neat *vinyl ester* specimens submerged in a 2.5% saltwater solution [50]. In general, saturation was reached at 28 - 30 weeks with neat resin showing higher moisture absorption than the composite specimens. The percentage weight gain differences in the composite specimens are attributed to lower fiber volume content and greater concentrations of resin rich deposits due to chop strand mat inclusion.

Figure 8: Mass gain over time for composites immersed in saltwater solution [50].

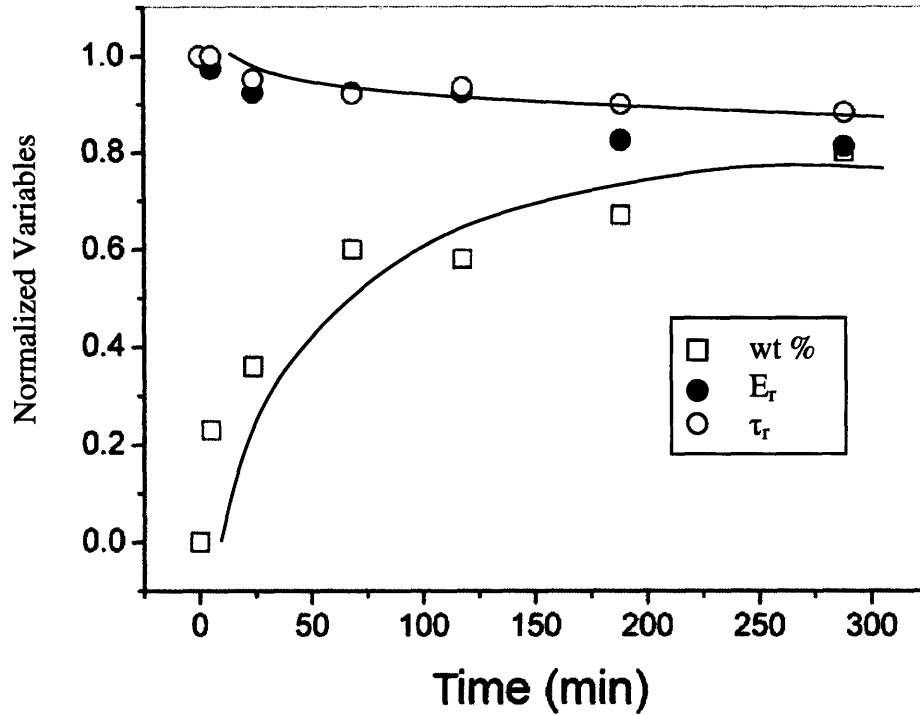
Water absorption occurs in three stages; first, diffusion according to Fick's law, where water permeates into void spaces; second, bonding interactions between water and the polymeric matrix; and third, water absorption by composite fibers [46, 55]. Figure 9 illustrates the relationship between *E-glass / vinyl ester* composite materials and their resistance to interfacial shear (τ_r), and flexural modulus (E_r) after submergence in distilled water relative to a pristine sample. Similar to Figure 8, Figure 9 shows weight gain due to water absorption, but provides additional insight to the plasticization of the material by observing the degradation of modulus and shear resistance concurrently.

Figure 9: Water absorption for mat composite, glass fiber / vinyl ester [46].

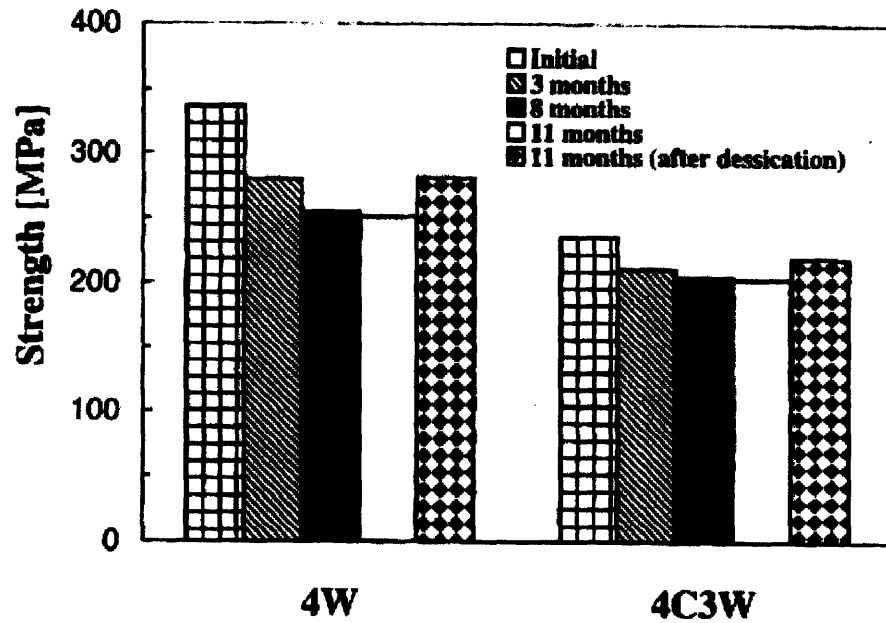
Figure 10 and Figure 11 provide data for 4W and 4C3W for reduction of tensile strength and tensile modulus after immersion in 2.5% salt solution and regained strength after drying (desiccation) [50]. The 4W data from initial measurements to the 11 month saturation show a 25.5% tensile strength reduction and a 14.9% tensile modulus reduction; 4C3W, although lower overall values, showed strength and modulus reductions of 14% and 10.1%, respectively.

Figure 10: Retention of strength after immersion in salt solution [50].

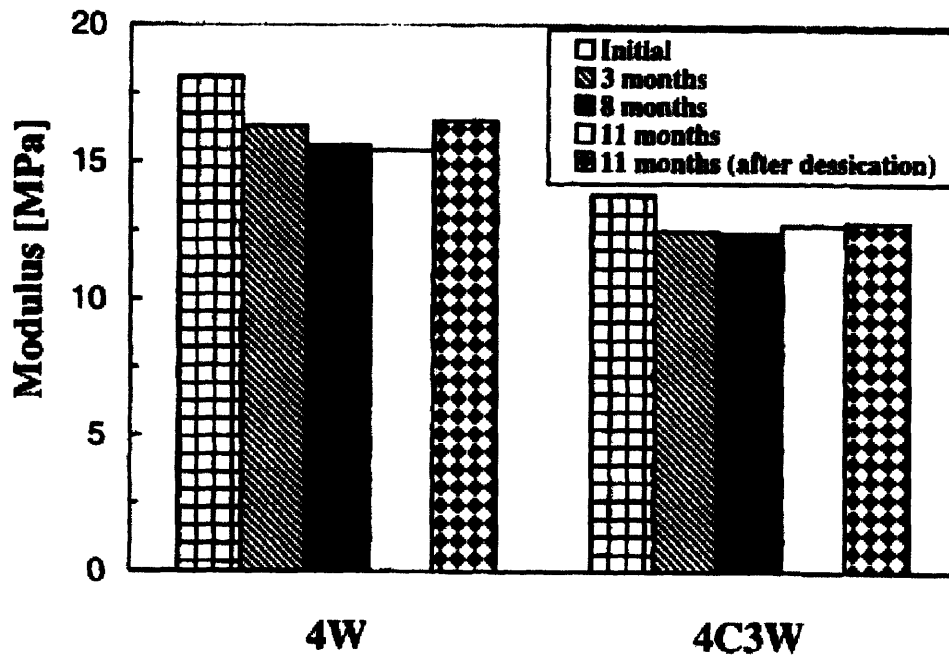
Figure 11: Retention of flexural modulus after immersion in salt solution [50].

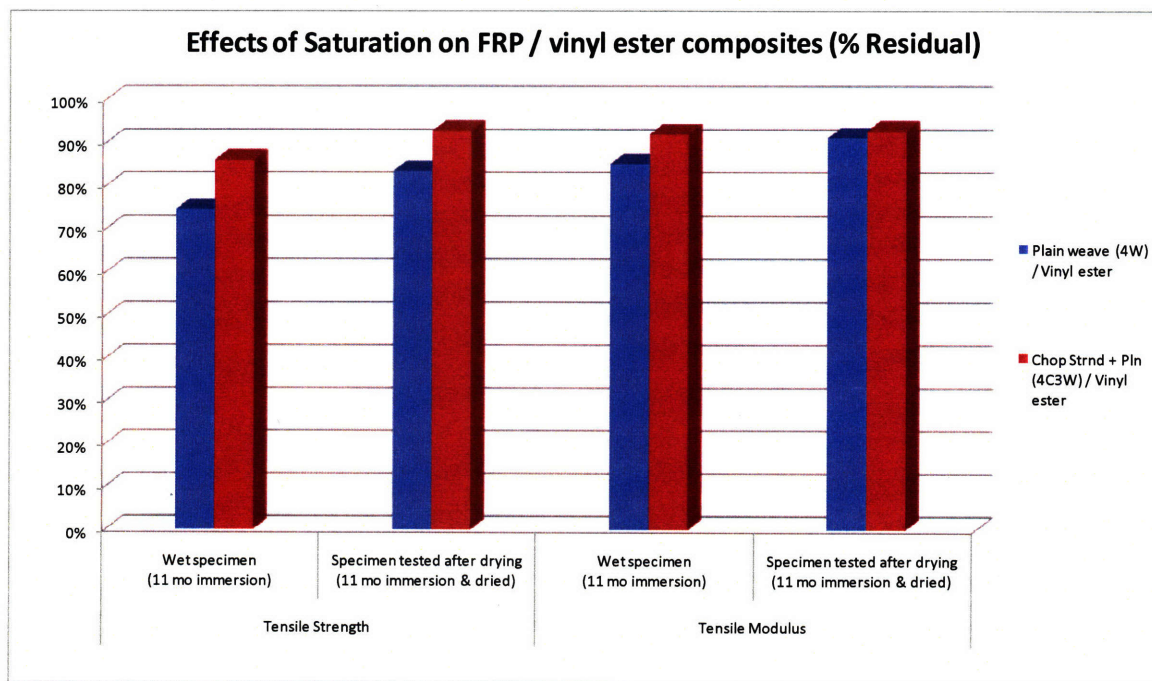
the 4W woven mat. Subsequently drying the samples resulted in partial restoration of tensile properties; although weaker than 4W, drying had greater effect in the 4C3W specimen due to the protective outer layers of chopped mat; Figure 12. Conversely, 4C3W samples with higher resin content experienced lower modulus increase compared to the 11-month, saturated samples. In theory, complete restoration of properties can only be accomplished if there have been no irreversible changes to the resin through saturation. Additional damage such as fiber matrix debonding, microcracking, the onset of plasticization, and fiber damage may be observed during saturation resulting in greater strength loss.

Figure 12: Effects of saturation on glass fiber / vinyl ester [50].

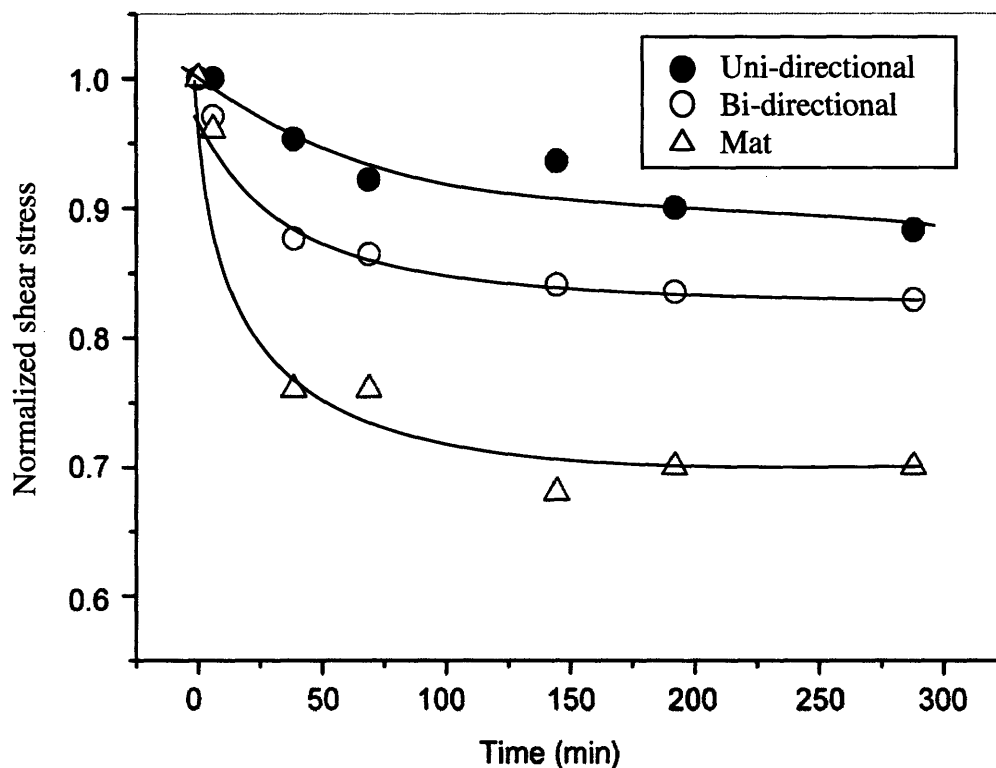
existence of void spaces between fibers and the matrix; an effect compounded by water intrusion [46]. Figure 13 shows the normalized shear stress for woven mat, uni-directional, and bi-directional *glass / vinyl ester* composite samples immersed in 80°C distilled water relative to samples not subjected to the test environment. This experiment was conducted over a shorter time frame than the previously referenced works. Because of this, the unidirectional sample was found to absorb more water causing the matrix to swell, reducing the interfacial voids that would otherwise reduce the shear strength. High void content results in 1) weaker interfacial strength due to inadequate adhesion, 2) mutual abrasion of fiber, and 3) crack initiation and growth due to void coalescence [27].

Figure 13: Resistance to shear stress during water immersion at 80°C [46].

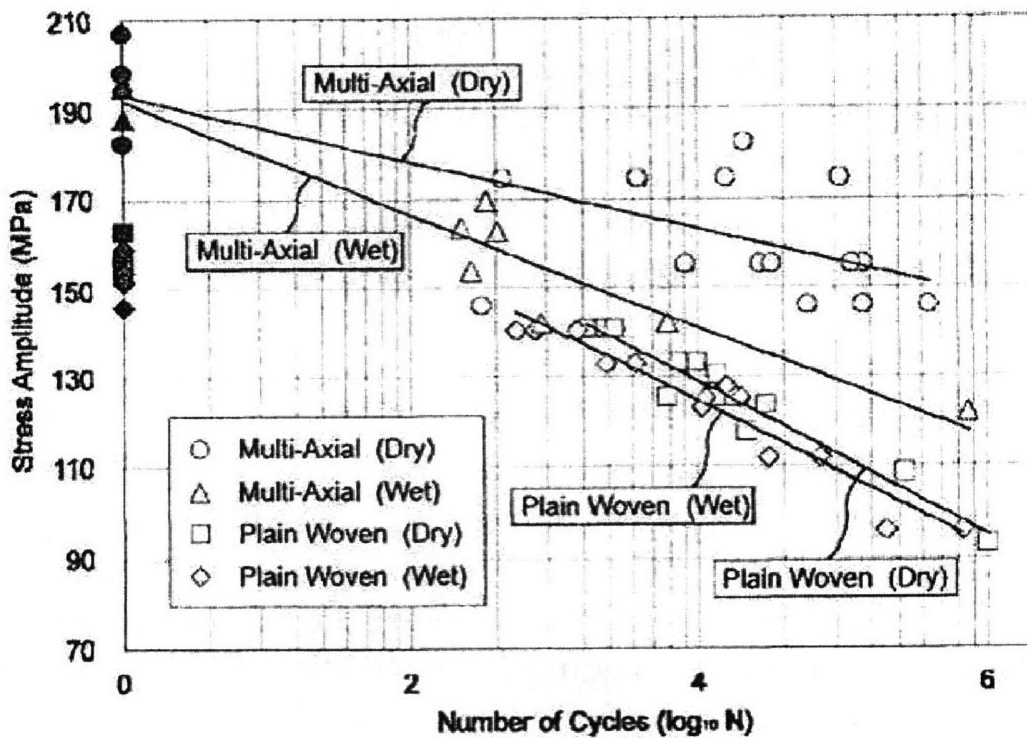
flexural and fatigue degradation under saturated conditions, 0.6% weight [53]. Figure 14, shows the difference between saturated and dry *carbon / vinyl ester* specimens after soaking in 95°C water for 120 hours and reaching saturation weight. While plain-woven specimens do not show appreciable differences, multi-axial fabrics, which likely have higher void content, display significant fatigue degradation over time compared to dry samples.

Figure 14: Fatigue strength comparison of saturated and dry CFRP laminates [53].

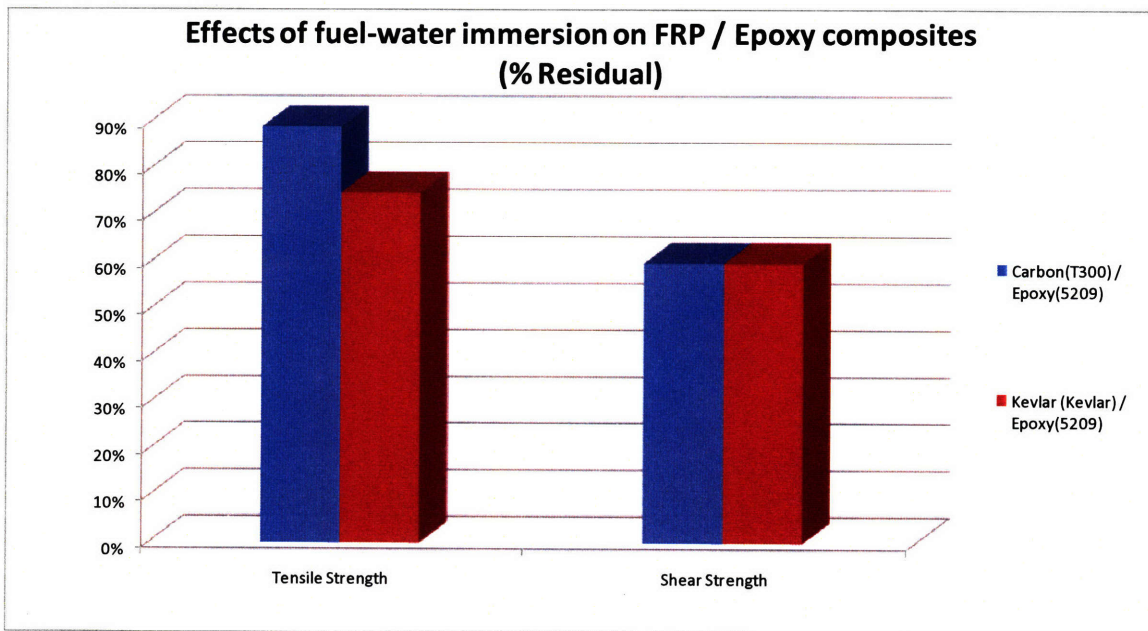
Fuel-water immersion testing with JP-4 on *graphite (carbon) / epoxy* and *Kevlar / epoxy* resins reduced the tensile strengths by 11% and 25%, respectively [37]. Shear strength was reduced by as much as 40% in both materials (Figure 15). Similarly, General Motors tested *E-glass / polyester* and *E-glass / vinyl ester* in a high-temperature, moist environment with fluids including automotive brake fluid, saltwater, and diesel fuel. Though no numeric results were provided, the experiment discovered that saltwater, antifreeze, and gasoline have the most detrimental effect on composite strength.

Figure 15: Effects of fuel-water immersion on FRP / epoxy [37].

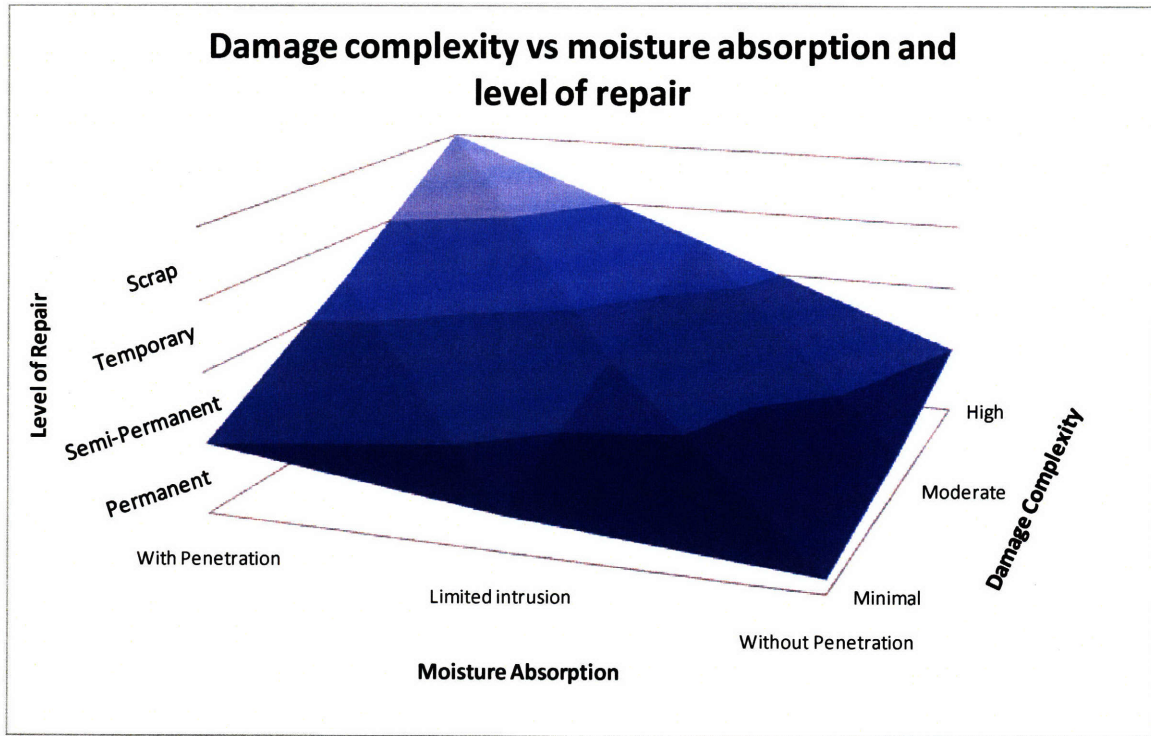
The marine environment contains corrosive materials, fluids, and hazards capable of attacking composite materials. Through vigilant inspection techniques and assessments, proper repair levels can be determined. Figure 16 graphically illustrates the relationship between level of damage complexity, moisture absorption, and effective level of repair. In the absence of quantitative rules, prudent engineering knowledge must be applied to determine the level of repair or if a component should be scrapped. Referenced work provides evidence that moisture intrusion inhibits the use of permanent repair methods underwater. The use of materials specifically manufactured for underwater curing such as pre-preg composite mats or epoxies combined with pressure or vacuum treatment methods may offer the possibility of semi-permanent or temporary

Figure 16: Schematic of damage complexity versus moisture absorption and level of repair.

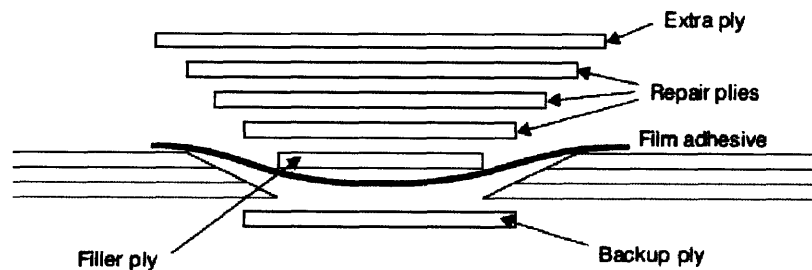
One of the primary parameters of repair is the scarf angle, which is used to obtain higher bond strength between the adhesive, repair laminate, and original structure. Figure 17 and Figure 18 illustrate the differences in tapered scarf repair and tapered step repair, both of which are shown with a backup ply. Scarf tapered repairs are sanded with sloped surfaces by sanding at exact angles to remove discontinuities and achieve a uniform stress distribution throughout the repair [30]. Inconsistent angles may change the adhesive bondline thickness and result in strength loss and susceptibility to fatigue [25].

Figure 17: Scarf tapered repair [62].

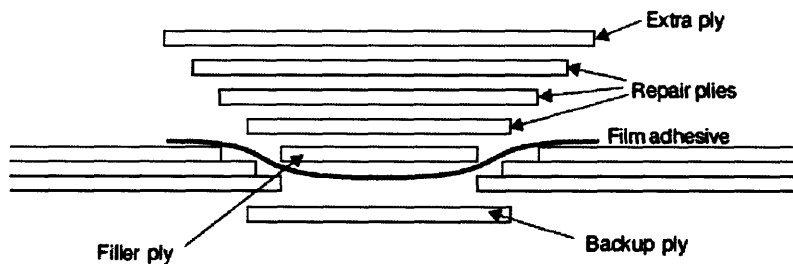
Figure 18: Step sanded repair [62].

Step repairs, similar to those shown in Figure 18, are most common on radomes or where radar transmission cannot have excess material that may interfere with radar permeability [25, 30]. As previously mentioned (Section 3.2.1), the carbon fiber superstructure of DDG-1000 will also require careful repair methods due to radar reflectivity. Repairs that are not uniformly smooth with the surrounding structure will increase the radar cross section of the vessel thus decreasing its' stealth capability and nullifying millions of dollars of research and development.

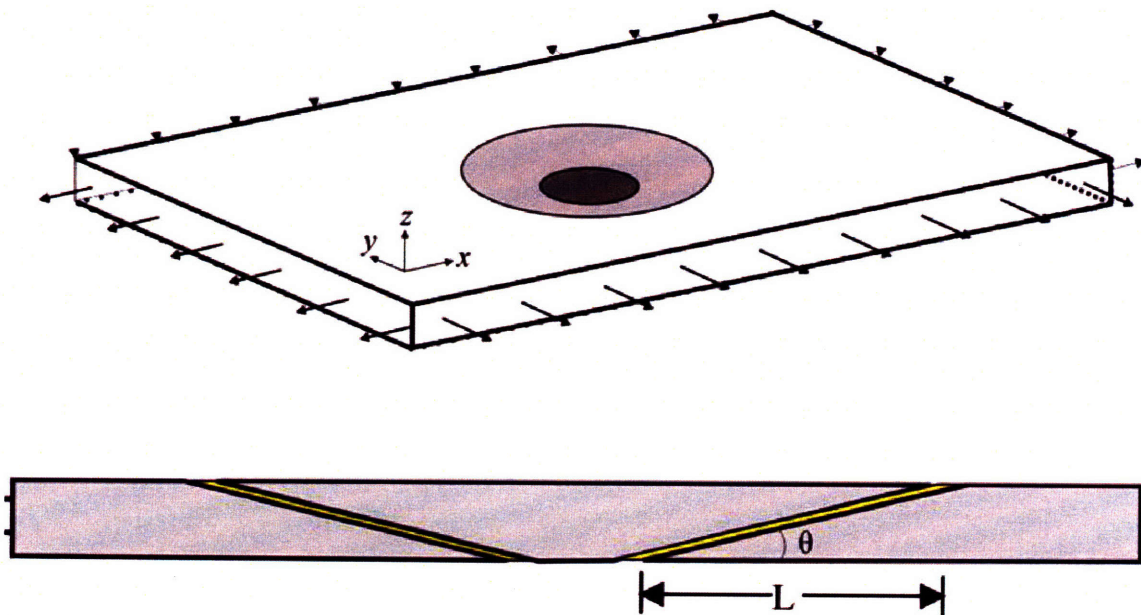
Figure 19: Scarf repair angle [49].

Due to the extensive use of composites, specifically thin sandwich panels, the aerospace industry provides a wealth of information on repair methods and scarf repair angles. Repairs conducted on aerospace composite panels have been recommended by the Structural Repair Manual to have scarf angles between 2° and 6° , depending on the location and thickness. A 2° (1/50 slope) repair angle should be used on thinner structures, while a 6° (1/20 slope) taper is permitted at panel edges where thickness increases for bonding and stress reduction [25, 47, 49]. A high angle scarf repair presents several disadvantages when applied to thicker marine panels, the most prominent being removal of large quantities of undamaged composite laminate structure. For example, damage to a 10 mm thick marine panel, using a 1/50 scarf angle or 12.5 mm per step, requires removal of 500 mm of laminate from the suspected edge of damage (Figure 19), likely an excessive amount [47].

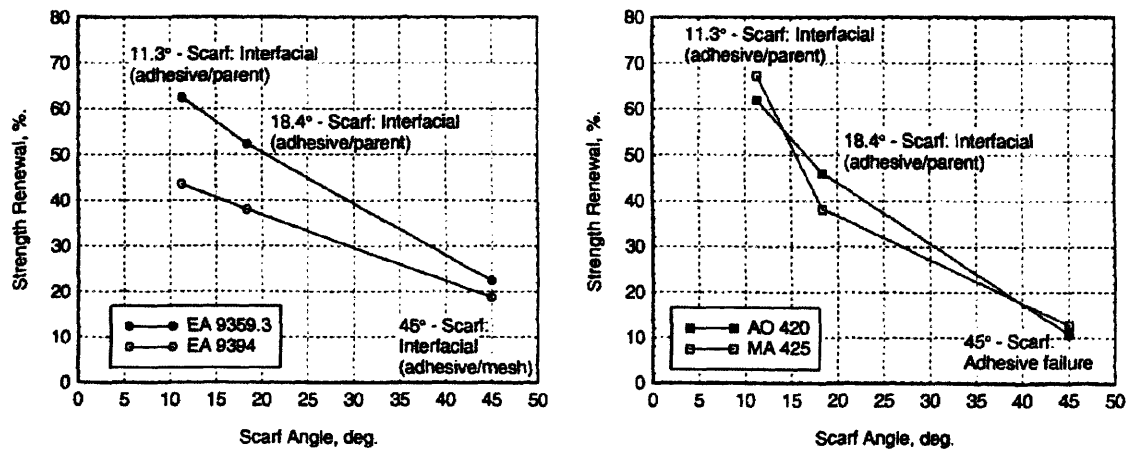
Figure 20: Repair strength renewal versus scarf angle [47].

resulted in the most promising strength renewal, up to 65% for both room temperature and elevated temperature cured adhesives. Figure 20 shows data collected for three scarf angles versus strength renewal as a percentage of the virgin compressive strength.

Ultimately, the balance between scarf angle or step angle and the maximum strength recovered should be optimized. Gama, et. al., conducted experiments with a 13.2 mm thick, 22-layer, S2-*glass* fabric plain weave / *epoxy* resin marine laminate [47]. Specimens were prepared using the Vacuum Assisted Resin Transfer Molding (VARTM) process, which produced a nominal fiber volume fraction of 50% and less than 1% void content. The experiments consisted of bending stiffness and percent renewed compressive strength after repair for three scarf repair angles: 45° (1/1 slope), 18.4° (1/3), and 11.3° (1/5).

Compared to a virgin specimen, elevated-temperature cure repair is capable of achieving 100% renewal of bending stiffness, while a room-temperature cure repair achieved 85% due to a lower adhesive modulus. It was also discovered that the bending moment at failure was highly dependent on the adhesive and scarf angle (Table 3). Testing of static strength versus scarf angle produced similar results, illustrating scarf angle importance. A 45° angle provided the least suitable results, and the 11.3° angle

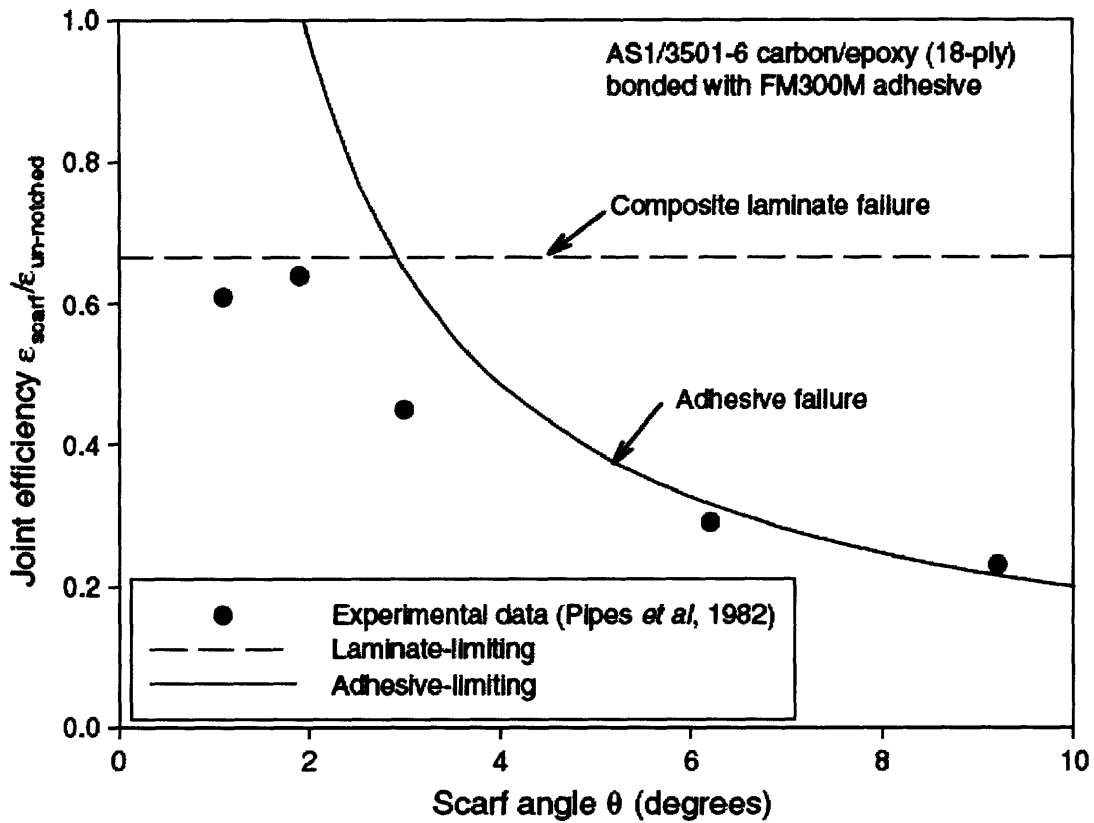
Figure 21: Optimized scarf angle: experimental & predicted [49].

Plotting efficiency against scarf angle, determined by equation (1) for a selected adhesive resulted in Figure 21.

Figure 21 illustrates the comparison of numerical results for *carbon / epoxy* laminates with experimental results produced by Pipes, et. al. [49]. For this particular composite and adhesive combination, the optimal angle was found to occur at 2.9°. Inspection of the graph shows a high correspondence between experimental data and finite element

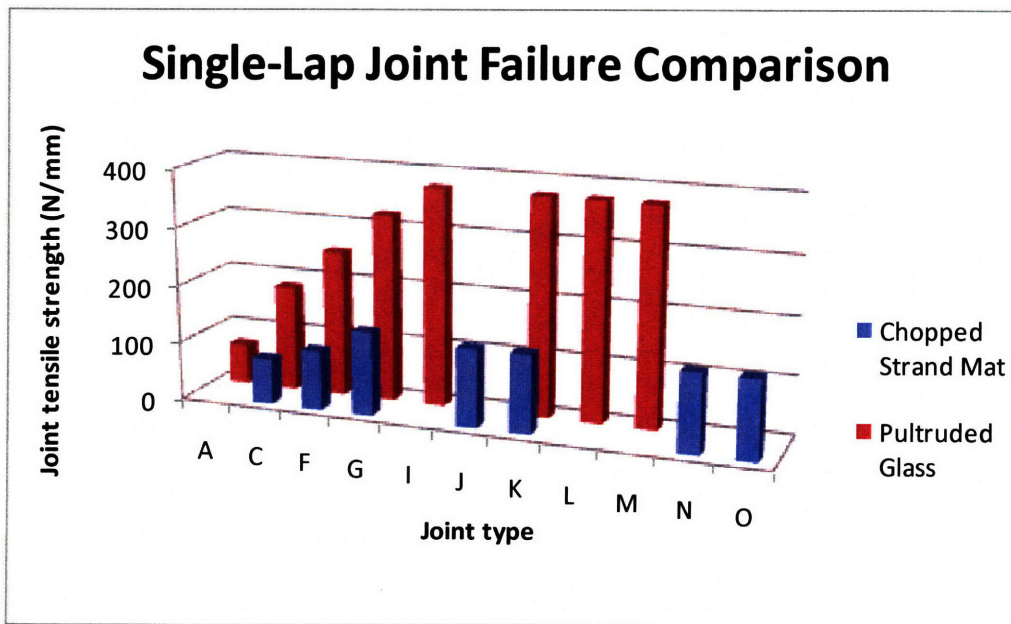
Figure 22: Single-lap joint failure comparison [30].

Figure 22 shows a direct comparison of joint strength at failure between the chopped strand mat and pultruded glass fiber samples with differing lap joint configurations.

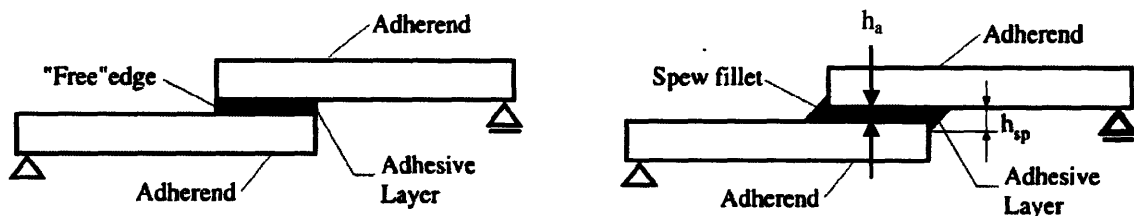
Figure 23: Adhesive bond without and with spew fillet [58].

Spew fillet is the excessive adhesive material pressed beyond the boundaries of the patch during the repair process, providing additional stress distribution [44]. Research suggests that a spew fillet may reduce peel stress by more than 32% [68]. The variations of spew fillet geometry and associated stresses clearly illustrate the spew fillet's advantage [58]. Further analysis compares three different evaluation methods, including finite element and theory for adhesively bonded aluminum plates. These analyses modeled a 45° spew fillet twice the thickness of the adhesive [$(h_{sp}/h_a)=2$] as shown in Figure 23 [58].

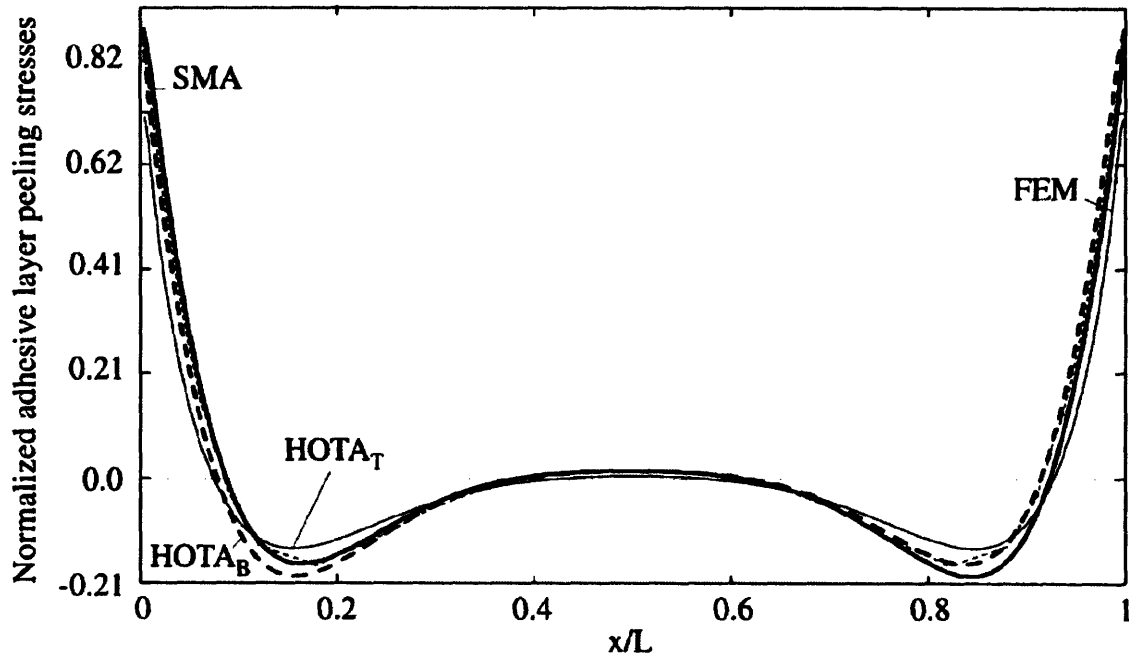
Figure 24: Bondline peel stress with 45° fillet (2x adhesive thickness) for a joint of length (L) [58].

Figure 24 shows a maximum peel stress of slightly more than 0.82, while Figure 25, an example without a spew fillet, is more than three times that factor. In both figures, the stresses are normalized by the adhesive strength. Thus, a joint without a spew fillet would be structurally weak and very susceptible to fatigue and failure [58].

(SMA: Spring model approach; HOTA: High order theory approach; FEM: Finite element method)

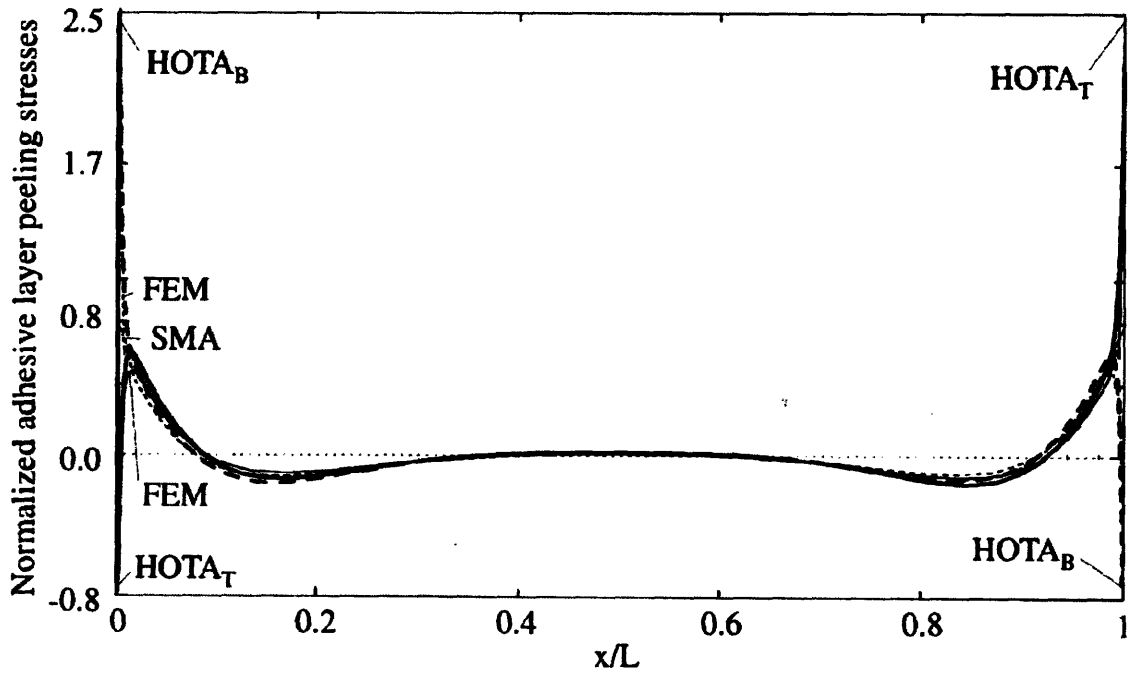
Figure 25: Bondline peel stress without fillet for joint of length (L) [58].

(SMA: Spring model approach; HOTA: High order theory approach; FEM: Finite element method)

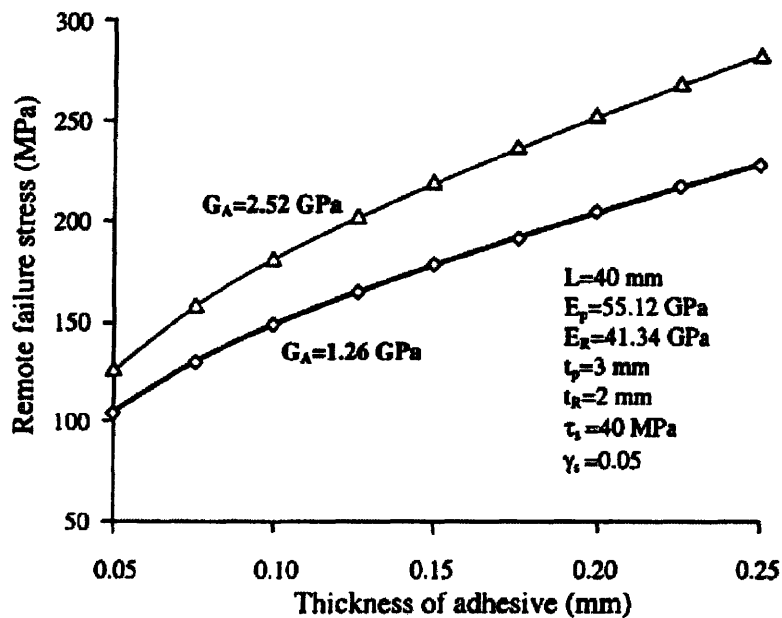
Figure 26: Failure stress versus adhesive thickness [60].

Single-lap repair patches may be subjected to large stresses and cyclic loading, which are transmitted through the adhesive bonding layer between the patch and adherend. In all patch designs, the common goal is to provide an adhesive bond that transmits stress to the adherends and fails within the adherend near the adherend/adhesive interface prior to adhesive failure [37]. Excessively thin adhesive layers and corresponding patches may present undesired flexibility or weakness [30, 60, 61]. However, thicker patches create overly stiff structures that result in increased brittleness and added weight. Figure 26 and Figure 27 illustrate the relationship between adhesive bondline thickness and the resulting failure stress.

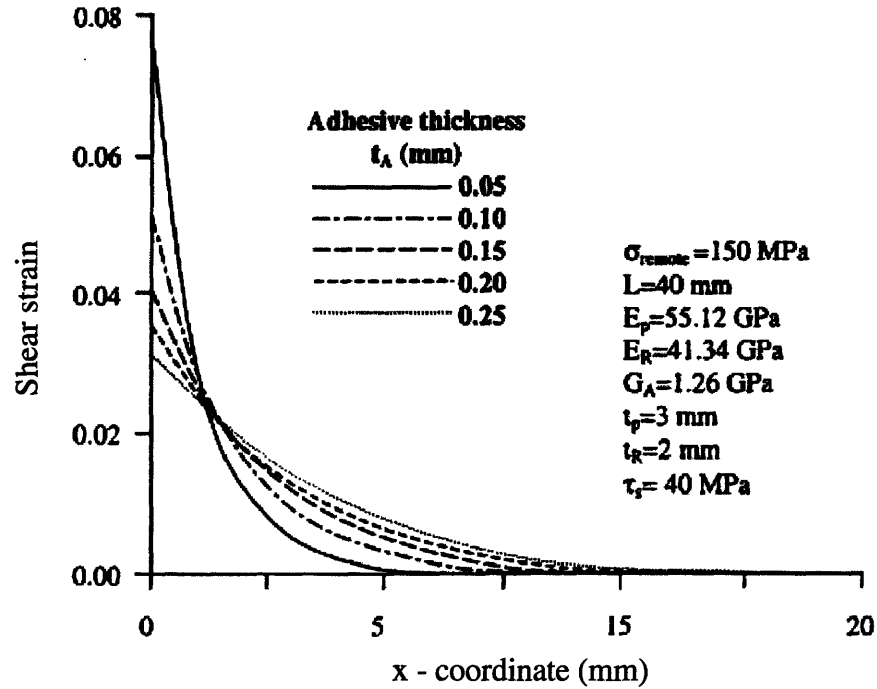
Figure 28: Patch end shear strain versus adhesive thickness [60].

Additionally, Figure 28 illustrates the relationship between adhesive thickness at the end of the patch and a reduction in shear strain. As thickness increases, shear strain is distributed throughout the edge area resulting in a lower peak at the zero point. Therefore, a patch with an internal taper similar to taper 'G' in Table 5 combined with an appropriate adhesive thickness will substantially reduce the peel stress at the edge.

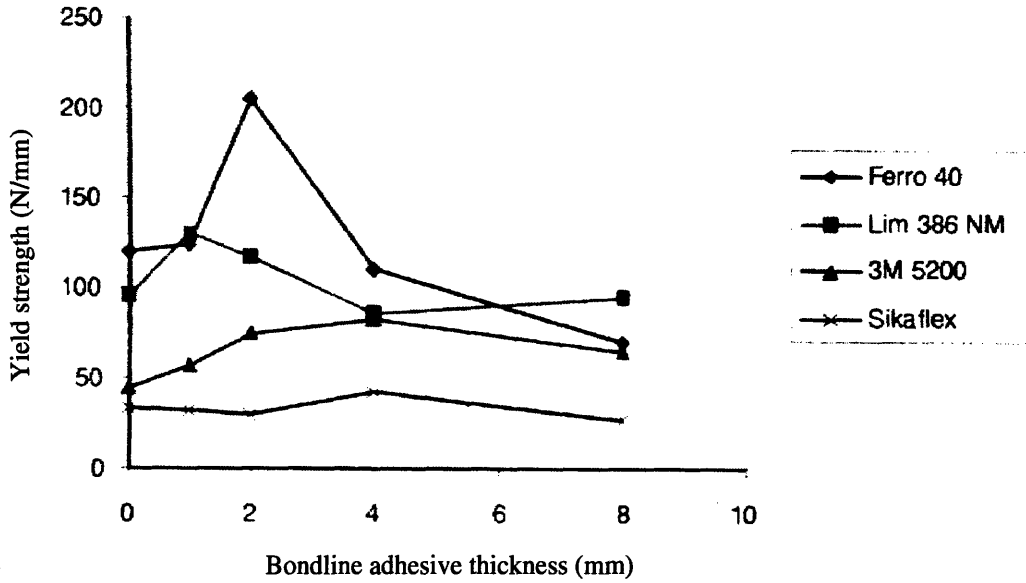
Figure 29: Single-lap joint bondline thickness versus strength [30].

Further analysis concerning bondline thickness for single-lap joints in marine FRP structures is shown in Figure 29 [30]. Four different flexible polyurethane adhesives were compared and produced data showing relatively little improvement in yield strength and, in three cases, degraded effects above 4 mm adhesive bondline thickness. Ultimate strength, shown in Figure 30, displayed similar results; however, two adhesive specimens, though much stronger, showed drastically reduced performance above 1 mm adhesive bondline thickness. Other research suggests that increasing the thickness of the adhesive layer may reduce the stress concentration level by as much as 21% [68]. Thus, because of manufacturing and environmental variations, bond layer thickness is recommended to fall within the range of 0.125 – 0.39 mm for most joint types [37].

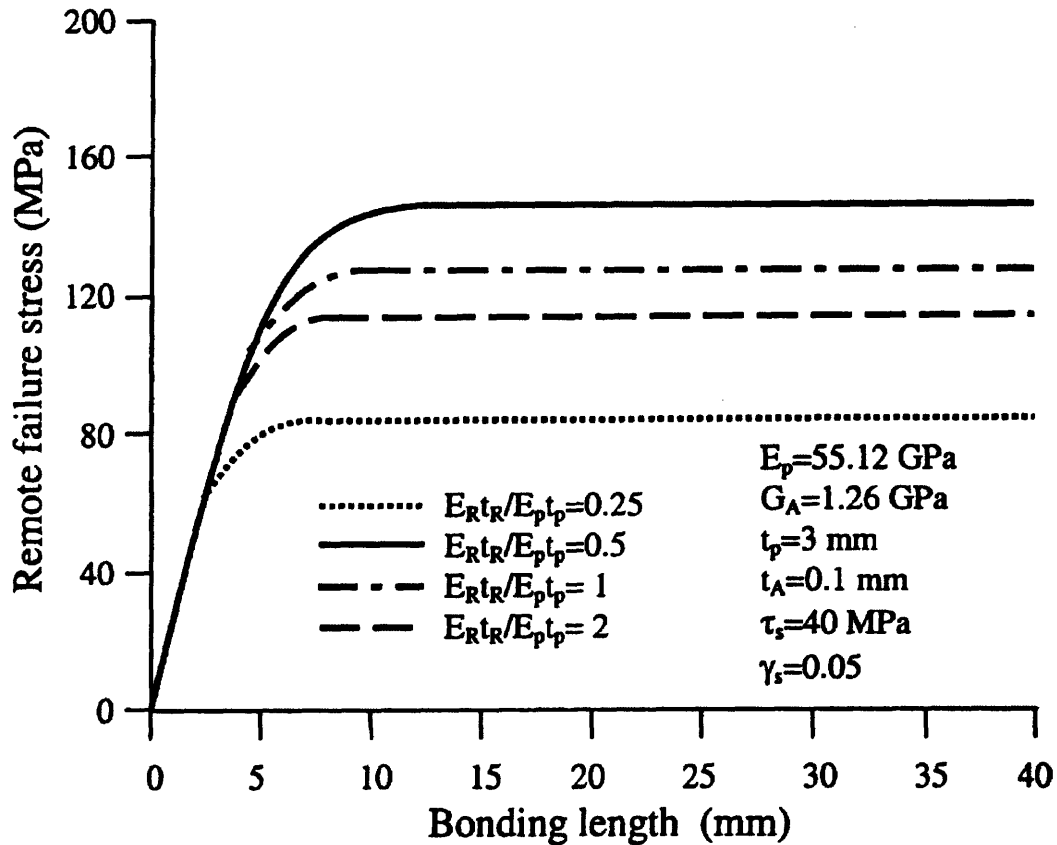
Figure 31: Failure stress of double-lap joint versus bond length [60].

Patch overlap refers to the amount of patch material extending beyond the known damage boundaries. Hu and Soutis [60] addressed the use of a circular double-lap joint patch over a hole representing damage removal from a structural laminate composite. Figure 31 was produced through the use of different patches with various thicknesses. With patch stiffness ($E_R T_R$) equal to twice that of the parent ($E_p t_p$) laminate structure, $E_R T_R / E_p t_p = 0.5$, and expected failure stress for a double-lap joint, the optimal patch overlap correlates to a length of 12 mm.

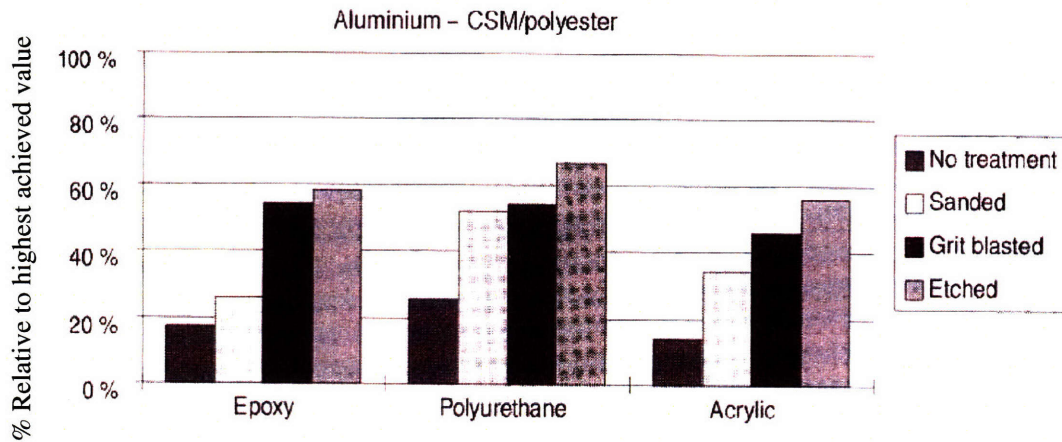
Figure 33: Aluminum-CSM/polyester surface treatments and adhesives [30].

The combined effects of surface roughening and surface treatments are illustrated in Figure 33 and Figure 34 [30]. Experimental data are provided for single-lap joints made with 3-mm *chopped strand mat (glass) / polyester* and *carbon fiber / epoxy* laminate samples bonded to aluminum panels. In each case, the bond strength was significantly increased over specimens without surface treatment or simple sanding. Grit

blasting and grit blasting plus chemical etching have the most pronounced effects, achieving nearly 60% relative to the highest achieved value [30, 71].
