Nondestructive Evaluation and Underwater Repair of Composite Structures

NAVAL ENGINEER
and
MASTER OF SCIENCE IN MECHANICAL ENGINEERING

MASSACHUSETTS INSTITUTE OF TECHNOLOGY

June 2008

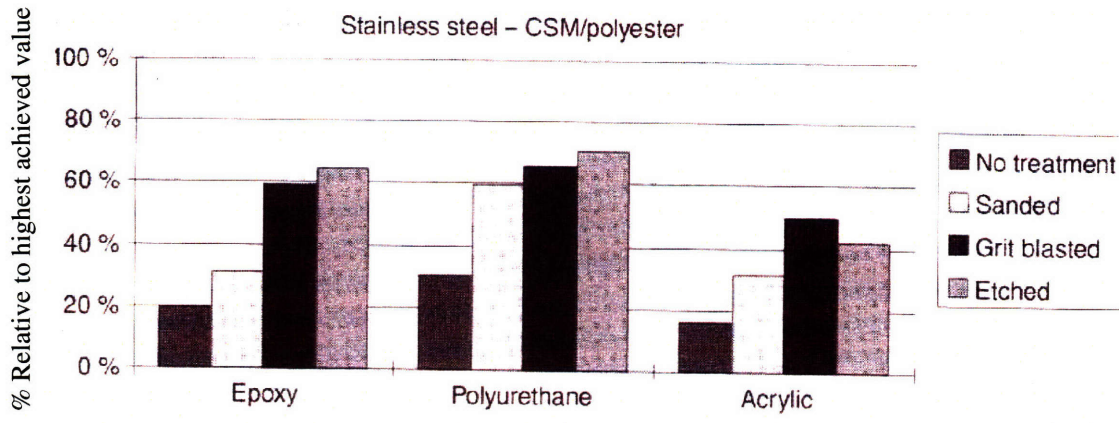
Figure 35: Steel -CSM/polyester single-lap joint surface treatments and adhesives [30].

Additional experiments conducted with *chopped strand mat (glass) / polyester* and *carbon fiber / epoxy* laminate samples bonded to stainless steel panels produced similar data, Figure 35 and Figure 36 [30]. Again, experimental data show the benefit of grit blasting combined with polyurethane adhesive for high bonding strength.

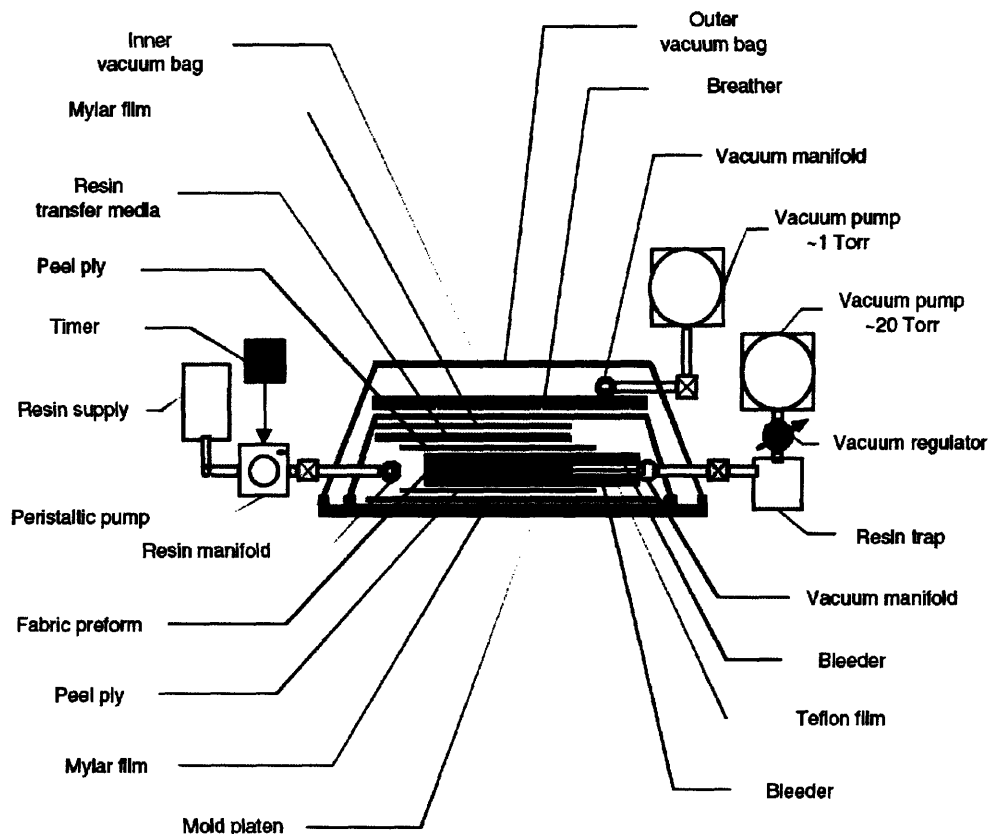
Figure 37: Vacuum assisted resin transfer molding (VARTM) configuration [65].

Vacuum assisted resin transfer molding (VARTM), shown in Figure 37, has been used to achieve greater laminate compaction [3]. Similarly, SCRIMP (Seaman Composite Resin Infusion Molding Process) has been used to construct pilings and entire ship scale sections [69]. Both methods are capable of reducing voids and emission of solvent vapors during manufacturing.

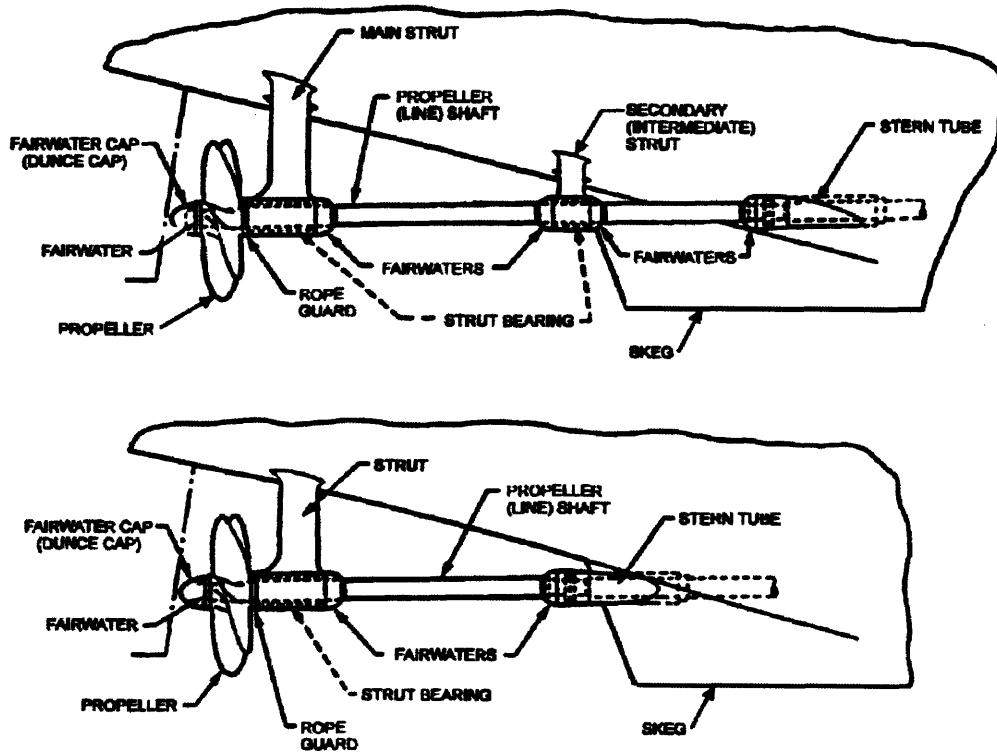
Figure 38: Typical shafting arrangements for U.S. Navy ships [5].

The U.S. Navy's underwater shaft covering procedure was developed to repair the propulsion shaft covering on surface combatants [5, 72]. The primary purpose of the shaft covering is to reduce or eliminate corrosive effects on the shaft. The procedure is normally accomplished in drydock. An underwater procedure was developed to repair a damaged shaft covering in a minimal amount of time without the expense or inconvenience of drydocking. Typical shaft arrangements for U.S. Navy ships are shown in Figure 38.

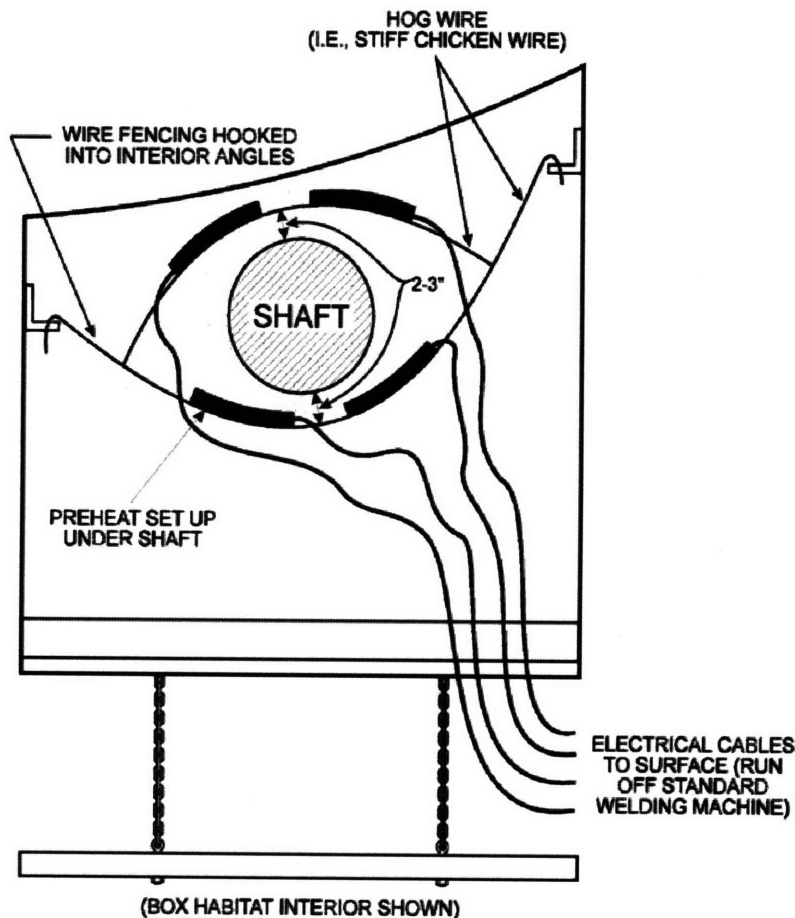
Figure 39: Underwater habitat configuration [5].

After removal of the existing shaft covering, the traditional procedure involves installing a habitat for the divers to perform work in a dry environment, similar to an underwater bubble after water has been evacuated. This habitat provides a platform for

the divers to stand on while preparing the shaft and applying the repair materials. Primarily, the habitat provides the means to heat the shaft to reduce the cure time of currently approved materials.

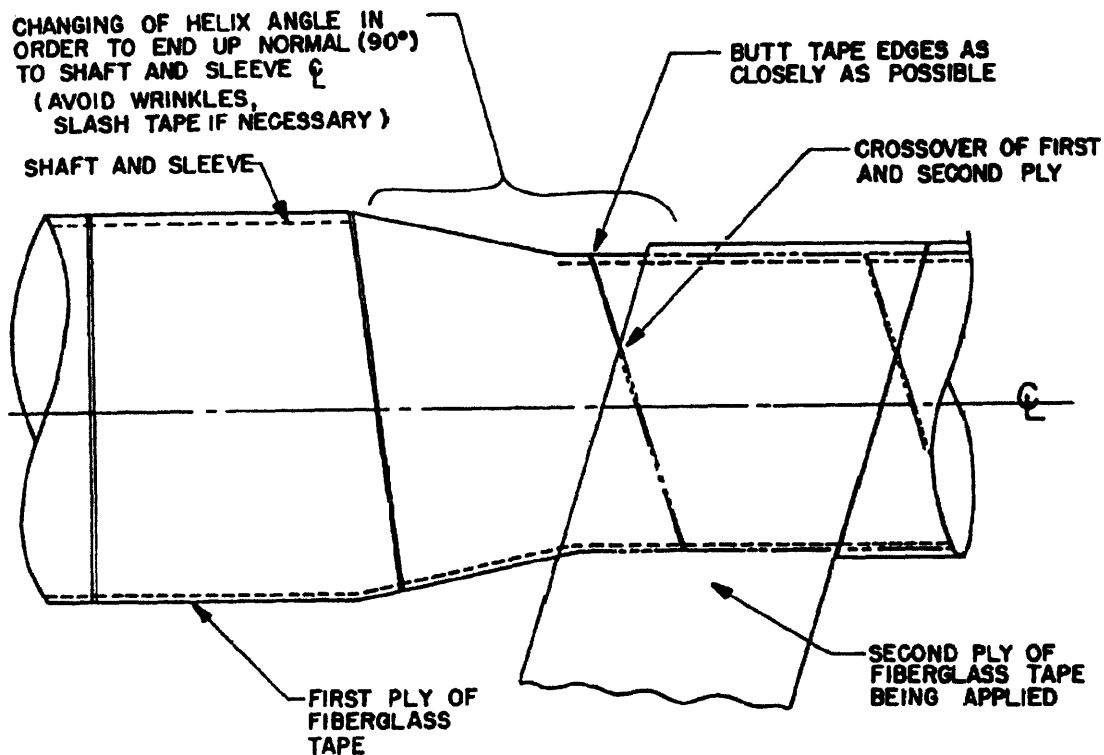
Figure 40: Schematic of FRP wrap [72].

The U.S. Navy procedure for shaft coverings requires 4 layers of alternately wrapped FRP cloth in a manner shown in Figure 40. Wrapping begins with a 360° vertical wrap, followed by gradually angled wraps to travel the length of the shaft. Resin is applied before each new layer and after complete saturation of the previous layer in order to prevent air pockets within the laminate. This procedure differs from the procedure described in Section 5.2.3, with the use of four layers versus three. The experimental specimens in Section 5.2.3 were designed for increased strength and

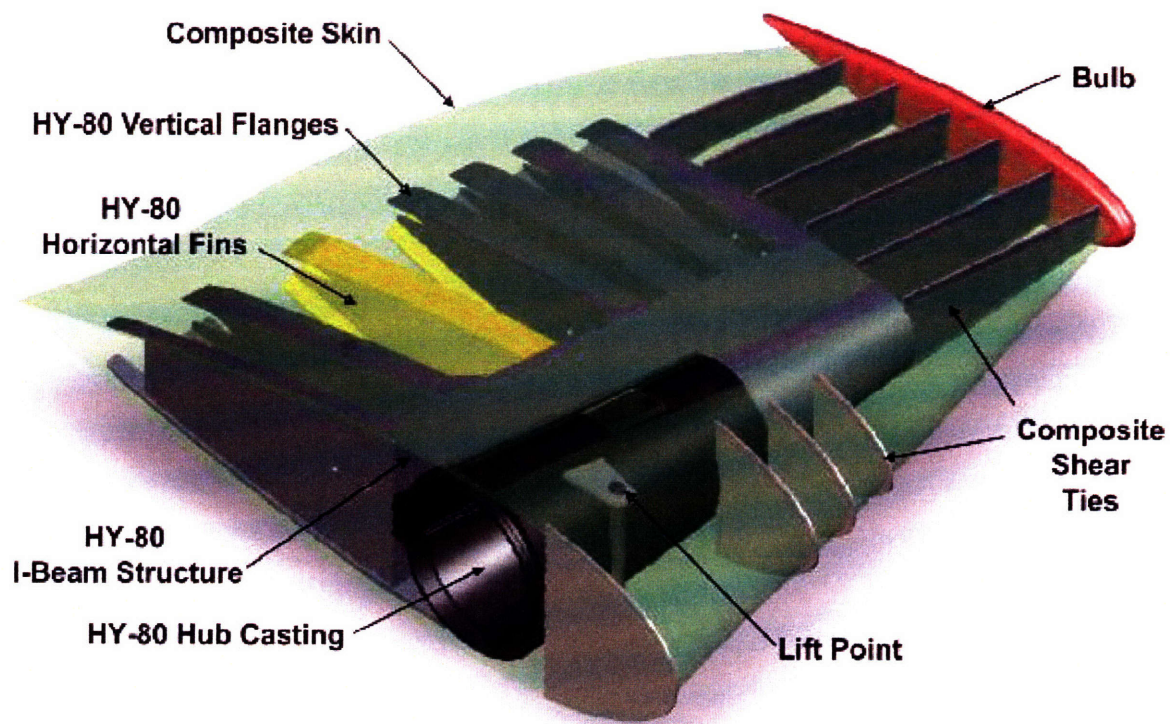
Figure 41: Composite Twisted Rudder Schematic [73].

The DDG-1000 is the most recent acquisition in the U.S. Navy's arsenal with a build contract awarded in February 2008. Though there are many technical advances in the design of this ship, the composite twisted rudder (CTR) is of particular interest. The CTR combines the strength of composite laminates and a foam core with hydrodynamics for decreased drag and reduced weight. Using a 25-layer, *E-glass* composite laminate over a steel frame and foam core, the rudder must transmit directional inputs from the ship to the water and endure very high torsional loads from the hydrodynamic forces from the ship's motion and propeller wash [73]. Figure 41 provides an internal structural depiction of the CTR including the steel hub casting and support structure.

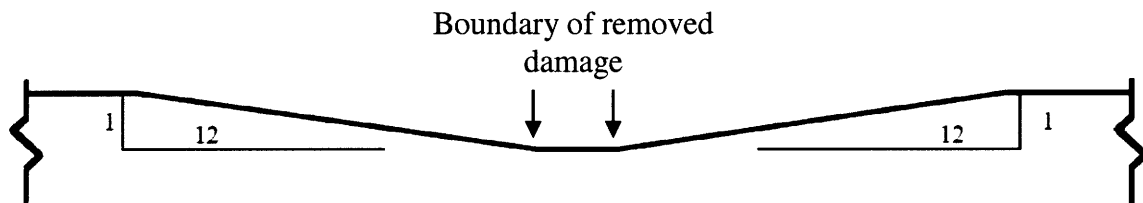
Figure 42: Taper slope [73].

The recommended taper angle, or slope as shown in Figure 42, for the CTR is 12:1 [73]. This is the typical selection for a thick section laminate; however, greater angles can be used if adequate distance between the repair area and edge of the structure remains.

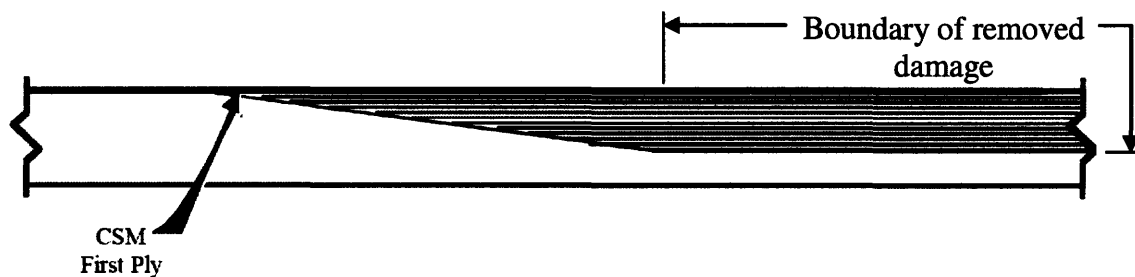
Figure 43: Shortest ply first method [73].

Laminate can be laid in two methods, shortest first (Figure 43) or longest first (Figure 44). Shortest ply first, Figure 43, provides a better surface for reinforcing plys on top of the repair as well as eliminating finishing work. Longest first, shown in Figure 44, requires more finishing work to smooth the patch.

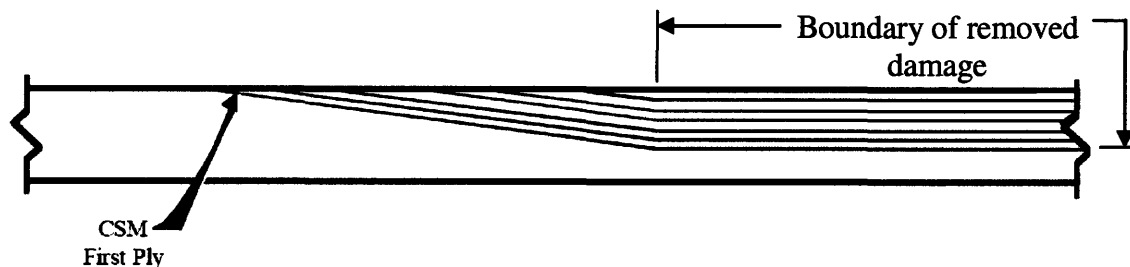
Figure 44: Longest ply first method [73].

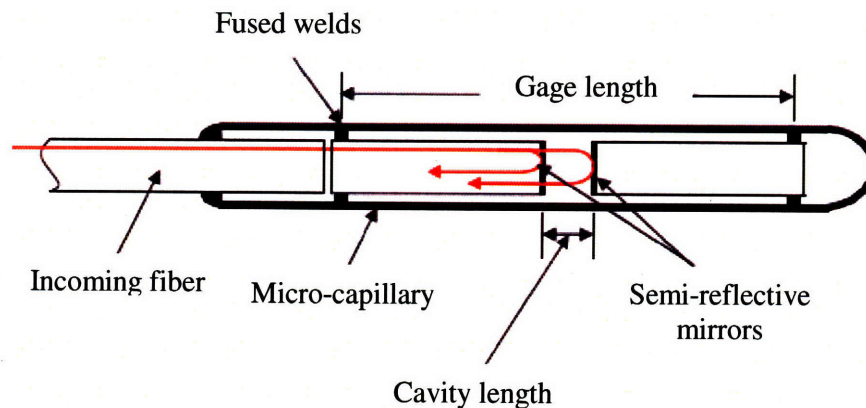
Figure 45: Extrinsic Fabry-Perot Interferometric fiber optic sensor [20].

Fabry-Perot sensors, Figure 45, are termed “extrinsic” because of the cavity between the fiber ends, resulting in a sensor output that is immune to perturbations in the input and output fibers caused by transverse loading [18, 82]. Inside the capillary housing, one fiber end acts as a lead-in/lead-out source, where as the other is a mirror reflecting the light signal back [16]. EFPI sensors, because of the rigid micro-capillary housing, limit the data to longitudinal directions and increase the resin void around the sensor resulting in stress concentrations; a factor compounded by orthogonal sensor orientations [18].

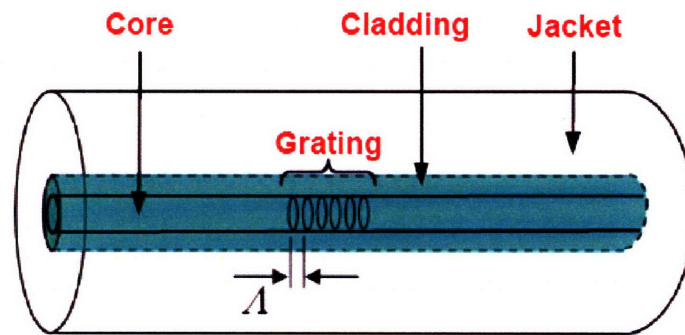
Figure 46: Fiber Bragg Grating (FBG) sensor [81].

Fiber Bragg Grating sensors, Figure 46, although more simple, are based on similar technology without the capillary housing and air-gap and are generally much smaller diameter fibers than the EFPI. FBG sensors operate on the concept of selectively reflecting a single wavelength while continually transmitting another [79, 81]. In doing this, FBG sensors are particularly adaptive to multiplexing with many sensors on one fiber spaced at known intervals and protected by the cladding and jacket. The simplicity

of construction compared to that of the EFPI makes FBG sensors particularly adaptable to use in composite laminate structures and results in a higher failure strain of 2% versus 1.2% for EFPI sensors [16].

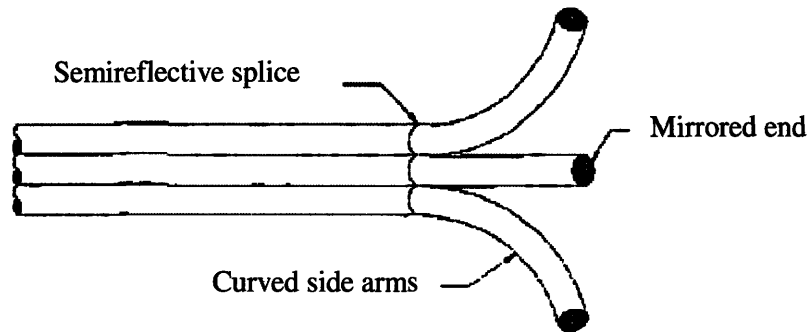
Figure 47: Fabry-Perot rosette sensor [19].

The most common result of embedding sensors is the reduction in the strength of the parent structure. In order to prevent strength loss, optical strain or temperature sensors should be embedded between laminae with the same fiber orientation [18, 84]. Aligning the sensor in parallel with the surrounding fibers prevents resin rich areas around the sensor and minimizes non-uniform stress fields, which will limit the accuracy. However, if the sensor provides damage detection information, optimum results occur when the sensor is embedded as close to the surface of maximum tensile strain as possible and oriented orthogonally between collinear layers [18, 85]. Data suggest that compressive strength for orthogonally embedded sensors may be reduced by as much as 26% [84]. In the case of a much larger embedded Fabry-Perot fiber optic rosette sensor

in neat resins and polymer matrix composites, Figure 47, the compressive strength was reduced by two-thirds [18, 19].
