EXPERIMENTAL SIMULATION OF CREVICE CORROSION OF A
FUNCTIONALLY GRADED COMPOSITE SYSTEM OF F91 AND
FE-12CR-2SI EXPOSED TO HIGH-TEMPERATURE LEAD-BISMUTH
EUTECTIC COOLANT

SUBMITTED TO THE DEPARTMENT OF NUCLEAR SCIENCE AND
ENGINEERING IN PARTIAL FULFILLMENT OF THE REQUIREMENTS FOR THE
DEGREE OF
BACHELOR OF SCIENCE IN NUCLEAR SCIENCE AND ENGINEERING
AT THE
MASSACHUSETTS INSTITUTE OF TECHNOLOGY
June 2011

ABSTRACT

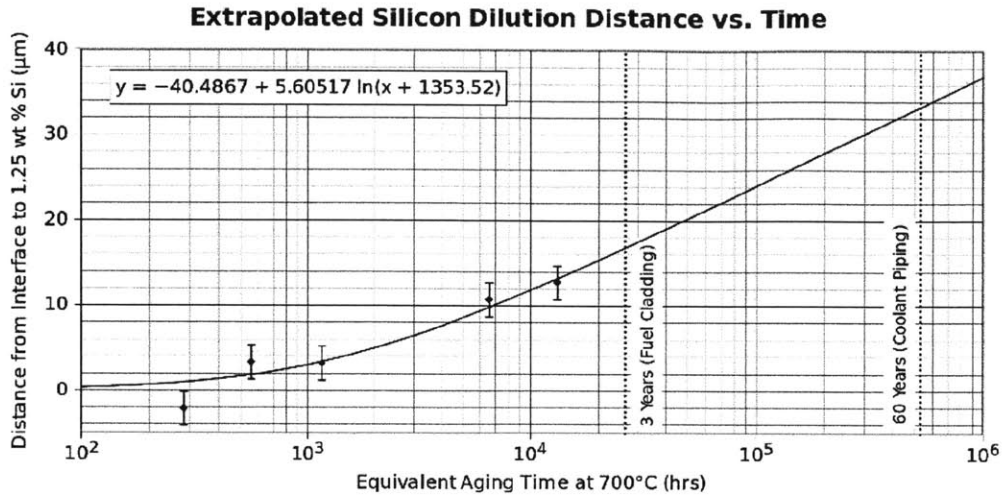
FIGURE 9. Curve showing extrapolated silicon dilution distances in the FGC. The expected lifetime of fuel cladding is three years. At this point, expected silicon dilution distance is approximately $17 \mu\text{m}$ [3].

are typically very thin: the Fe-12Cr-2Si must be thick enough that surface concentrations of silicon are not depleted. Again, results were highly encouraging, and are shown graphically in Figure 9.

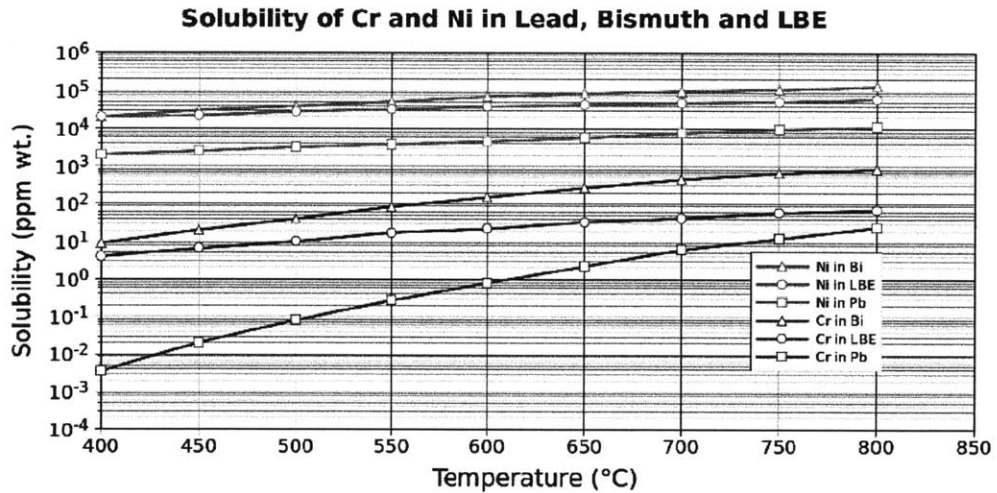
FIGURE 10. Cr and Ni solubilities in liquid LBE. Nickel's high solubility eliminates it from consideration as an alloying element in structural steels for LBE environments [3, 8].

10 shows the solubility of two common alloying elements, chromium and nickel, in liquid LBE. Nickel exhibits very high solubility, eliminating it as an alloy addition in an LBE-cooled system.

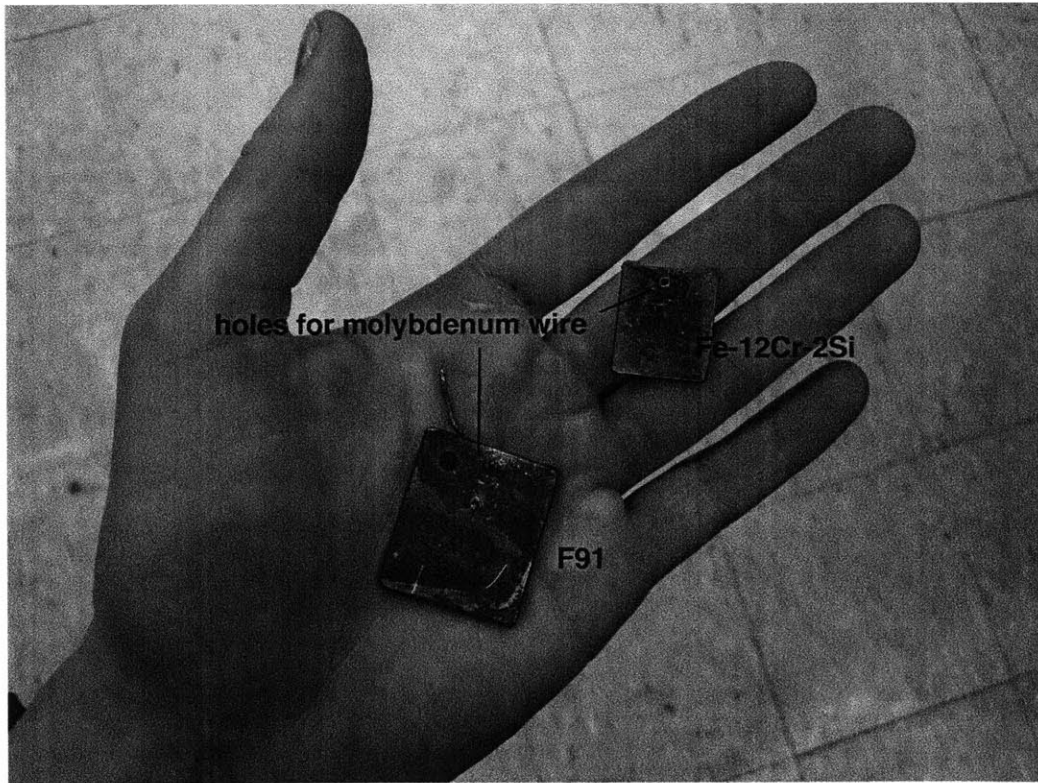
FIGURE 11. An exposed sample of F91 (bottom) is shown with an exposed sample of Fe-12Cr-2Si post-exposure. A thick, black oxide film has developed on their surfaces due to oxygen contamination during the experiment.

3.2.1. *F91 and Fe-12Cr-2Si samples.* Figure 11 shows two samples used in one of the LBE exposure experiments. The larger sample is F91; the smaller sample is Fe-12Cr-2Si. (Note that these samples were photographed post-exposure during a problematic test: the thick black oxides that developed on them were indicative of oxygen contamination.)

The F91 sample was 30 mm long; the Fe-12Cr-2Si sample was 20 mm long. Two holes³ were drilled in the top center of each sample using a 1.27 mm drill and drill press to facilitate attachment to the sample holder used during the exposure tests.

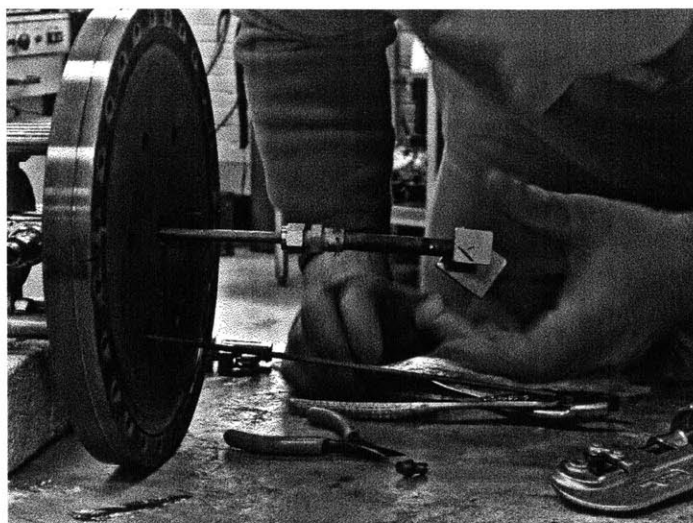
FIGURE 13. The samples being adjusted on the titanium rod. (The polished surface reflects the wood table, giving it a gold appearance in this photograph.) Note that the titanium rod was attached to the furnace lid with the same molybdenum wire, which was an ideal attachment wire in this experiment due to its strength, flexibility, and temperature resistance. The entire holder can be moved up and down. Also note the in-furnace thermocouple, which protrudes beneath the samples.

The samples were then attached to a titanium holder used during the exposure experiments with molybdenum wire, which was threaded through each of the two drilled holes to avoid sample flotation in LBE, which is denser than the metals in question. Figure 13 shows the samples being adjusted after initial placement on the sample holder; Figure 14 shows the samples immediately prior to being placed inside the furnace. The molybdenum wire was hooked to prevent the samples from slipping off. During this stage of the experiment setup, it was important to exercise caution that tools or the molybdenum wire did not scratch the polished surface of the samples.

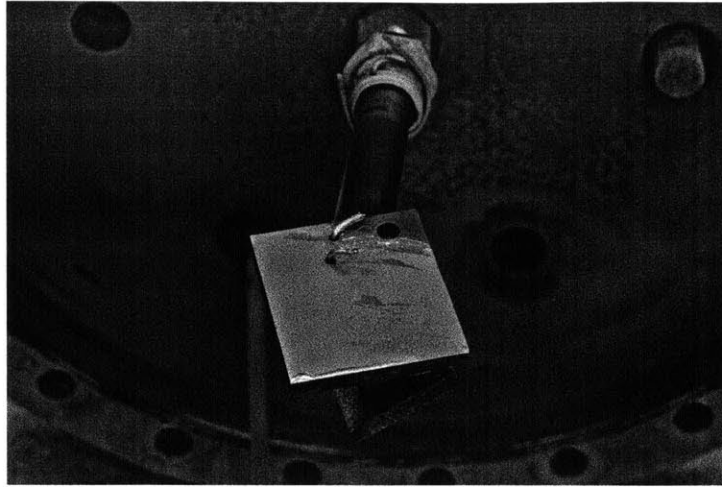
FIGURE 24. The F91 sample, after 30 hours of LBE exposure in a pure H_2 environment at $715^\circ C$. Note that the vapor film on the inside of the lid is a grayish-blue color, instead of the yellowish film observed after the second test run, indicating that oxygen contamination was not an issue in this experiment.

4.2. Test Three: Great Success! The third test run was more successful. The gas valves were closed, the samples removed from the LBE, and the furnace shut off 30 hours after the samples were initially dunked in the LBE. Figure 24 shows the F91 sample following exposure. Figure 25 shows the Fe-12Cr-2Si following exposure. The visibly large grains in the Fe-12Cr-2Si indicate the possibility of preferential corrosion for differently oriented grains: it is possible to distinguish the grains in plain light because different amounts of LBE adhered to the different grains. (LBE adhesion is a characteristic sign of corrosion damage.) Figure 26 shows the test pieces of Fe and Cr following the test. There was very minimal corrosion visible on the Cr, which was expected to oxidize more easily than Fe.
