Lessons from Accidents during Tunnel Construction

Rita L. Sousa^{*1}, Herbert H. Einstein²

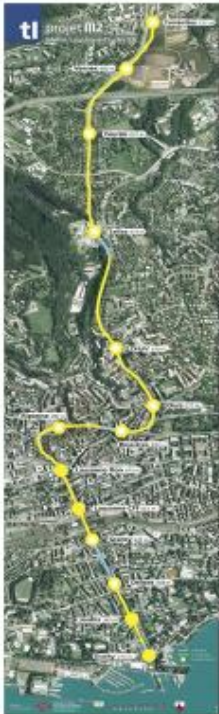
Layout of the Lausanne M2 Metro Line

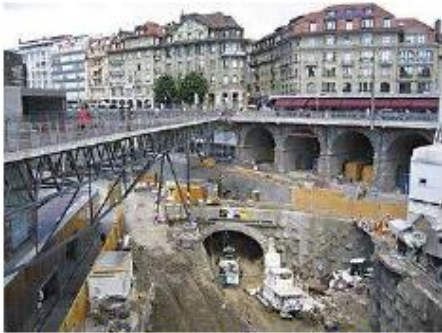
Saint-Laurent tunnel's passage under the 19th Century masonry bridge

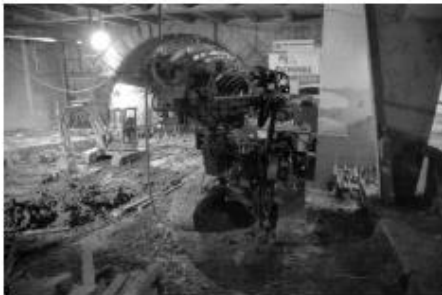
Line M2 in construction on the stretch of the former Metro-Ouchy

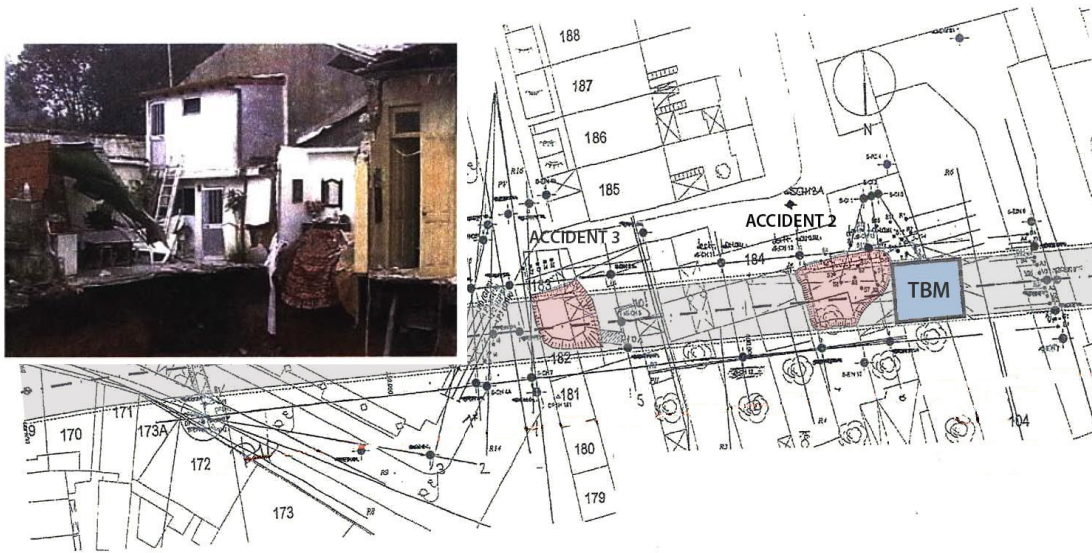
Figure 10 Collapse of Porto Metro line C in January 2001 (adapted from Forrest, 2006 and private correspondence)

As mentioned before, most events occur in the heading (face and or crown) area of the tunnel, but some behind the face. This was the case in the Porto Metro accident (Project ID 9). On January 12, 2001 the foundation underneath a building collapsed suddenly in just a few minutes, resulting in the death of one person inside the building and causing a crater at the surface with a net volume of around 250 m³ (Figure 10). The TBM had passed under building between December 16 and 18, it was stopped 50 m ahead since December 28, 2000. The stoppage was due to excessive settlements at the surface and the need to fill a cavity of around 15 m³ due to over-excavation (accident 2 in Figure 10). The above-mentioned major accident is accident 3 in Figure 10.

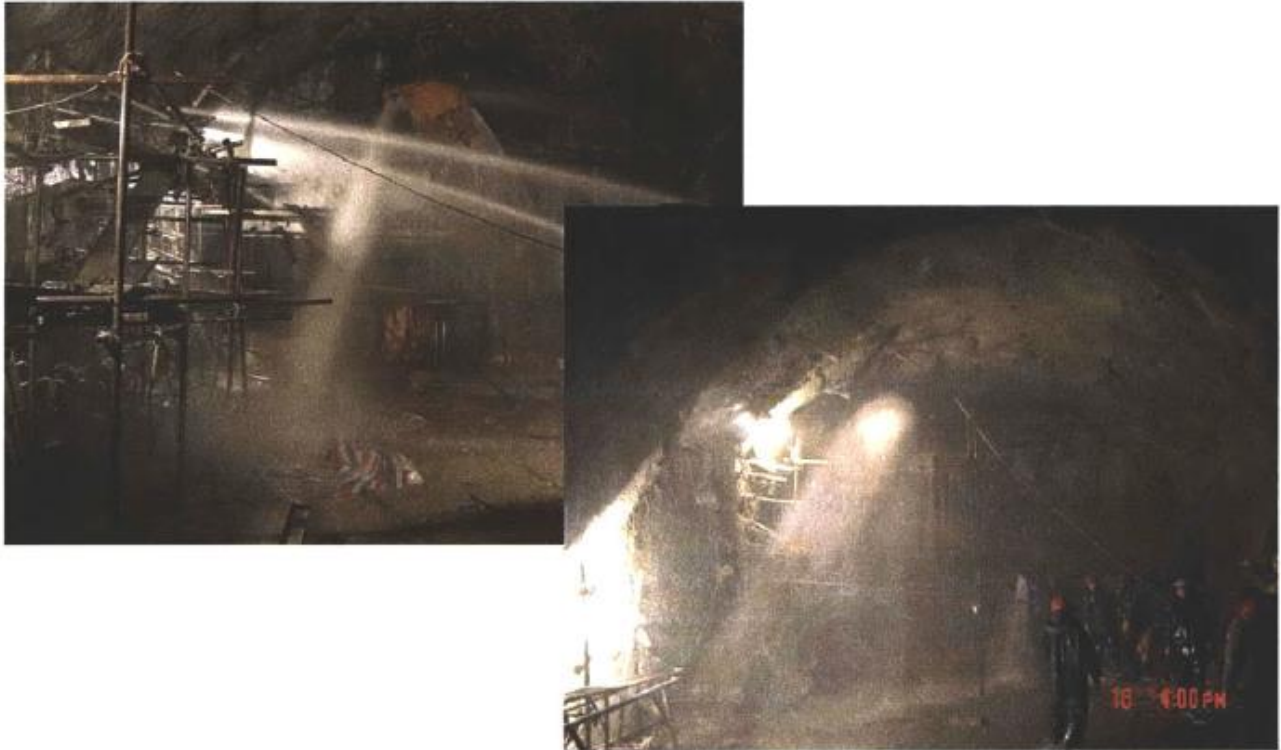
Figure 12 Water burst resulting in flooding, China (private correspondence)

A special case of water inflow is water burst which consists of water inflow under pressure in the tunnel. Figure 12 shows water bursts that occurred in a tunnel in China.

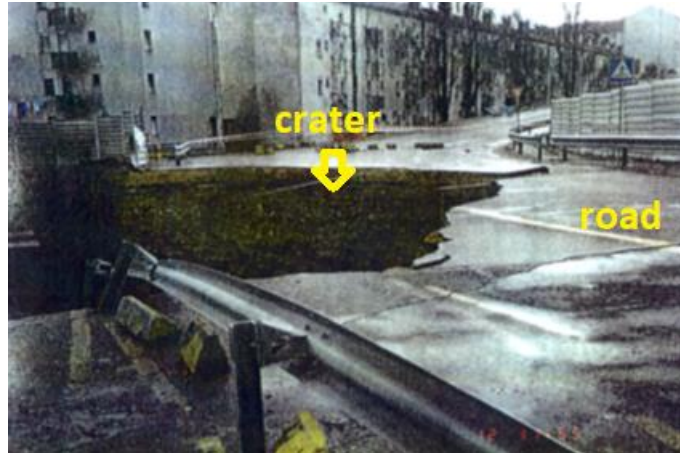
Figure 34 Collapse that occurred in Olivais Station, Lisbon, Portugal (adapted from Appleton, 1998)

Adoption of incorrect geomechanical design parameters and use of inappropriate models were some of the errors that occurred in the case of Olivais metro (Project ID 10) in Lisbon (Figure 34), where the geomechanical parameters used in the design numerical calculations were overestimated (Appleton, 1998).
