Gaining mechanistic insight into key factors contributing to crack path transition in particle toughened carbon fibre reinforced polymer composites using 3D X-ray computed tomography

Keiran Ball^{a,*}, Yeajin Lee^a, Carolina Furtado^b, Albertino Arteiro^c, Palak Patel^b, Marta Majkut^d, Lukas Helfen^e, Brian L. Wardle^b, Mark Mavrogordato^a, Ian Sinclair^a, Mark Spearing^a

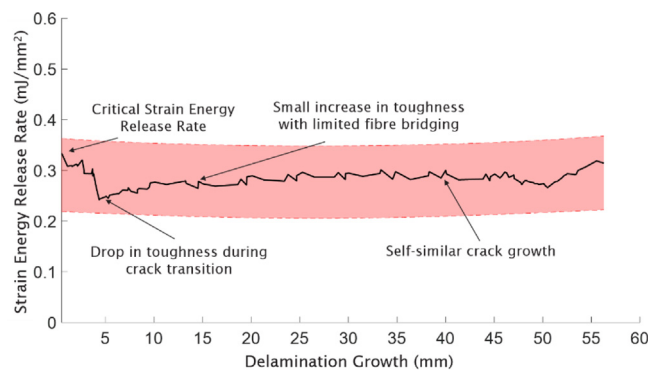
A delamination resistance curve (R-curve) is shown in Fig. 1. The SERR is the energy dissipated during fracture per unit process of a newly created surface area. The strain energy release rate (SERR) for six specimens of the same material system have been plotted. The red shaded area around the data is the 95% prediction interval for a fitted second order polynomial curve through the data. The R-curve shows an initial drop in toughness when the crack begins to propagate over a crack growth length of 5 mm, where the toughness decreases by 29%. The toughness then increases with further delamination to be larger than the initial toughness of the material before falling slightly and levelling out to become relatively flat or self-similar. Finally, at the end of crack propagation, the toughness falls below that of the critical toughness of the material at crack initiation.

Fig. 1. Variation in strain energy release rate with delamination length during DCB test plotted with the 95% prediction interval.

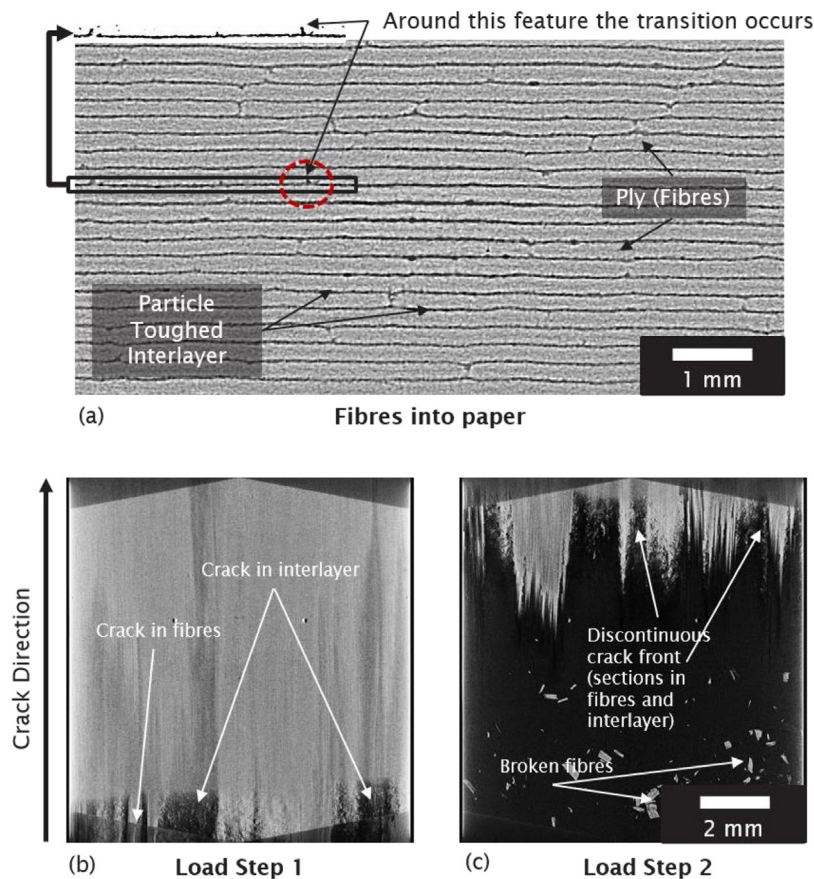
Fig. 2(a) shows the cross-section through a CFRP specimen. Several features are notable such as the distinct interlayer in between plies. This is formed as a result of the TP's forcing a ply separation. There are also some regions of resin pockets where the interlayer appears thicker than the regions immediately either side. The circled part of the image has been segmented and shows a gap in the ply adjacent to the interlayer. When this region was mapped to the fracture surface of the specimen, it could be seen that this was the location of a so-called 'trigger' region where the crack began a transition to the ply. Fig. 2(b) and (c) shows a plane through the crack with the crack growth direction from the bottom of the image to the top. The first step of loading is shown in Fig. 2(b), where the crack being in the interlayer is distinguished by the indistinct texture on the image, whereas the more defined 'finger-like' structures indicate the crack propagating within the ply. The same frame of the subsequent step is shown in Fig. 2(c), where most of the frame is taken up by the wake of the crack. Broken fibres are visible in the wake of the crack. At the top of the image, the crack has transitioned in some regions from the interlayer to the ply.

Fig. 2. (a). Cross-section through CFRP sample with the fibres into the screen showing variation in interlayer thickness and fibre tow gaps. (b). Step 1 of the in situ load increment shows the crack in different layers of the composite. (c). Step 2 of the load increment in the same frame. The wake of the crack can be visualised, showing the transition of the crack to the ply.

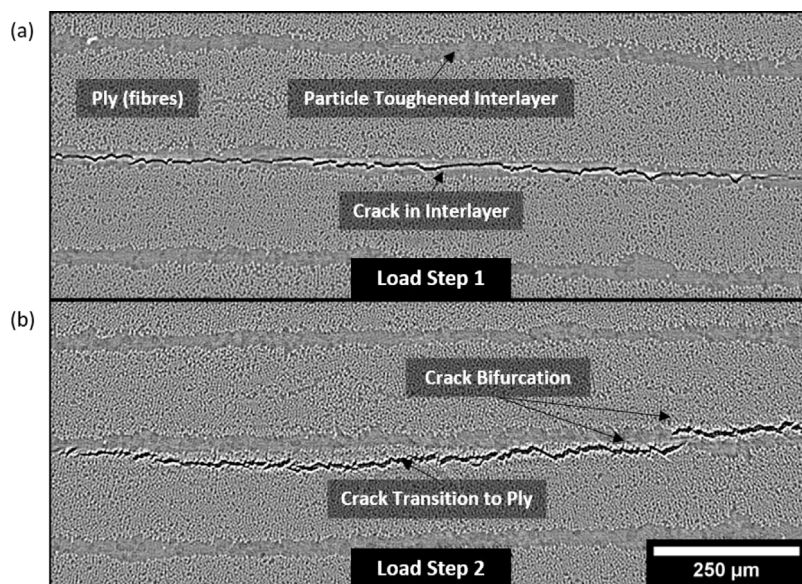
The first load step during an *in situ* SRCT experiment is shown in Fig. 3(a). The fibres in the ply layers can be clearly distinguished, as can the resin-rich interlayer regions between them. The bright edge around the crack is caused by phase-enhanced contrast, and the resulting fringe allows for a clear distinction of the crack boundaries. In the first load step, the crack remains within the PT interlayer and along the interlayer-ply interface. Fig. 3(b) shows the subsequent step in the experiment near the new crack tip further into the specimen. The crack can be seen to have transitioned to the ply in the central region of the image. The transition corresponded to a transition through the ply boundary in the width direction of the image and has bifurcated towards the RHS of the image.

Fig. 3. (a) The first load step in the SRCT experiment. The crack can be seen to be in the interlayer for this section of the sample. (b) In the second load step and along the same section of the specimen, the crack has partly transitioned to the ply.
