**Community-Based Water Supply:
Tubewell Program in Lumbini Zone, Nepal**

Submitted to the Department of Civil and Environmental Engineering
in Partial Fulfillment of the Requirements for the Degree of
Master of Engineering in Civil and Environmental Engineering

Massachusetts Institute of Technology

June 2002

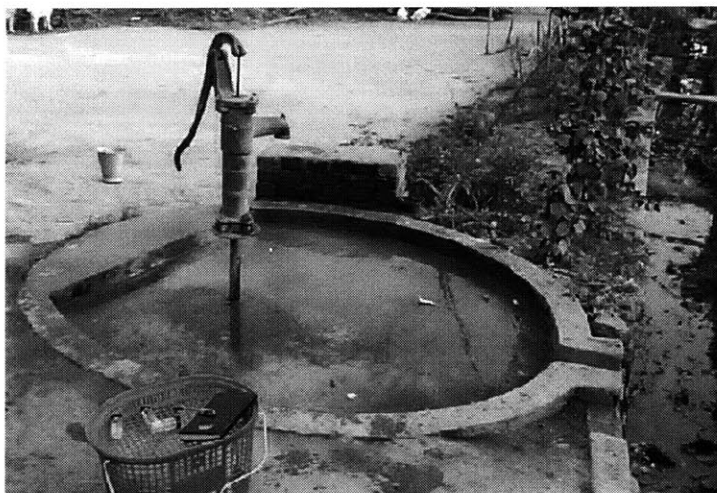
Figure 1-2. A Tubewell

shown in Figure 1-2. There are household (private) tubewells and community (public) tubewells. In the Terai area, on average about 8 households share one public tubewell[♣]. Some of the private household wells are used by outsiders, too. There has been an effort to install tubewell by various agencies in Nepal, because:

A tubewell should be sealed with a concrete platform at the base and connected to a drainage channel, as shown in Figures 1-2 and 2-2. The drainage channel drains off excess water and keeps the surrounding of the platform dry. In a well-constructed platform, the disposal channel drains into a soakage pit, which is a pit dug at the end of the drainage channel and filled with gravel or broken bricks. The pit receives water coming through the channel and keeps the surrounding dry. A platform serves three important purposes:

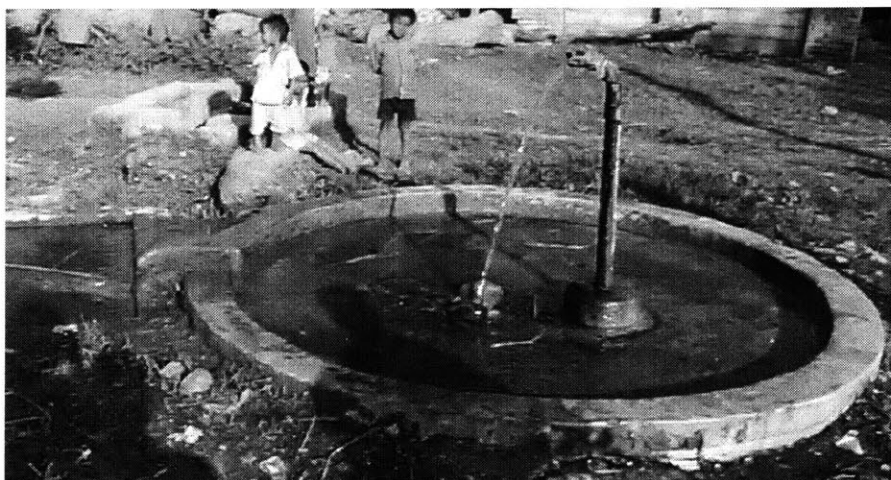
Figure 2-2. An Artesian Well

An artesian well is a well in which the water level rises above the top of the confined aquifer*. In some cases, the water level actually rises above the ground surface, then the well is known as a “flowing artesian well”¹⁴. In Nepal, a flowing artesian well equipped with a pipe or a tube is usually referred to as an “artesian tubewell”. Water flows out of the tube continuously without the need of pumping, as shown in Figure 2-2.

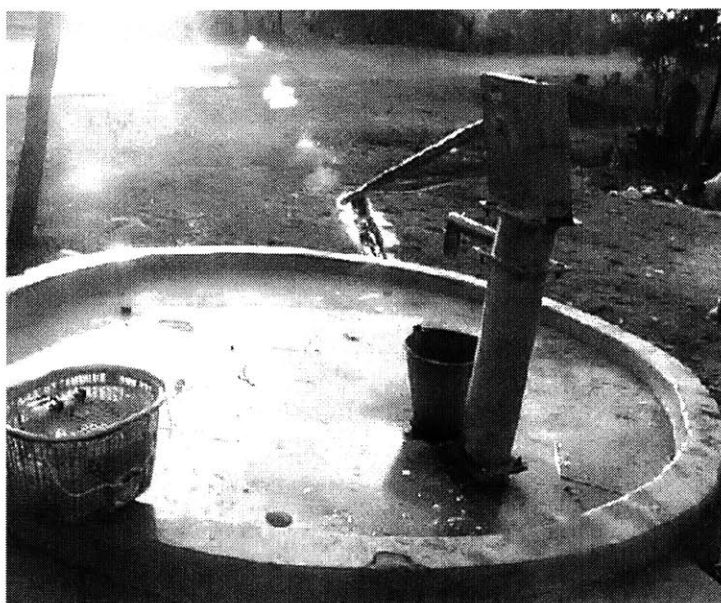
Figure 2-5. A Lift Tubewell

In a lift handpump, the working principle is similar, but the piston assembly is inside a cylinder, which is connected to the handle by a connecting rod, deep down in the borehole. Lift handpumps are used to extract water from deep aquifers. Therefore, tubewells fitted with lift handpumps are referred to as deep tubewells. The lift handpumps used in RWSSSP are India Mark II/III as shown in Figure 2-5. Figure 2-6 shows the details of a lift tubewell.

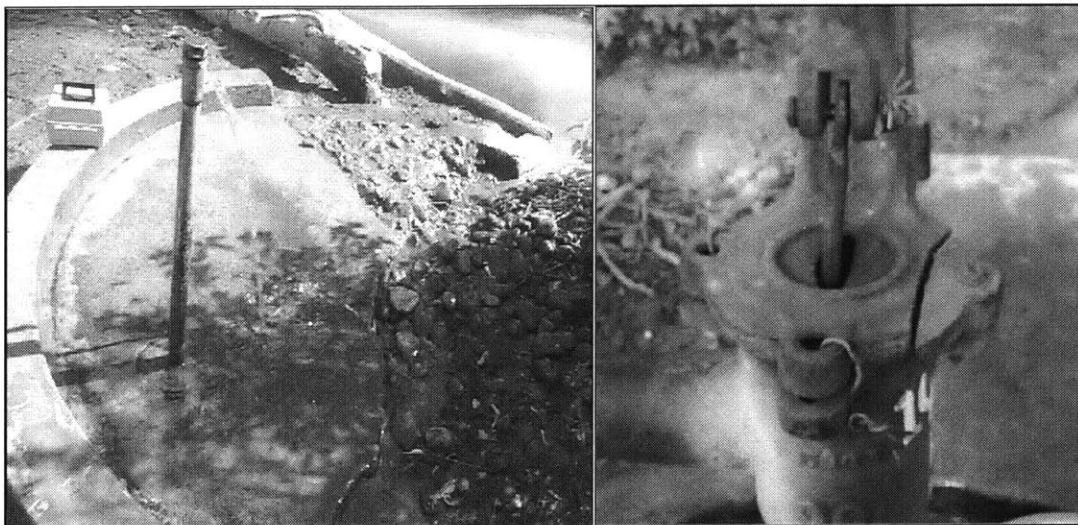
Figure 3-1. A Broken Platform and A Broken Handpump

First, some of the platforms were in bad condition in which case, dirty water could infiltrate into the well. Second, some handpumps were broken– nuts and bolts were missing– but no repair was to be carried out. A rope or an iron wire would be used to replace the missing nuts or bolts. Mud would be used to fill the cracks on a pump body to stop leaking. A broken handpump is not water-tight, therefore, bacteria can get into the well. Figure 3-1 shows an example of a broken platform and an example of a broken handpump. Third, in some cases, the users were not concerned about these problems, since the well was “working” anyway. Fourth, in some other cases, the users reported the breakdown to the user committee, but the user committee just ignored the problem, or no funds were available to fix the problem. This is a clear indication of inadequate maintenance.

1. Platforms in bad condition leading to wastewater infiltration.
2. Broken handpumps.
3. User who were unconcerned about tubewell problems.

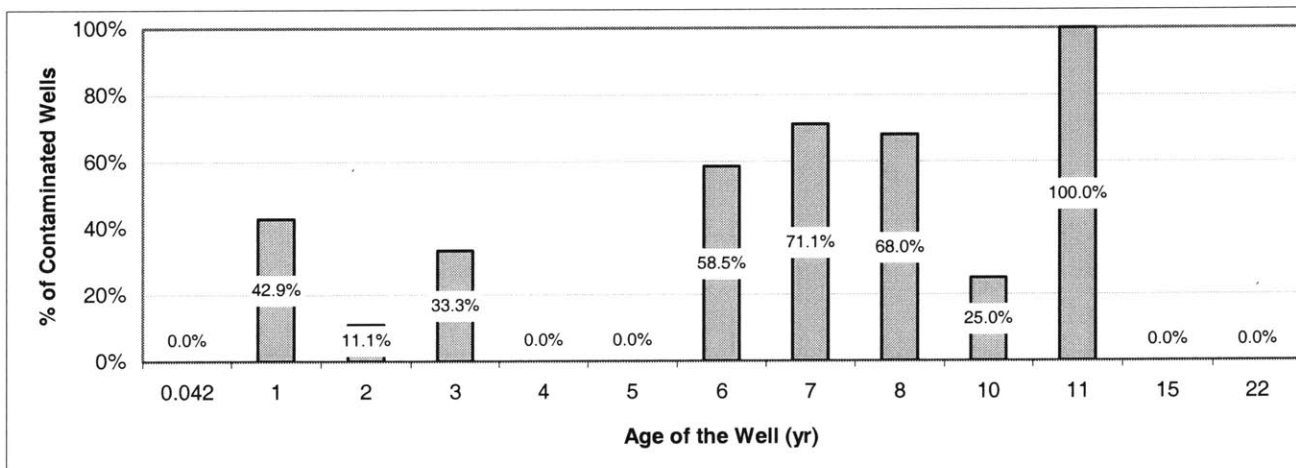
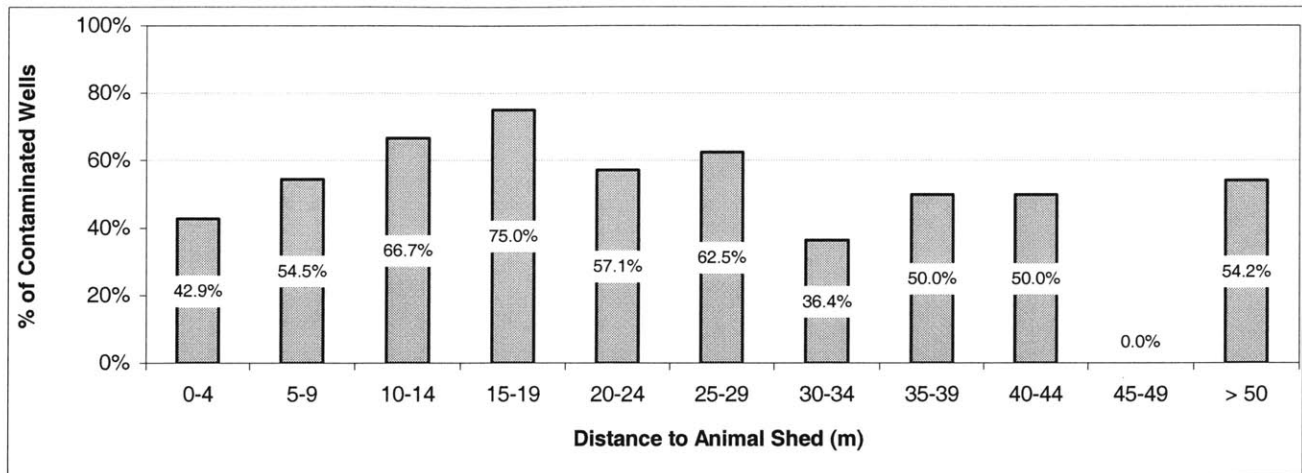
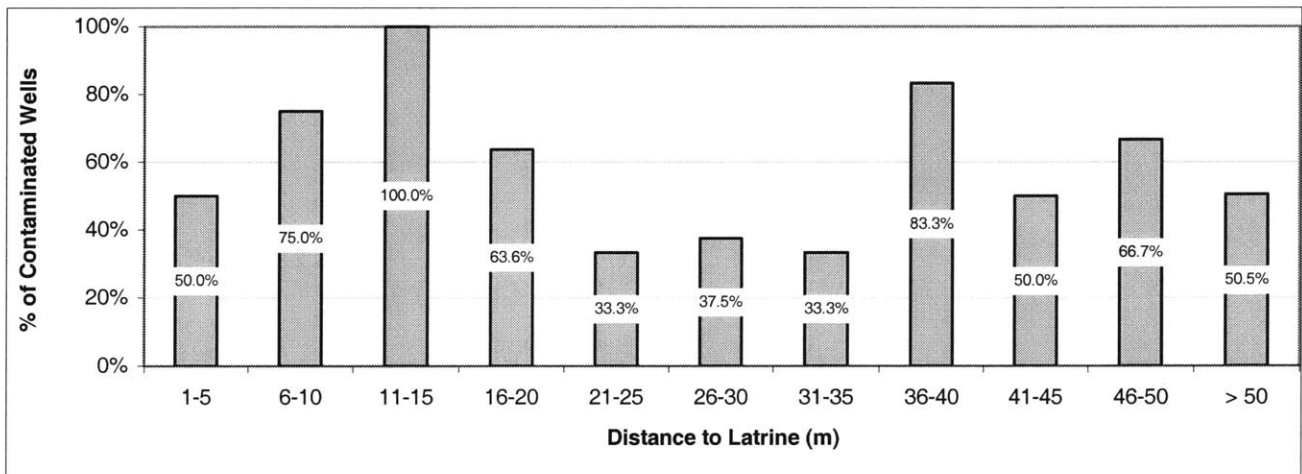
bin and the percentage of contaminated wells within that bin is calculated. Figures 3-2 to 3-5 show the results of the analysis of the first four parameters graphically.

Figure 3-2. Percentage of H₂S Bacteria Contaminated Wells vs. Number of Users per Well

Figure 3-3. Percentage of H₂S Bacteria Contaminated Wells vs. Age of the Well

Figure 3-4. Percentage of H₂S Bacteria Contaminated Wells vs. Distance to Latrine

Figure 3-5. Percentage of H₂S Bacteria Contaminated Wells vs. Distance to Animal Shed

Figures 3-2 to 3-5 show that the first four parameters do not contribute to the H₂S bacteria contamination— the percentage of contaminated wells varies randomly as the values of the parameters increase. These random changes in the percentage of contaminated wells imply that the first four parameters are very unlikely to be the causes of the contamination.

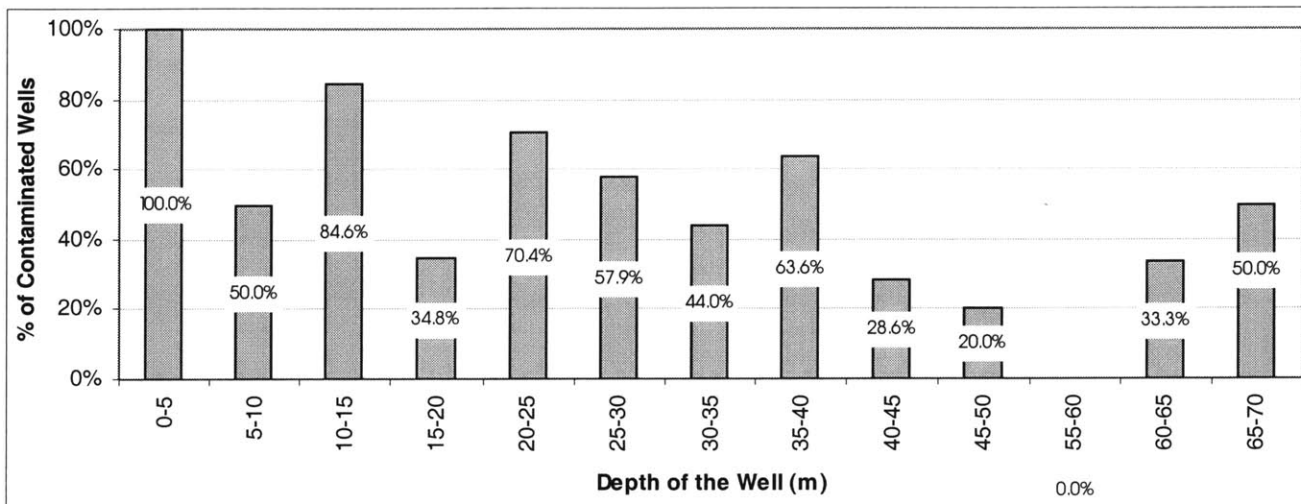
Figure 3-6. Percentage of H₂S Bacteria Contaminated Wells vs. Depth of the Well

Figure 3-6 shows the analytical result for the fifth parameter. It seems that there is a slight trend of reduction in the percentage of H₂S bacteria contamination as the depth of well decreases. In 1991, FINNIDA commissioned a groundwater resource study¹⁸. It was found in the study that most of the tubewells withdrew water from the topmost aquifer (first layer) for

domestic use. The water redrawn from this aquifer was not microbially safe, because direct percolation of wastewater from the surface was high. For this reason, RWSSSP has been constructing tubewells, which withdraw water from the second aquifer, 18 to 69 meters deep¹⁹. It was also found that the actual depth of the aquifer differed from place to place.

Because all RWSSSP tubewells are constructed into the second aquifer, it will take a long time (on the order of years) for the contaminated surface water to travel from the surface to the aquifer. Bacteria will have died out within that period. Therefore, even though one might assume that the nearer a tubewell is to a latrine or a animal shed, the higher the risk of contamination there would be, the data analysis of these two parameters shows that the distance to latrines or to animal sheds do not contribute to the problem of contamination. Nevertheless, it is still good practice not to build the wells near latrines and animal sheds, because the foundation or platform of the well may be damaged and dirty water that leaks from the latrine or animal sheds may percolate through the soil and reach the second aquifer.

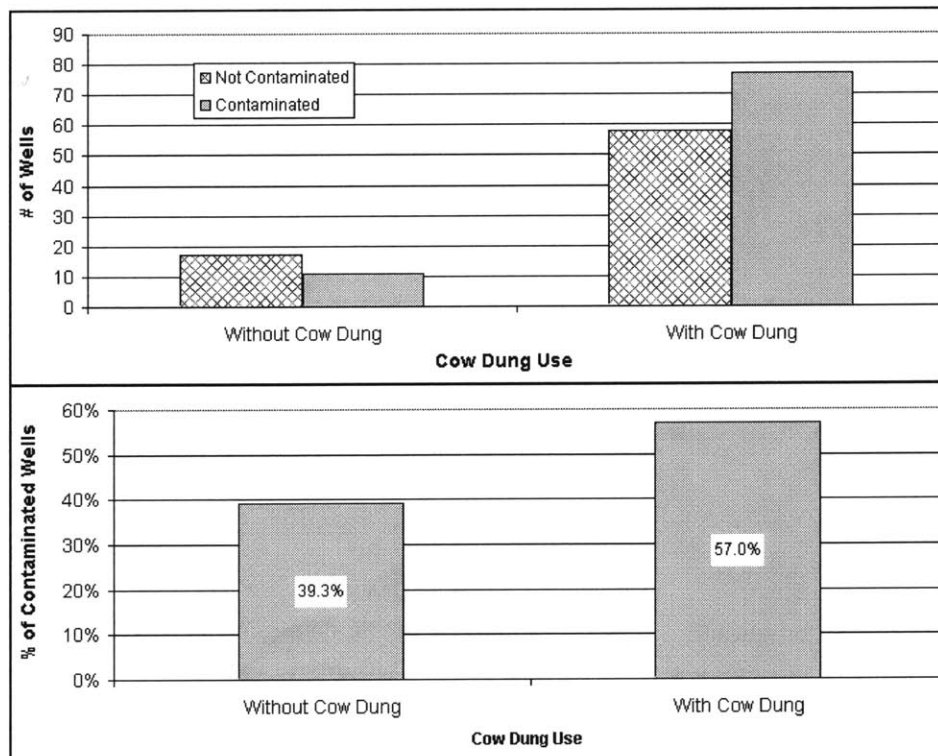
Figure 3-7. Level of H₂S Bateria Contamination vs. Use of Cow Dung

Table 3-1 shows the numbers of tubewells that were constructed with and without cow dung within that 163 well data set. It also shows how many of these wells were found to be contaminated with H₂S bacteria. The result is also shown graphically in Figure 3-7. As seen from the figure, there is an increase in the percentage of contaminated wells “with cow dung” compared to “without cow dung” to (17.8% increase). This indicates that the use of cow dung in the construction process may be a contributing factor to the H₂S bacteria contamination.

Number of Wells
Without Cow Dung	Not Contaminated	17
	Contaminated	11
With Cow Dung	Not Contaminated	58
	Contaminated	77

Using cow dung is a traditional way of building tubewells in Nepal. The primary concern with using cow dung is not primarily the fecal pathogens in the cow dung, because fecal pathogens will die out quickly after leaving their host. How long pathogens remain viable in water after they leave their host varies with the species. Typically, the pathogens lose their viability and ability to infect exponentially with time. Hence, cow dung will not affect the microbial quality of the well water in long term. In her microbial water quality survey in Lumbini, Nepal, MEng student Hannah Sullivan found that wells that were constructed with cow dung just several days prior to sampling show extremely elevated level of contamination by fecal coliform bacteria, sometimes on the order of 10,000 CFU per 100 milliliter (CFU/100 ml)²⁰.

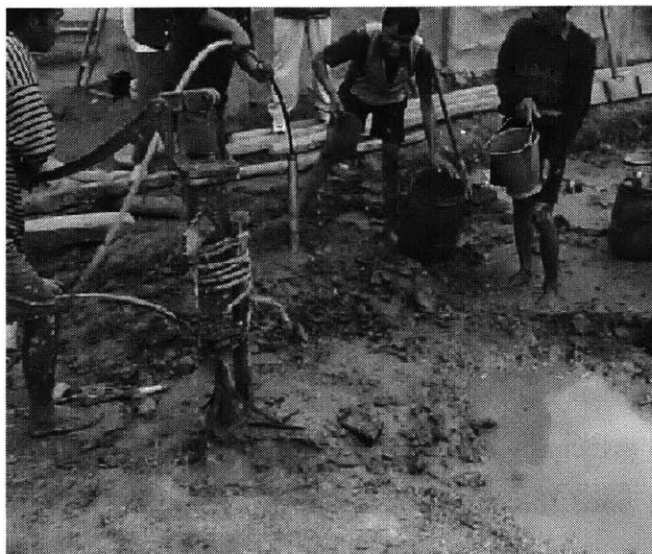
Figure 5-1. Construction of a Tubewell

Another problem in the tubewell program is that as soon as the handpump is installed, a platform is supposed to be constructed. However, sometimes, due to financial constraints or delays in the decision-making process, the cement needed to construct the platform cannot be

purchased on time. The following picture shows a tubewell under construction. Contaminated water might percolate into the well through the mud after the tubewell is constructed. At this particular site, I was told that the platform would not be constructed for 22 days, because the UC had not purchased the cement early enough.
