*Multi-Physics Nano-Engineered  
Structural Damage Detection and De-Icing*

# MULTI-PHYSICS NANO-ENGINEERED STRUCTURAL DAMAGE DETECTION AND DE-ICING

**Keywords:** *Hierarchical Structures, non destructive evaluation, de-icing, carbon nanotube*

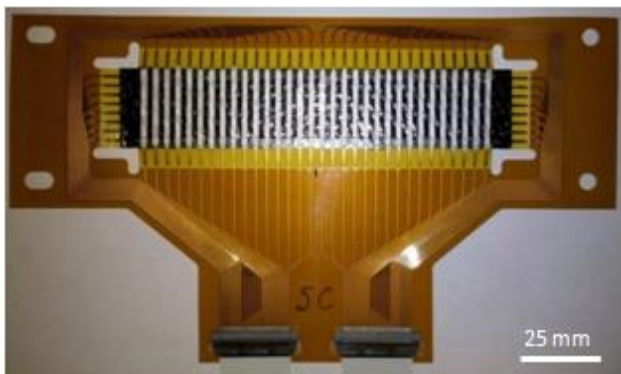
Fig. 1. Ice-detection sample. The electrodes (perpendicular white lines) were printed by direct writing.

Once the feasibility of using nano-engineered composites for direct de-icing applications has been demonstrated via Joule heating, an ice-detection system was developed for controlled de-icing and anti-icing applications. Ice-detection here is based on effective heat capacity, where power is applied to a 115×25×2 mm<sup>3</sup> nano-engineered specimen for seconds, and the slope of the temperature rise is shown to be well correlated to the thickness of ice present. Silver epoxy vertical electrodes (32) on the top face and horizontal electrodes (8) on the back face were printed and connected to a DC power supply (see Figure 1). Two thermocouples were mounted, one on the center of the specimen and the other ~15 cm to the left of the center of the sample. Different amounts of water were poured on top of the sample, cooling it down to -15 °C to cause icing. A vacuum tape frame was assembled around the specimen to prevent water leaks [8].

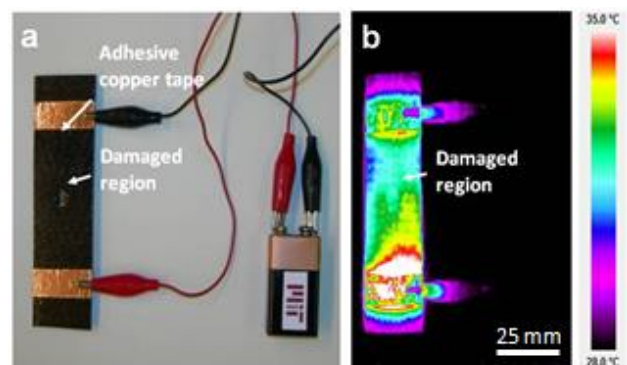
Fig.2. Power and resolution characteristics of nano-engineered non-destructive evaluation (NDE) technique: (a) optical image and (b) thermograph of a composite specimen powered by a 9V battery.

When a potential difference was applied to an impact damaged nano-engineered composite (Figure 2), electric field lines concentrate in the vicinity of cracks as electrons flow around the damage, causing “hot spots” via Joule heating. This effect was

amplified because the heat flow was impeded in areas of damage. These changes of temperature can be locally visualized through a conventional IR thermal camera. Low-power operation (a nine volts standard battery is exemplary, providing a 15 °C rise at 1 Watt) and high spatial resolution was demonstrated that is beyond state-of-the-art in non-destructive evaluation [7].

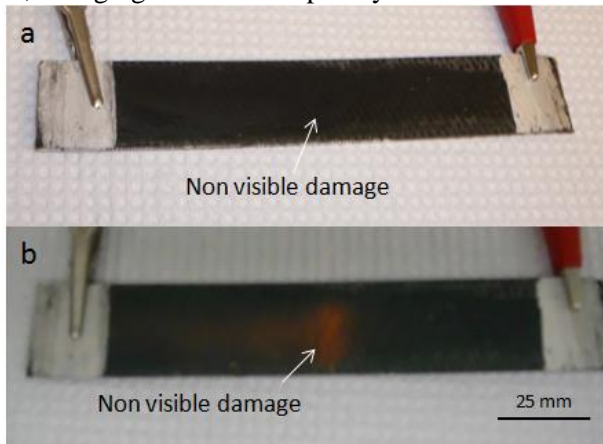
Fig 3. Optical damage detection: (a) Optical image of a composite specimen with non visible damage in the center: (b) When a difference of potential is applied (9V battery), a change of color is produced in the damaged region.

different temperatures. When a potential difference is applied to a specimen with a non visible damage (Figure 3), Joule heating increases the temperature of the specimen. The electric field lines concentrate around the damaged area, producing an increment of temperature, which can be detected as a red color on the non visible damage region 25 seconds after the power is applied (Figure 3). If the voltage is applied for longer times, the whole sample heats above 30 °C, changing its color completely.

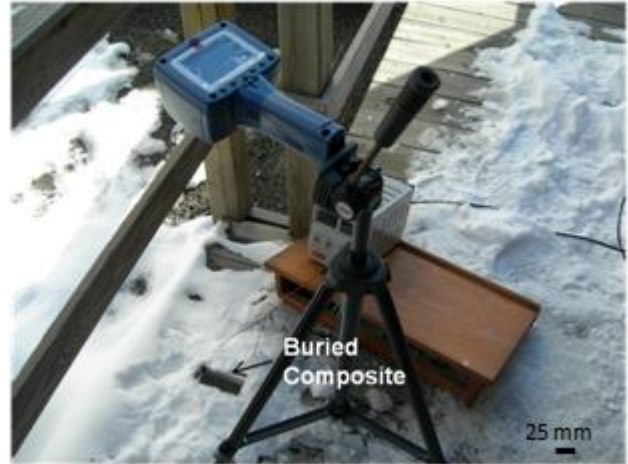
Fig.4. De-icing experimental setup of the heated (22.2W for 15min) composite material embedded in snow (-10°C, 2.5cm of snow thickness).

The nano-engineered composite material is investigated for another multifunctional application: de-icing and anti-icing. Icing, in the flight environment with a temperature range from ~ -40°C to 0°C, is a serious problem that has caused several aircraft incidents. The nano-engineered composite has demonstrated the capability to reach high temperatures to melt ice (see Figure 4) using very low power: a composite specimen (9.6 cm<sup>3</sup> in volume) buried under 25-mm-thick snow (ambient

temperature -10°C) melted in 15 minutes at 22W power.

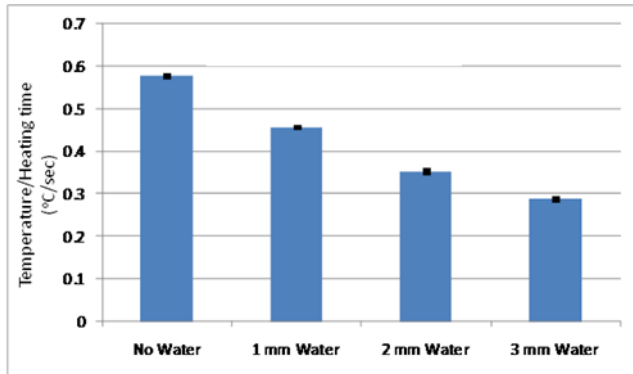
**Figure 5. Heating rates of several specimens with water on the surface placed at -15 °C.**

This algorithm is in agreement with the experimental values of several specimens at -15 °C ambient temperatures with varied thickness (0, 1, 2, 3 mm of water) of ice on top of them (see Figure 5).
